DISSERTATION

STRUCTURAL HEALTH MONITORING IN ADHESIVELY BONDED COMPOSITE
JOINTS

Colorado State University

Spring 2024

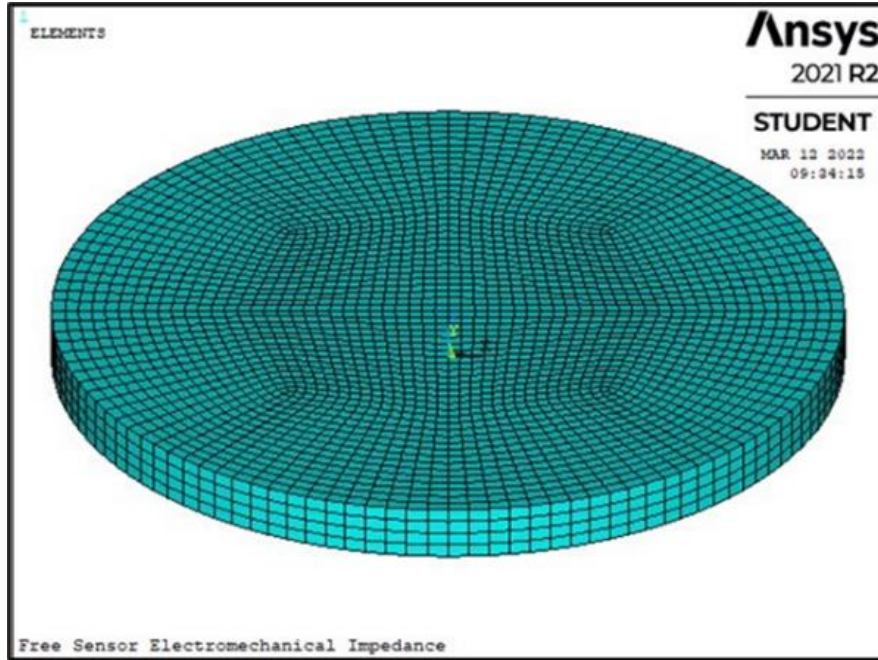
Prior to performing the sensor free boundary state experiments, an analytical model of the sensor is created using the Ansys²⁶ code to simulate the impedance response. The model is shown in Figure 13 and is run in the free boundary condition state to match the experiment. The element

mesh density through the thickness is initially selected at 4 elements. Note that element density along the radial and thickness axes can be increased if model calibration is required. The SOLID226 20 node element is used to represent the sensor since it includes a voltage degree of freedom for impedance analysis.

Figure 13. Sensor disk analytical model.

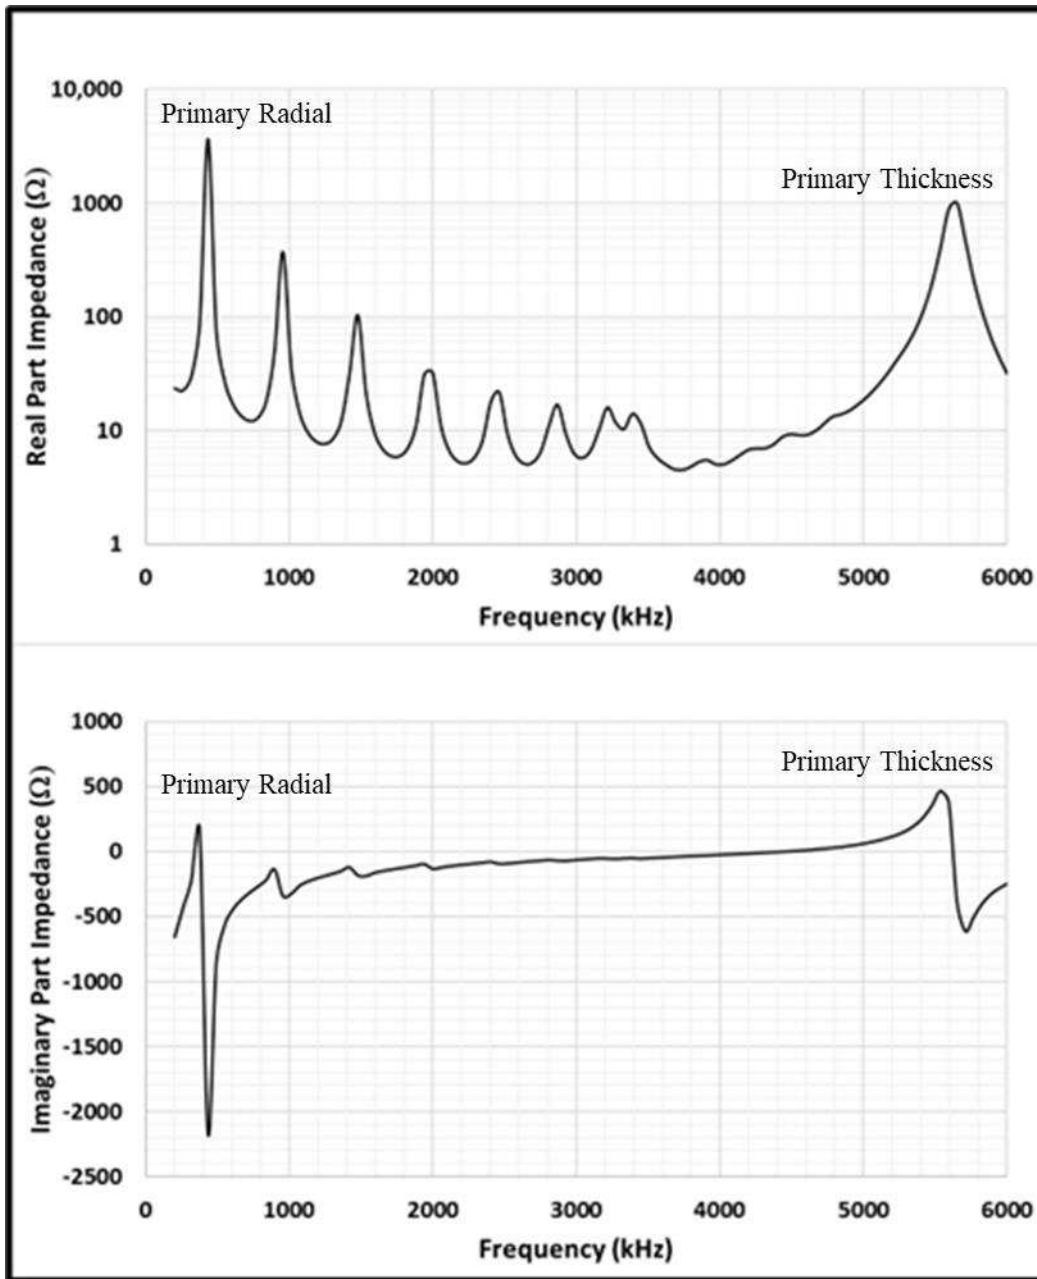
where $[C_p]$ is the stiffness matrix, $[\epsilon_p]$ is the dielectric matrix, and $[e_p]$ is the piezoelectric matrix²⁷. The density of the sensor material is 7600 kg/m^3 . In order to represent the experiment, a coupled field harmonic analysis is run by applying a unit voltage differential between the upper and lower disk surface and recovering the generated charge that is summed to create the induced current. The current response and the applied unit voltage level are used to compute the electromechanical impedance. The frequency analysis was run at 1 Hz intervals in the range of 200 kHz to 6000 kHz to cover the radial and thickness response resonant frequencies. The free sensor analytical impedance response (real and imaginary) is shown on Figure 14 with the primary radial and thickness resonances noted.

Figure 14. Free sensor analytical impedance response.

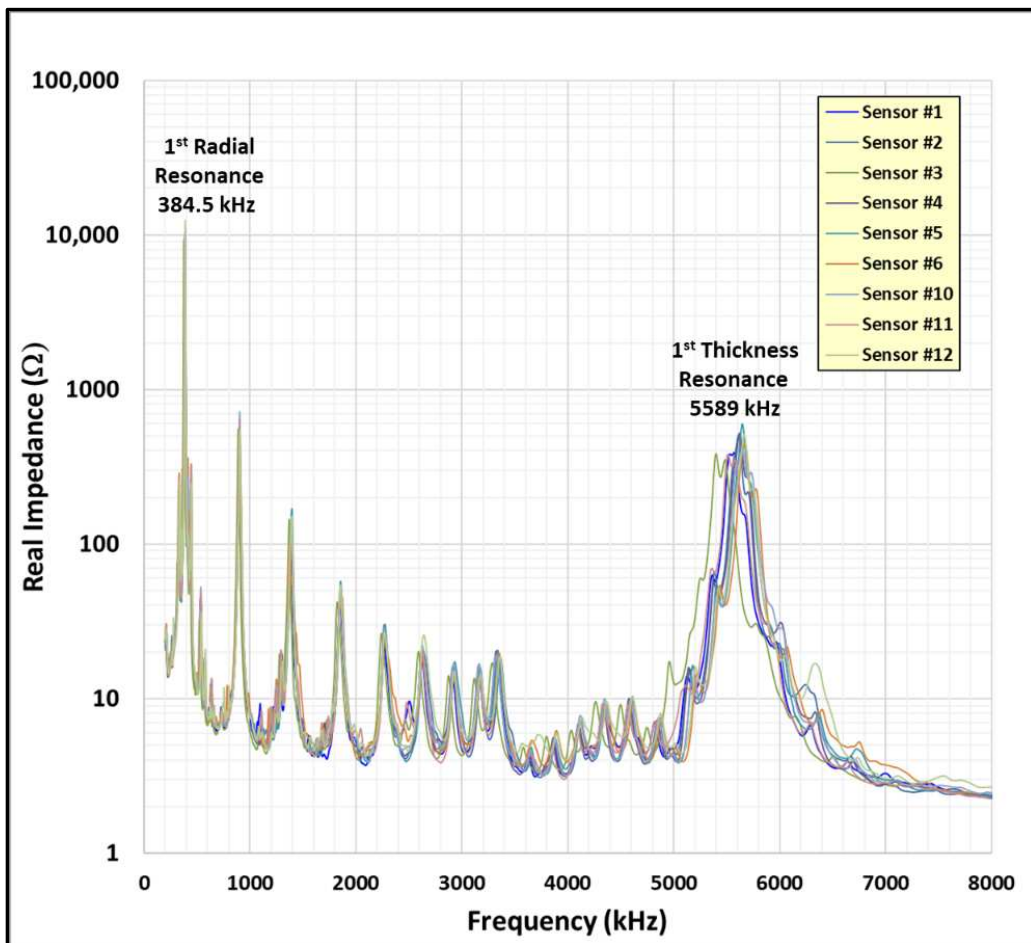
excited²⁸⁻²⁹. The voltage is applied in a linear frequency sweep from 200 kHz to 20000 kHz. The frequency sweep takes about three minutes to complete and comprises 16501 frequency points. For the first sensor test, the sweep is run multiple times obtaining the same results. After that, each additional sensor is tested only a single time. For each run, the data is exported for plotting. The real part of the electromechanical impedance, for each of the 9 sensors, is plotted on Figure 15. The strongest peak is the 1st radial resonance occurring at an average of 384.5 kHz. The thickness resonance occurred at a higher frequency (5589 kHz), since the disk is thin compared to its radius.

Figure 15. Free sensor real impedance response.

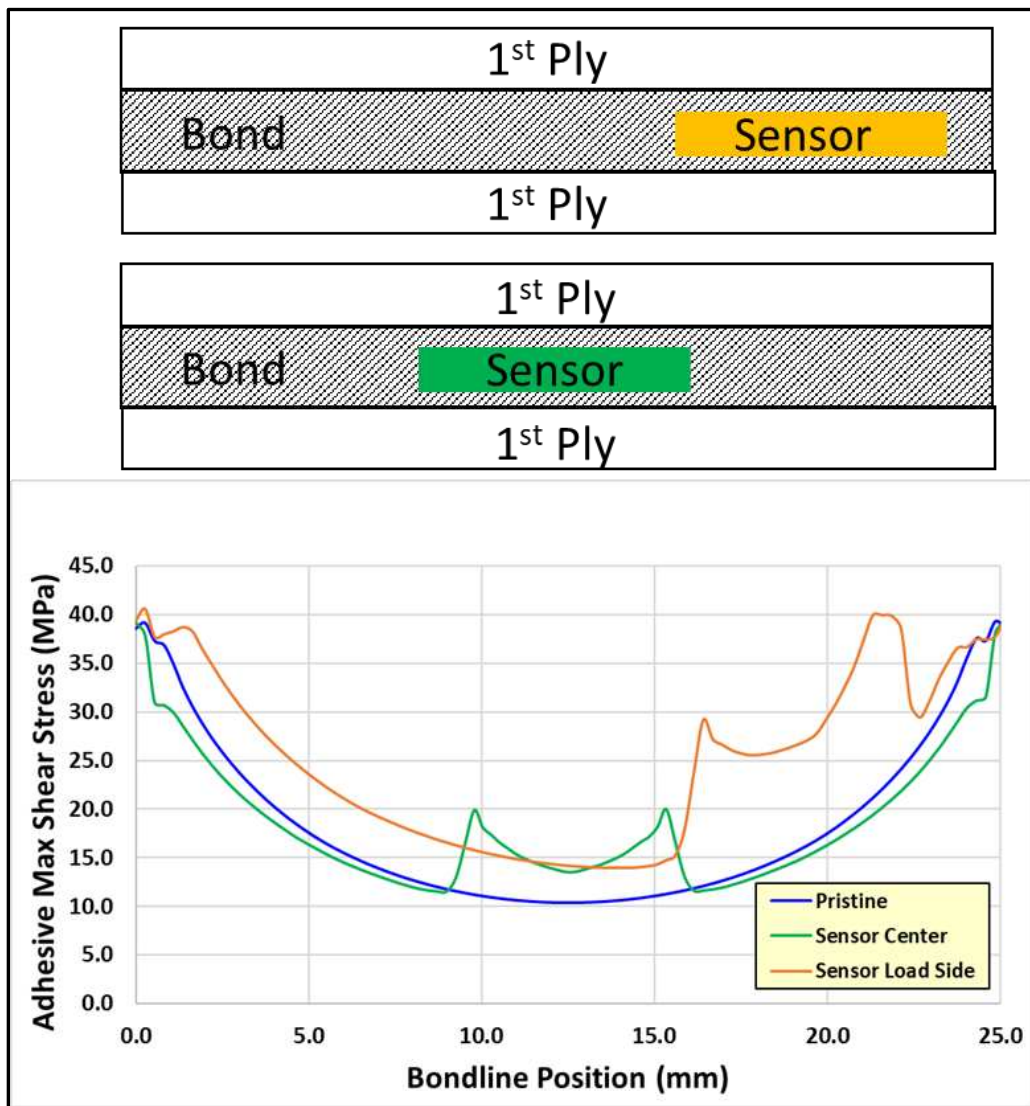
The sensor is directly connected to the adhesive elements at the nodal locations. The model is run statically with one end constrained and an enforced displacement applied to the free end. The sensor mechanical properties are the same as previously presented. The sensor took up approximately 4% of the shear bond area, so no significant joint degradation is expected due to a simple reduction in the bond area related to the embedded sensor. The simulation results showing the maximum shear stress distribution through the bondline are shown on Figure 17 for the pristine, center-embedded sensor, and load end-embedded sensor.

Figure 17. Analytical lap shear adhesive bond maximum shear stress distribution.

For the pristine case, it is seen that the maximum shear stress through the bond thickness occurs at the endpoints of the bond area. There is about a 4:1 ratio between the center and endpoint maximum stresses. The analytical results further indicate that the shear bond performance degrades when the sensor is embedded in the area of maximum shear stress as indicated on Figure 17 showing a higher maximum shear stress in the bond. There is a stress concentration at the edge of the bondline and adding the sensor to this location results in a higher imposed shear stress than the pristine case and may result in premature failure initiation. Embedding the sensor at the center of the bond (the minimum stress position) results in a similar sensor effect on the stress distribution, but due to the location, the stress intensification at the sensor edges does not approach the stress seen in the pristine case at the bond endpoints. Based on these results, the bondline sensor locations for testing are selected to be the center position and the load end position. This covers the range of minimum to maximum sensor effect on the bondline shear stress distribution.

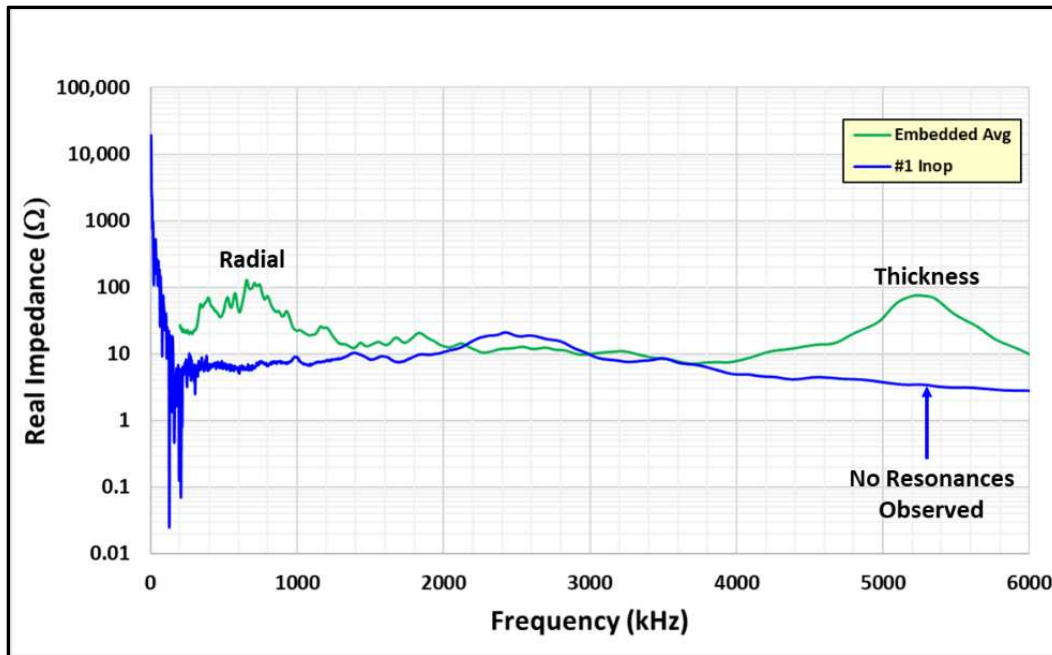
frequency range of interest. This may be due to problems occurring during the coupon bonding operation and demonstrates a need for redundant sensors if these are used in aircraft film adhesive bondline integrity monitoring. Due to this result, only the four coupons with functioning sensors are tensile tested. These are coupons 2, 3, 11, and 12. Figure 24 shows a plot of the real and imaginary components of the embedded sensor impedance. These embedded sensors are averaged and show a consistent impedance response with the first radial impedance resonance at 656 kHz and the first thickness resonance at 5200 kHz. Figure 25 shows an example of one of the inoperable sensors compared to the average of the operable sensors. As seen in the figure, there are no appreciable radial or thickness resonances in the frequency range, consistent with the operable sensors, suggesting either a failure during the cure of one of the wire leads, or of the brittle piezoelectric sensor itself.

Figure 25. Inoperable embedded sensor #1 impedance response.

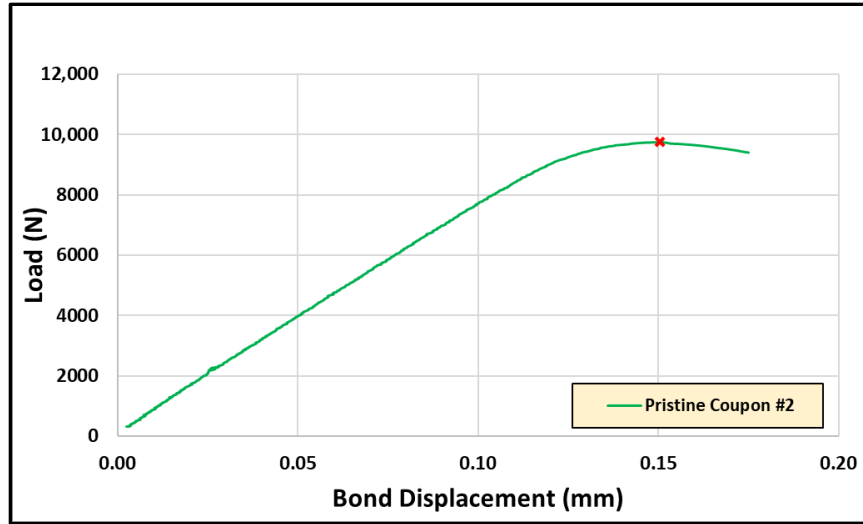
The coupons without sensors (5) are tested following the procedure in the previous section with the exception of the second applied load, which used an increase of 2224 N instead of 445 N. For each additional load, the level is increased by 445 N until failure occurs. The coupon is not removed from the test machine between loads. The average failure load for the pristine coupons is 10280 N and a bondline stress of 15.9 MPa. For pristine coupon 2, Figure 26 shows the load versus bond displacement on the final load increment to failure with an 'x' on the curve depicting the maximum load achieved on that test. The other pristine coupons exhibited similar load versus displacement plots. The failures were mixed-mode with mostly cohesive failures (in the adhesive). One of the coupons failed in a composite adherend fiber tear.

Figure 26. Pristine test coupon #2 load versus displacement (final load increment).

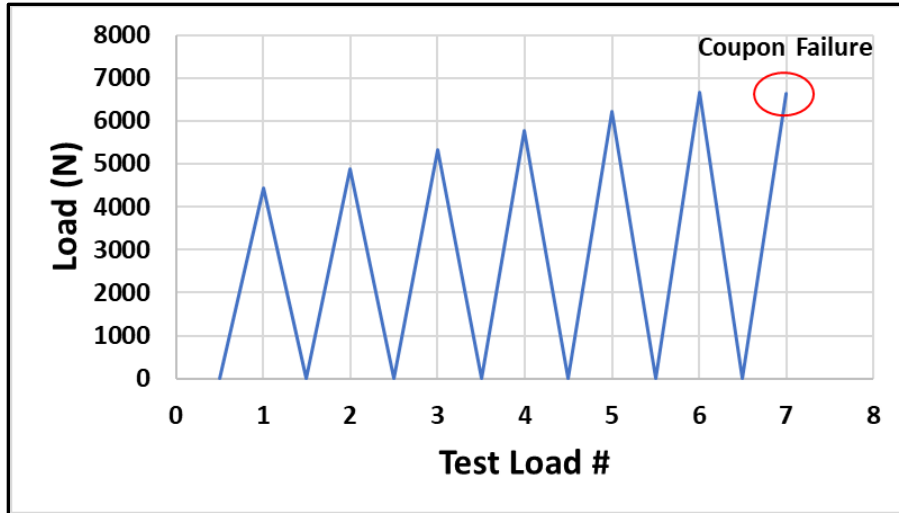
An example of the applied sequential loadings for an embedded sensor coupon is shown on Figure 27. The sample (with sensor #11) failed at 6630 N on the 7th load increment exhibiting a mixed mode failure (primarily cohesive but some thin layer adhesive). The failed coupon 11 is shown on Figure 28. The cohesive failure mode indicates that failure originated in the bond adhesive, and the thin layer adhesive failure aspect indicates that the failure was close to becoming an adhesive failure at the bond interface. The adhesive exhibited a high degree of porosity, which was noticeable by the incomplete adherend surface coverage with adhesive. The brittle sensor was fractured into multiple pieces.

Figure 27. Example coupon (11) test loads.

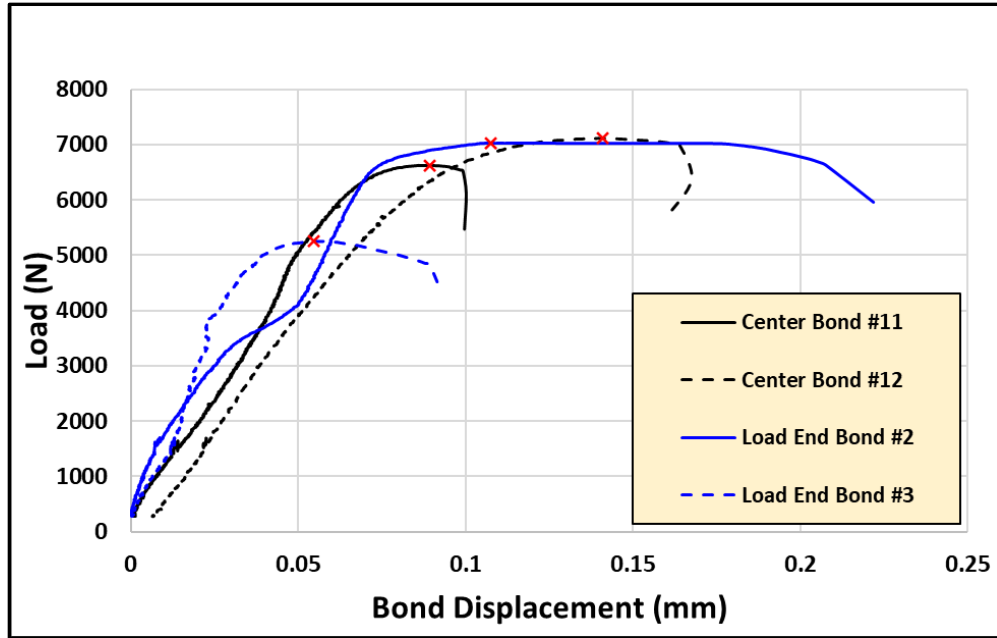
The embedded sensor coupons failed at an average load of 6510 N after six load increments, corresponding to a bondline stress of 10.1 MPa. A plot of the final failure load test versus bond displacement for the tested embedded sensor coupons is shown on Figure 29. The ‘x’ on each curve indicates the peak load achieved on the coupon.

Figure 29. Failure load test cycle versus displacement.

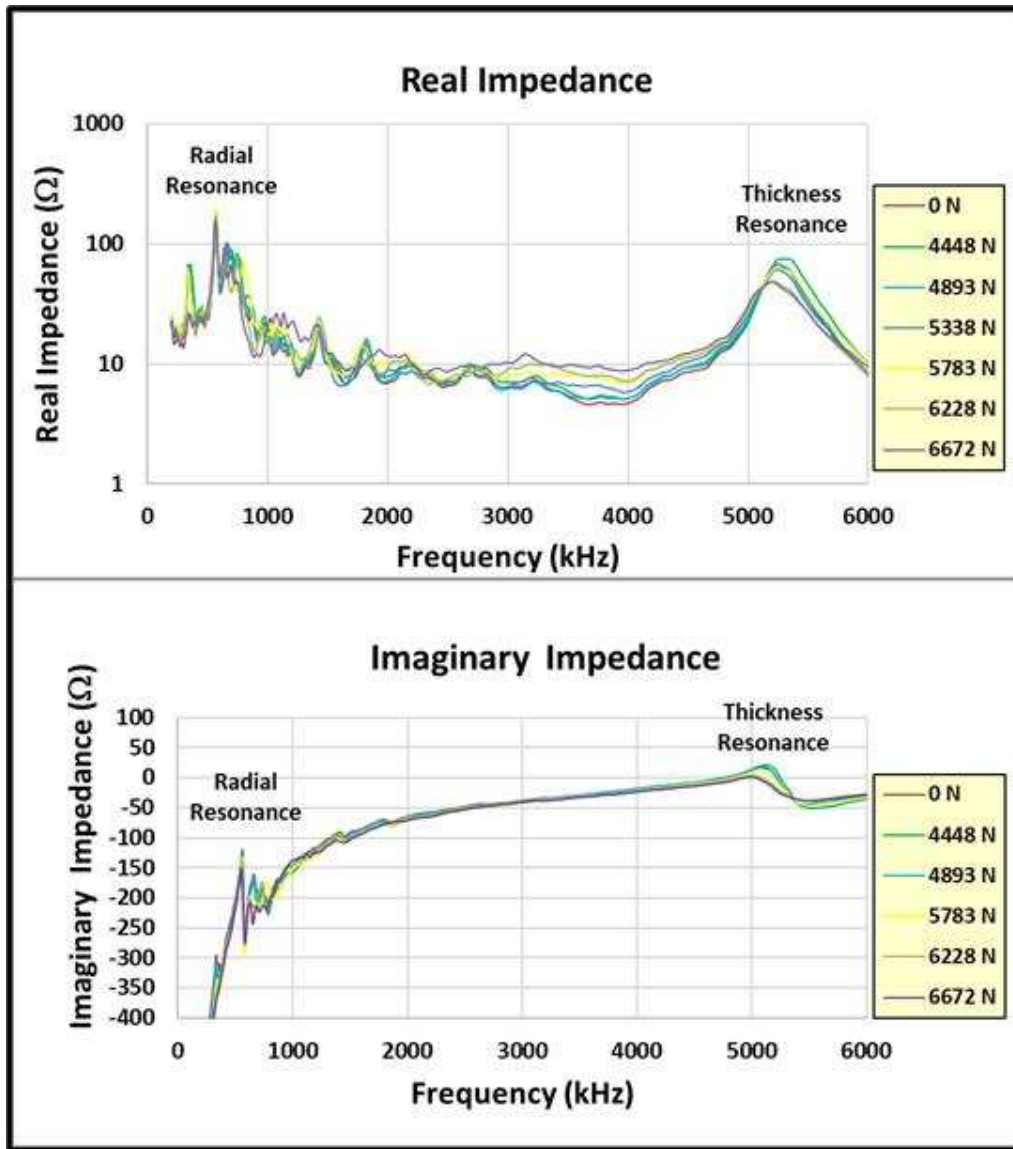
the real and imaginary values of the impedance for each load level on the sensor #11 coupon. Note that the various colored curves represent each sequential load increment.

Figure 30. Sensor #11 impedance for each load increment.

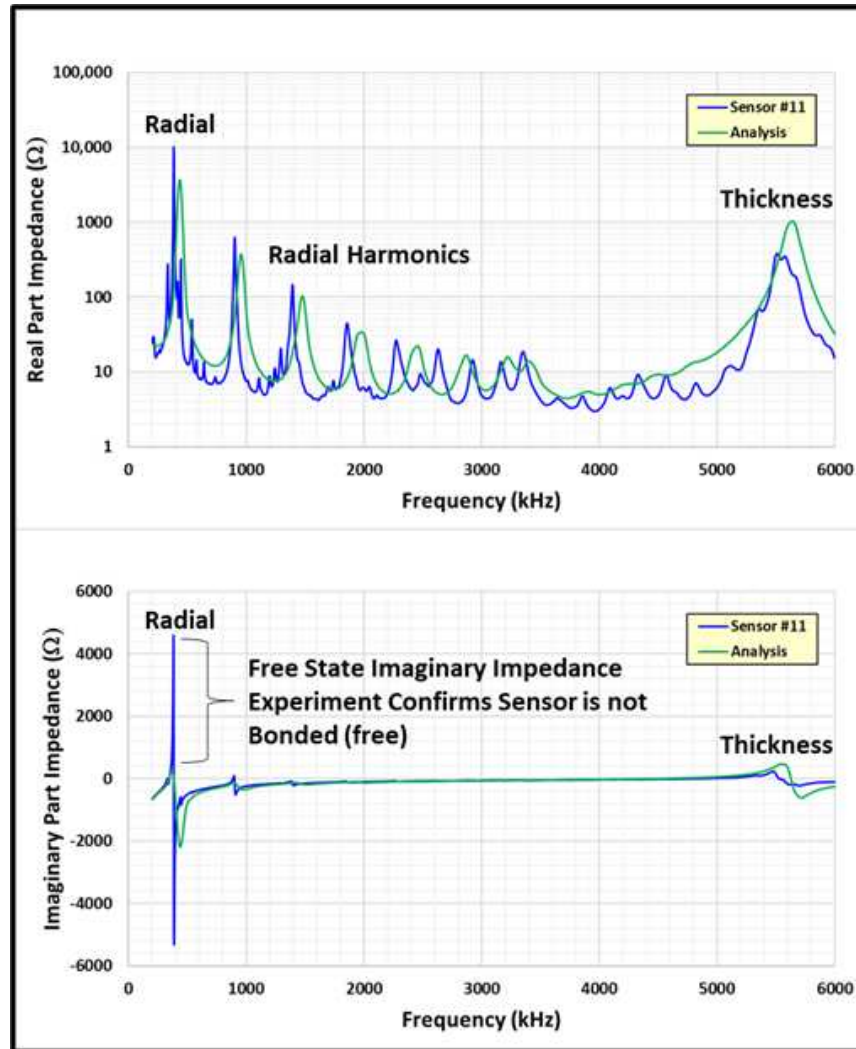
The free state impedance response was first compared to the simulation results, shown in Figure 31. Sensor #11 impedance results are chosen for the comparison. The analytical representation correlates well with the experimental results for the real part of the impedance. This indicates that the simulation captured the structural resonance of the sensor. The small difference in the primary radial resonance is most likely due to the effect of the wires suspending the sensor. This is amplified in the higher order harmonics. This is not a concern, since embedding the sensor constrains the response and removes any contribution of the higher order resonant responses. The primary thickness impedance showed good correlation to the test results. It is interesting to note that the imaginary impedance showed a much higher amplitude at the radial resonance than the simulation. This is due to the free state of the sensor in the experiment and indicates that the sensor was not bonded, which matches the free boundary state of the test. As a result of the acceptable correlation, the ANSYS analytical model can be used directly in possible 3D representations of the joint for embedded sensor impedance simulation studies.

Figure 31. Free sensor impedance, sensor #11 versus analysis.

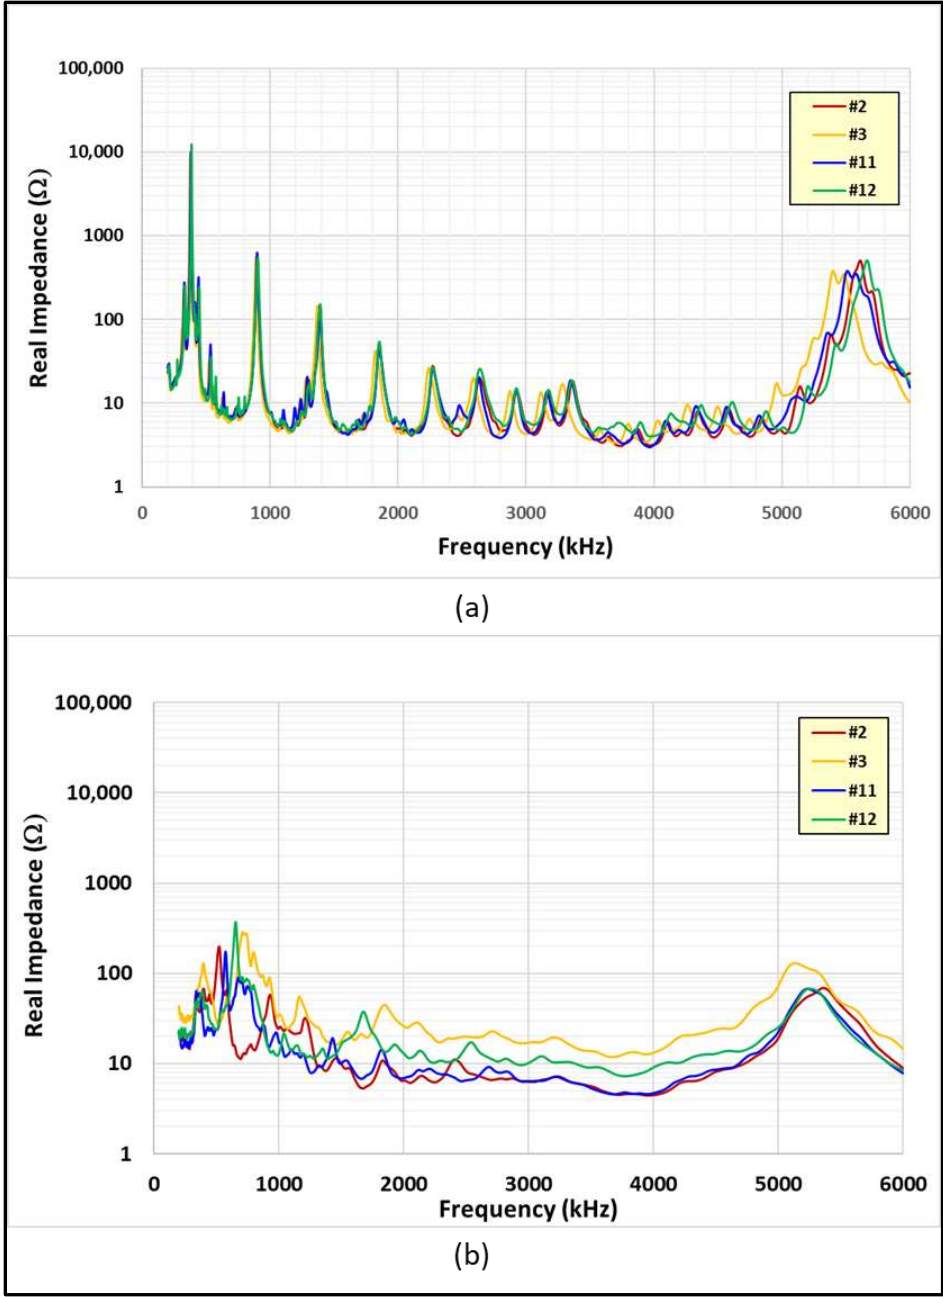
Note that the radial harmonic modes are no longer distinct enough to readily separate in the embedded sensor response, as shown in Figure 32 (b). The resonance responses of the four sensors are averaged and plotted for free versus embedded sensor impedance comparison in Figure 33. The primary radial response increased from an average of 384 kHz to 656 kHz with much lower amplitude and higher damping. The increase in resonant frequency and damping is due to constraining the sensor within the bondline of the coupon, resulting in higher pointwise structural stiffness. The thickness mode response also showed a decreased amplitude with higher damping (broader peak). The thickness resonance decreased in frequency from an average of 5600 kHz to 5200 kHz.

Figure 32. (a) Free sensor, (b) embedded sensor, baseline impedance results.

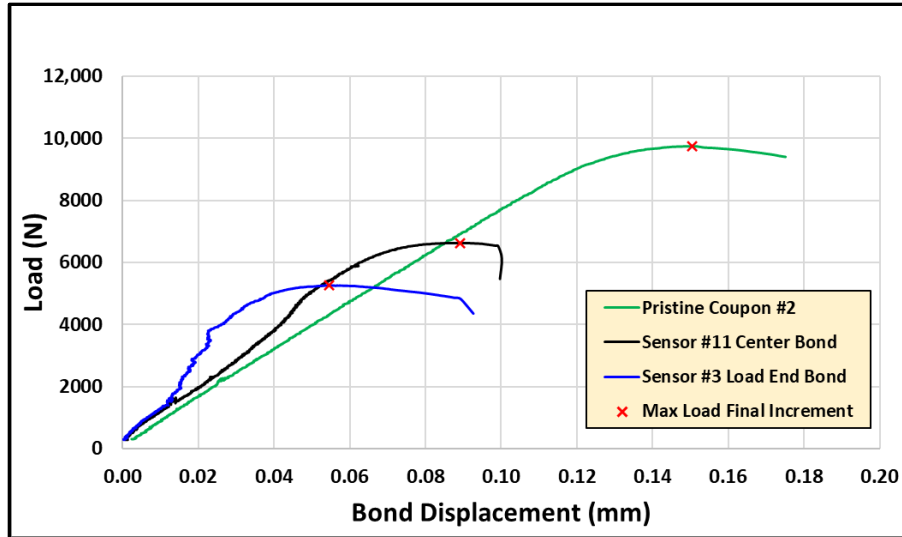
Figure 34. Load versus displacement of pristine and sensor coupons.

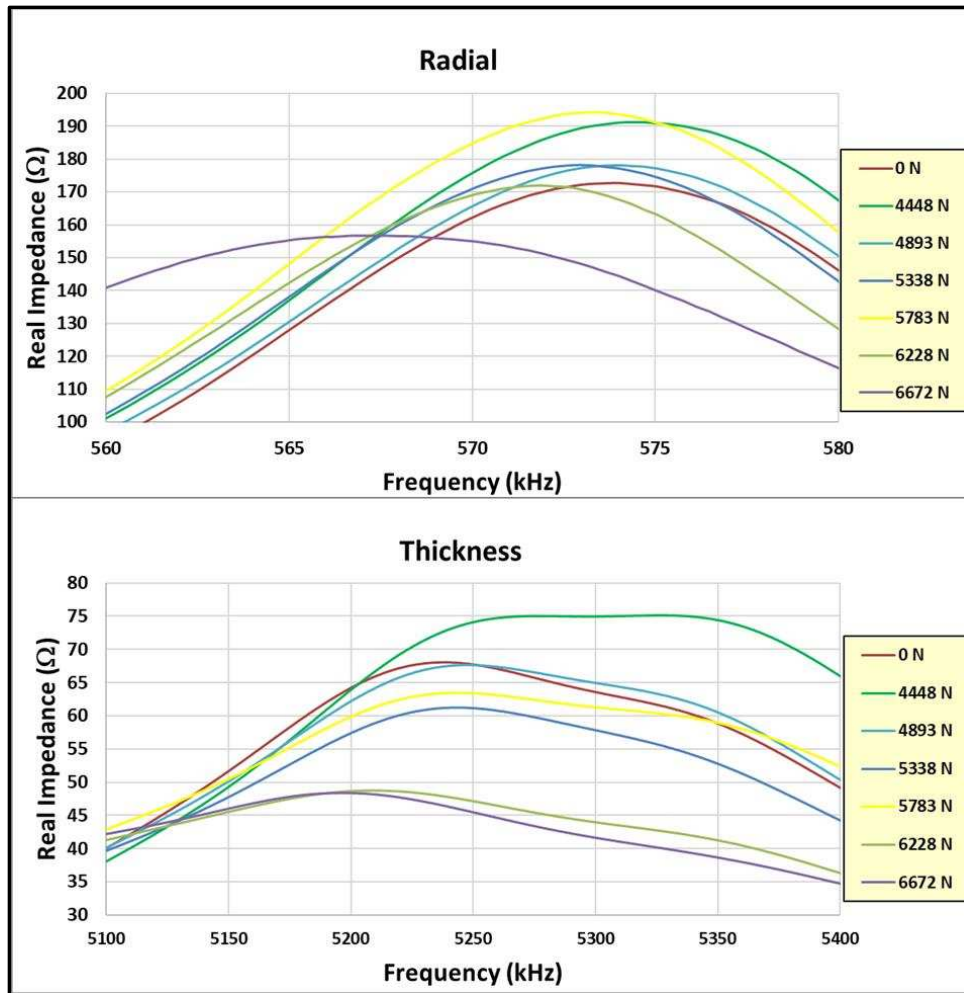
The radial and thickness resonance results, with increasing load, are plotted in more detail in Figure 35 for the coupon with sensor #11. Each line is an incremental load cycle that is increased until the coupon failed. A large change was noticed in the thickness response on the final incremental load before failure. This was most likely due to a loss in joint stiffness and a gain in damping, which lowered the resonance amplitude. It is interesting to note that both the radial and thickness resonant frequencies increased slightly from the baseline values after the initial loading. The real impedance amplitude also increased. This could be due to initial consolidation of the joint under a light load. After the initial loading, both resonances began to decrease in frequency and amplitude. A major change is seen in both responses during the final load cycle (highest). The response amplitude is greatly reduced, and the damping is significantly increased. It is also interesting to review the imaginary part of the impedance load response in detail for both resonances. This is plotted in Figure 36.

Figure 35. Radial and thickness impedance (real) resonance & load level sensor #11.

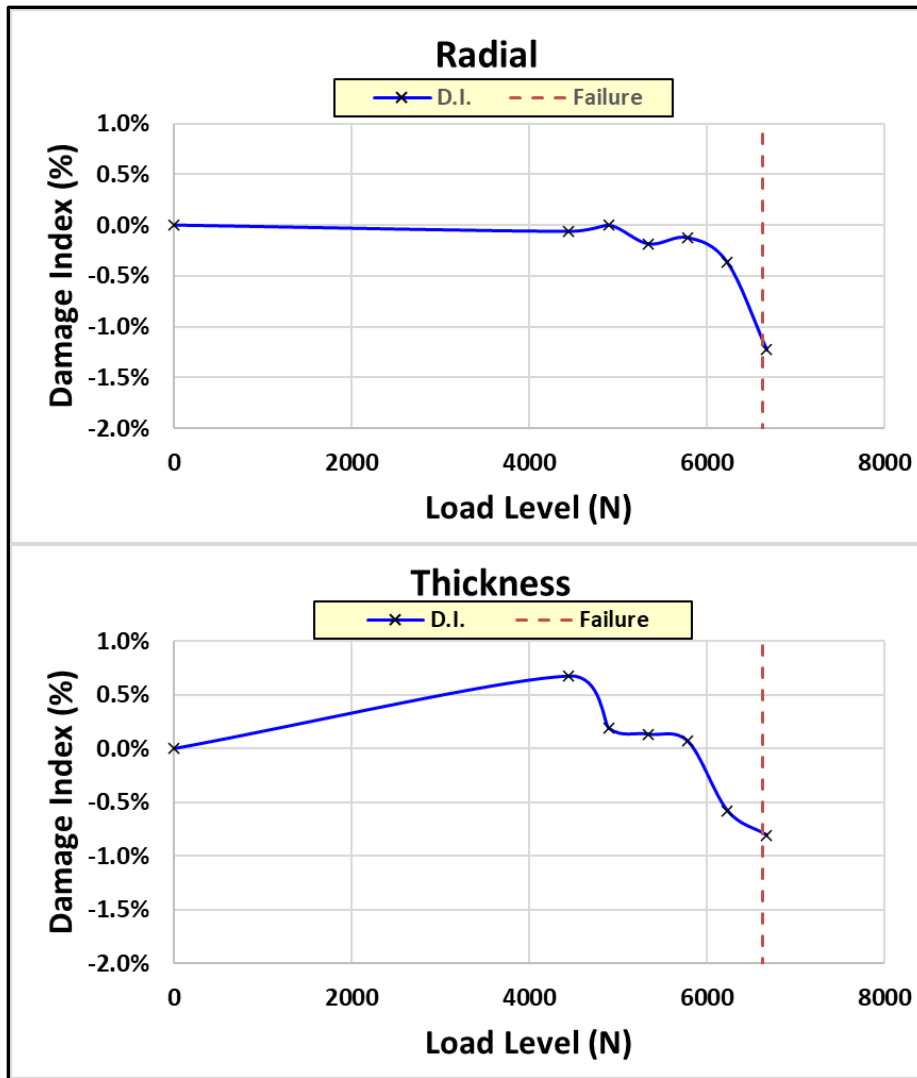
Figure 37. Sensor #11 damage index versus load level.

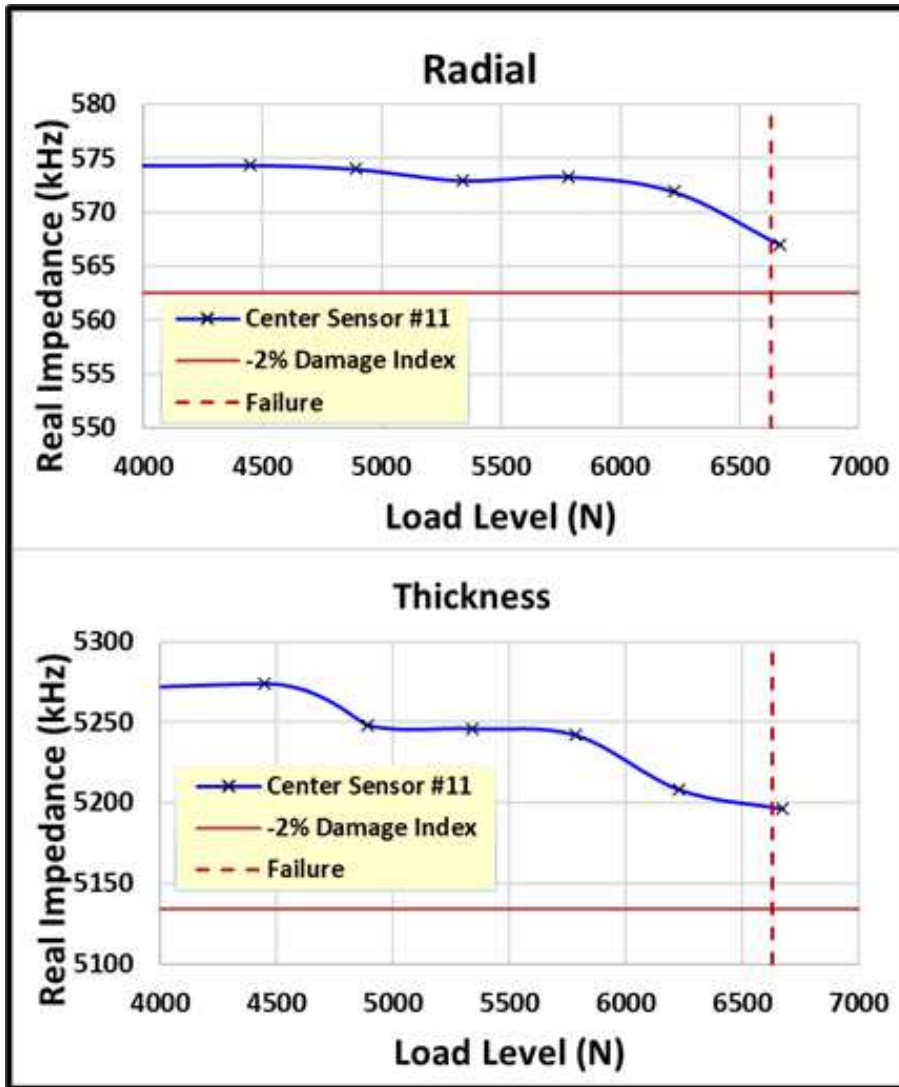
For further definition, Figure 38 shows each measured impedance resonance (radial and thickness), plotted against load level with the failure load denoted and the -2% damage index identified.

Figure 38. Sensor #11 real impedance versus load level.

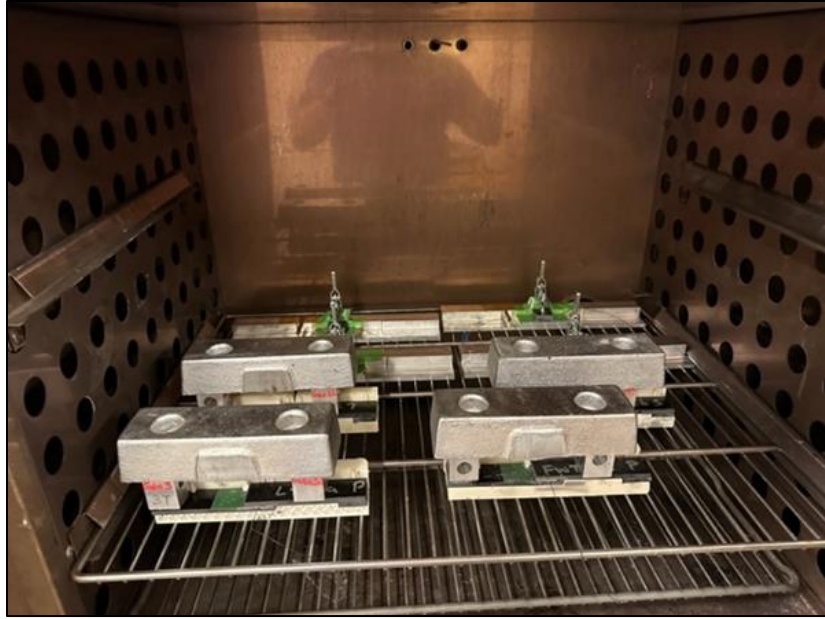
The two-part structural paste adhesive is mixed together and applied to the prepped bond surfaces and fit into the bond fixture. The coupons are then placed in the oven for an accelerated cure at 66°C for 1 hour as shown in Figure 42. There are 4 lap shear bond fixtures, therefore 3 cures are required to fabricate 12 test coupons. Weights are placed on the coupons to ensure consolidation of the adhesive.

Figure 42. Coupons placed in the oven for the accelerated cure.

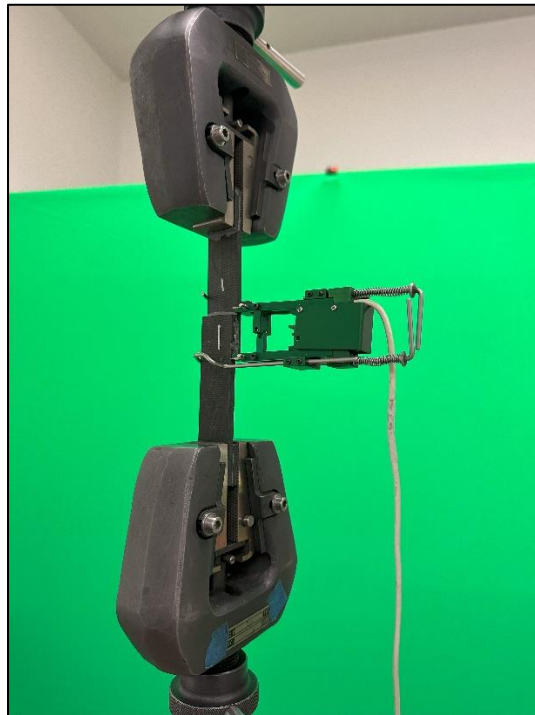
Figure 52. Coupon 1 loaded in the test machine.

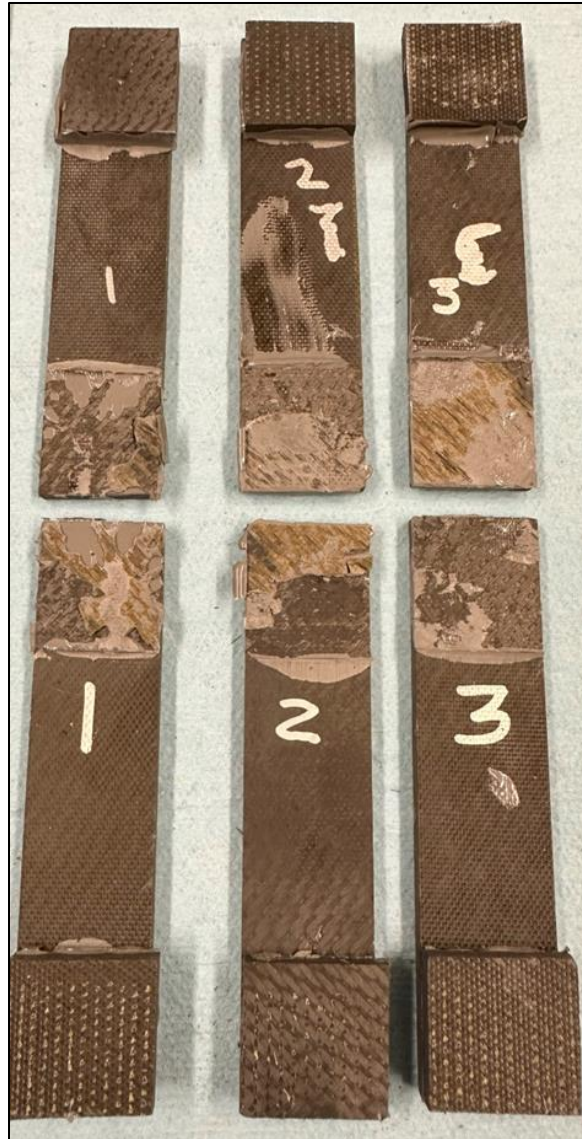
Figure 53. Failed pristine coupon adherends.

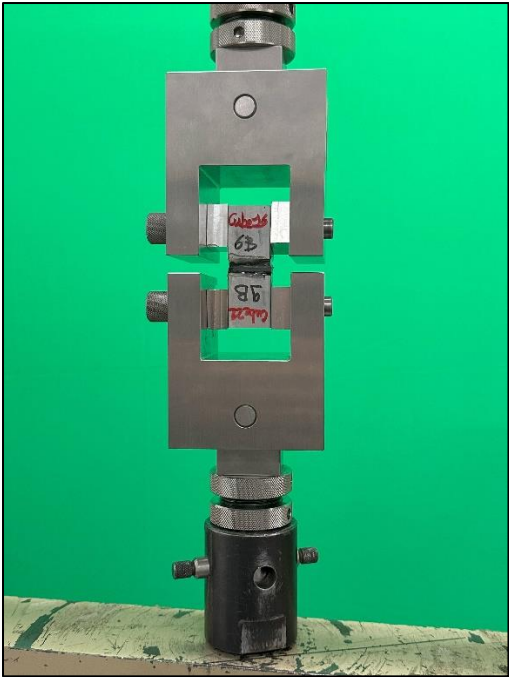
Figure 59. Pristine flatwise tension coupon in the test machine.

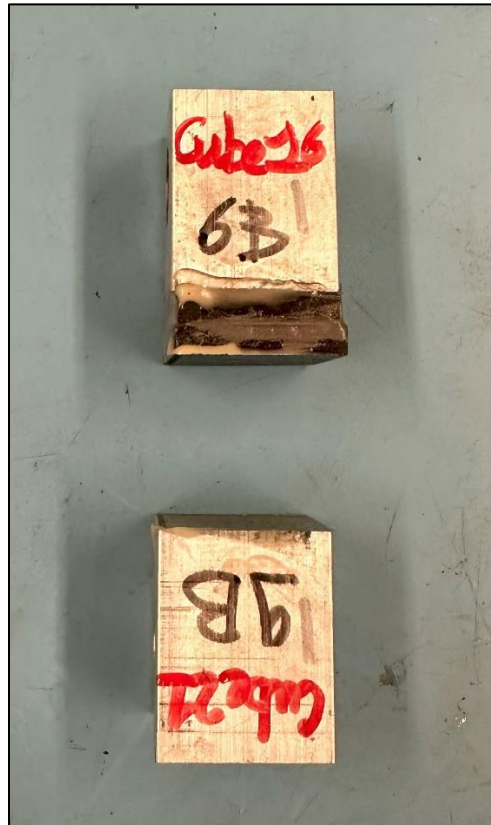
Figure 60. Failed pristine flatwise tension coupon.

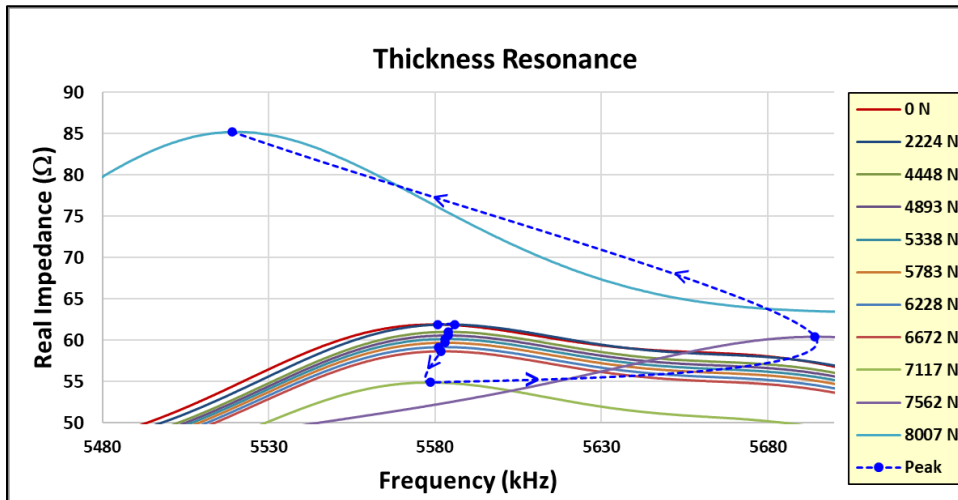
Figure 70. Coupon #5 thickness impedance resonance.
