AQUALASTIC® CANAL REPAIR SOLUTIONS FOR URBAN, RURAL, DEGRADED AND LEAKING IRRIGATION CANALS

ABSTRACT

The AquaLastic® Canal Repair System is a solution for severely degraded, leaking and potentially leaking concrete irrigation canals.

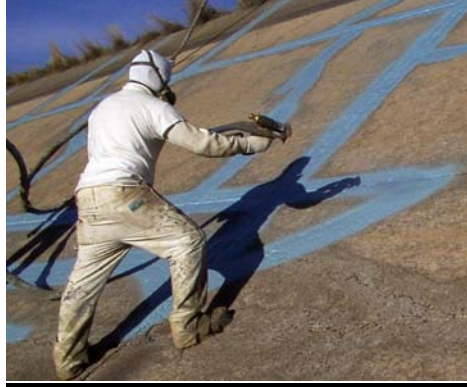
AquaLastic® being applied using high pressure application equipment

AquaLastic® is a state-of-the-art, high performance, sprayed, plural component pure polyurea elastomer. This system is based on amine-terminated polyether resins, amine chain extenders and MDI prepolymers. It provides a flexible, resilient, tough, monolithic membrane with good water and chemical resistance. It is applied using high pressure application equipment.

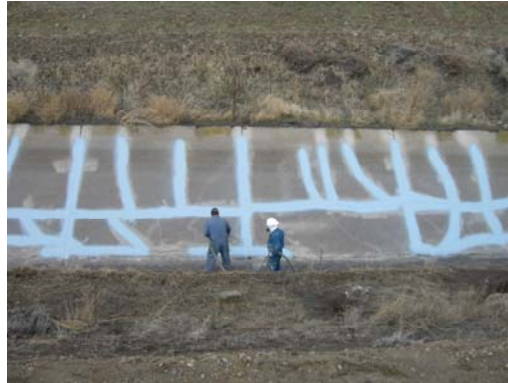
Roza Irrigation District AquaLastic® Application

There were two sections of the main canal, approximately 3,598 linear feet that had been leaking excessively due to a large number of cracks caused by expansion and contraction from freeze-thaw cycles that rendered the concrete non-water tight. Once the water escaped through the cracks it entered drains under the concrete liner that were originally intended to carry water away from the liner. The amount of water that was leaking was known via a water meter.

The project entailed sandblasting a three to four inch strip each side of all the cracks and clearing the canal of debris. This work was carried out by the AquaLastic® Certified Applicator and the crew then applied approx 80 – 100 mils of AquaLastic® to the cracks, bridging the gaps to create a water-tight seal to eliminate the leakage.

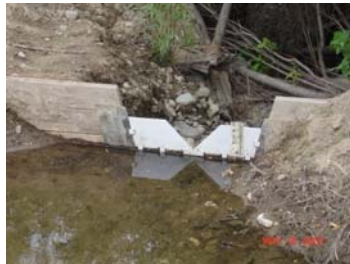
Escaping water was metered at this point

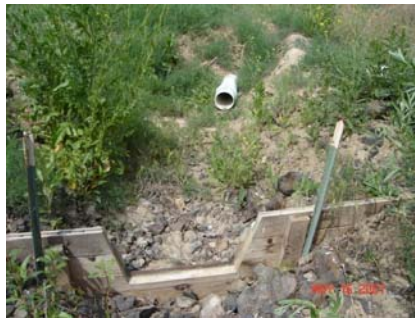
The metered site after AquaLastic® application. No water can be seen.

Prior to the start of the project, the estimated water loss was approximately 1,220 acre-feet per irrigation season. After the completion of the project, not only did AquaLastic® eliminate 99% of the seepage, far exceeding the required 88%, but during the following 2007 season, the total water loss was approximately 14 acre-feet, for a net savings of 1,206 acre-feet. This saving is equal to \$145,500 annually and so the project more than paid for the application costs during the next drought season when the additional water could be marketed.

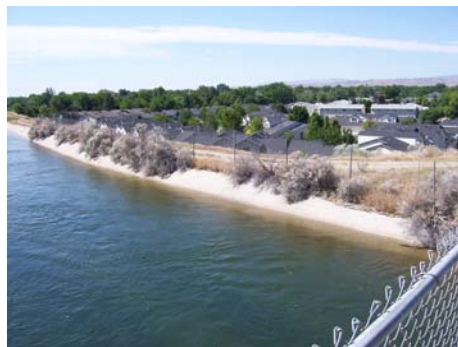
Urban development encroaching on canals

Idaho flows right through the center of Boise and numerous residential areas. Some real estate agents have even gone so far as to describe the properties as ‘water front’. Managers of The Boise Project have, as a consequence, wrestled with a number of problems concerning the proximity of urban build-up to their canals. In one such case, they were dealing with the problem of water leaking into the basement of a house that was situated well below canal level.

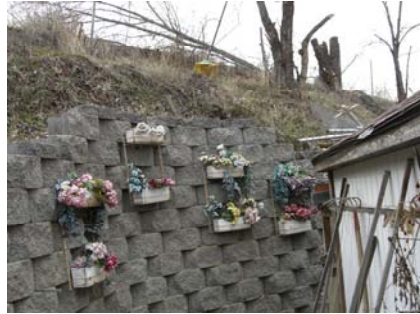
Photo taken from the backyard of the house. The canal flows above the level of the house behind the constructed retaining wall.

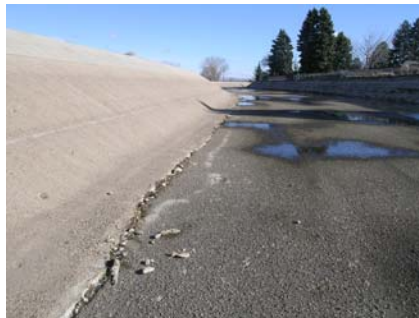
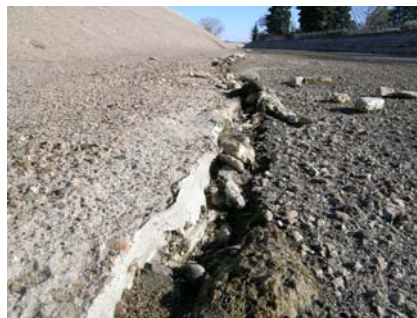
The canal prior to application

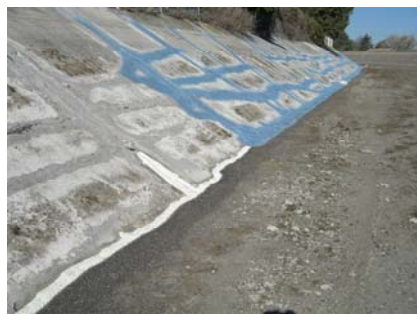
The canal during application

AquaLastic® crack sealer was applied to the stretch of canal most likely to be leaking, in spring '07. The Boise Project's own maintenance team undertook sandblasting the crack areas prior to application. The largest cracks between the walls and the bottom of the canal were filled first with specially selected industrial foam filler and then the coating was applied by AquaLastic® Certified Applicators to form a water-tight seal over the top.

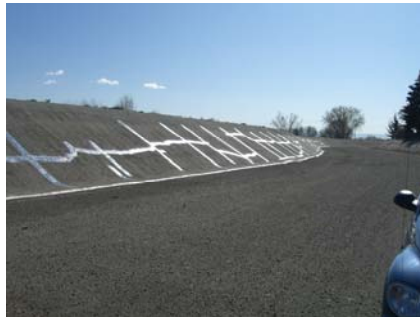
The Boise Project New York canal

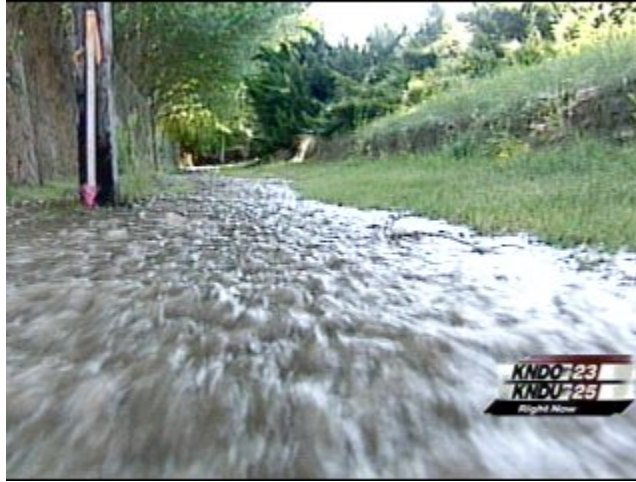
A recent canal break in an area not yet treated with AquaLastic® caused severe problems for the district, demonstrating the potential consequences. In this case, farmland was flooded rather than housing, but the emergency reinforced the potential reality of a breach in a populated area of the City of Kennewick.

Extract from KNDU.com website. “KENNEWICK, Wash. - Crop owners and Farmers are wondering when water will come after a Kennewick Irrigation District canal broke Monday.

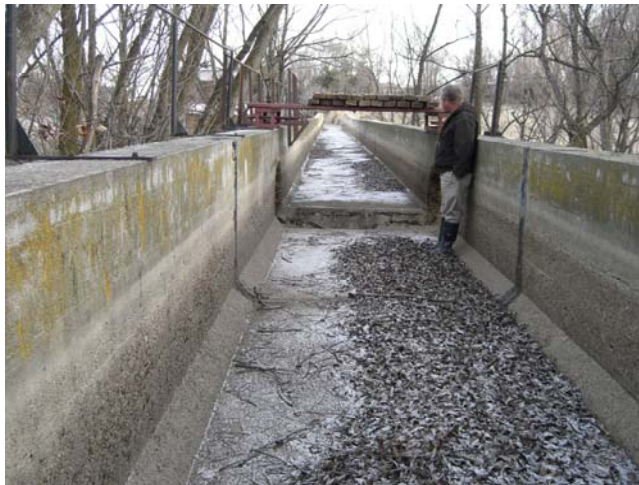
Degraded high level flume photographed early spring '08

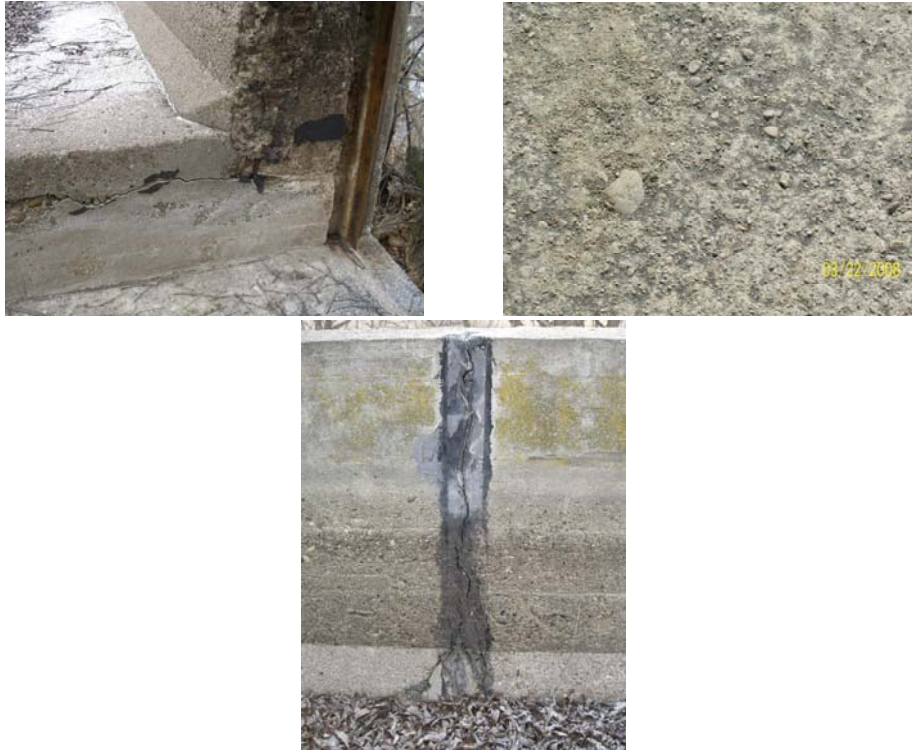
The flume exhibited advanced deterioration in all areas with damaged joints and exposed aggregate.

Manager of Nampa and Meridian Irrigation District, John Anderson estimated that the flume was losing 25 Miner Inches or 1 Acre Foot per day. Water was visibly leaking and there was severe spawling on the concrete.

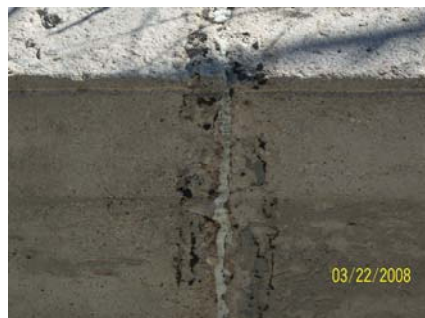
Example of patch peeling away

He explained that the Irrigation District had patched-up the flume many times and within one irrigation season, the patches were peeling away.

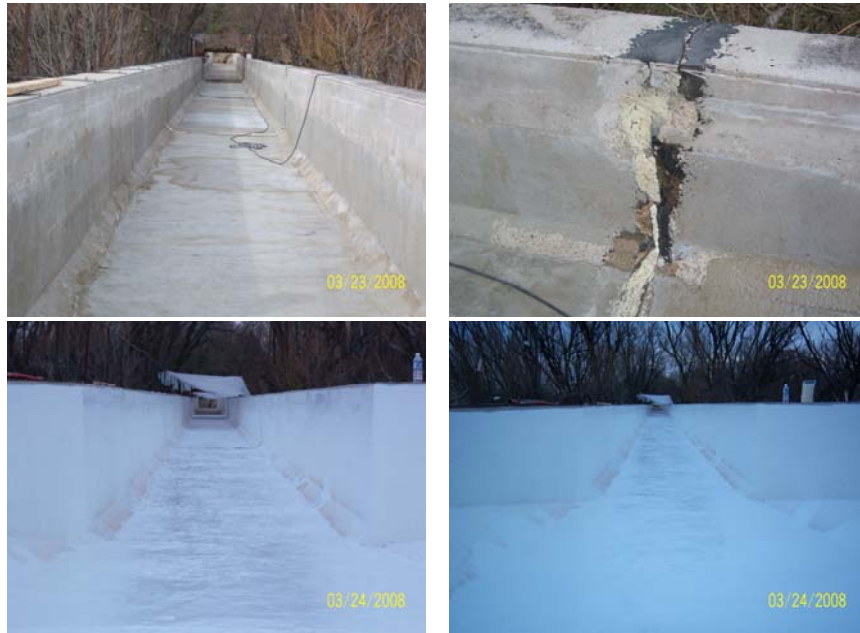
Several processes took place before AquaLastic® was applied

The repair process included several steps before AquaLastic® was applied to the entire surface area. The flume was sandblasted throughout the inside circumference and across the top of the sides. It was then patched with a polymer cement and primed with Epoxy paint.

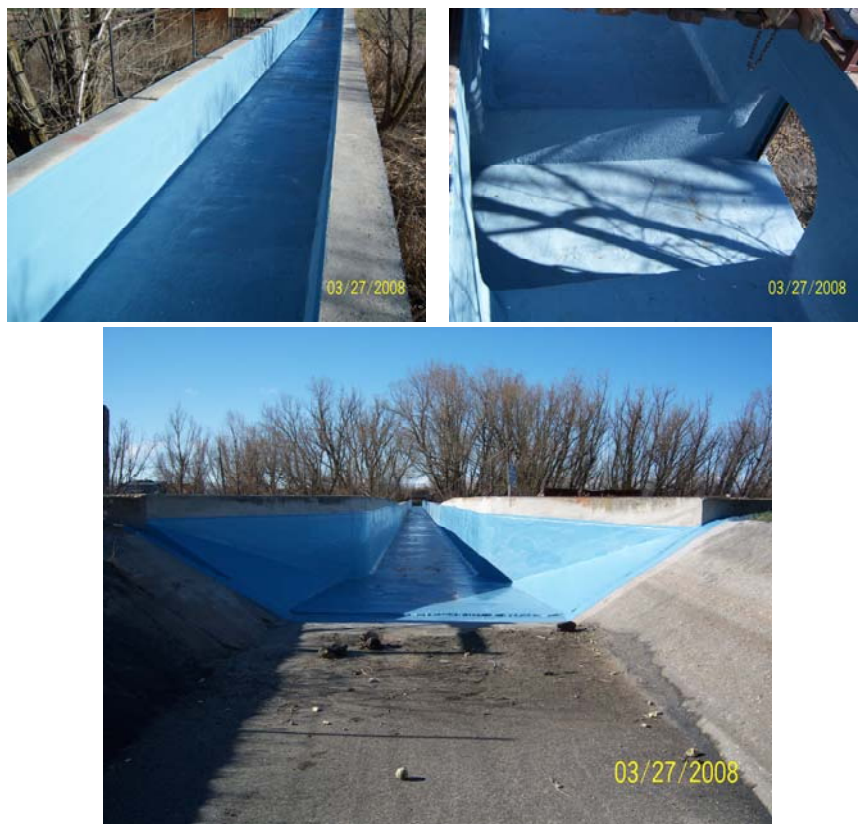
The flume is completed and ready for re-watering at a fraction of the cost of replacement

John Anderson says there have been no visible leaks throughout the irrigation seasons of 2008 and 2009 and that the flume over-wintered well in Idaho's harsh winter weather with no observed problems associated with the AquaLastic® coating.

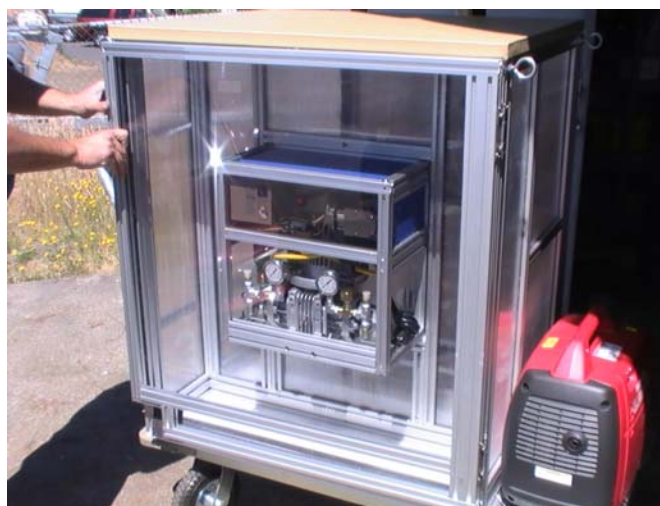
Irrigation Districts can now undertake many of their own concrete canal repairs with the new, state of the art AquaLastic® Low Pressure System (ALPS).

Extensively tested on irrigation canals in the North West, the AquaLastic® Low Pressure System consists of a low pressure, self-contained system that is so compact, it will fit into the back of a standard sized pick-up and even onto the back of an ATV. The unit is mounted on wheels for easy loading and maneuvering into vehicles or directly into canals or onto access roads and tracks. Complete with a central heating system and elongated heated hoses, it is designed for use in canals any time of the year, including low temperature winter conditions.
