Wetland Mapping and Fen Survey in the White River National Forest 2011

Wetland Mapping and Fen Survey in the White River National Forest

Delia Malone, Erick Carlson, Gabrielle Smith, Denise Culver, and Joanna Lemly Colorado Natural Heritage Program Warner College of Natural Resources 1475 Campus Mail Fort Collins, CO 80523

November 2011

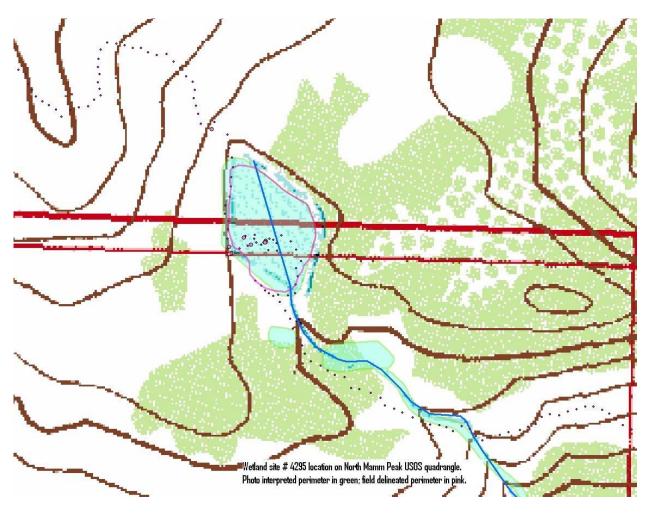
Wetland site # 4295 location on North Mamm Peak USGS quadrangle. Photo interpreted perimeter is in green; field delineated perimeter is pink.

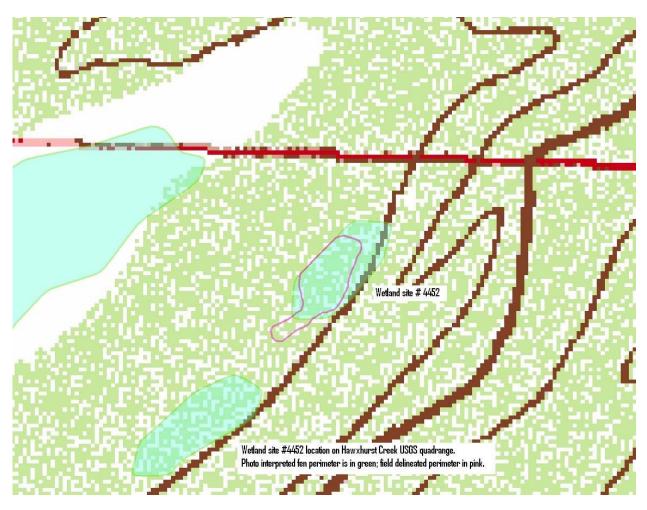
Wetland site # 4452 on Hawxhurst Creek USGS quadrangle. Photo interpreted fen perimeter is in green; field delineated perimeter in pink.

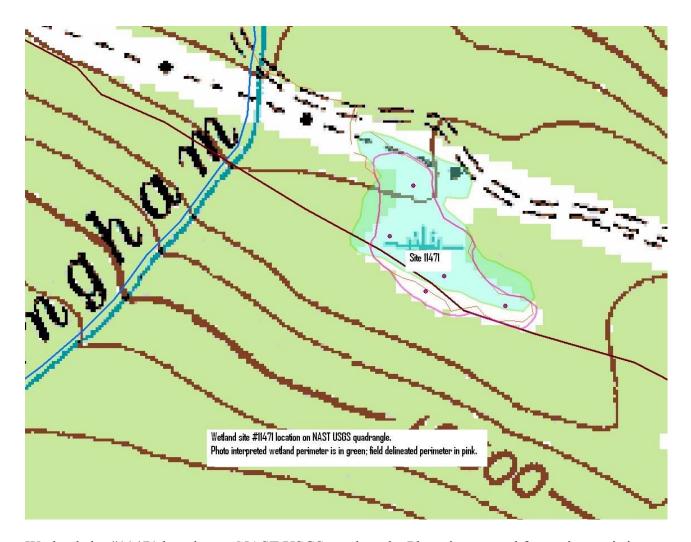
Elk wallow at this shallow pond in this fen.

Wetland site #11471 location on NAST USGS quadrangle. Photo interpreted fen perimeter is in green; field delineated perimeter is in pink

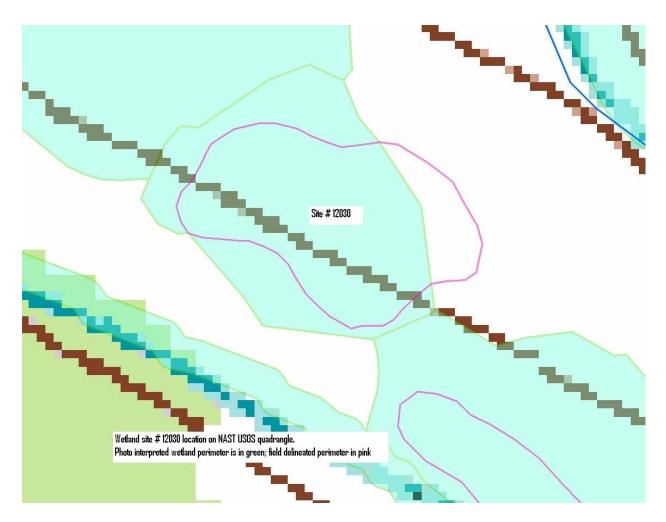
Drying peat has resulted in vegetation drying.

Wetland site #12030 location on NAST USTS quadrangle. Photo interpreted fen perimeter is in green; field delineated perimeter is in pink.

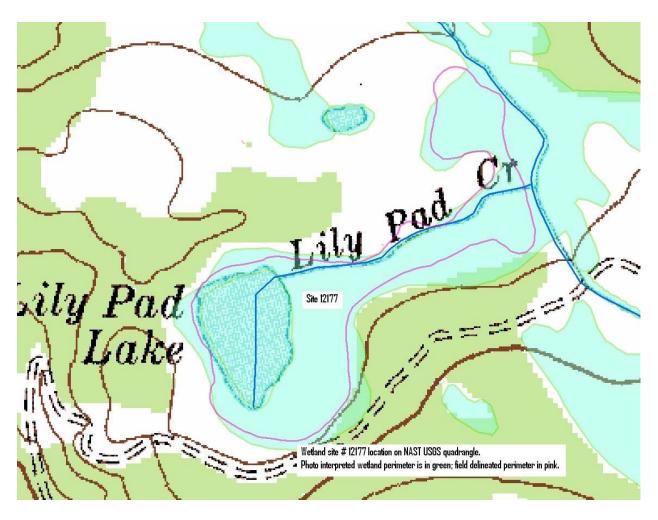
Intensity: 1) Moderate to high; one open, natural-surface road open that is used frequently, at least several to many times per week, during the season; road interrupts groundwater flow to the fen. 2) Low to moderate; one small (anthropogenic?) ditch drains water from the wetland; water table is slightly below normal levels. 3) Low; a few trails by humans around the lake used nearly every year resulting bare soil and vegetation damage. **Extent**: 1) Covers <10% but traverses across the entire slope above the fen. 2) Covers <10% but impact may be greater than areal coverage. 3) covers <10%.

Wetland site # 12177 location on NAST USGS quadrangle. Photo interpreted fen perimeter is in green; field delineated perimeter is in pink.

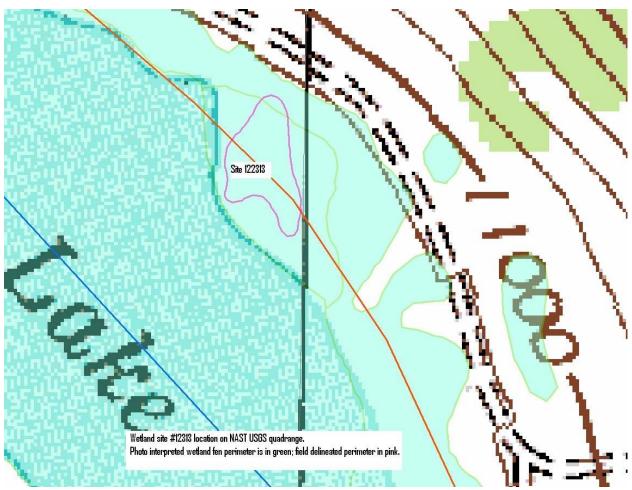
Peat mining and water level fluctuations have eliminated fen habitat.

Wetland site #12313 location on NAST USGS quadrangle. Photo interpreted fen perimeter is in green; field delineated perimeter is in pink.

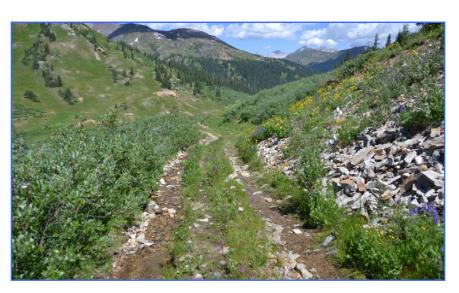
A mining road interrupts and diverts groundwater flow away from the fen and down the road to a gully.

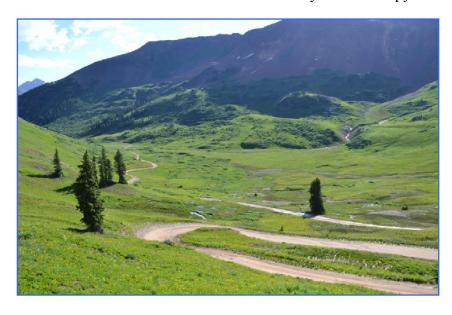
A road that traverses the hillside in Paradise Basin alters groundwater flow to the fen below.

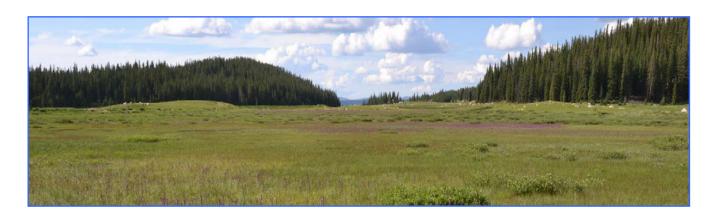
Ditch draining wetland

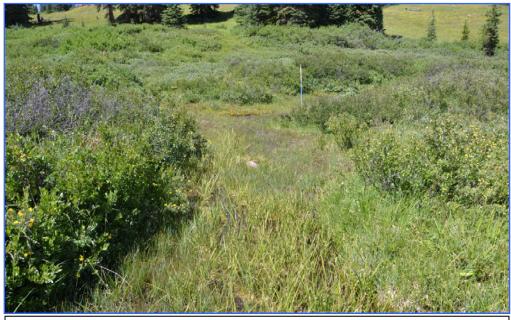
A ski trail has been cut through the shrubland wetland.
