THESIS

RESTORATION PRIORITIZATION OF UPPER COLORADO TRIBUTARIES IN THE KAWUNEECHE
VALLEY, ROCKY MOUNTAIN NATIONAL PARK, CO

RESTORATION PRIORITIZATION OF UPPER COLORADO TRIBUTARIES IN THE KAWUNEECHE VALLEY, ROCKY MOUNTAIN NATIONAL PARK, CO

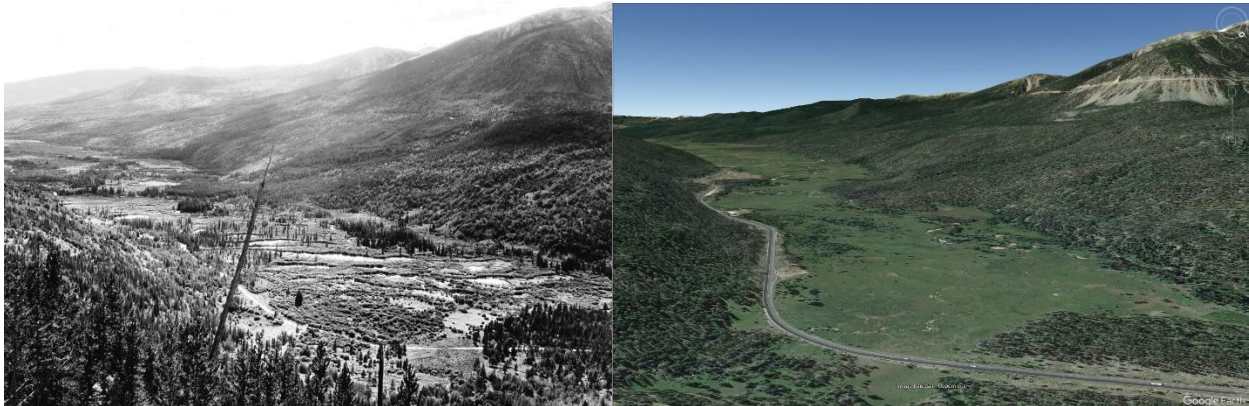
Figure 1. (left) Kawuneeche Valley showing the Upper Colorado River and numerous beaver ponds in 1920 (source: NPS), (right) Kawuneeche Valley in 2019 with meanders of the Colorado River visible but no beaver ponds (source: Google Earth). Grand Ditch is visible on the hillslope in the upper right of the image.

and Simon, 1999; Wolf et al., 2007; Polvi and Wohl, 2012; Larsen et al., 2021). Large portions of the Kawuneeche Valley have undergone the transition from wet meadow habitat to a drier elk-moose meadow grassland community (Figure 1) since the decline of beaver in the 1990s.

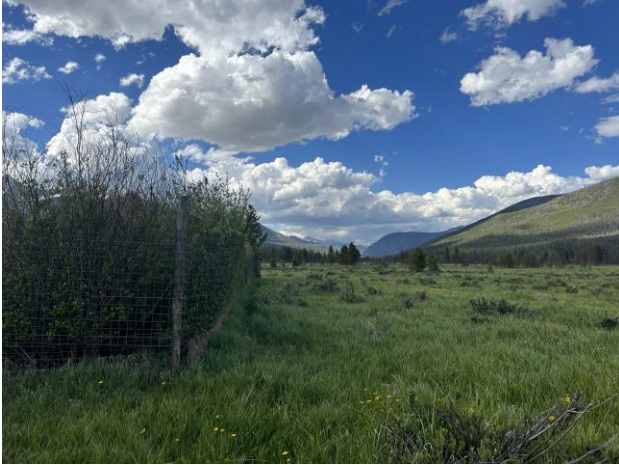
Figure 4. Exclosure fencing around a vegetation research plot shows the effects of ungulate browse pressure on tall willows. Photo is taken at Lower Baker Creek study reach looking north.

by *Poa pratensis* and other nonnative and undesirable upland species (Figure 4). Sedges including *Carex utriculata* and *Carex aquatilis* and tall grass (*Calamagrostis canadensis*) are common near stream banks and other wetter areas (Cooper et al., 2023).

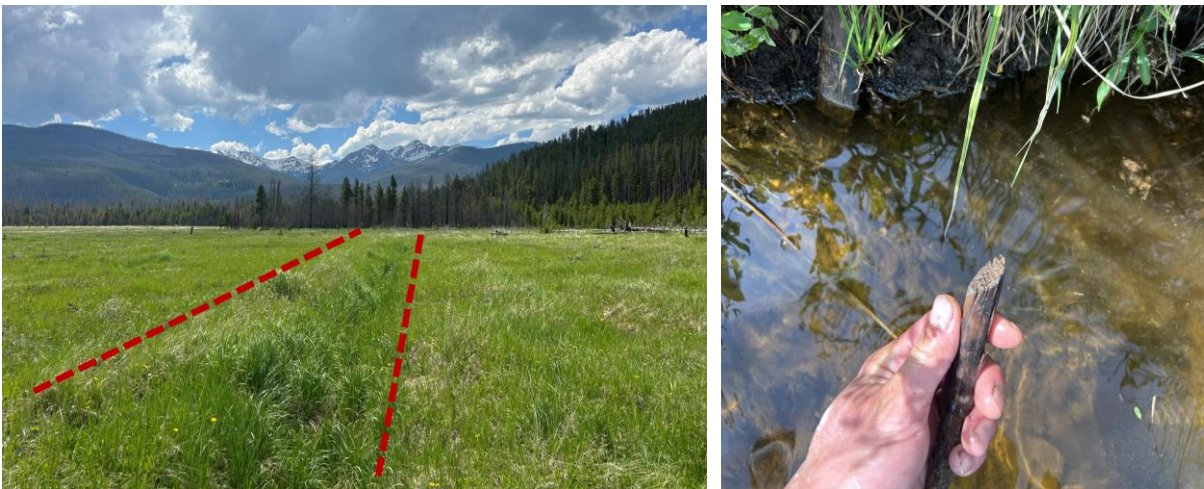
Figure 5. (left) A relict beaver dam berm indicated by red dashes (looking south from Upper Baker). (right) Evidence of beaver chew in the bank indicating a historical dam location.

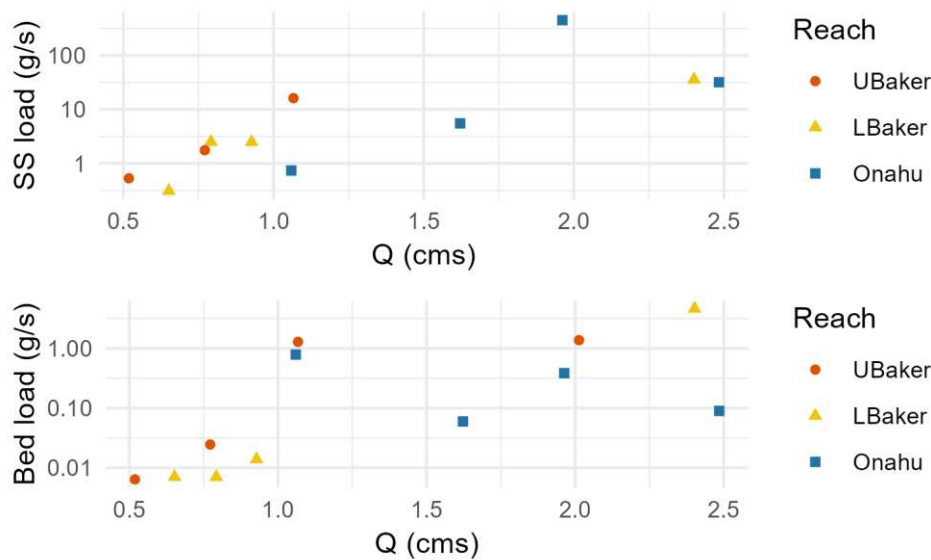
Figure 8. Suspended sediment (SS) and bedload transport rate results.

Limited sediment transport was observed during the 2024 snowmelt season and, hence, few measurements of suspended sediment and bedload transport were collected (Figure 8). Onahu Creek had the greatest SS transport rate (449.8 g/s), and Lower Baker had the greatest bedload transport rate (4.6 g/s). Greater transport rates of SS and bedload were observed prior to peak flows, exhibiting an expected flushing of stored sediment from the bed (Resh et al., 1988; Kondolf and Wilcock, 1996). Due to similarity in results and limited sampling data, no further discussion of sediment transport is included.

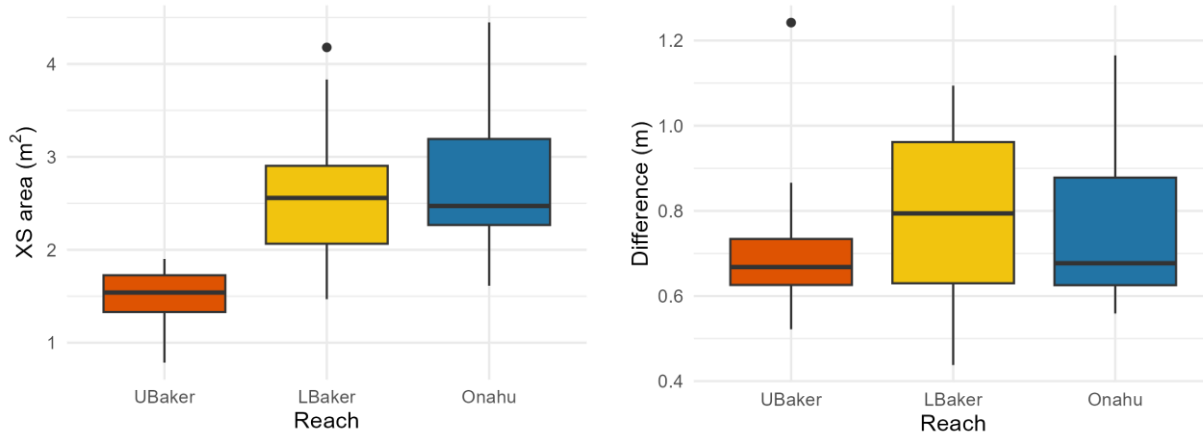
Figure 9. (left) Interquartile distributions of bank-full cross-sectional (XS) area. (right) Interquartile distributions of difference between bankfull and thalweg elevations.

I found that width-to-depth ratio was not an adequate metric for describing channel morphologic condition, specifically levels of incision. I observed low levels of incision at all three study reaches, despite varying width-to-depth ratios (Appendix II). I instead assessed cross-sectional area as a more appropriate indicator of the impact of channel geometry on channel-floodplain connectivity. Based on field cross sectional surveys, Upper Baker has the smallest average cross-sectional area (1.51 m²) (Figure 9). Tukey tests indicate that cross-sectional area differed significantly between the Upper and Lower Baker sites ($p < 0.001$) and the Upper Baker and Onahu sites ($p < 0.001$), but not between Lower Baker and Onahu ($p = 0.646$). Morphologic bankfull elevation and thalweg difference were not statistically significant between any of the three sites, indicating differences in cross-sectional area are the product of varying bankfull

widths. Channel geometries indicate differences in cross-sectional areas, but no apparent differences in levels of incision.

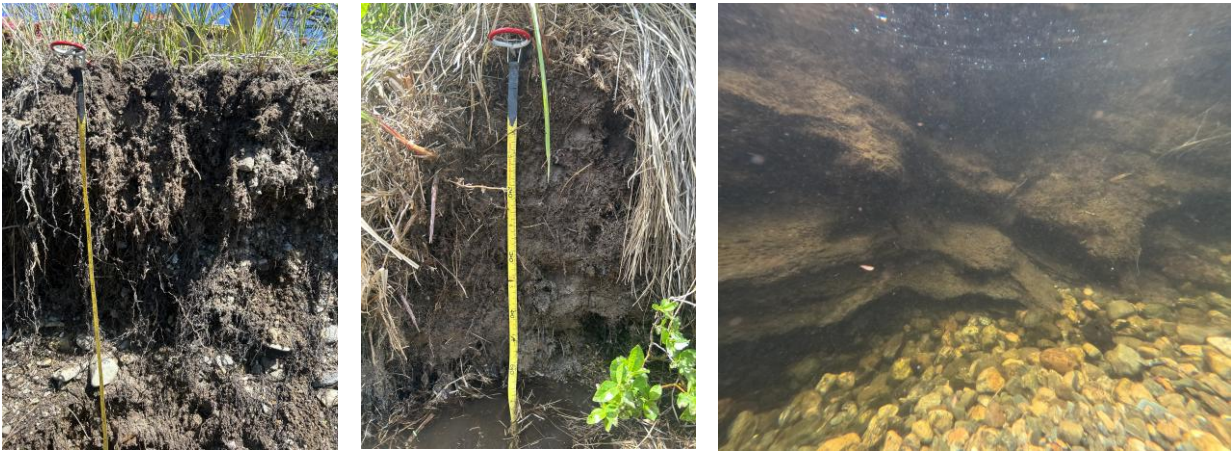
Figure 11. Examples of observed bank characteristics: fines over sandy gravel (left), fines throughout (middle), fines over a silty-clay peat layer over coarse material (right).

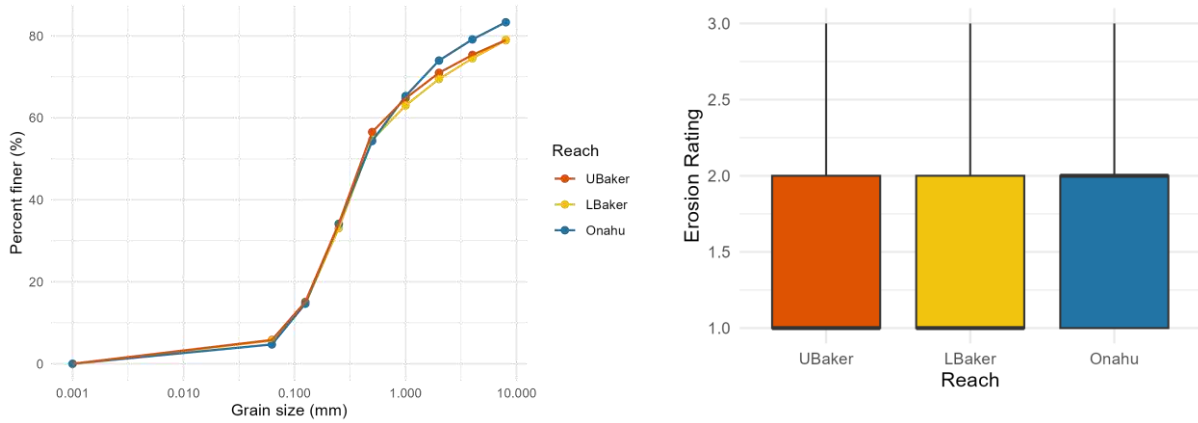
Figure 12. (left) Bank sediment cumulative frequency distribution plot results. (right) Interquartile distributions of erosion index assessments.

Bank sediment cumulative frequency distributions indicate all three sites have similar sediment characteristics (Figure 12). Upper Baker Creek had a D_{50} of 41 mm, Lower Baker Creek had 43 mm, and Onahu Creek had 43 mm.

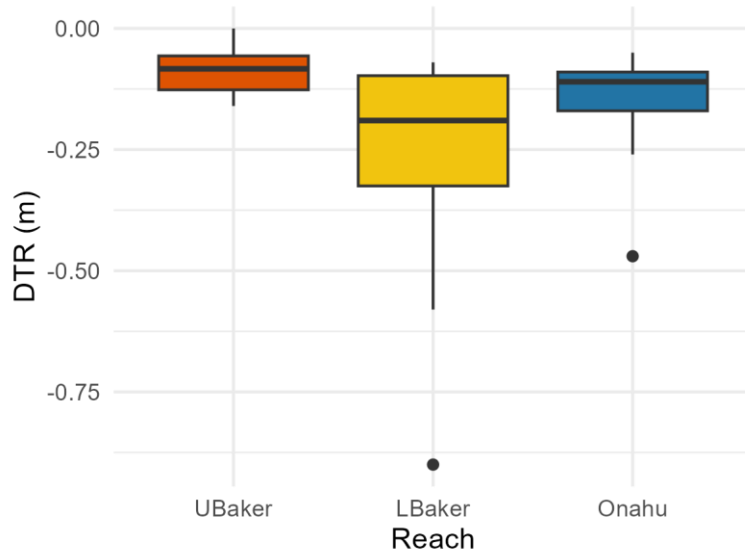
Figure 13. Interquartile distributions of thalweg depth-to-refusals below the channel thalweg surface, indicated by negative values on the y-axis.

Kruskal-Wallis test indicates TDTR between sites did not differ significantly ($p = 0.076$) (Figure 13). TDTR data are not discussed further due to similarity in results and limited sample data.

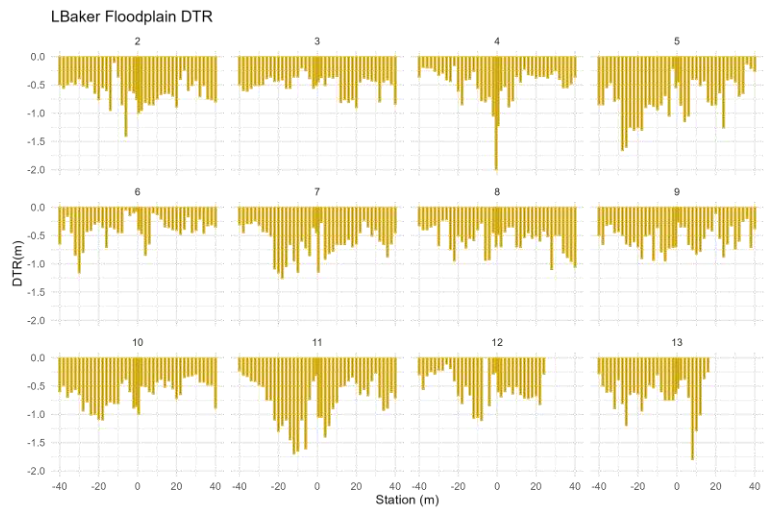
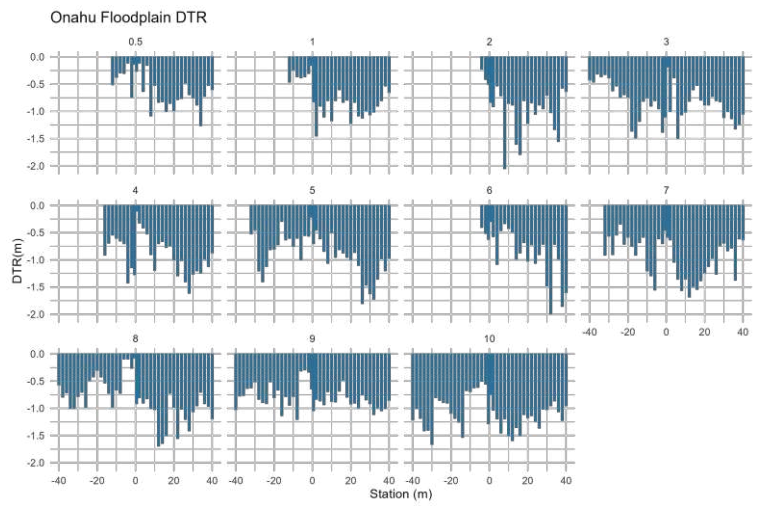
Figure 17. Transect plots of floodplain depth-to-refusal by reach. Transect number indicated above each plot. Negative stations indicate left-bank and positive stations indicate right-bank.

Floodplain sediment depth-to-refusal (FDTR) measurements varied from -2.35 m to 0 m below the ground surface. Upper Baker Creek has the deepest fine-grained sediments within the floodplain at -2.35 m (Figure 18). A Kruskal-Wallis test indicated significant difference in the median FDTR values at each site ($p < 0.001$) with Dunn test's indicating significant difference between each site ($p < 0.001$). Detailed plots of textural classifications for each transect can be found in Appendix III.

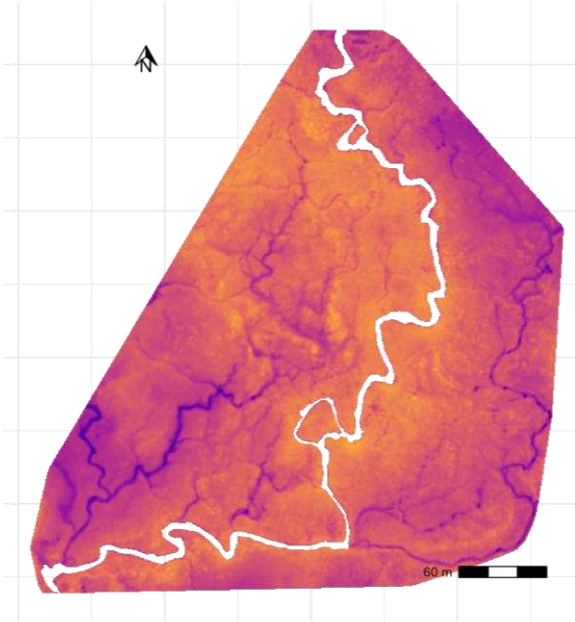
Figure 19. Relative elevation models at 10-year flood extent. Color scales are fixed for qualitative comparison.

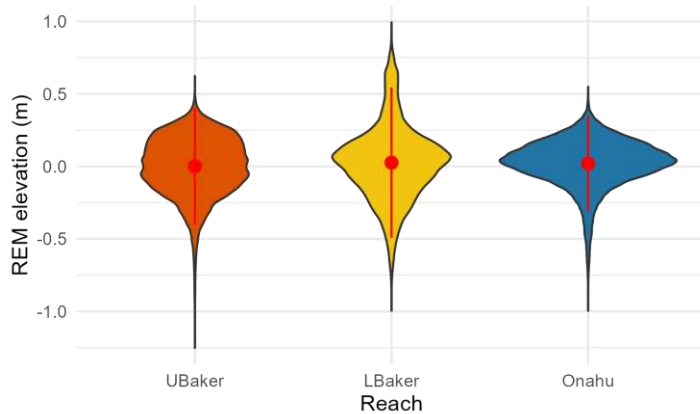
Figure 20. Violin plot of relative elevation model pixel values, red dots indicate mean pixel values with red line extent indicating one standard deviation range.

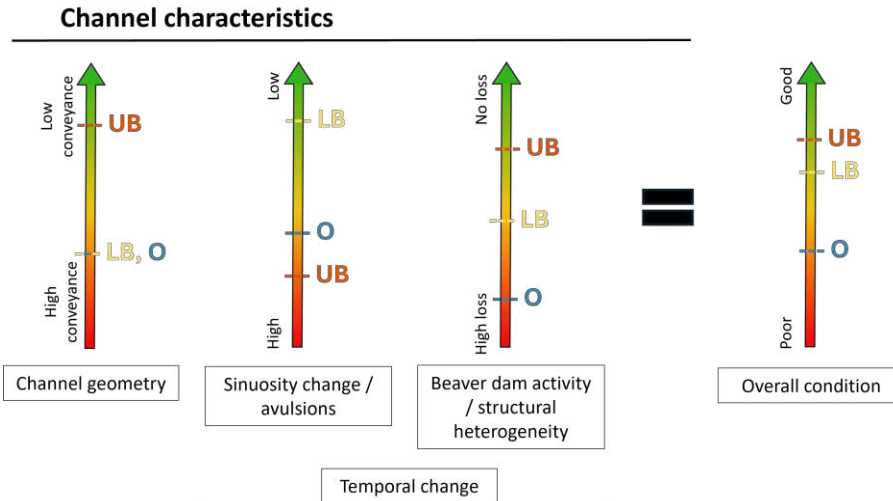
Figure 23. Condition assessment of channel characteristics (UB = Upper Baker, LB = Lower Baker, O = Onahu) indicating that Upper Baker has the best channel geomorphic condition, followed by Lower Baker then Onahu Creeks.

Upper Baker	Lower Baker	Onahu
Channel geometry	3	1	1
Sinuosity change / avulsions	1	3	2
Beaver dam activity / structural heterogeneity	3	2	1
Total	7	6	4

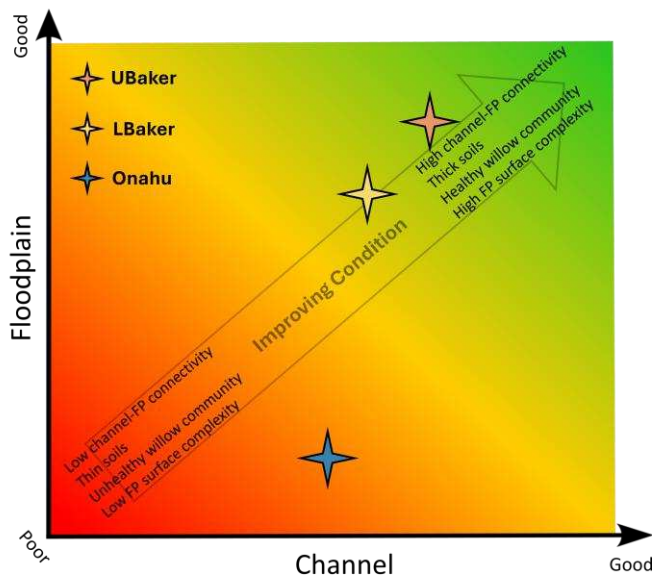
Figure 25. Conceptual ranking of existing geomorphic condition based on channel and floodplain characteristics for Upper Baker, Lower Baker, and Onahu Creeks. The diagonal arrow indicates improving channel and floodplain characteristics relative to restoration priorities. Upper Baker Creek shows the best overall geomorphic condition, followed by Lower Baker and Onahu Creeks.

Upper Baker Creek has the best geomorphic condition of the three sites, characterized by high channel-floodplain connectivity, thick floodplain soils capable of high water retention capacity at inundating flows, the best relative willow condition, and high floodplain surface complexity that diverts and stores water across the floodplain. In comparison, Onahu Creek exhibits low channel-floodplain connectivity, poor willow condition, and lower relative valley-bottom surface complexity (Figure 25).

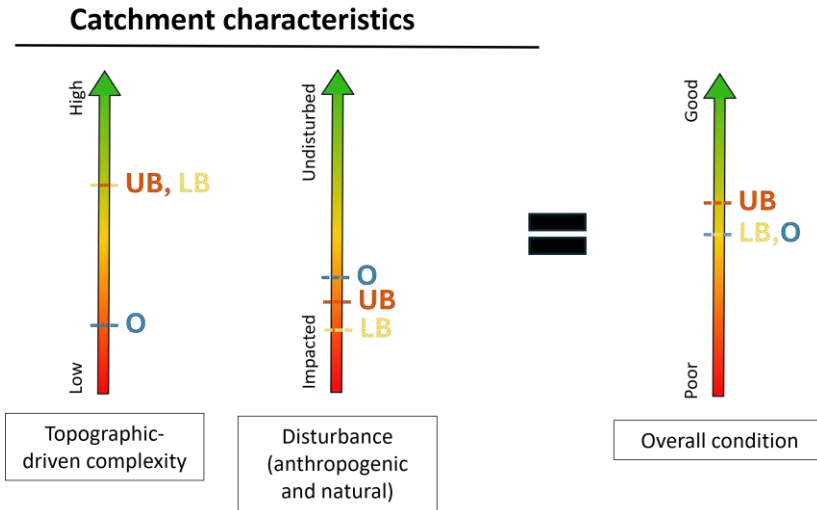
Figure 26. Condition assessment of catchment characteristics (UB = Upper Baker, LB = Lower Baker, O = Onahu) indicating that Upper Baker has the best catchment geomorphic condition, followed by Lower Baker and Onahu Creeks.

Upper Baker	Lower Baker	Onahu
Topographic-driven complexity	3	3	1
Disturbance (anthropogenic and natural)	2	1	3
Total	5	4	4
