Artificial Ground-Water Recharge On The Arikaree River Near Cope, Colorado

Completion Report

ARTIFICIAL GROUND WATER RECHARGE ON THE ARIKAREE RIVER NEAR COPE, COLORADO

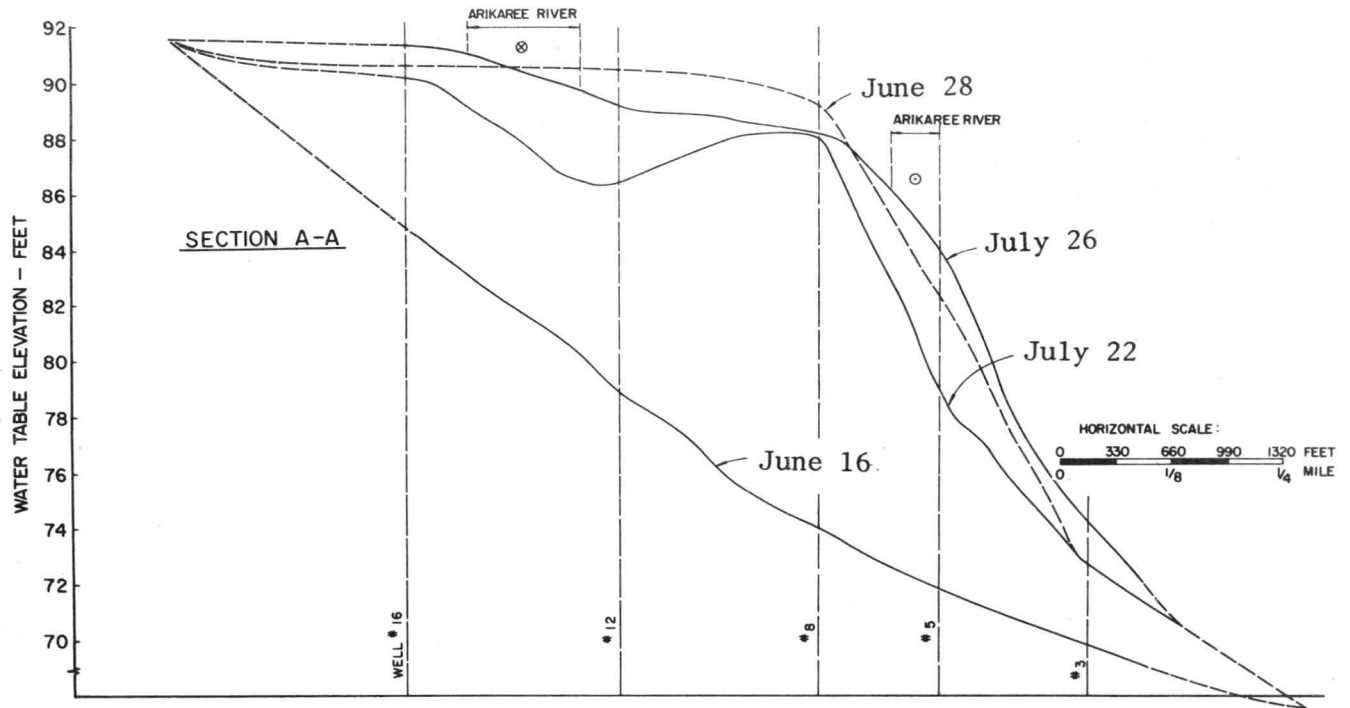
Figure 12. Cross sections for June 16, 28, July 22, 26, 1965.

After each flow, a change in saturated thickness map was prepared to show the effect of recharge. A planimeter was used to determine the volume of aquifer that was saturated as the water level rose. Assuming a porosity of 20 percent, the estimated volume of recharge was computed. Table 2 gives dates and amounts of water recharged. Cross sections, Figs. 12-16, show the size and shape of the recharge mounds.
