CIVIL ENGINEERING DEPARTMENT  
COLORADO STATE UNIVERSITY  
FORT COLLINS, COLORADO

CE Research No. CER71-72MMS-32  
June 1972

# THE USE OF REMOTE SENSING TO OBTAIN DATA FOR DESCRIBING THE LARGE RIVER

## Interim Report

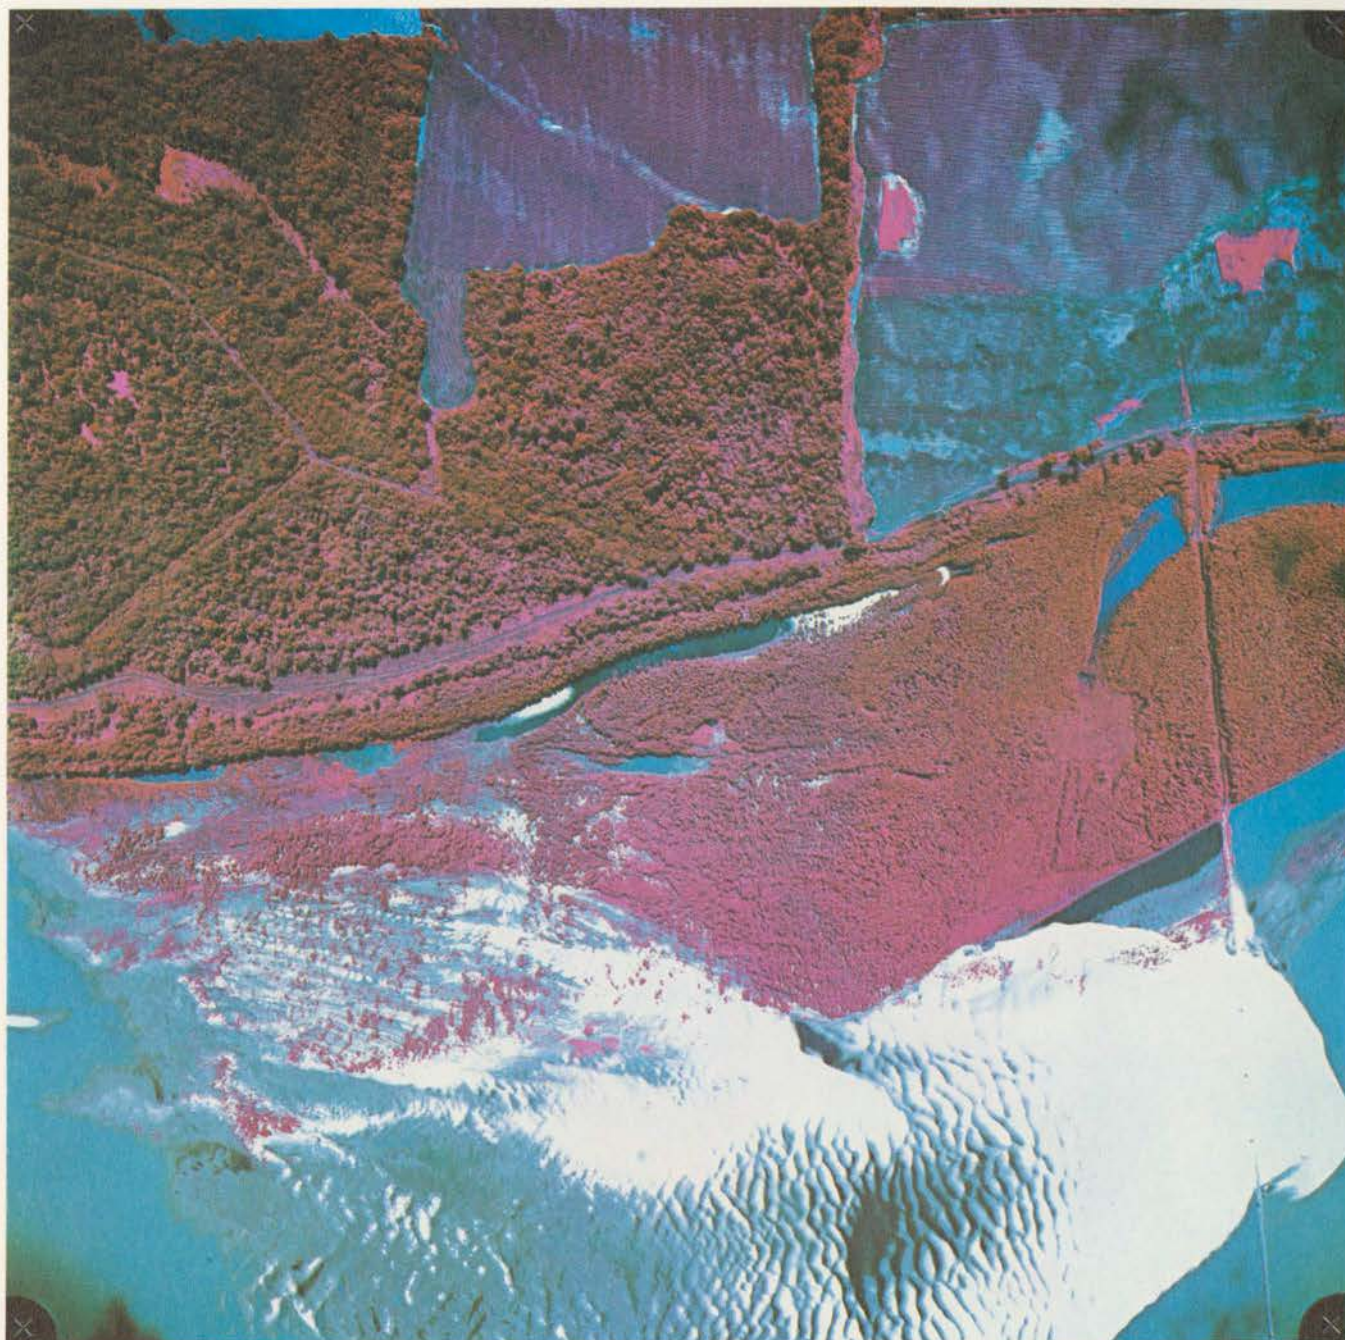
4 0 9 0

As an example, on 3617 along the left bank-flood plain, a variation in the tone of the vegetation apparently of the same type indicates probably a high moisture area or a different soil type. On 4090\*, the bare field is exhibiting a variety of tones of green and grey. This may result from a combination of soil-moisture/soil-type.

Photograph 4090\* illustrates the effect with moisture standing on the field. In some cases, the specular reflection off of the wet areas makes it appear white or very light even though there is just a film of water on top of the ground. A slightly different view angle in relation to the sun removes this specular reflectance property and the area simply looks a little darker color. There is a cultural feature noticed on this field, apparently a pipeline crossing, and one can see the location of this form from the apparent difference in moisture content and/or soil type at the surface of the ground.

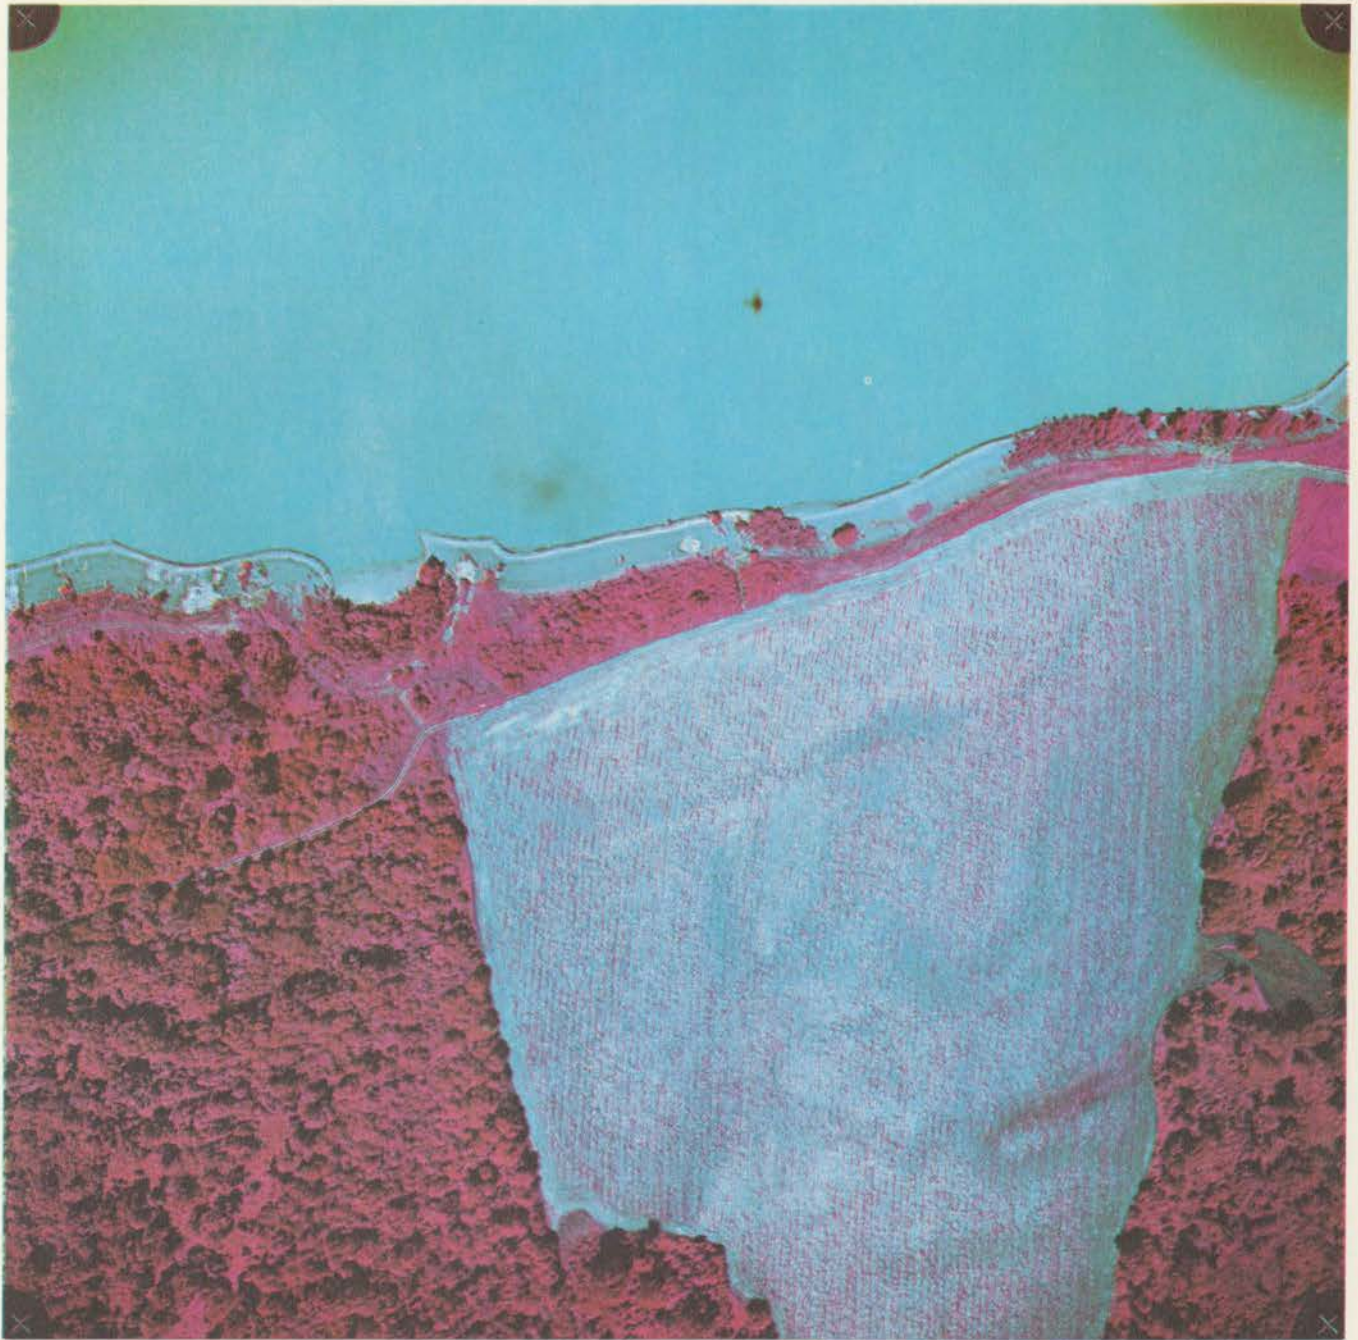
4 1 8 5

Picture 4185\* is a relatively large scale representation of the near bank flood plain and the open field shown in this picture illustrates some variation in color. The light red tone indicates growing vegetation; the lighter tones in the soil infer a dryer material of a certain character; whereas, the darker, green tones (resembling buried channels) indicate a tighter more clayey material with a higher moisture content.
