THESIS

COLLAPSE SIMULATIONS OF STEEL BUILDINGS UNDER FIRE

Department of Civil and Environmental Engineering

Colorado State University

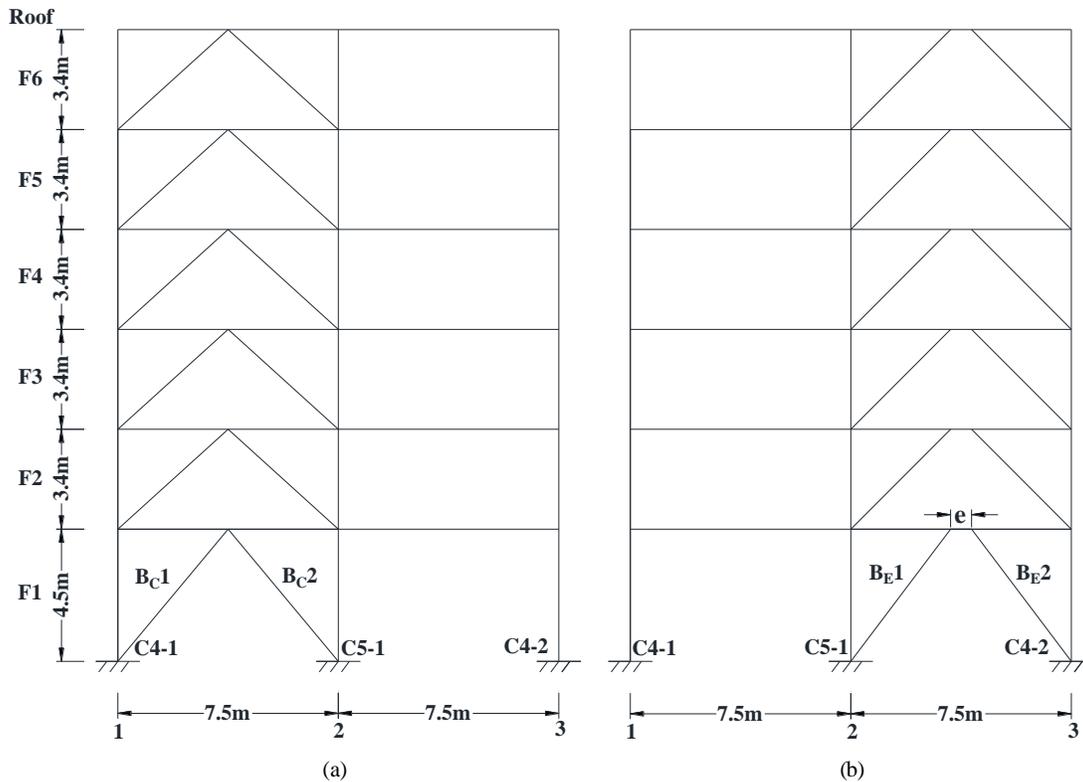
loading, so that energy dissipation is achieved by concentrating inelastic deformations in designated regions called “shear links”. The seismic behavior of CBFs and EBFs is fairly well understood as a result of extensive research conducted in the past. However, their behavior under fire loadings is yet to be fully investigated and therefore are the focus of this study.

Figure 1.1 Elevation View of Braced Frame Systems

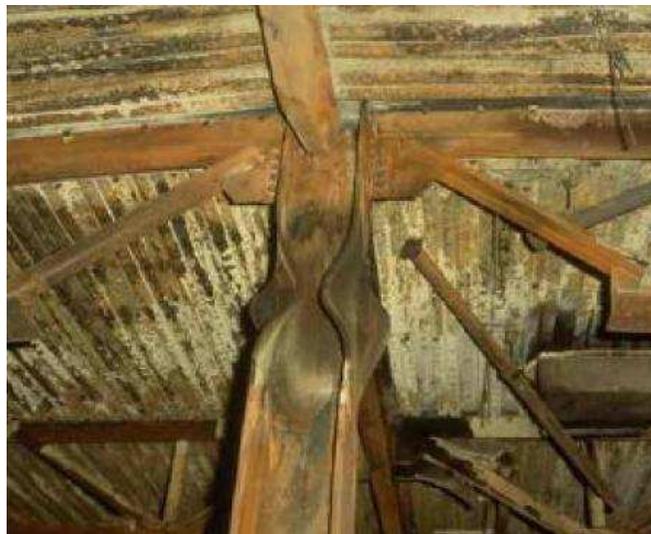
subsequent axial shortening. The column deformations were thought to have been the result of the rigid transfer beams in the upper level of the building restraining thermal expansion of the heat-affected column regions. Figure 2.1 shows the local buckling in a heat-affected column. It was noted that the heavier exposed column sections within the fire compartment showed no signs of permanent deformation, most likely attributed to the larger volume-to-surface area aspect ratios that resulted in lower steel temperatures (Newman, 2000).

Figure 2.1 Local Buckling of Column (Newman, 2000)

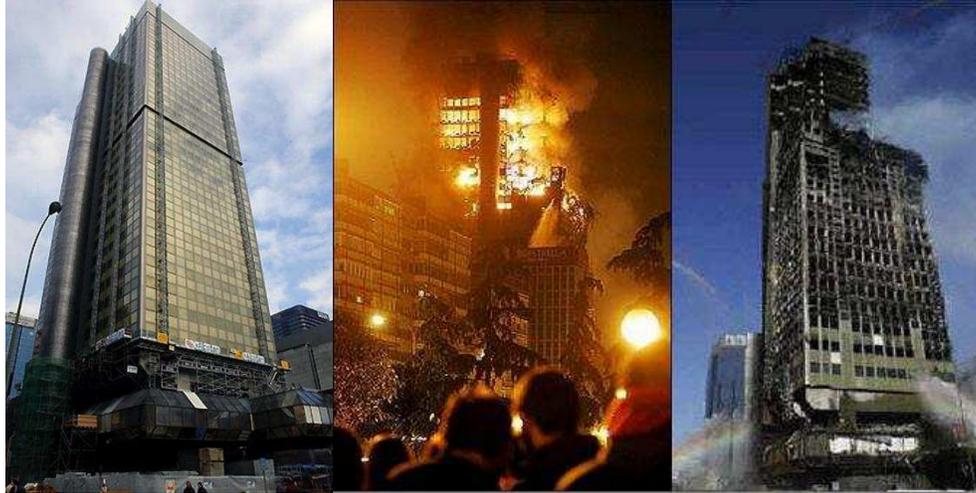
Figure 2.5 Windsor Building Fire (NILIM, 2005)

Structural damage was significant on the top 11 stories due to the lack of fire protection. Perimeter steel columns including exterior bays of waffle slabs almost completely collapsed. However, the reinforced concrete core maintained its strength and prevented total collapse of the structure. The partial collapse mechanisms reported in NILIM (2005) was described in the following manner: (1) the steel columns near the fire buckled due to material degradation at elevated temperatures; (2) the axial loads on the buckled columns were redistributed to adjacent structural members; (3) the number of deteriorated columns increased due to the developing fire; however the waffle slab worked as a cantilever and prevented structural collapse; (4) The fire spread and the waffle slabs reached their load capacity as a cantilever for the extended supporting area and ultimately collapsed; and (5) the floor collapse triggered failure of other floors and the waffle slabs were ripped off at the connections to the core. It was found that a mechanical floor between

the 16<sup>th</sup> and 17<sup>th</sup> floors provided enough redundancy to prevent progressive collapse. Figure 2.5 provides a before, during, and after the event images of the structure.

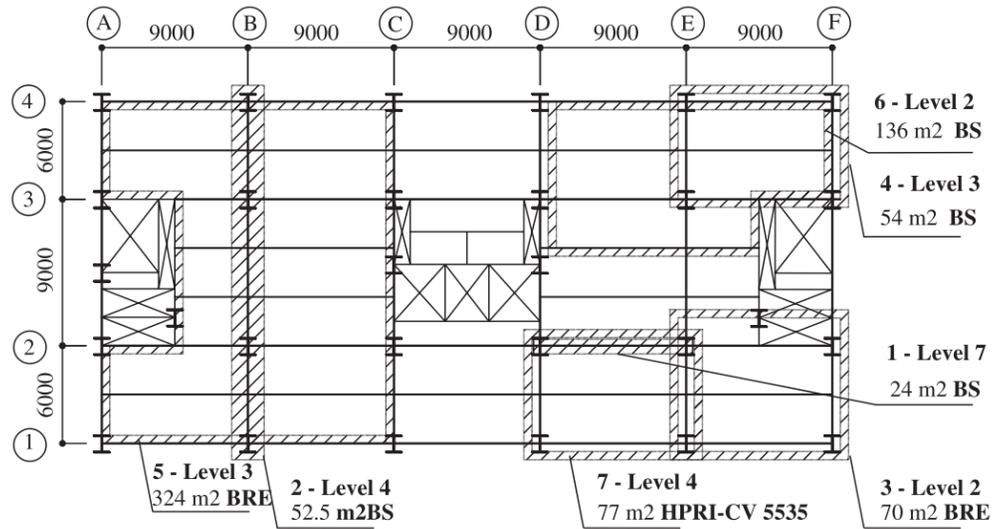
Figure 2.8 Floor Plan of Cardington Fire Test Steel Structures (British Steel, 1999)

The Cardington Fire Test was a series of large-scale fire tests conducted of steel structures with composite concrete slab. This test identified the discrepancies between the behavior of an individual member and a member in a structural system at elevated temperature. The steel test structure was built in 1993 and comprised of steel framed construction using composite concrete slabs supported by steel decking in composite action with the steel beams. It has eight stories (33m height) and is five bays wide ( $5 \times 9 = 45\text{m}$ ) by three bays deep ( $6 + 9 + 6 = 21\text{m}$ ) in plan, see Figure 2.8. The main steel frame was designed for gravity loads, the connections consisting of flexible end plates for beam-to-column connections and shear tab for beam-to-beam connections were designed to transmit vertical shear load. Seven large-scale fire tests at various positions within the experimental building were conducted. The main objective of the compartment fire tests was to assess the behavior of structural elements with real restraint under a natural fire. The failures of shear tab connection were observed as shown in Figure 2.9 as the bolts sheared due to thermal contraction of the beam during cooling.

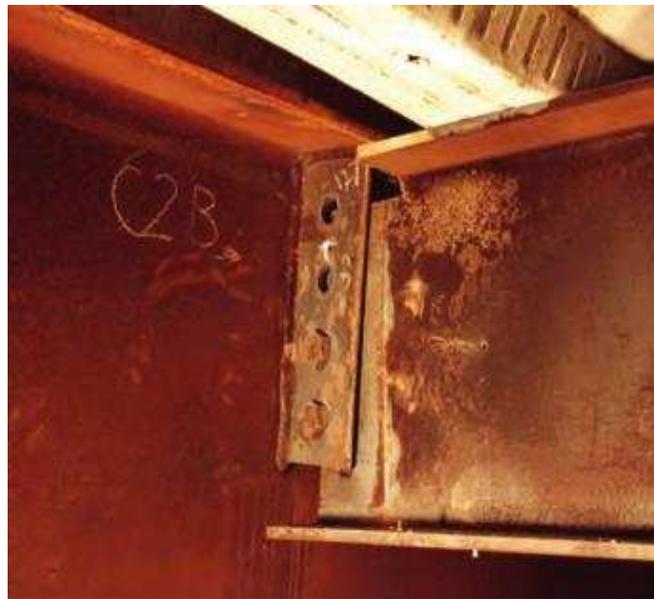
Figure 2.9 Shear Tab Connection Failure in Cardington Fire Test (British Steel, 1999)

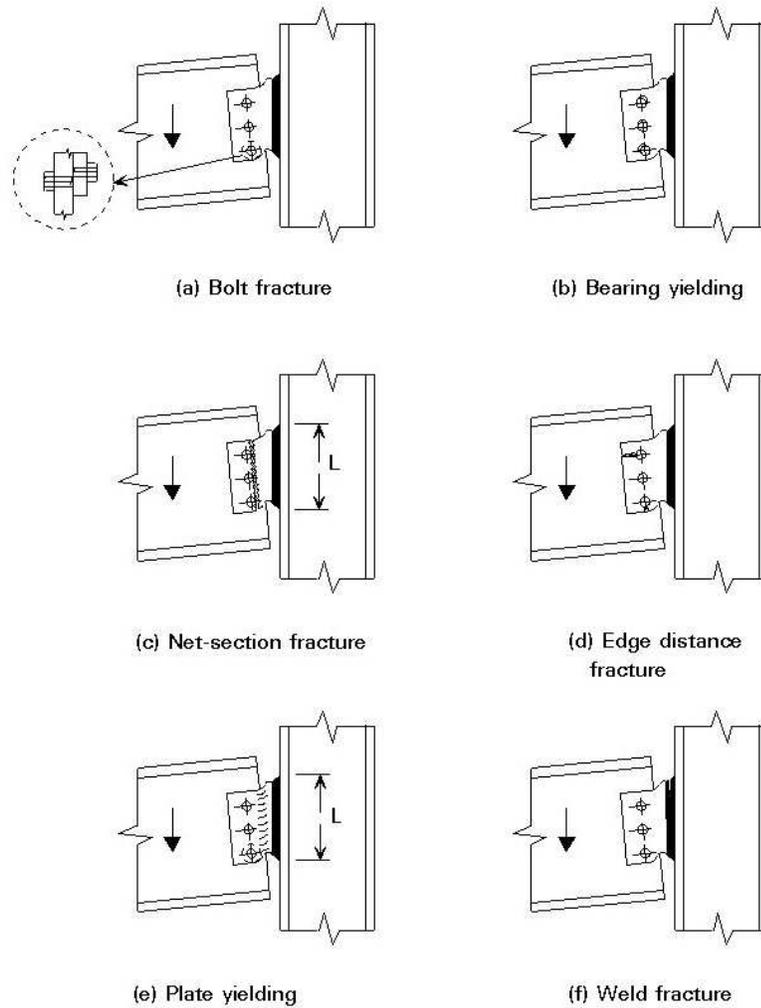
Six potential failure modes of shear tab connections are identified as follows: 1) yielding of the gross area of the plate, 2) bearing of the plate and beam web bolt holes, 3) fracture of the edge distance of bolts, 4) shear fracture of the net area of the plate, 5) fracture of bolts, and 6) fracture of welds. Consistent with the aim of providing a rational design procedure, the above failure modes were divided into two categories: ductile failure modes (Modes 1 and 2) involving yielding of steel and brittle failure modes (Modes 3 to 6) involving fracture of steel. For each failure mode, a design formula was suggested in the AISC Specifications (365-10). The design procedures were developed to ensure that the ductile failure mode will occur first, followed by the more brittle ones. The six failure modes for shear tab connections are summarized in Figure 2.10.

Figure 2.10 Modes of Failure for Shear Tab Connection (<http://www.fgg.uni-lj.si/~pmoze/esdep/master/wg11/10500.htm>)

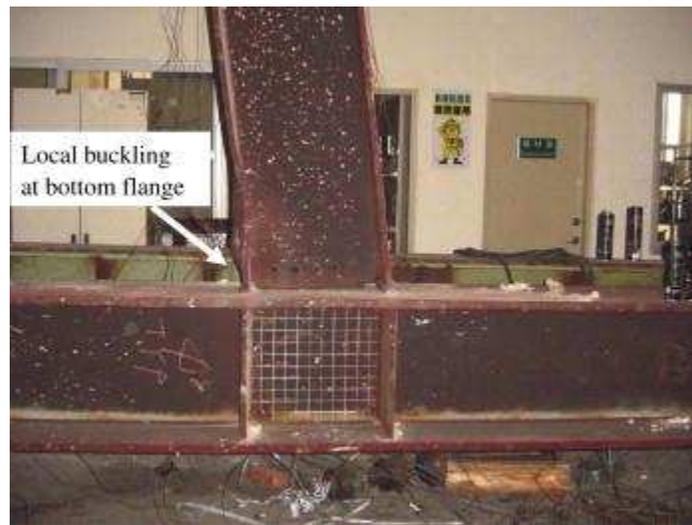
From these studies, it was found that the beam-to-column connection was able to retain its design strength up to 650°C. However, the stiffness dropped to 25% of its value at ambient temperature. Ductile behaviors were observed with necking and tearing at the top flange and local buckling at the bottom flange. Local buckling at the bottom flange was observed in the study (Figure 2.11). The research also found that the stability and integrity of steel connections can be retained with proper fire-proofing materials.

Figure 2.11 Local buckling of bottom flange of beam-to-column Specimen at 650°C (Yang et al., 2009)

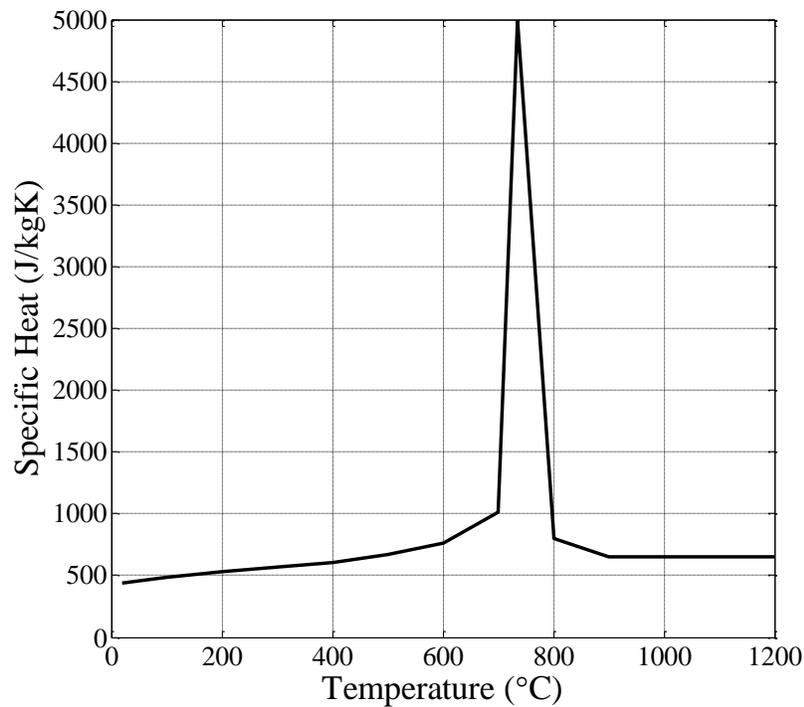
Figure 3.7 Specific Heat of Steel

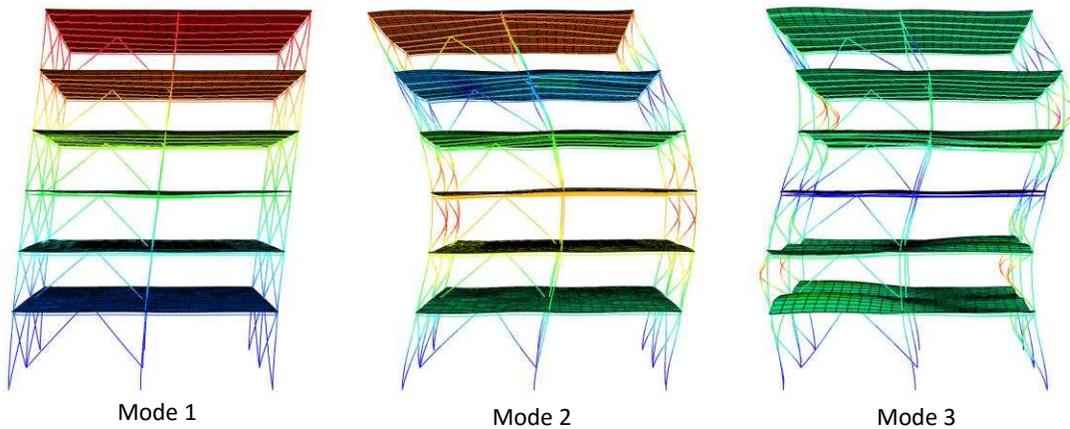
For this section, an eigenvalue analysis was performed on both frame models and the natural period of vibration and mode shapes were compared to the test results. First three mode shapes for both the CBF and EBF structures were captured in Figure 4.8 and Figure 4.9. A comparison of the natural period of vibration values obtained in this study and the values presented by the preliminary test report (Foutch, Roeder, and Goel 1986) can be found in Table 4.2. The comparison between the analytical results and test results shows good agreement and serve as validation of the dynamic properties implemented in the model.

Figure 4.8 Mode shapes of CBF

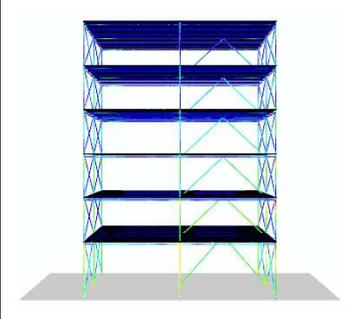
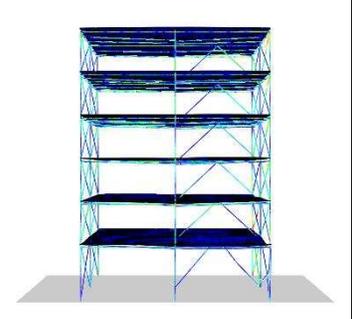
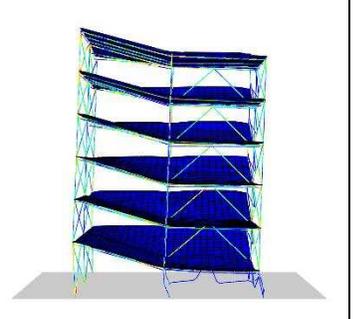
Table 5.2 Collapse Sequence for Case-1

Step Time=0 sec Temperature=20°C	Step Time=10 min Temperature=704°C	Step Time=20 min Temperature=773.5°C

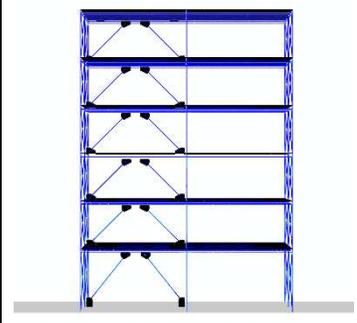
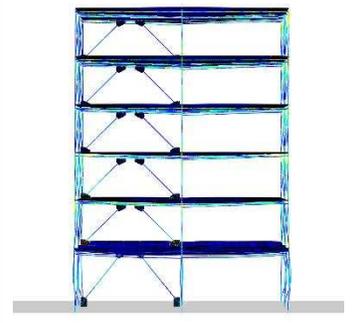
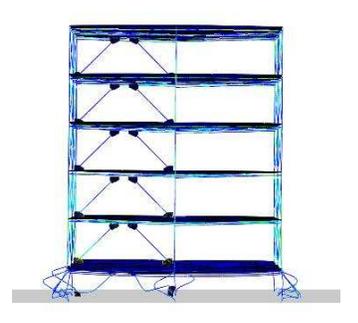
Table 5.5 Collapse Sequence for Case-4

Step Time=0 sec Temperature=20°C	Step Time=10 min Temperature=704°C	Step Time=20 min Temperature=773.5°C

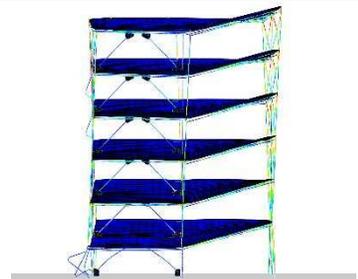
Table 5.8 Collapse Sequence for Case-7

first floor starts to drop with large deformation observed in the X braces. After half hour of heating the corner bay, where the temperature on the time-temperature curve is at 737.5°C, the first two floors dropped vertically with noticeable twisting of the entire structure. Substantial deformation is also observed in the braces and columns in fire-loaded bay. At 50 min (529°C), the failure continued with total collapse of the first three floors.

Step Time=0 sec Temperature=20°C	Step Time=10 min Temperature=700°C	Step Time=20 min Temperature=789°C

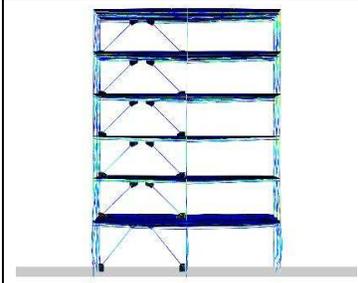
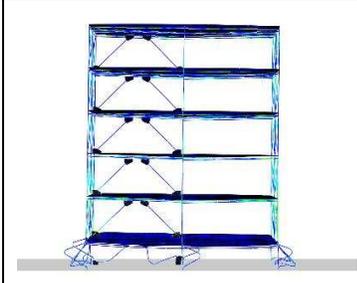
Table 5.9 Collapse Sequence for Case-8

of first floor columns. At 30 min (737.5°C), the lower two floors collapsed in a progressive manner where the demand on second floor increased substantially once the first floor was totally collapsed and also substantial increase in demand on the third floor once the second floor was in contact with the ground. At 40 min (860.6°C) and 50 min (909.4°C), total system collapse was observed with slight tilt of the structure due to its unsymmetrical nature.

Step Time=0 sec Temperature=20°C	Step Time=10 min Temperature=700°C	Step Time=20 min Temperature=789°C

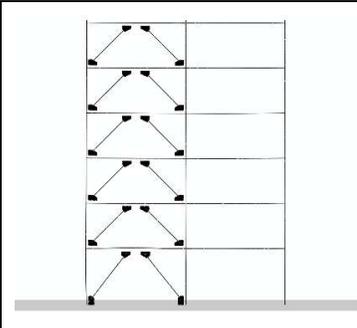
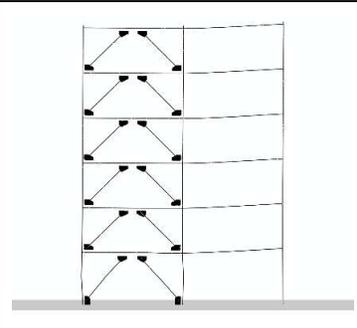
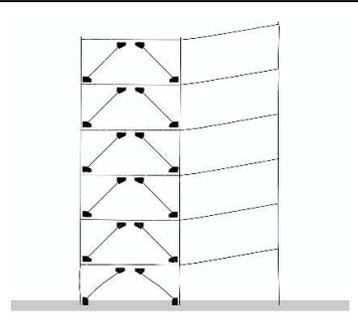
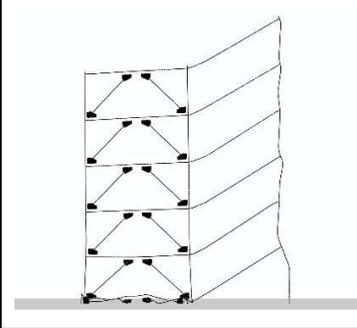
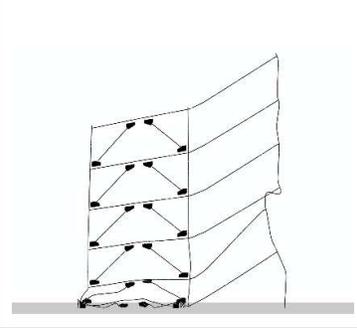
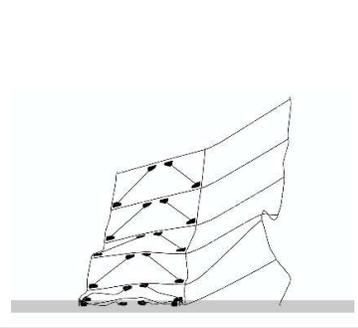
Table 5.14 Case-3 EBF Frame B Collapse Sequence

Step Time=10min Temperature=704°C	Step Time=15 min Temperature=718.4°C	Step Time=20 min Temperature=773.5°C

Step Time=30 min Temperature=843°C	Step Time=40 min Temperature=860.6°C	Step Time=50 min Temperature=909.4°C

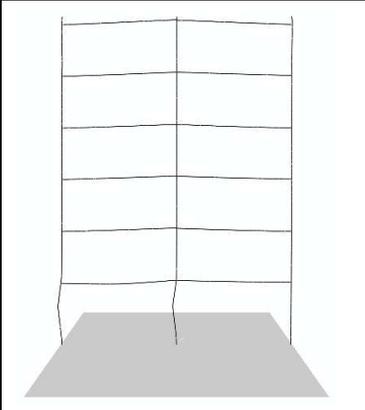
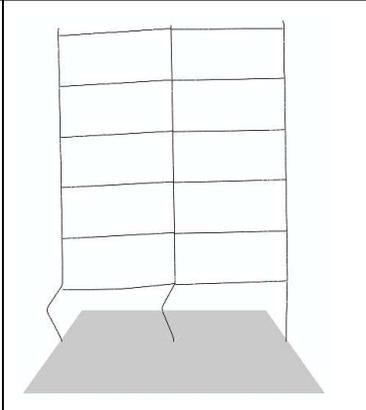
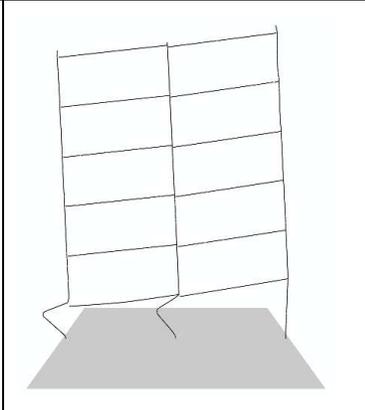
Table 5.15 Case-3 Gravity Frame 2 Collapse Sequence

Step Time=10min Temperature=704°C	Step Time=15 min Temperature=718.4°C	Step Time=20 min Temperature=773.5°C

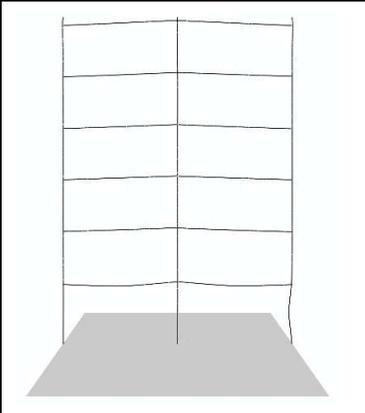
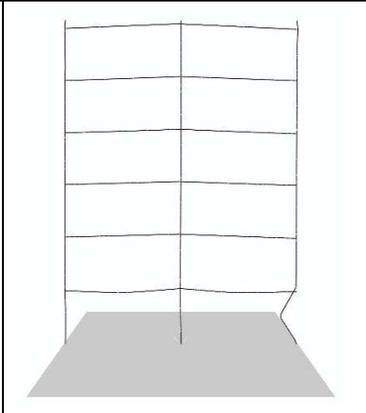
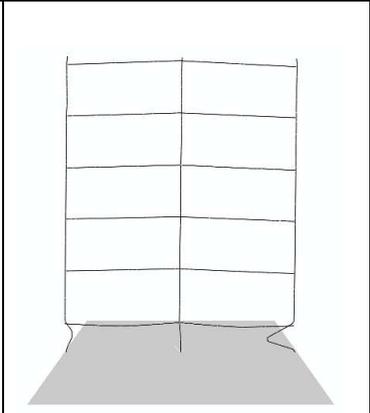
Table 5.17 Case-4 Gravity Frame 2 Collapse Sequence

Step Time=10 min Temperature=704°C	Step Time=15 min Temperature=718.4°C	Step Time=20 min Temperature=773.5°C

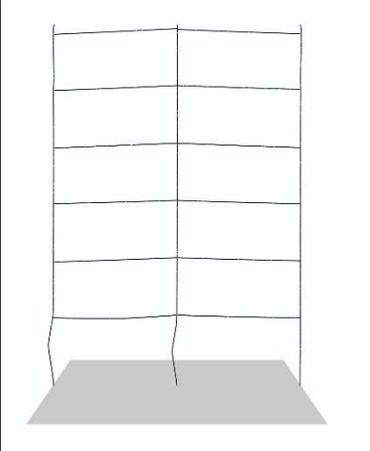
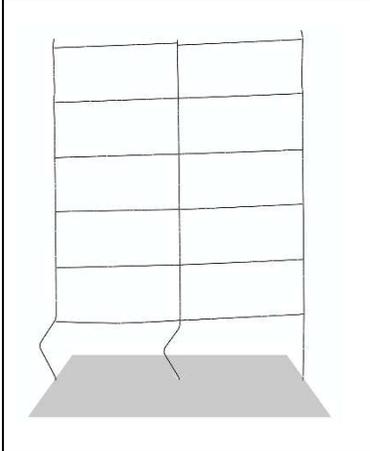
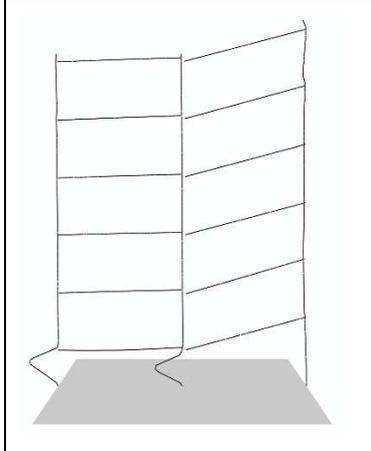
Table 5.19 Case-5 Gravity Frame 2 Collapse Sequence

Step Time=10min Temperature=700°C	Step Time=15 min Temperature=754.5°C	Step Time=20 min Temperature=789°C

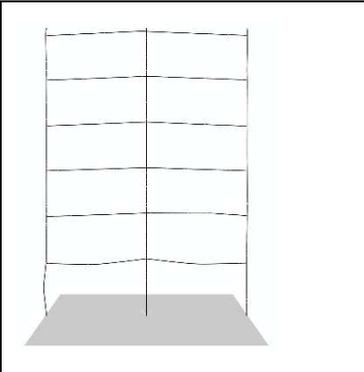
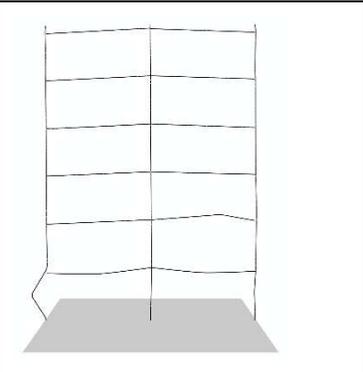
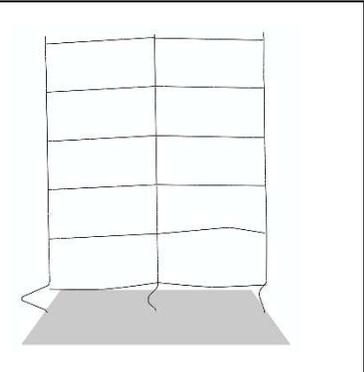
Table 5.21 Case-6 Gravity Frame 2 Collapse Sequence

Step Time=10 min Temperature=700°C	Step Time=15 min Temperature=754.5°C	Step Time=20 min Temperature=789°C

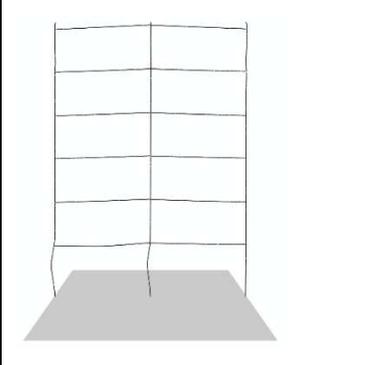
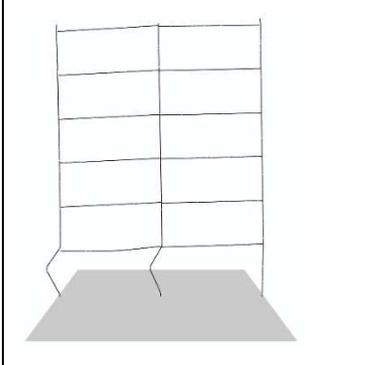
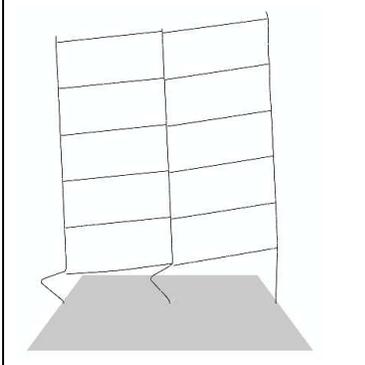
Table 5.23 Case-7 Gravity Frame 2 Collapse Sequence

Step Time=10min Temperature=700°C	Step Time=15 min Temperature=754.5°C	Step Time=20 min Temperature=789°C

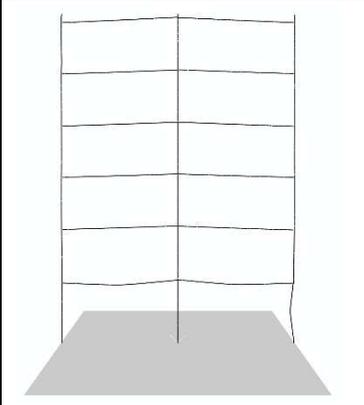
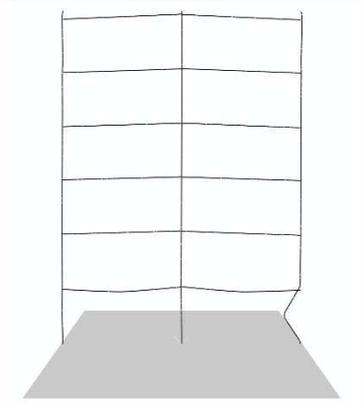
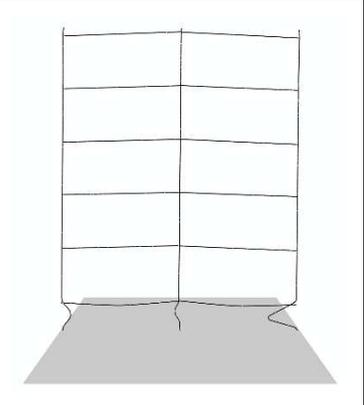
Table 5.25 Case-8 Gravity Frame 2 Collapse Sequence

Step Time=10min Temperature=700°C	Step Time=15 min Temperature=754.5°C	Step Time=20 min Temperature=789°C

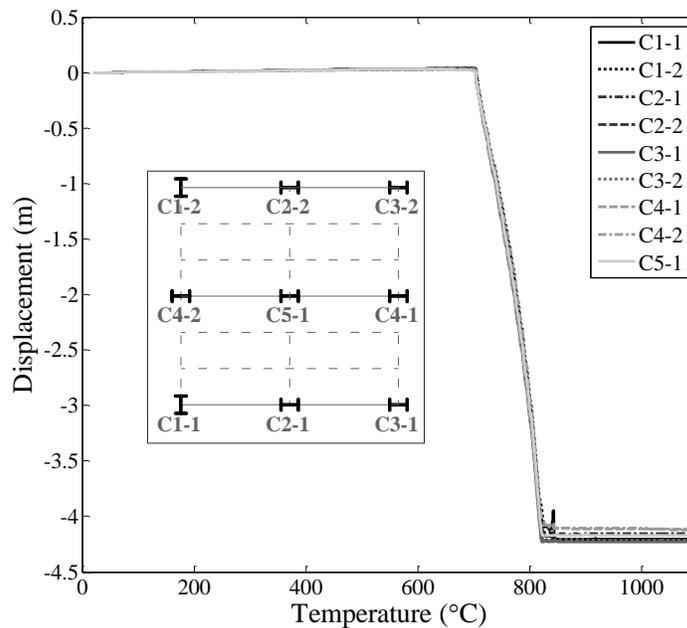
For Case 2 (CBF and E119 in the whole floor), shown in Figure 5.8, the whole first floor was subjected to elevated temperature. A small upward displacement is observed initially due to thermal elongation of the steel. When the temperature reached 700°C, the structural steel lost more than half of its strength and the entire floor started to displace vertically downward as shown in the figure through equal displacement of all columns. Full contact with the ground was reached at 823°C.

Figure 5.8 Case-2 Vertical Displacements of First Floor Columns

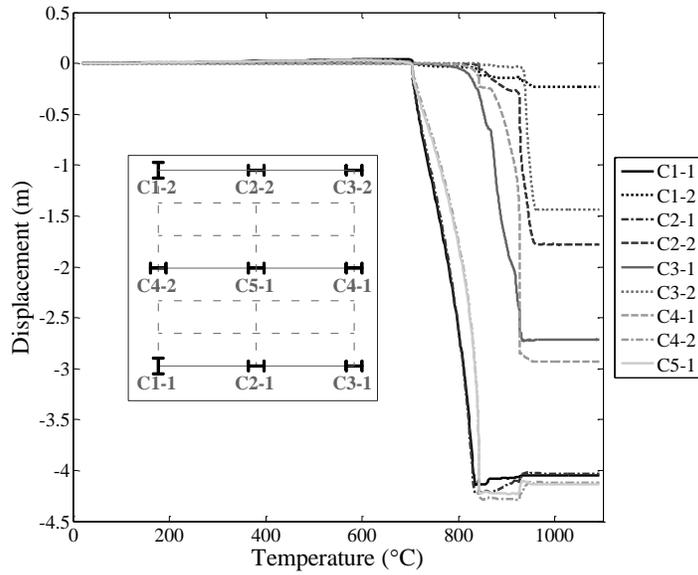
brace type used, the columns did not fail all at once. For example, the corner column far from the fire only had a displacement of 0.233m.

Figure 5.9 Case-3 Vertical Displacements of First Floor Columns

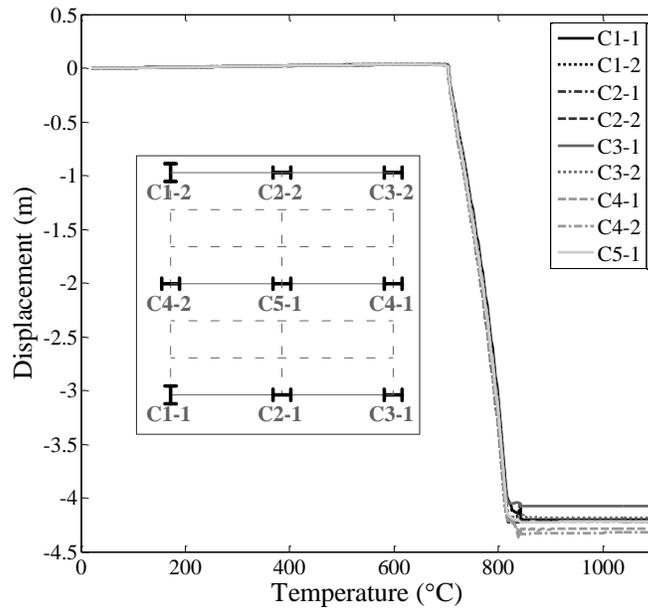
For Case 4 (EBF and E119 in the whole floor), shown in Figure 5.10, progressive failure of the entire floors is shown to start at approximately 700 °C with complete floor collapse at around 840 °C. All columns sustained the same displacement levels as expected.

Figure 5.10 Case-4 Vertical Displacements of First Floor Columns

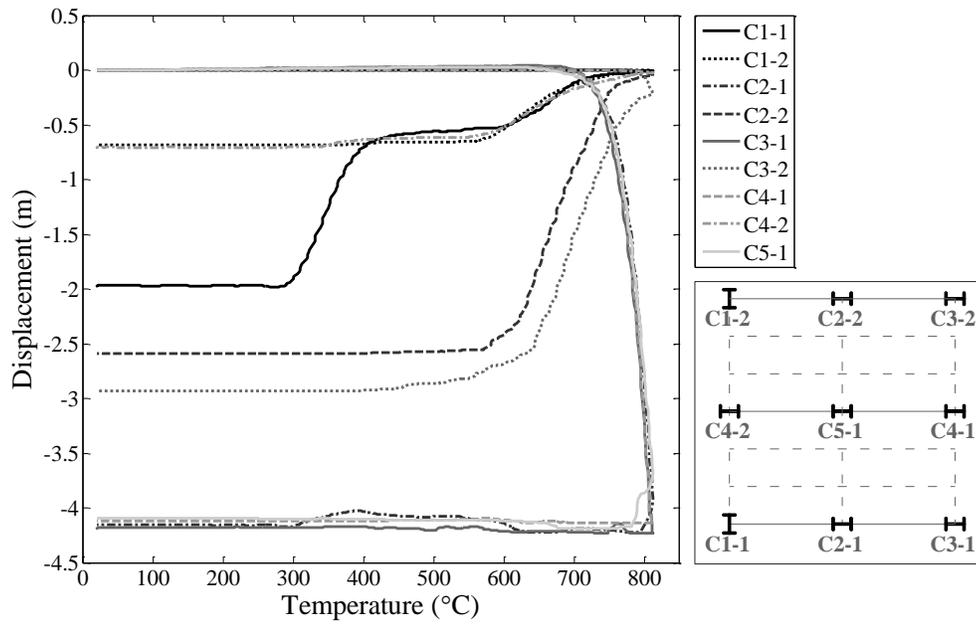
For Case 5 (CBF and EC3 parametric fire curve in a single compartment), shown in Figure 5.11, small thermal elongations of the heated columns were observed before the heated compartment started to drop at 670°C because the EC3 parametric has a slight faster rate of temperature increase. The heated compartment impacted the ground at around 810°C. The system started to cool down following reaching the peak temperature. This is shown in the response curves where the curves end at room temperature.

Figure 5.11 Case-5 Vertical Displacements of First Floor Columns

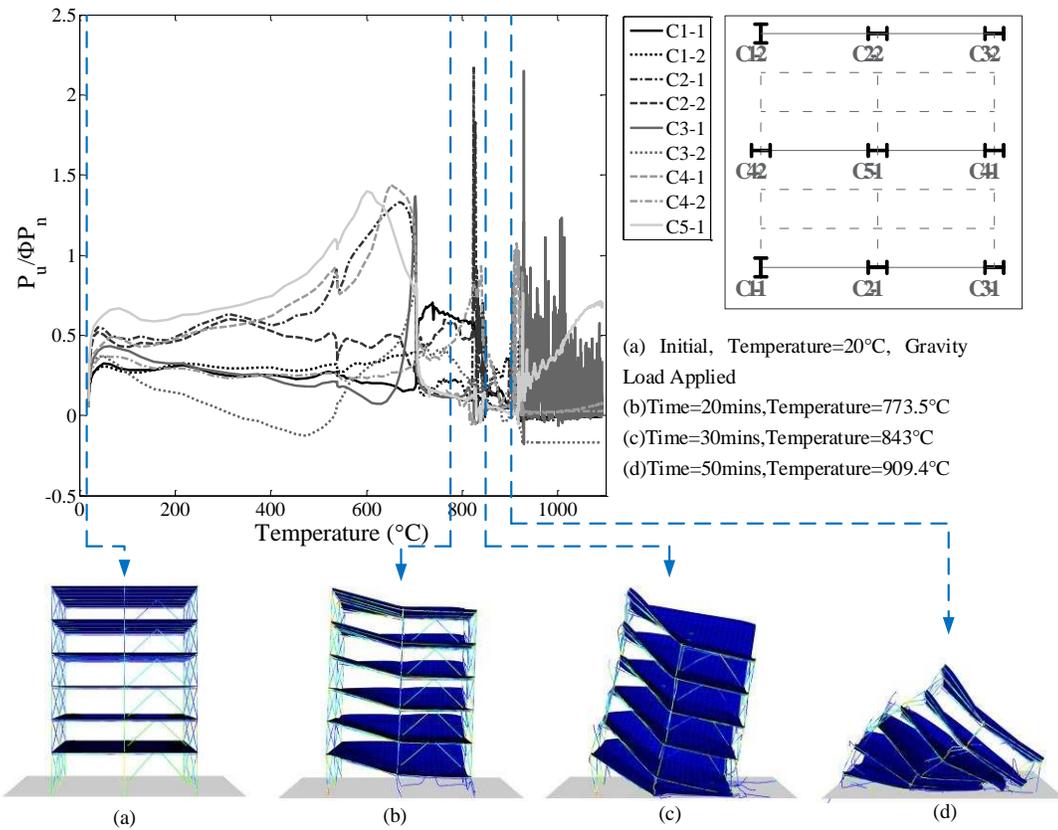
For Case 1, the ratios of  $P_u/\phi P_n$  at selected key temperature points, for all first floor columns, are shown in Table 5.26 below. At 600°C, only column C2-1 and C5-1 reached their capacity with a ratio larger than 1. At 700°C, columns C3-1 and C4-1 of the heated compartment reached their capacity limits.

Figure 5.15 Case-1 First Floor Column Axial Forces

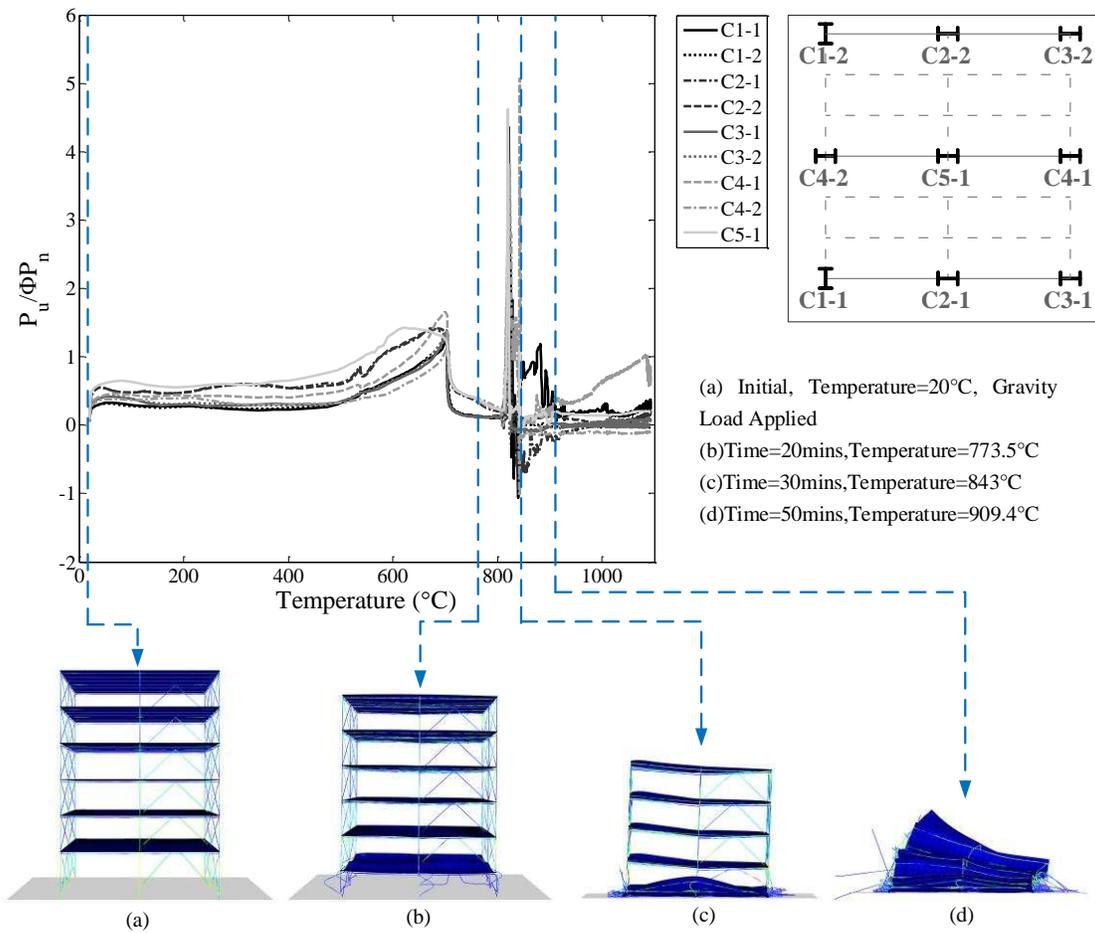
For Case 2, the ratios of  $P_u/\phi P_n$  for all the first floor columns at selected key temperature points are shown in Table 5.27 below. At 600°C, only centerline columns C2-1, C2-2 and C5-1 reached their ratio limit of 1. This is because of the larger tributary areas associated with these columns, which caused them to carry more loads than other columns. At 700°C, all columns of the first floor exceeded their limit as a result of the whole first floor being heated were evenly heated, which marks the onset of collapse of the entire building.

Figure 5.16 Case-2 First Floor Column Axial Forces

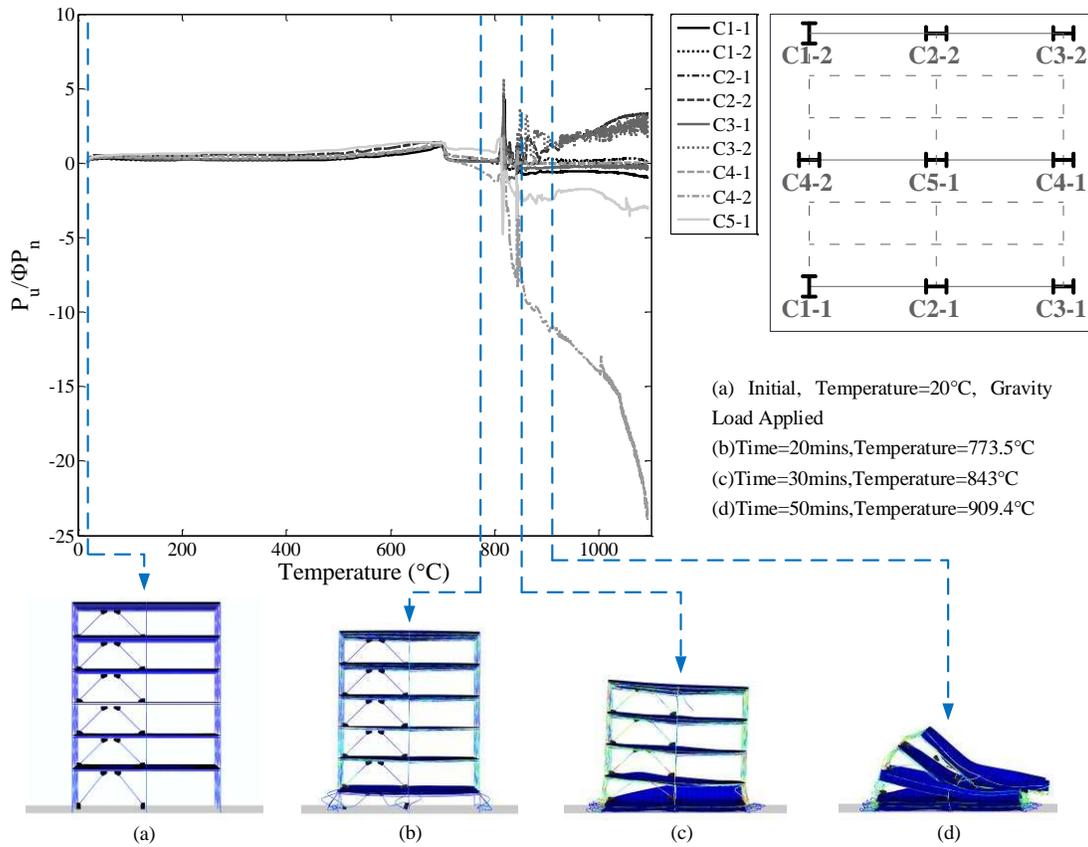
For Case 4, the ratios of  $P_u/\phi P_n$  for all first floor columns at selected key temperature points are shown in Table 5.29 below. At 600°C, the centerline columns, C2-1, C2-2 and C5-1, had already reached their load capacity. When the fire temperature increased to 700°C, all first floor columns failed at this point. With the increased temperature, columns C4-2 and C5-1 were subjected to tension because of the large bending in the gusset plates welded to them.

Figure 5.18 Case-4 First Floor Column Axial Forces

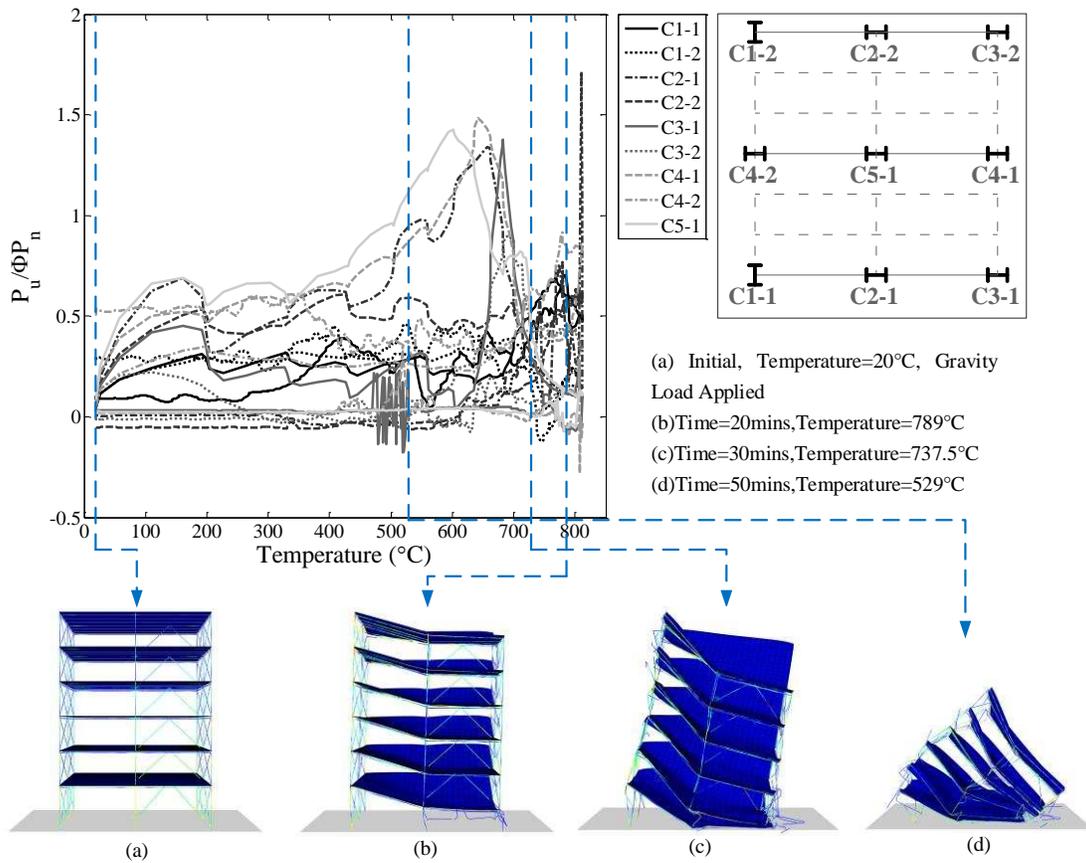
For Case 5, the ratios of  $P_u/\phi P_n$  for all first floor columns at selected key temperature points are shown in Table 5.30 below. At 600°C, three of the four fire-loaded compartment columns had already reach their limits, which led to collapse of the whole building. Column C3-2 had several negative values as shown in the table, which means the column was under tension instead of compression, this was caused by the sway of the building during the collapse.

Figure 5.19 Case-5 First Floor Column Axial Forces

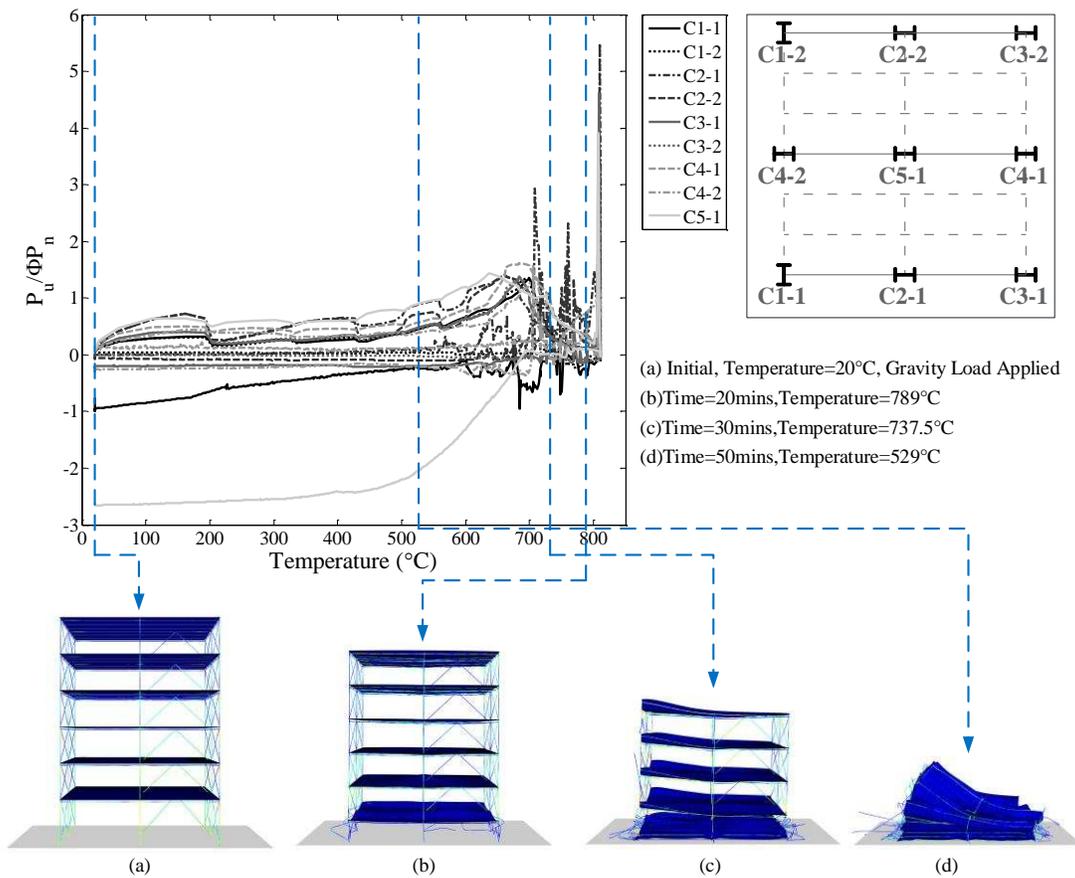
For Case 6, the ratios of  $P_u/\phi P_n$  for all first floor columns at selected key temperature points are shown in Table 5.31 below. The center columns, C2-1 and C5-1, had ratios larger than 1 at 600°C because of their associated larger tributary areas. At 700°C, most columns had their ratio exceed one.

Figure 5.20 Case-6 First Floor Column Axial Forces

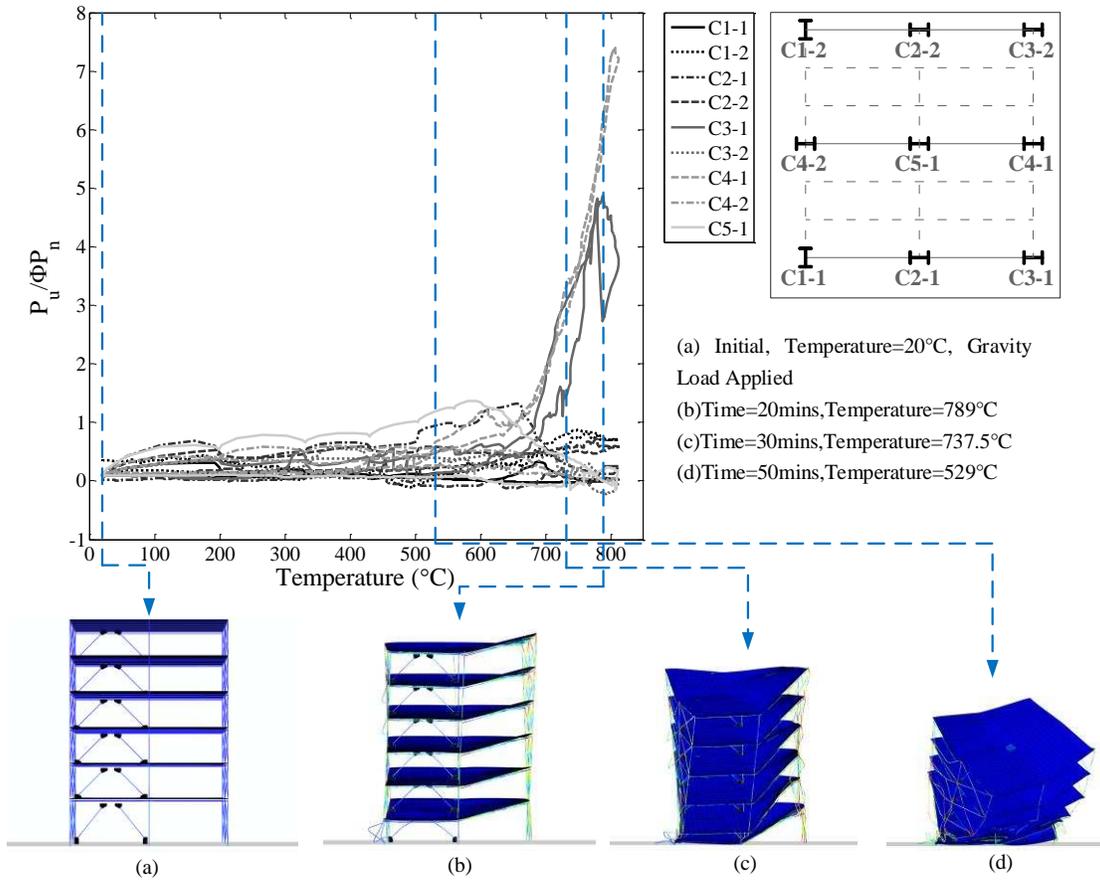
For Case 7, the ratios of  $P_u/\phi P_n$  for all first floor columns at selected key temperature points are shown in Table 5.32 below. Column C5-1 was the first columns to fail in this case at 500°C. Columns C5-1 is the center column with the largest tributary area. At 600°C, only columns C2-1 and C5-1 reached their load capacity limits. Other columns, C3-1 and C4-1, far exceeded their limit at 700°C, which was caused by load redistribution of the failed compartment columns.

Figure 5.21 Case-7 First Floor Column Axial Forces

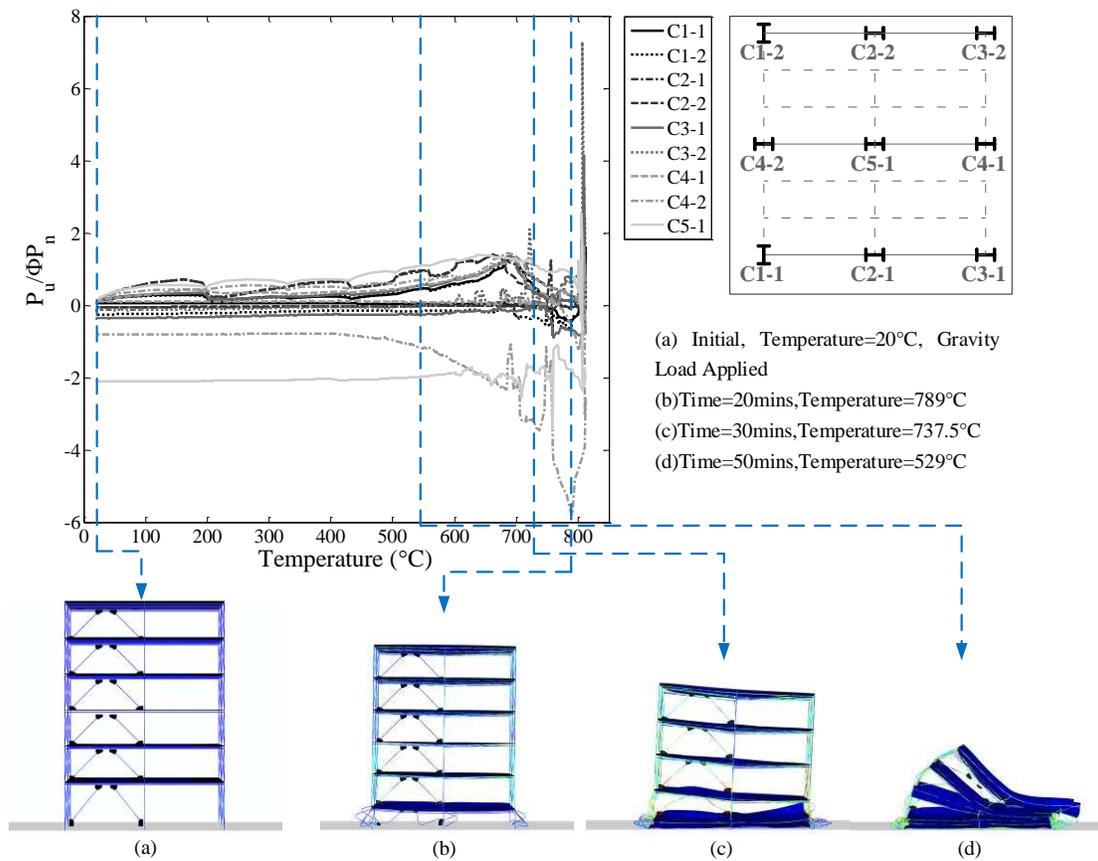
For Case 8, the ratios of  $P_u/\phi P_n$  for all first floor columns at selected key temperature points are shown in Table 5.33 below. The ratios for the centerline columns C2-1, C2-2 and C5-1 exceeded a value of one at 600°C as expected. At 700°C, all columns exceeded their ratio limits, then the collapse of the building began.

Figure 5.22 Case-8 First Floor Column Axial Forces

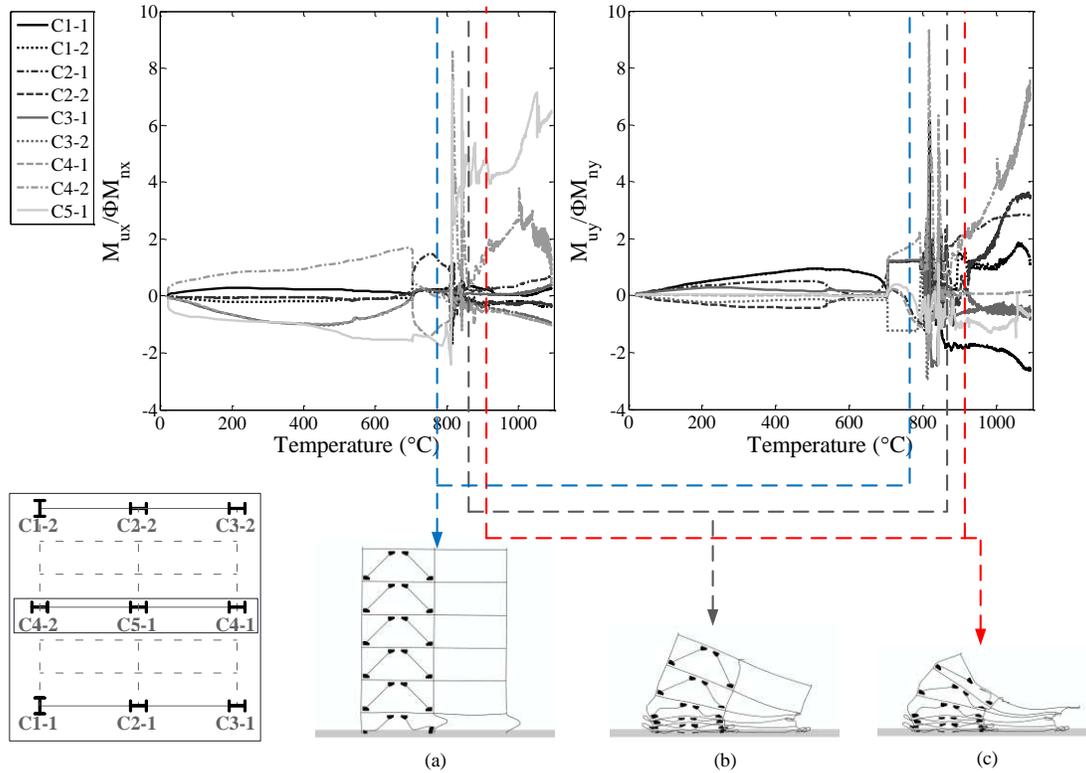
Table 5.40 and 5.41 show the ratios of columns' end moment at selected temperature points for the x-axis and y-axis. Columns C4-1 and C5-1 reached their load capacity at rather low temperature of approximately 300°C. At 800°C, other columns started to experience large demand about the y-axis.

Figure 5.26 Case-4 First Floor Column End Moment
