THESIS

COLLAPSE SIMULATIONS OF STEEL BUILDINGS UNDER FIRE

Department of Civil and Environmental Engineering

Colorado State University

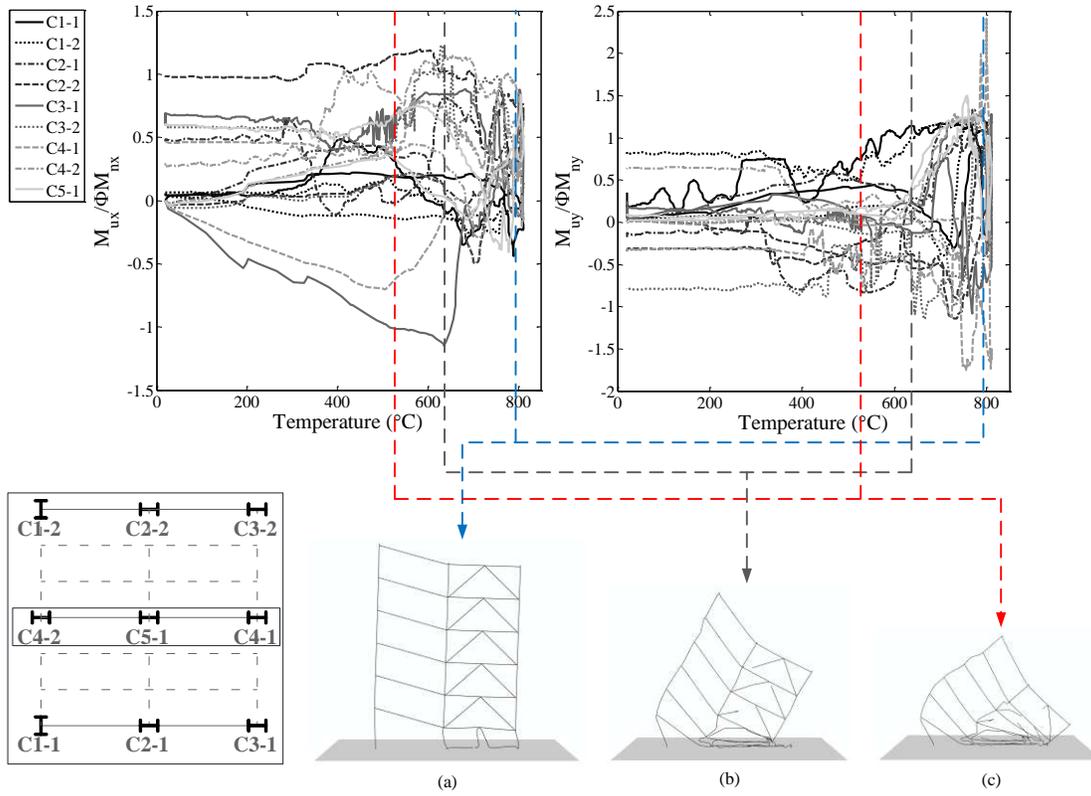
For Case 5 (CBF and EC3 parametric fire curve in a single compartment), shown in Figure 5.27, the demand on the columns about both the x-axis and y-axis is somewhat similar to that of Case-1. Table 5.42 and 5.43 show the ratios for the columns' end moment at selected temperature points for the x-axis and y-axis. As shown in the tables, only column C3-1 was found to have reached its capacity limit about the x-axis. About the y-axis, C2-1 was the first to reach its limit at 700°C. Various other columns reached their capacity about the same axis at 800°C.

Figure 5.27 Case-5 First Floor Column End Moment

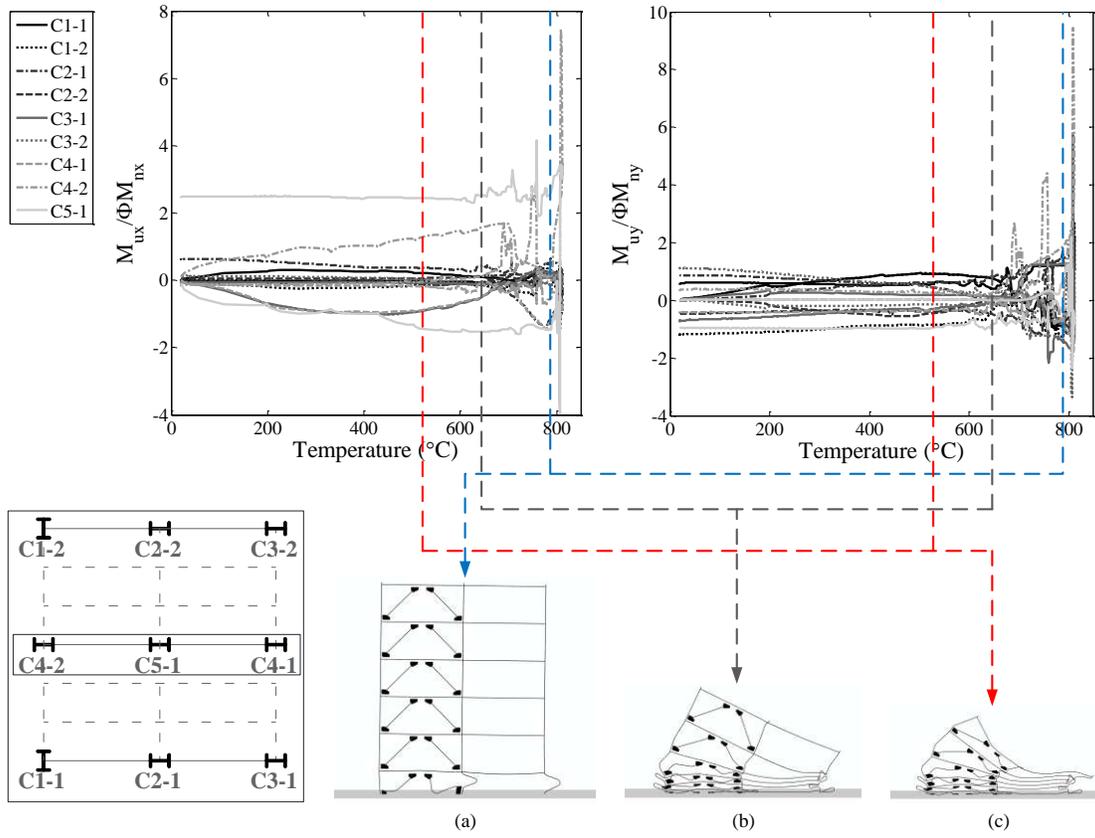
Table 5.48 and 5.49 show the ratios of columns' end moment at selected temperature points for the x-axis and y-axis. Columns C4-1 and C5-1 reached their load capacity at about 400°C. Various other columns reached their limit about the y-axis at about 800°C.

Figure 5.30 Case-8 First Floor Column End Moment

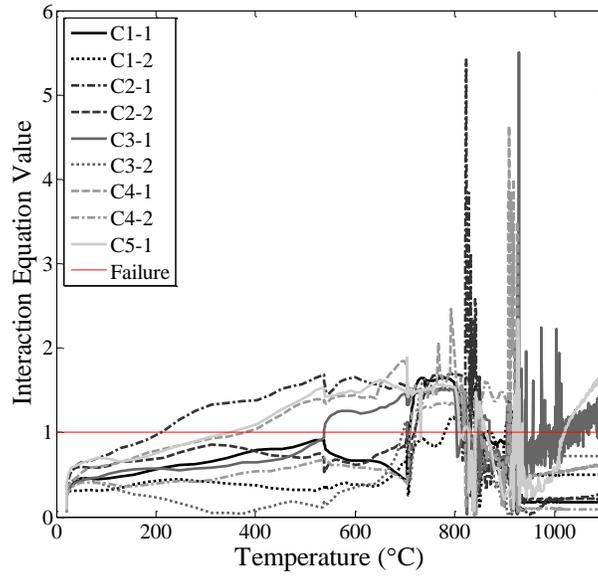
For Case 1 (CBF and E119 in a single compartment), shown in Figure 5.31 and Table 5.50, the curves representing the response of the four fire compartment columns reached failure (value=1) before all other curves surpassing the value of 1. In addition, column C2-1 was the most critical column as the ratio exceeded one at 200°C.

Figure 5.31 Case-1 Interaction Equation Value

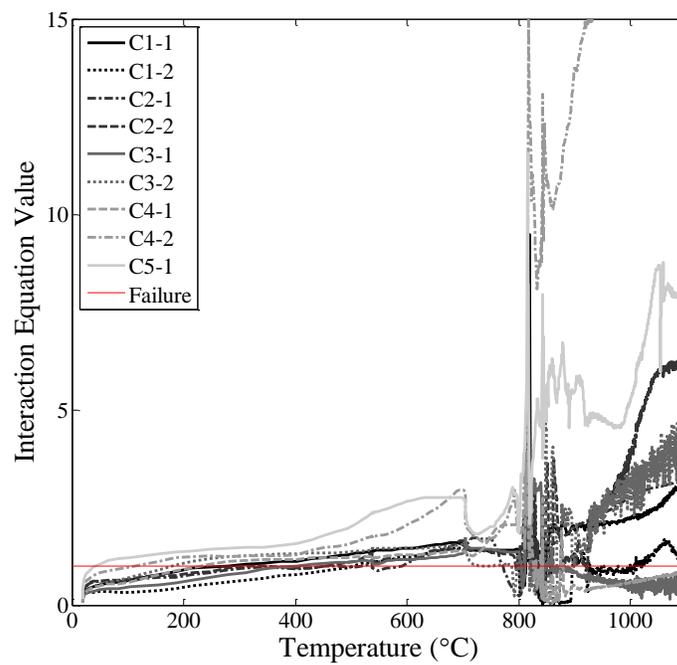
For Case 4 (EBF and E119 in the whole floor), shown in Figure 5.34 and Table 5.53, all response curves passed the failure line with columns C5-1 exceeding the limit again as early as 100°C. Other columns followed at 200°C and 300°C. At 500°C, all columns, except one) had reached their limit, making the EBF with a whole floor fire being the worst case thus far.

Figure 5.34 Case-4 Interaction Equation Value

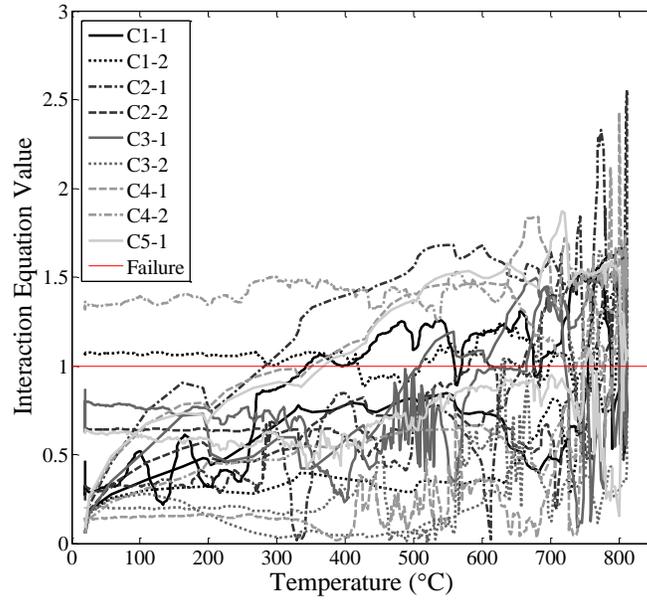
For Case 5 (CBF and EC3 parametric fire curve in a single compartment), shown in Figure 5.35 and Table 5.54, the curves representing the response of the four fire compartment columns reached failure (value=1) before all other curves. Column C-2 was under the most demand as shown by its ratio exceeding one at 300°C. At 400°C, columns C4-1 and C5-1 also surpassed the ratio of one.

Figure 5.35 Case-5 Interaction Equation Value

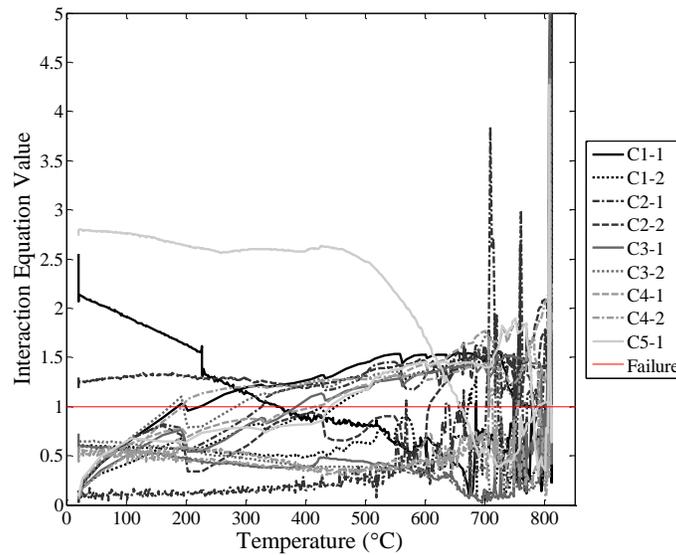
For Case 6 (CBF and EC3 parametric fire curve in the whole first floor), shown in Figure 5.36 and Table 5.55, all response curves reached to failure line almost concurrently at about 700°C as shown in the table. The demand on C1-1 and C4-2 was rather larger as shown by their ratio exceeding a value of one early on at 200°C.

Figure 5.36 Case-6 Interaction Equation Value

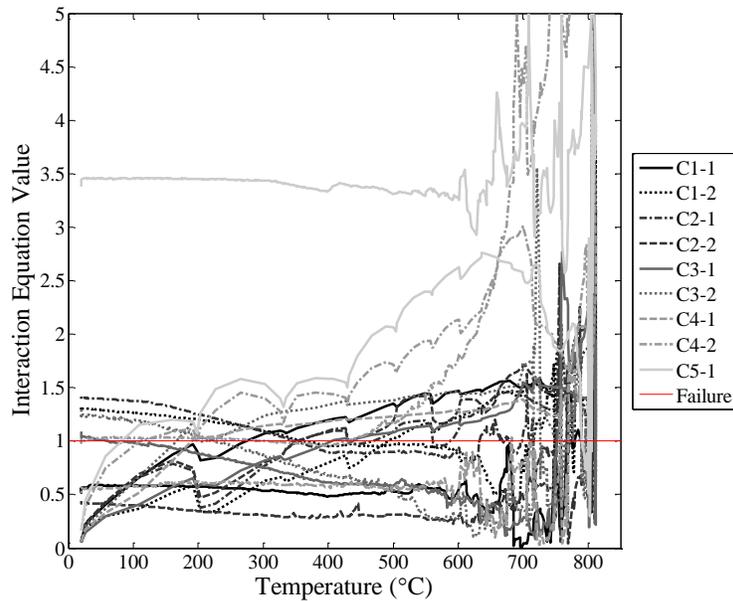
For Case 8 (EBF and EC3 parametric fire curve in the whole first floor), shown in Figure 5.38 and Table 5.57, all response curves reached failure almost concurrently. At 400°C, all columns, except for C1-2, had exceeded their limit.

Figure 5.38 Case-8 Interaction Equation Value

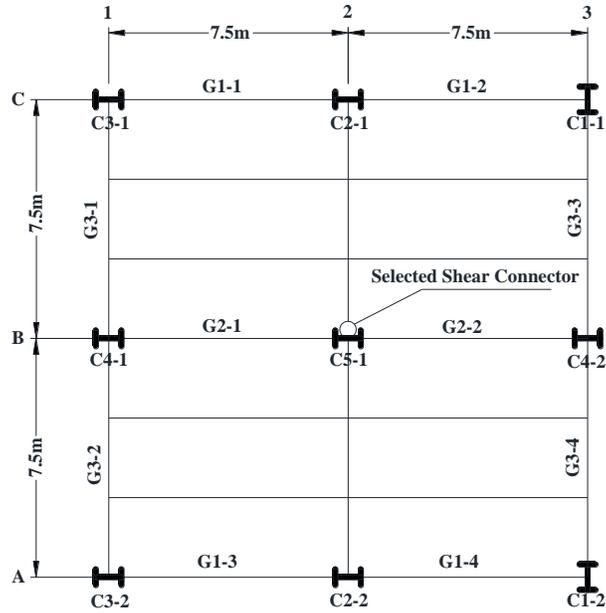
The shear connector model used in this study was describe in detail in Chapter 4. The shear model utilized a failure mechanism to break the connector at a certain separation distance of the connector nodes. Horizontal and vertical separation of a selected connector (marked in Figure 5.39) of the first floor were obtained from the simulation results and plotted for each case as shown below.

Figure 5.39 Floor Plan of the Buildings showing the Selected Shear Connector

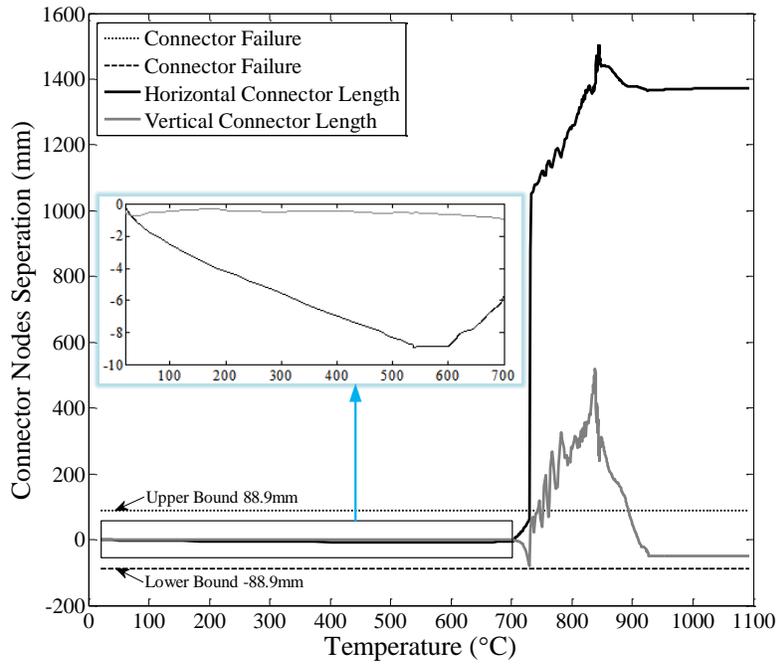
Figure 5.40 Case-1 First Floor Shear Connector Nodes Separation

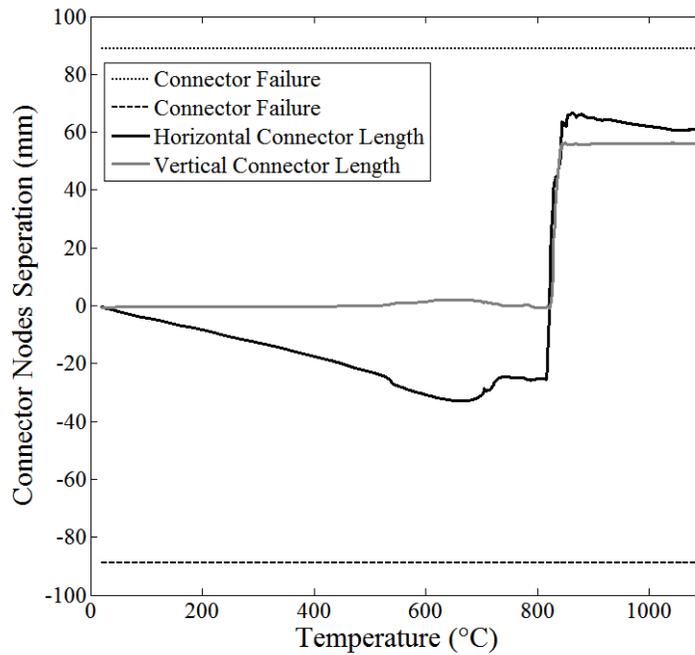
Figure 5.41 Case-2 First Floor Shear Connector Nodes Separation

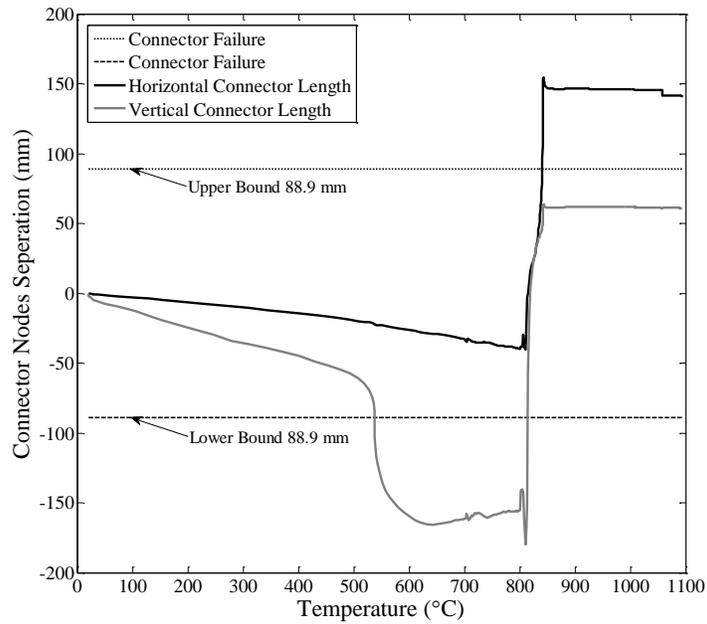
Figure 5.43 Case-4 First Floor Shear Connector Nodes Separation

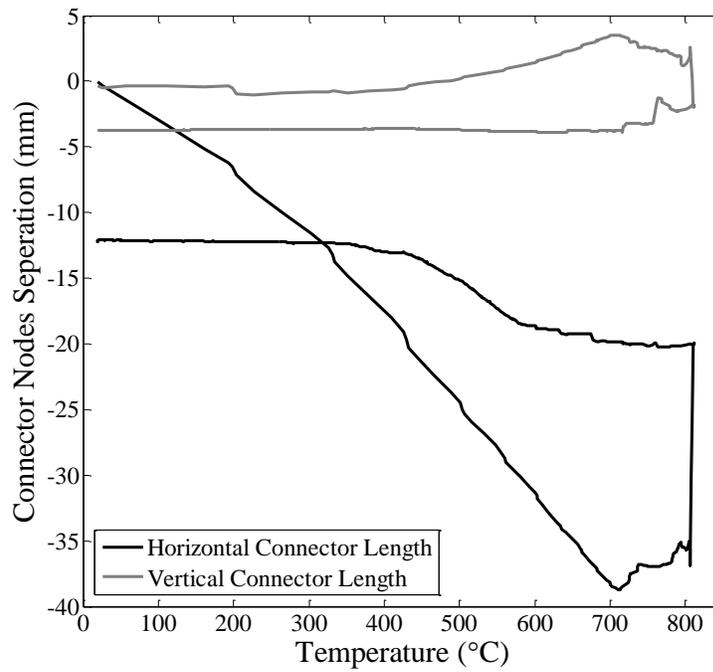
Figure 5.45 Case-6 First Floor Shear Connector Nodes Separation

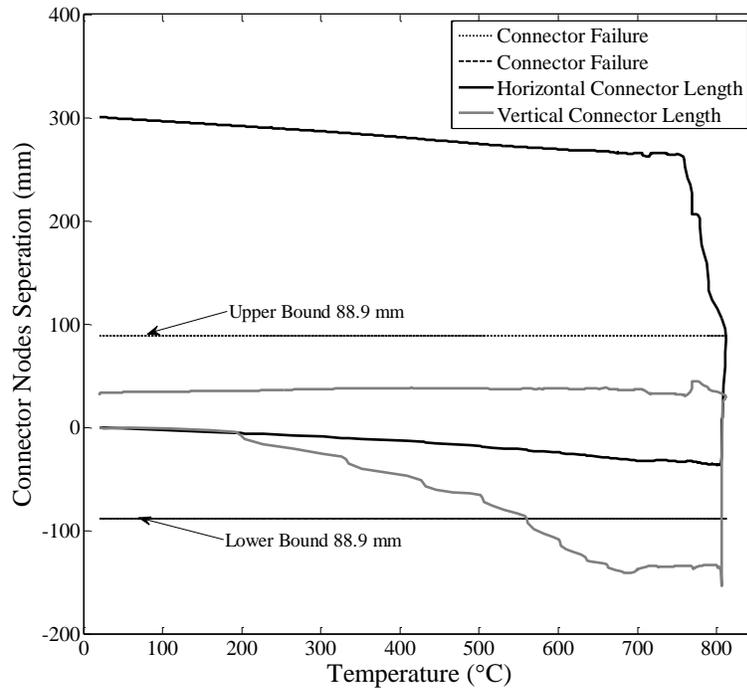
Figure 5.47 Case-8 First Floor Shear Connector Nodes Separation

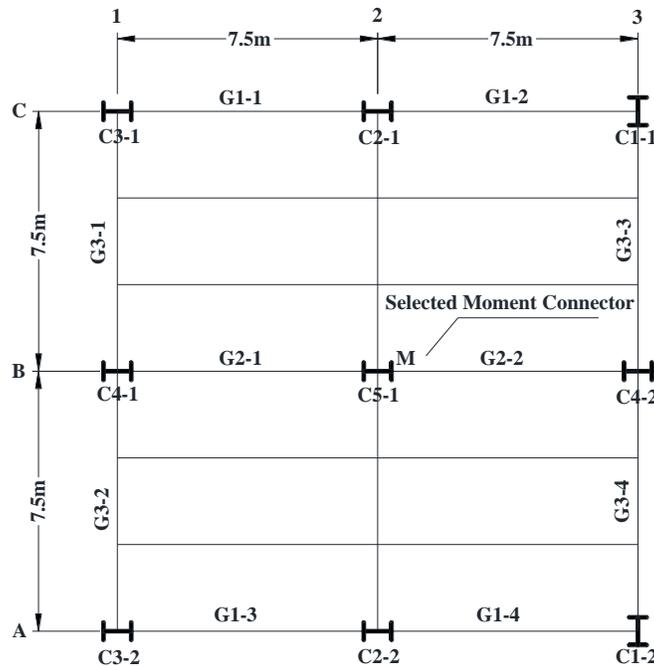
Figure 5.48 Selected Moment Connector

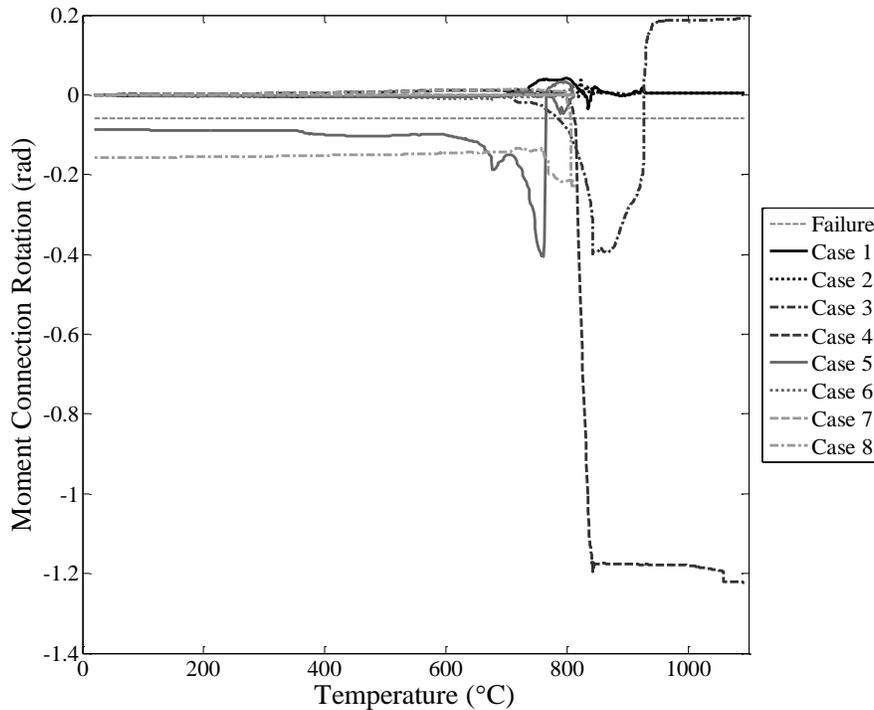
Figure 5.49 Moment Connector Rotation

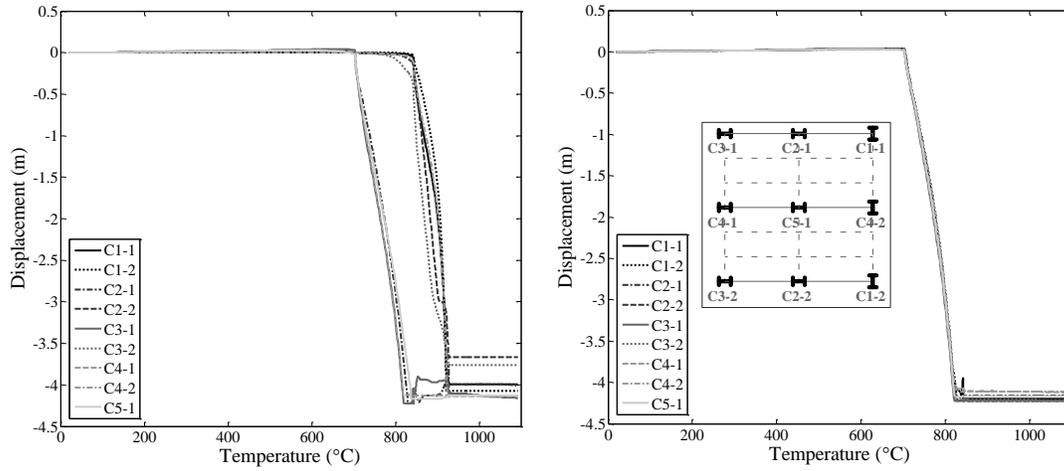
Figure 5.50 Column Vertical Displacement – Case 1 (Left) VS. Case 2 (Right)
