# Colorado Forestry Best Management Practices

Forest Stewardship Guidelines for Water Quality Protection

2021 Field Monitoring Report  
Compiled November 2021

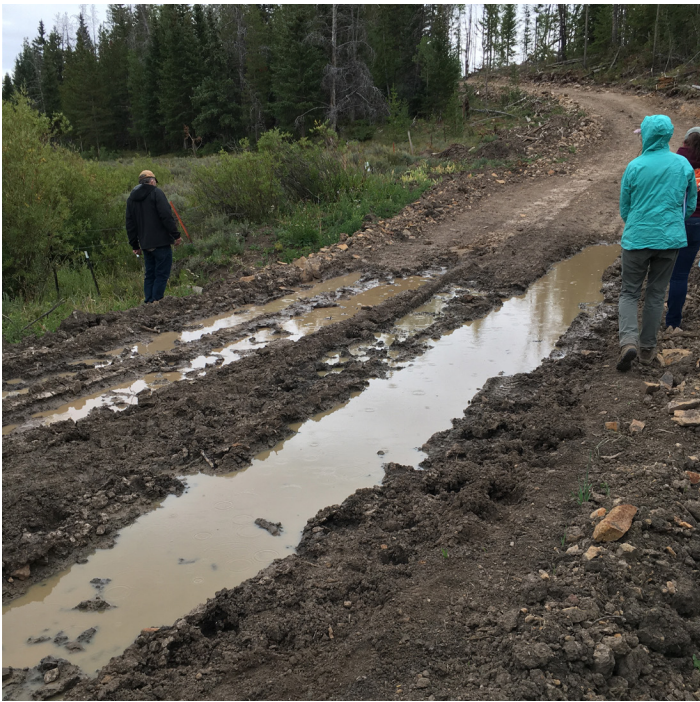
*Figure 6: Team members observe inadequate drainage at a stream crossing. Photo: Diana Selby, CSFS*

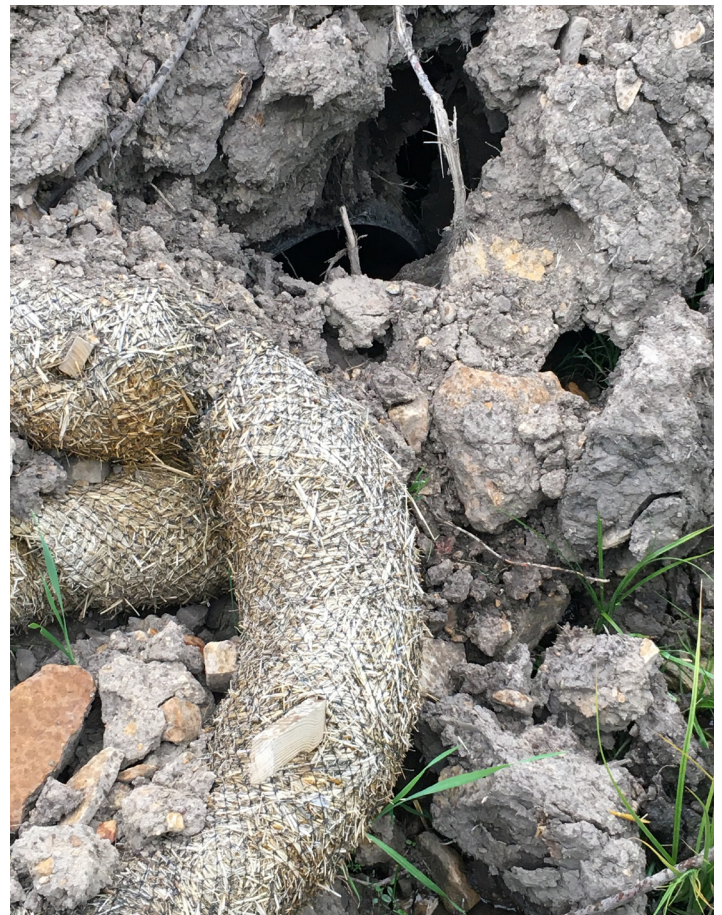
*Figure 7: Materials fill in existing culverts on Sale #5. Photo: Diana Selby, CSFS*

away from a stream crossing site. In this instance, the monitoring team found that the two existing culverts that were installed for the crossing were inadequate and had begun to fill with soil. Additionally, drainage away from the stream crossing was not occurring. Even with these departures from application of BMPs, the team found that the soil and water resources were still adequately protected during the time of the evaluation. The team recommended that a larger and/or longer culvert would have been more appropriate for the site.

Sale #5 was found to have a minor departure in preventing erosion of the stream crossing culvert and the effectiveness was found to have minor and temporary impacts to the soil and water resources. Again, this rating was given because materials had begun to fill in the existing culverts.

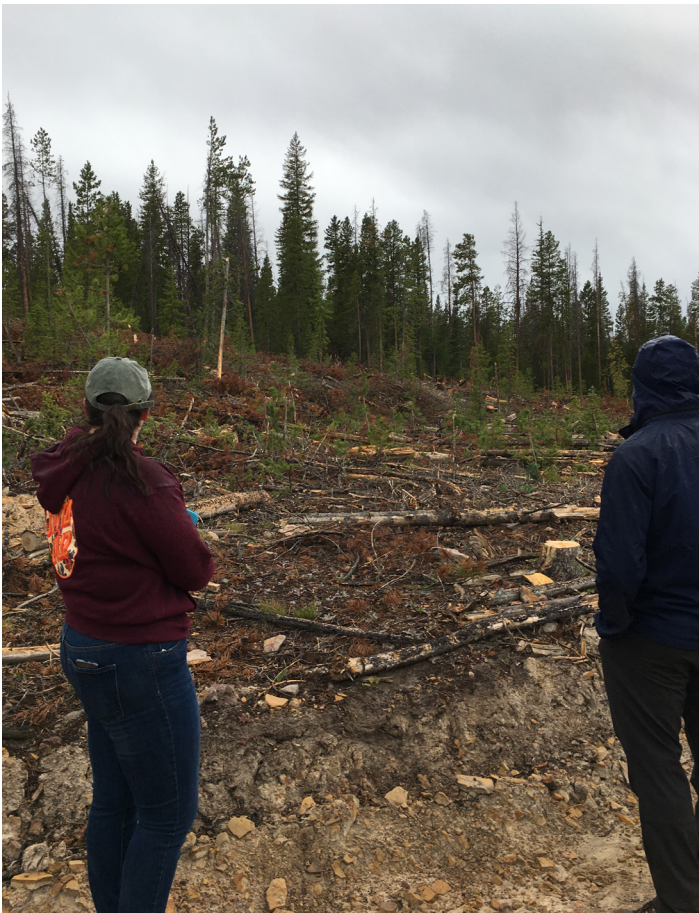
Scarification was used only on one of the sites (Sale #4) and met BMP requirements. All sites left adequate slash material to slow runoff, return soil nutrients and provide shade for seedlings. In addition, all sites limited activities to frozen or dry conditions to minimize soil compaction and displacement. Four of the five sites monitored treated their slash so as to preserve the surface soil horizon. The fifth site, Sale #5, was deemed to have improved the surface soil horizon

*Figure 8: Team members view slash treatment that improved moisture and soil horizon on Sale #5. Photo: Diana Selby, CSFS*

on a portion of the site where a higher level of slash remained across the unit after treatment.
