WIND-TUNNEL STUDY OF  
WIND RESISTANCE OF ROOFING SHINGLES

Owens-Corning Fiberglas Corporation  
Technical Center  
Granville, Ohio 43023

Fluid Mechanics and Wind Engineering Program  
Fluid Dynamics and Diffusion Laboratory  
Department of Civil Engineering  
Colorado State University  
Fort Collins, Colorado 80523

February 1983

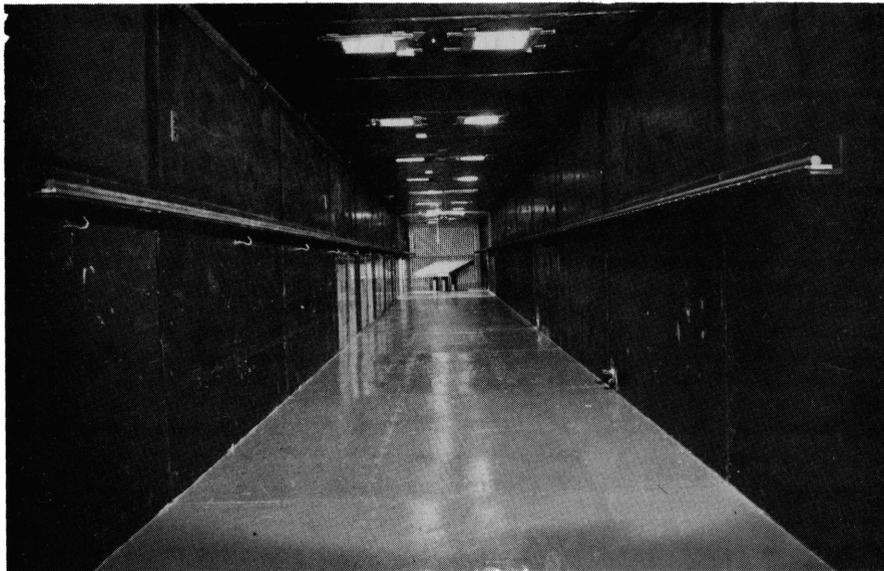
Figure 4a. Photographs of Test Configuration

Test Section Entrance Looking Upwind

Test Section Looking Downwind

Test Stand without Shingle Deck

Test Stand with Shingle Deck at Yaw = 45 Degrees

Decks were mounted on a support frame, Figure 2, at the downstream end of the Meteorological Wind Tunnel (MWT), Figures 3 and 4, on a turntable which permitted them to be rotated for yaw angles of 0° and 45°. The support frame held them at a pitch of 4 in 12 and permitted each deck to be held with carriage bolts and wing nuts to permit rapid change.

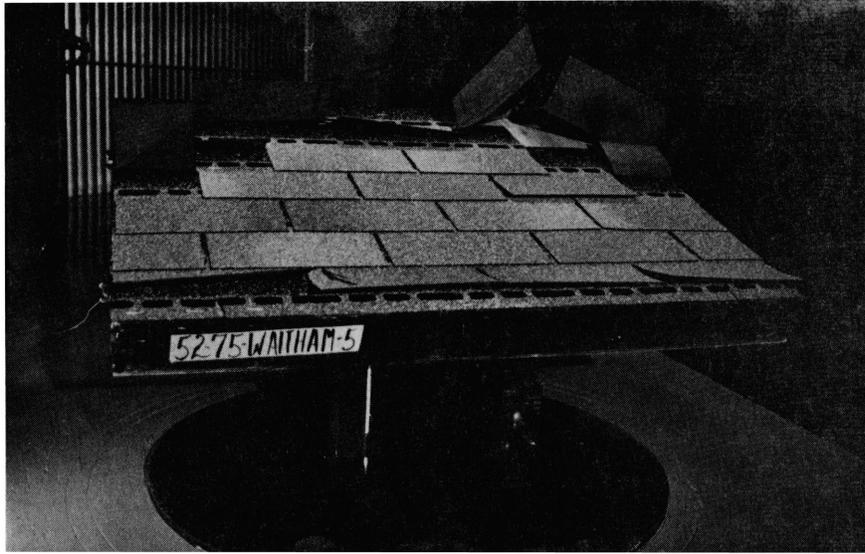
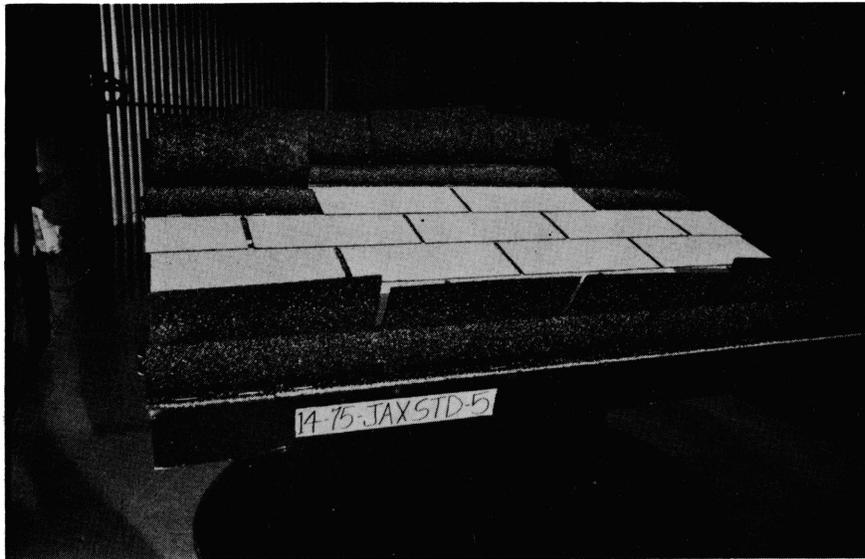
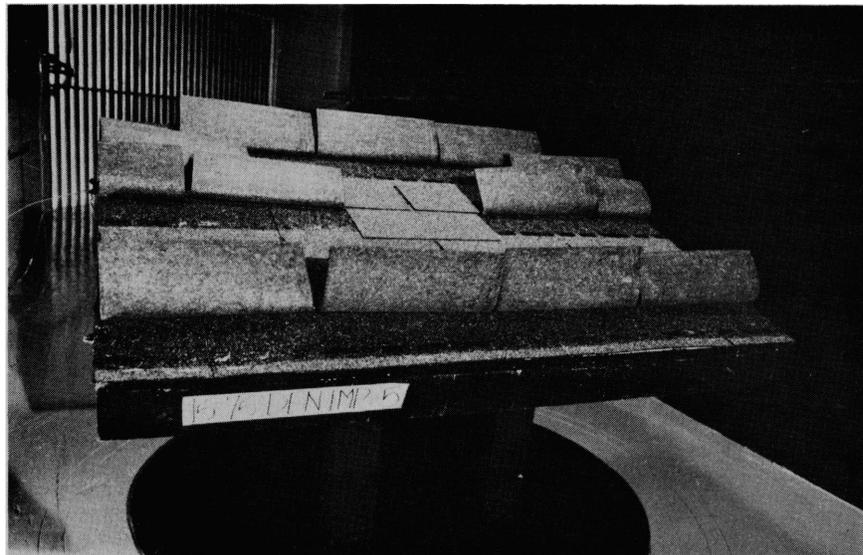
Figure 11a. Results for Typical Runs at 75°F

Deck 52-75-WALTHAM-5

Deck 13-75-ORGANIC-5

Deck 14-75-JAX STD-5

Deck 15-75-DEN IMP-5

Wind damage to shingles was reasonably consistent from run to run with repeat measurements of decks with similar shingles behaving in a similar way. Differences between shingle types were evident at both 75°F and 35°F with damage generally occurring for lower wind speeds at the colder condition. Figures 11a and b show post-run photographs of decks with four different shingle types at 75°F and 0° yaw. One sample shows considerable damage while the other three had differing degrees of crack damage. Decreasing severity of damage was usually associated with increased quality of shingle. These photographs were made before the shingles had relaxed back to the surface. Figures 12a and b show

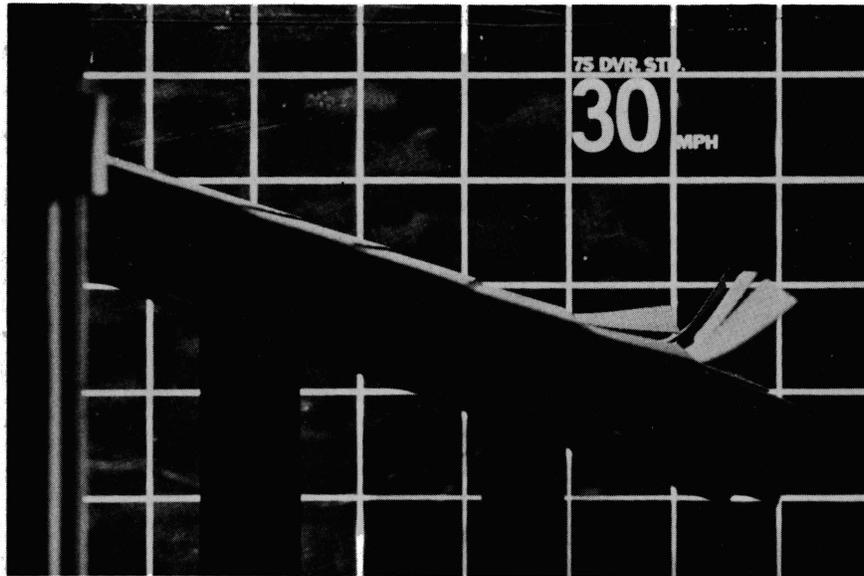
Figure 13. Flow Visualization for 0° Yaw

Flow visualization provided a direct observation of the flow field characteristics. Titanium dioxide smoke was released from sources in the flow field to provide a marker for fluid passing the release point. Figure 13 top shows smoke being released from sources at two elevations just in front of a shingled deck at 0° yaw (front edge of the deck normal to the approaching flow) with wind velocity below the level where shingle lifting occurs. The upper smoke trace is deflected up and over the deck without contacting the deck surface. The lower smoke trace was placed so that it would impinge on the front edge of the shingle deck. This flow is seen to separate, or detach, slightly from the top of the deck as it rounds the corner onto the top of the deck and to reattach to the deck a short distance from the leading edge. A careful examination of the separation region showed it to be 1/16 or 1/8 of an inch in thickness and an inch or so in length. A different deck geometry would have produced a different size of separation region.

Once the front shingle has lifted due to the pressures described above, the separated flow region is greatly increased in extent and intensity of uplift pressure as shown in the flow visualization photograph of Figure 13 bottom. Reattachment did not occur until the 3rd or 4th course. Flow impinging on the upward side of the uplifted shingle provides a positive pressure which adds to the uplift negative pressure

The mean pressures on the shingle deck from the fourth course up in the bottom photograph of Figure 13 could be either positive (downward acting) or negative (upward acting). Turbulence developed in the separated shear layer (the thin region of high velocity gradient between the high speed separated flow and the low speed bubble) combined with turbulence in the approach flow may induce a fluctuation about the mean pressure sufficiently large that at any location on the rear of the deck the pressure oscillates in time between positive and negative pressures. As approach velocity is further increased, a negative pressure fluctuation on a shingle in that region will become sufficiently large that it will lift the shingle. That lifted shingle would then be subject to the same aerodynamic forces as the first shingle and would tend to remain in a raised position.

Pressures under the separated flow bubble in the lower photograph of Figure 13 are negative and, except near the actual separation point, of fairly low magnitude. This low negative pressure is of insufficient size to lift additional shingles under the bubble.

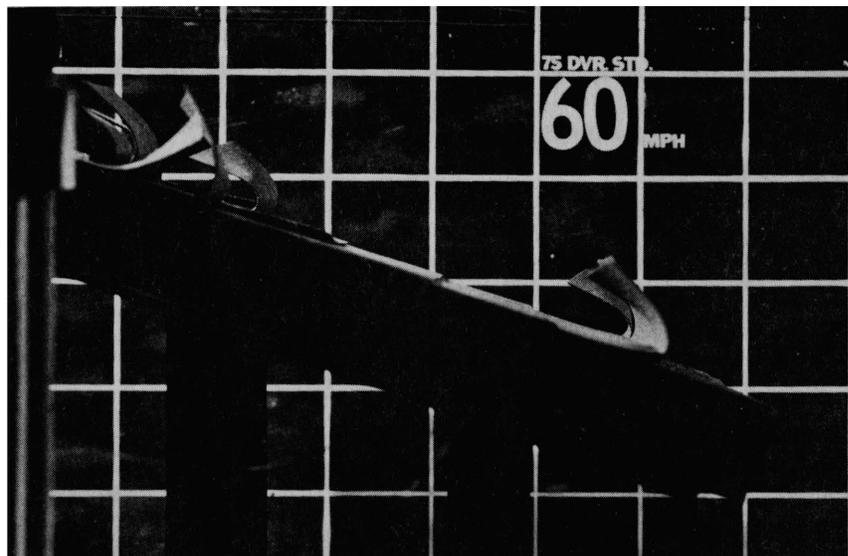
Figure 14a. Sequence of Shingle Lifting with Increasing Wind Speed

The mechanism for shingle uplift is illustrated in Figure 14 in which a sequence of photographs shows shingle uplift patterns at every 10 mph wind speed from 30 to 80. Initially the first course is raised (30 mph) and bent backwards (40, 50 mph). At 40 and 50 mph the separated shear layer probably does not reattach until the 5th or 6th course. By 60 mph, the first course of shingles has bent back sufficiently to permit an earlier reattachment of the shear layer. This

A useful exercise would be to estimate the wind pressures on an uplifted shingle. The easiest case is probably the 30 mph wind speed shown in Figure 14. The first course is lifted so that it is nearly normal to the approach flow. The velocity profiles of Figure 8 indicate that the velocity approaching the leading edge is nearly the same as that measured at the reference velocity location, 30 mph. At 30 miles per hour at an elevation of approximately 5000 ft (the laboratory elevation) the stagnation pressure of the wind,  $0.5 \rho V^2$ , is about 2.0 psf. The drag coefficient for the uplifted shingle might be in the range of 1.3-1.8 (based on the authors' previous experience in measuring drag coefficients) resulting in a net pressure acting on the shingle of 2.6 to 3.6 psf. If the exposed area of the shingle subject to this pressure is 5 x 12 in., then the force on each uplifted tab is 1.1 to 1.5 lb. The drag coefficient for this case is in some doubt, so the forces could be somewhat outside the range calculated. For higher wind speeds, the drag coefficient for the bent shingles would only be a guess. At 80 mph, if a drag coefficient of 0.5 is assumed for the first course of shingles, the net pressure on the lead shingle would be about 7.0 psf resulting in a net force of about 2.9 lb acting normal to the shingle surface.
