THESIS

A DEBRIS FLOW CHRONOLOGY AND ANALYSIS OF CONTROLS ON DEBRIS FLOW OCCURRENCE IN THE
UPPER COLORADO RIVER VALLEY, ROCKY MOUNTAIN NATIONAL PARK, CO

Kyle J. Grimsley

Colorado State University

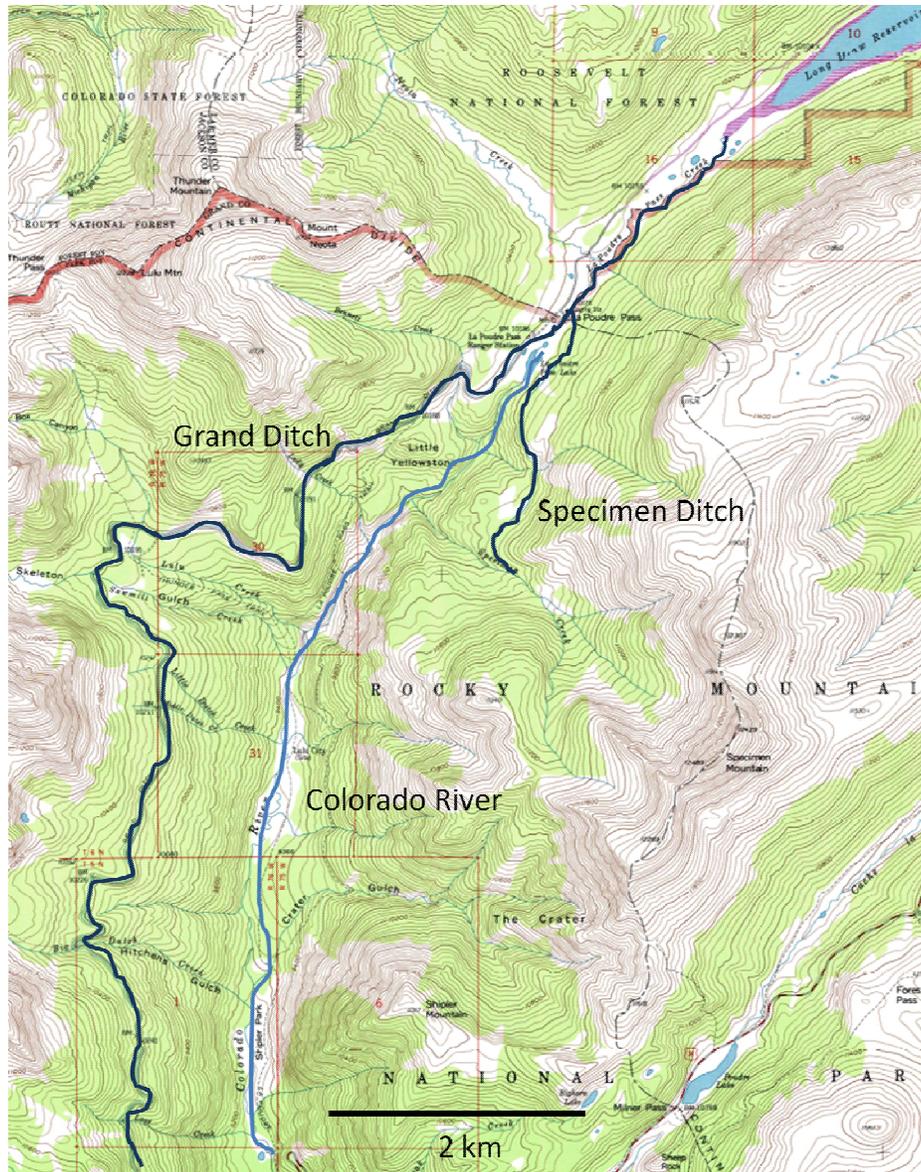
Figure 2: Positions of the Grand Ditch and Specimen Ditch relative to the Colorado River. The Colorado River flows south, while both ditches flow north into Long Draw Reservoir.

The Grand Ditch diverts water across the Continental Divide from the Never Summer Mountains in the Colorado River watershed into the Cache la Poudre basin (Figure 2). The ditch starts above the USGS Baker Gulch gage and extends for over 25 km at near 3100 m elevation. Construction took place from 1890 to 1936, and diversions began in the late 1890's (Woods, 2000). Approximately 50% of annual flow is captured depending on the amount and timing of snowmelt (Woods, 2000). The Grand Ditch thereby alters the regimes of both flow and sediment in the Upper Colorado River. A second, smaller, shorter (2.7 km) ditch on the northwestern slope of Specimen Mountain parallels the Grand Ditch on the east side of the Colorado River, before feeding in to the Grand Ditch at La Poudre Pass (Figure 2). This offshoot of the Grand Ditch, sometimes referred to as the Specimen Ditch, has received less scientific and public attention because it is more concealed and diverts much less water (National Park Service, n.d.).

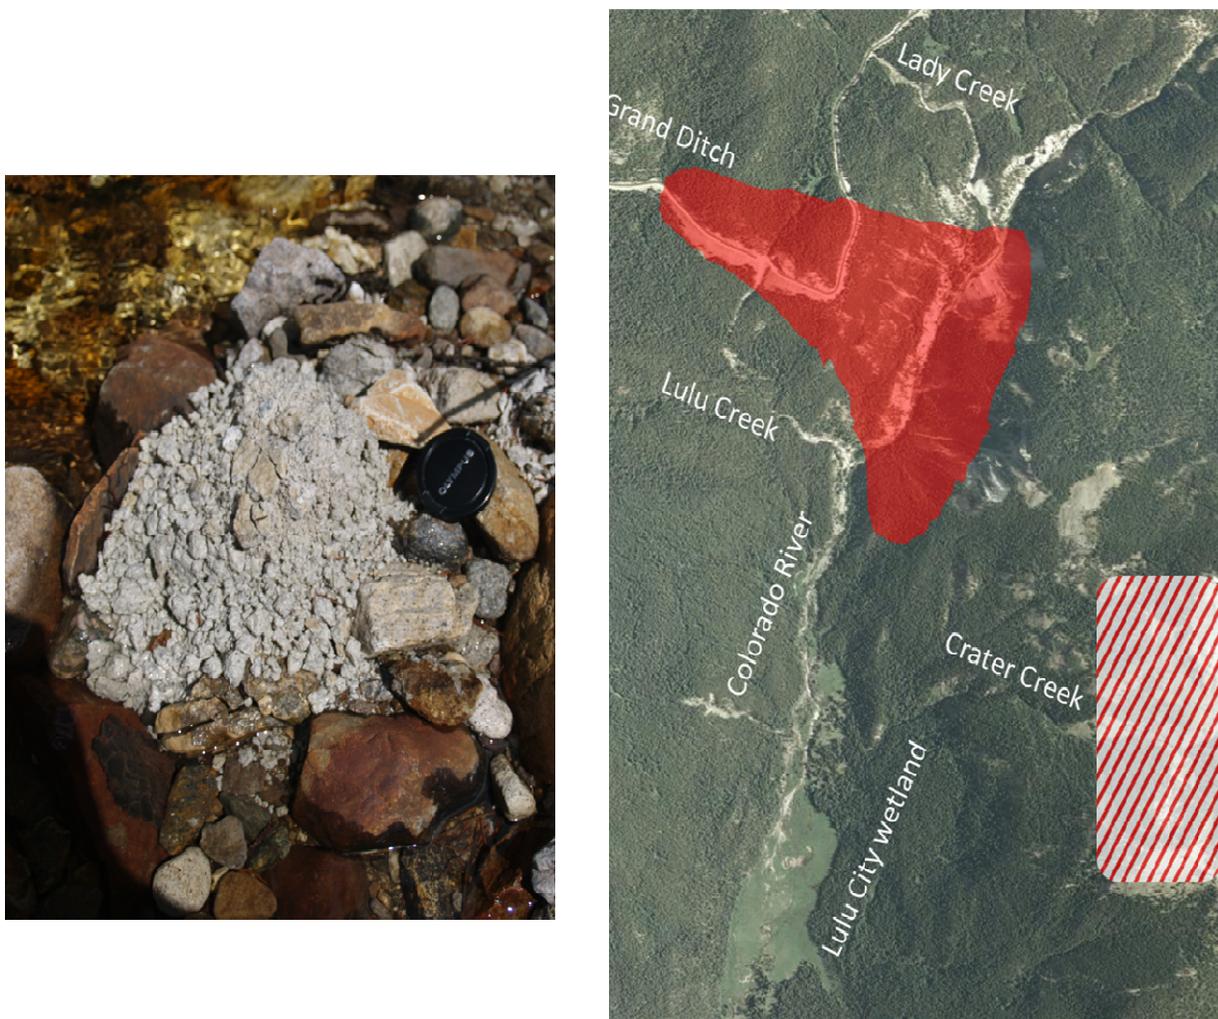
Figure 3: Left: A cobble of rhyolitic tuff from the 2003 debris flow that is degrading *in situ* into gravel- and sand-sized fragments. Right: Two zones of hydrothermal alteration in the Colorado River headwaters. Alteration in the vicinity of the Grand Ditch (solid shading) has been mapped and studied. Alteration at the top of Specimen Mountain (hatched shading) is interpreted from remote observations.

than the surrounding rock. Changes in mineralogy, especially production of clay minerals, alter both the appearance and strength properties of these rocks (Sanford, 2010). Clasts of altered rhyolitic tuff are observed to crumble *in situ* or in transport (Figure 3), and represent a large fraction of debris flow deposits in the northern areas of the study site. The median grain size of degrading tuff clasts is coarse sand (Rubin et al., 2012). Research on the extent and potential impacts of hydrothermal alteration in this region supports a heightened risk of slope failure (Sanford, 2010) in the shaded areas (John Ridley, Colorado State University, pers. comm., 2012) (Figure 3).

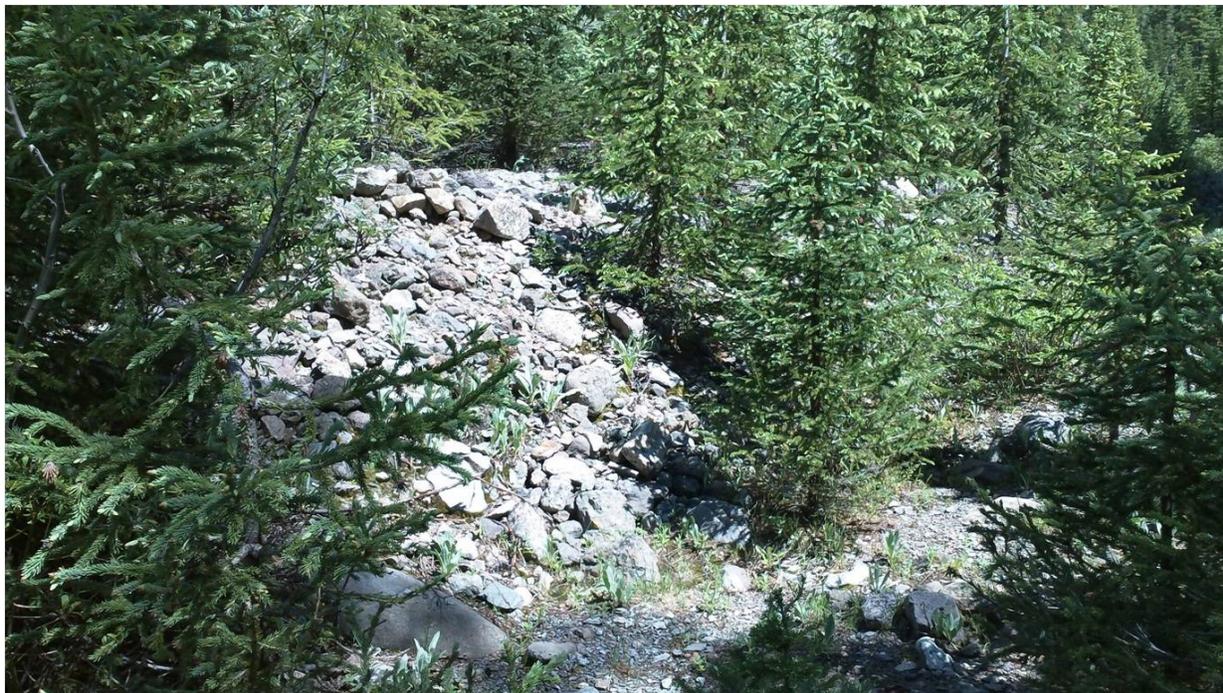
Figure 4: A debris flow berm on the left bank of the Colorado River above the junction with Lulu Creek. The berm is roughly 1 m high and clasts are predominantly rhyolitic tuff.

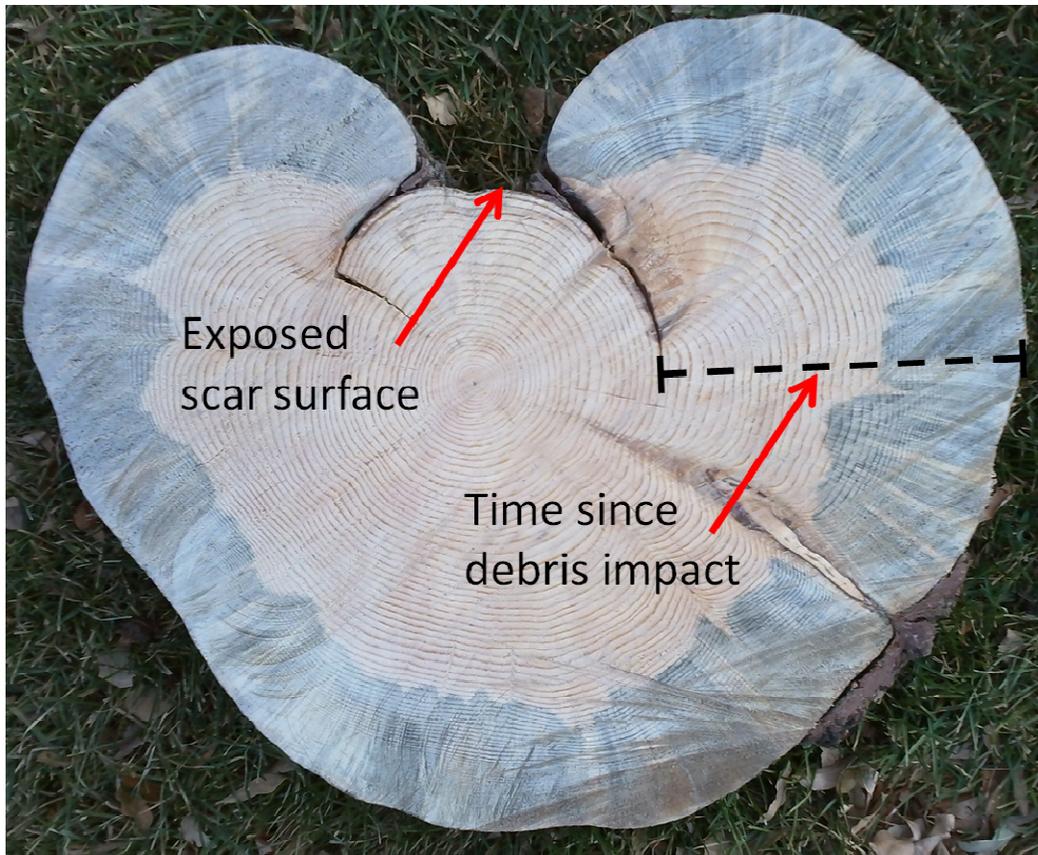
Figure 5: A scar sample collected with a chainsaw from a berm along Sawmill Creek. The blue coloration on the outer portion of the wood is a result of pine beetle infestation.

Debris flow ages were also evaluated by sampling scarred trees (Figure 5). Only trees that were located within or on the fringe of debris flow berms with an appropriate scar shape and orientation were sampled to reduce the risk of including false data from trees that were wounded from other processes such as fire or tree fall. Samples were collected by using a 61-cm bow saw to make two cuts into the cambium of the tree, one horizontal and one slightly dipping, through the center of the scar. While this technique is damaging to the tree, trees have typically been observed to survive this procedure (Hupp et al., 1987), and most of the trees sampled in this study were already afflicted by the pine beetle. Death dates of beetle-kill trees were determined using cross-dating and therefore did not create a source of uncertainty in debris flow ages. One scarred tree that was dying from pine beetle along Sawmill Creek was too thick to saw by hand and was therefore felled by a trail crew using a chainsaw (Figure 5).

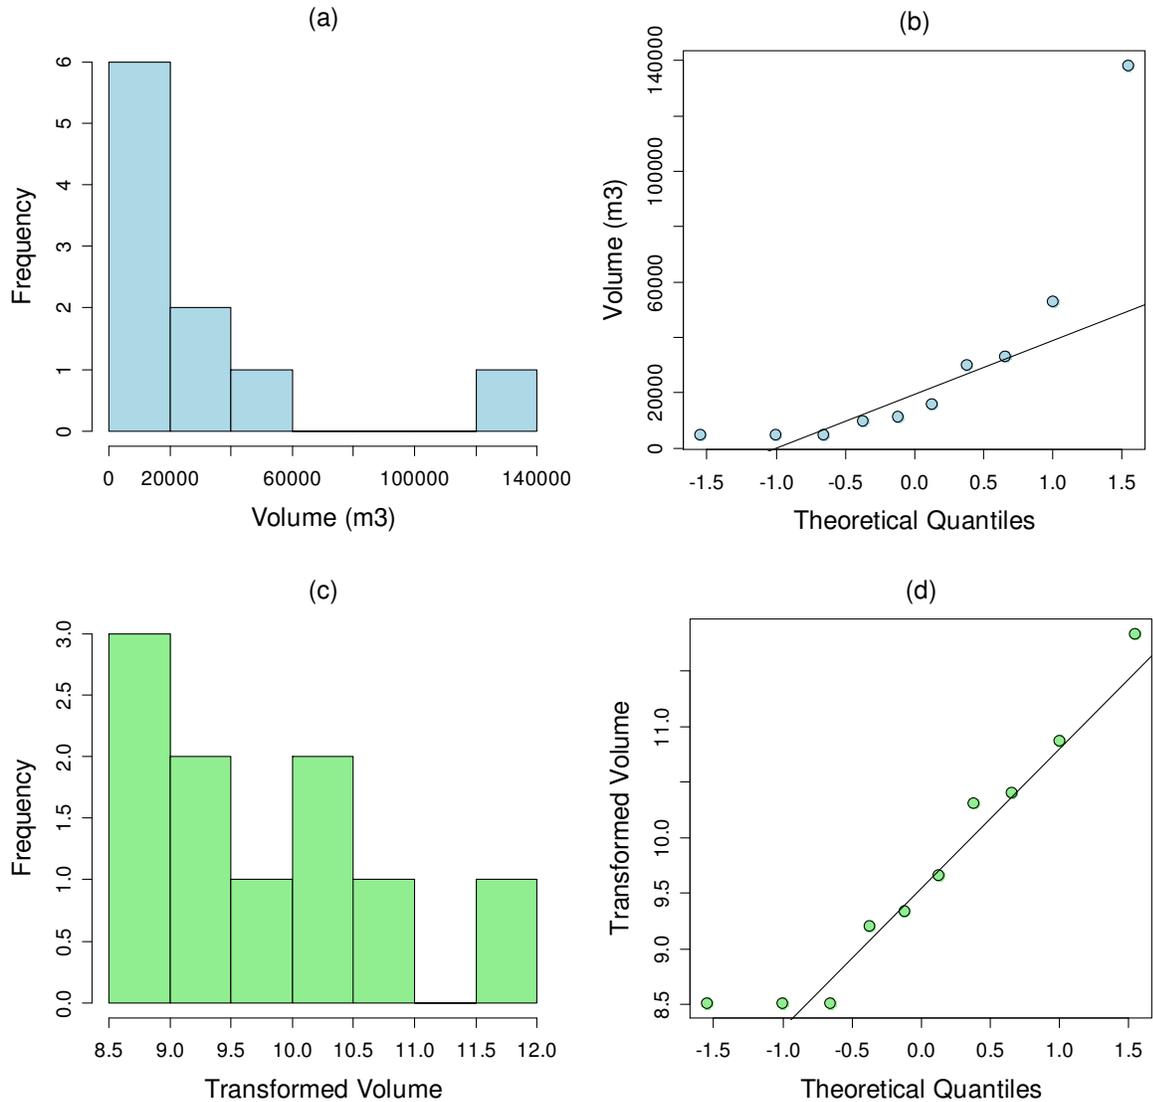
Figure 6: Plots testing normality for debris flow volumes: (a) histogram before transformation, (b) Q-Q plot before transformation, (c) log-transformed histogram, and (d) log-transformed Q-Q plot. The logarithmic transformation results in a more normal distribution for the volume series.

The histogram and normal quantile plot for volume show strong non-normality (Figure 6 a, b), with most of the data points concentrated at low values. After logarithmic transformation, the volumes were much more normally distributed (Figure 6c, d). The logarithmically transformed values are used

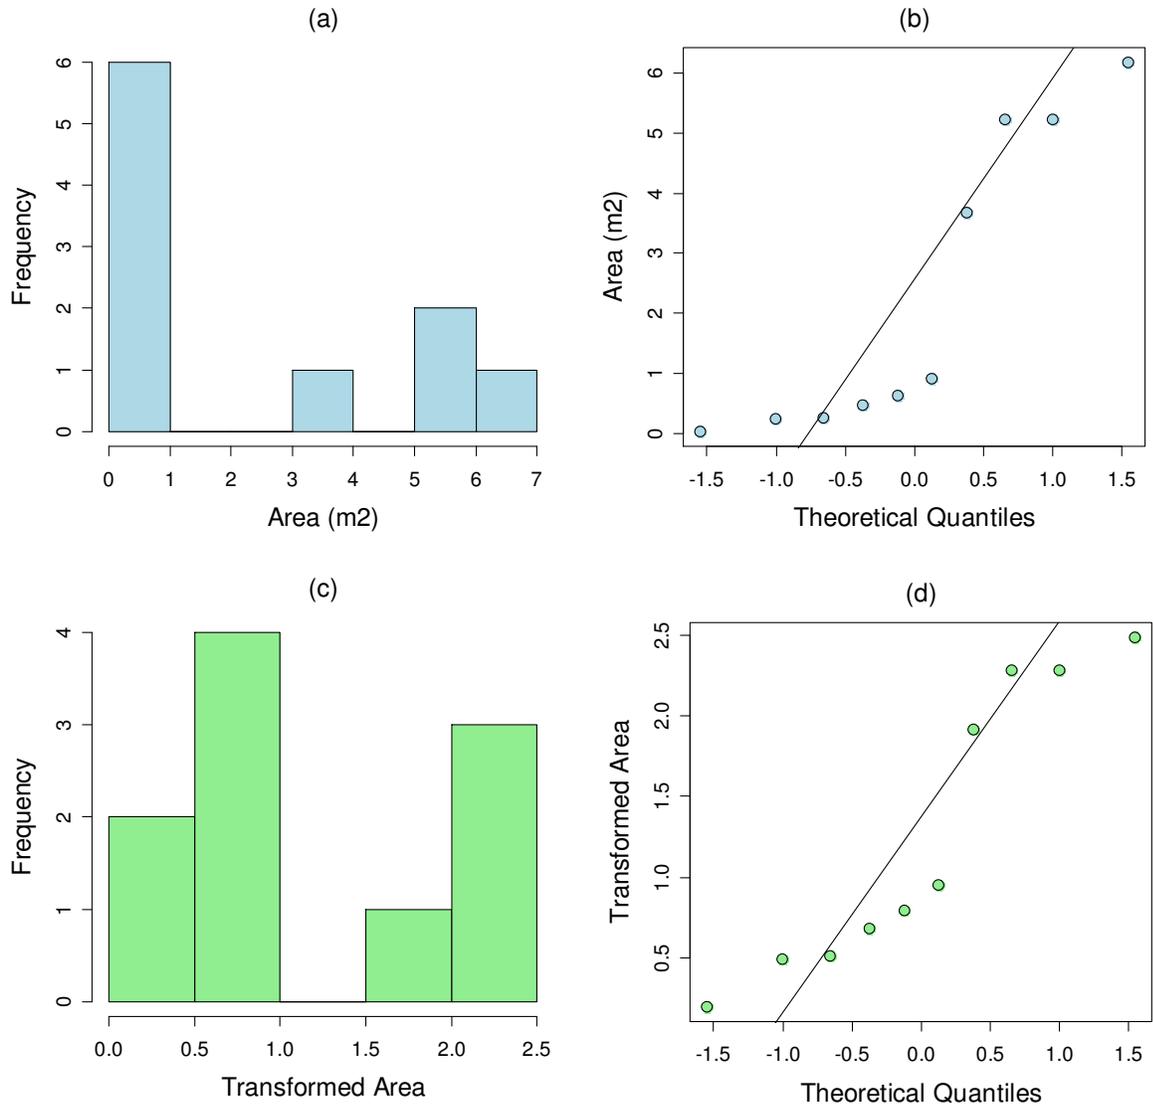
Figure 7: Plots testing normality for basin areas: (a) histogram before transformation, (b) Q-Q plot before transformation, (c) square-root-transformed histogram, and (d) square-root-transformed Q-Q plot. Square-root transformation results in a slightly more normal distribution of areas.

Similarly, the normality of the basin areas was improved using a square root transformation (Figure 7), and the transformed values were carried forward for the remainder of the analysis. Slopes were already normally distributed, while the variables 1) presence of the Grand Ditch and 2) hydrothermal alteration were represented categorically.

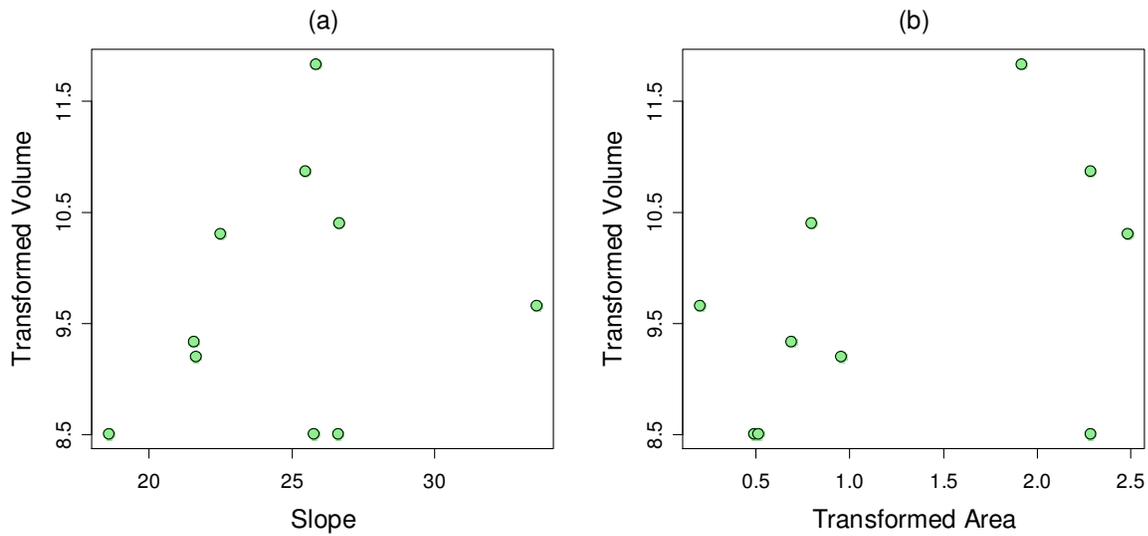
Figure 8: Scatter plots testing linear dependence of log-transformed volume on (a) slope and (b) square-root-transformed area. Concentration of points about the line $x = y$ indicates linearity.

The linear dependence of the independent variable on the dependent variables was tested using bivariate scatter plots of log-volume versus slope and square-root-area (Grand Ditch and hydrothermal alteration were excluded due to being categorical). The resulting plots have a large amount of scatter (Figure 8), but linearity is moderately satisfied.

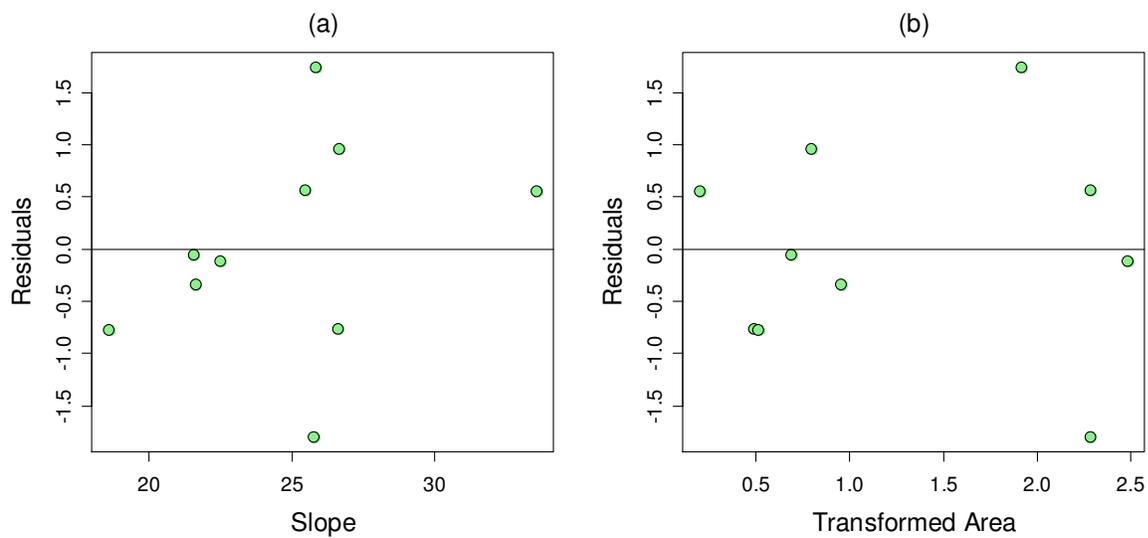
Figure 9: Residual plots testing equality of variance for slope and square-root-transformed area. An even distribution of residuals about the line $y = 0$ indicates homoscedasticity.

Homoscedasticity was tested using residual plots of the independent variables, where uniform distribution of residuals indicates equality of variance. Residual plots for slope and area show fairly

equal variance; the categorical variables were once again excluded (Figure 9). After concluding that the assumptions of normality, linearity, and homoscedasticity were reasonably well met, multivariate regression was performed on debris flow volume as a function of mean slope, basin area, presence of the Grand Ditch, and presence of hydrothermal alteration.

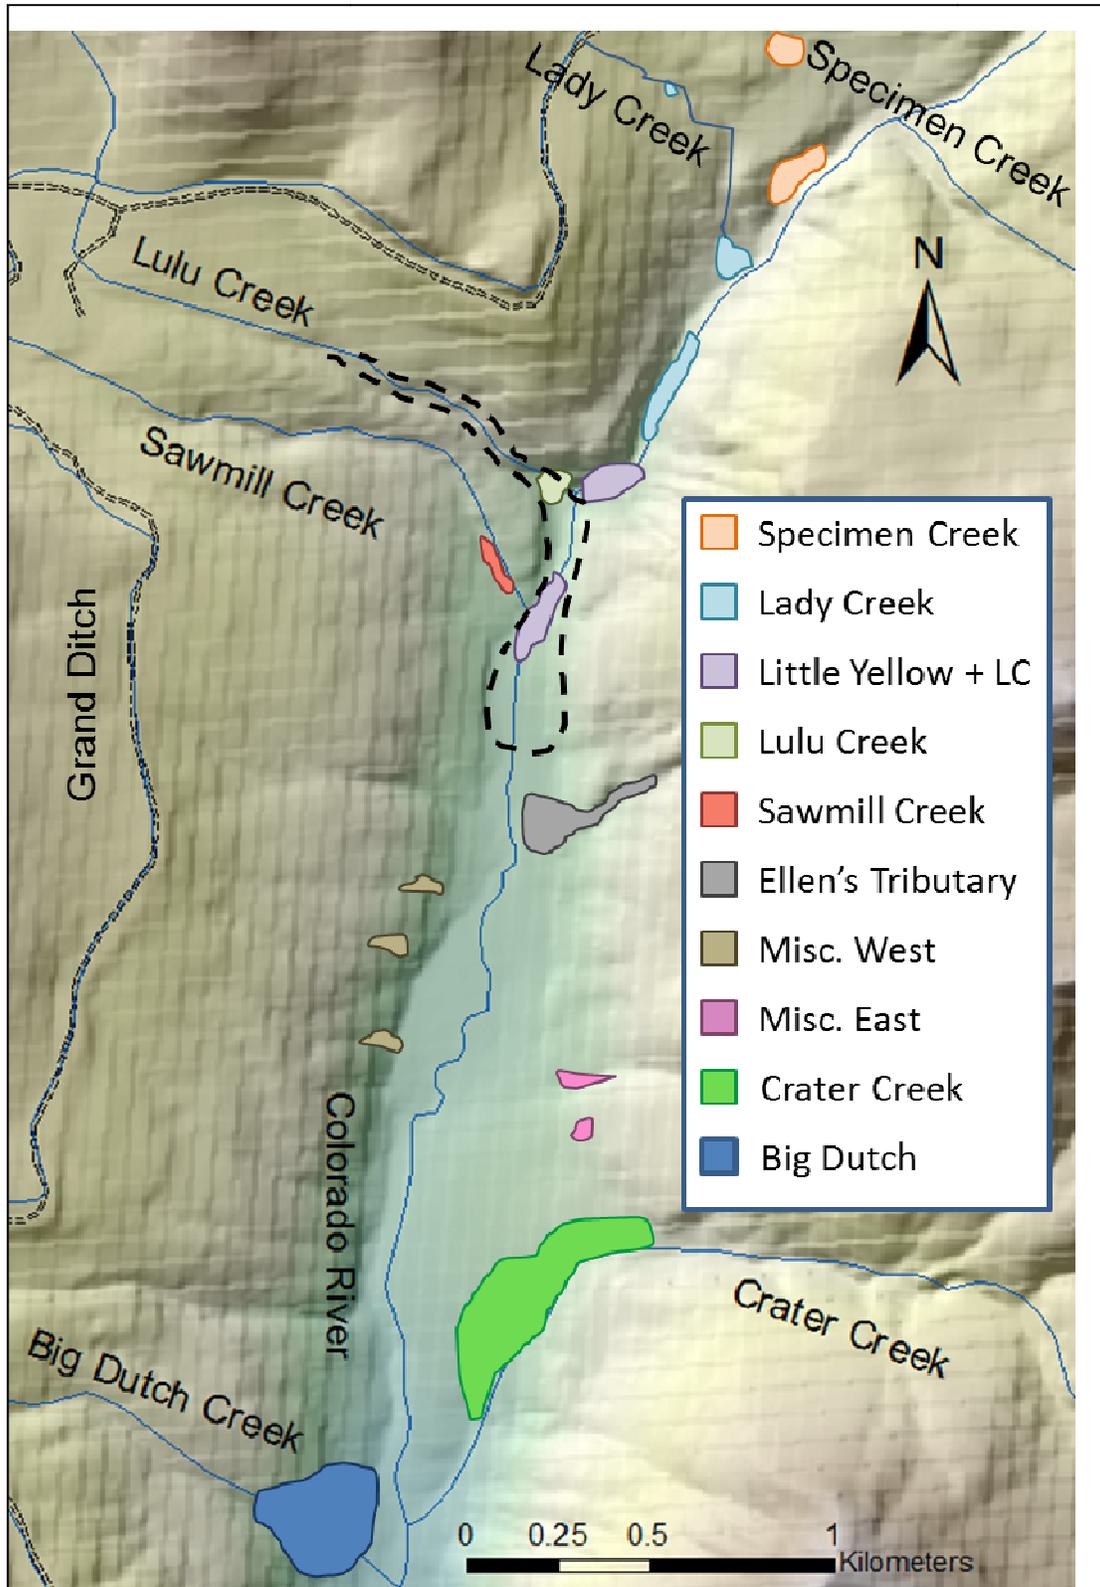
Figure 10: Mapped debris flow deposits extending to the valley floor along the Upper Colorado River. Approximate extent of deposition from the 2003 Grand Ditch debris flow along Lulu Creek is indicated with a dashed black line for comparison. The "Little Yellow + LC" label is used for locations where Little Yellow and Lady Creek deposits are both present.

Lulu Creek (LU, west) (Figure 10) is dominated by the dramatic after-effects of the 2003 debris flow from the Grand Ditch, including unconsolidated sediment berms up to 2 m high, abundant downed or scarred trees, and altered channel position and morphology. Coarse sediment is profuse, extending down to the Lulu City wetland on the Colorado River, and the wetland itself remains buried in fine sediment. Hydrothermally altered rhyolitic tuff is a major component of the 2003 coarse sediment, which itself is prone to crumbling and in-situ degradation. Paired scars on several mature trees on both sides of Lulu Creek just above its junction with the Colorado River indicate that at least one older debris flow has occurred there since completion of the Grand Ditch. No corresponding sediment deposits are distinguishable, and a rain-on-snow flood may be another possible explanation for these scars. However, rain-on-snow events tend to be minor at elevations above 2450 meters in this part of the

Deposition at the Miscellaneous West site (MW, west) (Figure 10) occurs on the western hillslope between Sawmill Creek and Big Dutch Creek and is characterized by a lack of well defined major drainage. Berms and scarred trees along small channels indicate minor debris flow activity, but it is unclear whether these deposits are dispersed from a single source or represent small individual slope failures. Lichen growth is low to moderate (ordinal value of '2'), the estimated drainage area is 0.26 km² (0.13 km² btGD) and the mean slope is 33.7% (29.9% btGD).

Big Dutch Creek (BD, west) (Figure 10) has a multithread channel pattern in the vicinity of the heaviest deposition, and it appears that debris flow activity may have played a factor in controlling this channel morphology. Typically only one or two of the up to four channel threads have active flow, and those with no flow are aggraded with debris flow material. Big Dutch Creek joins the Colorado River just below the end of Lulu City wetland, where the valley bottom once again narrows. Lichen growth is low to moderate (ordinal value of '2'), the estimated drainage area is 5.22 km² (.35 km² btGD) and the mean slope is 47.6% (33.9% btGD).

Debris flow material at the Little Yellow site (LY, east) (Figure 10) originates from a steep hillslope on the east side of the Colorado River. The catchment is very small (0.04 km^2) and too steep (66.4%) for consistent vegetation growth, making it the only entirely barren basin included in the study. Deposition is limited to open areas along the Colorado River, where it frequently overlies Lady Creek deposits. The downstream extent of deposition suggests that this was a relatively large debris flow. The Little Yellow debris flow is younger than that from Lady Creek, based on superposition and supported by sparse lichen growth (ordinal value of '2').

The depositional zone along Ellen's Tributary (ET, east) (Figure 10) has two distinct sections. Where the break in slope first occurs, roughly 0.5 km from the Colorado River, the channel is partially confined and the debris flow material is coarse but narrowly deposited. Within 0.25 km of the Colorado River, the slope decreases and the valley is unconfined, resulting in fan-like deposition of finer sediment. No deposition is observed along the active Colorado River, although this is unsurprising given the wide, flat valley bottom. Debris flow surfaces appear relatively inactive and lichen growth is moderate to heavy (ordinal value of '4'). The drainage area of the basin is 0.63 km^2 and the mean slope is 50.2%.

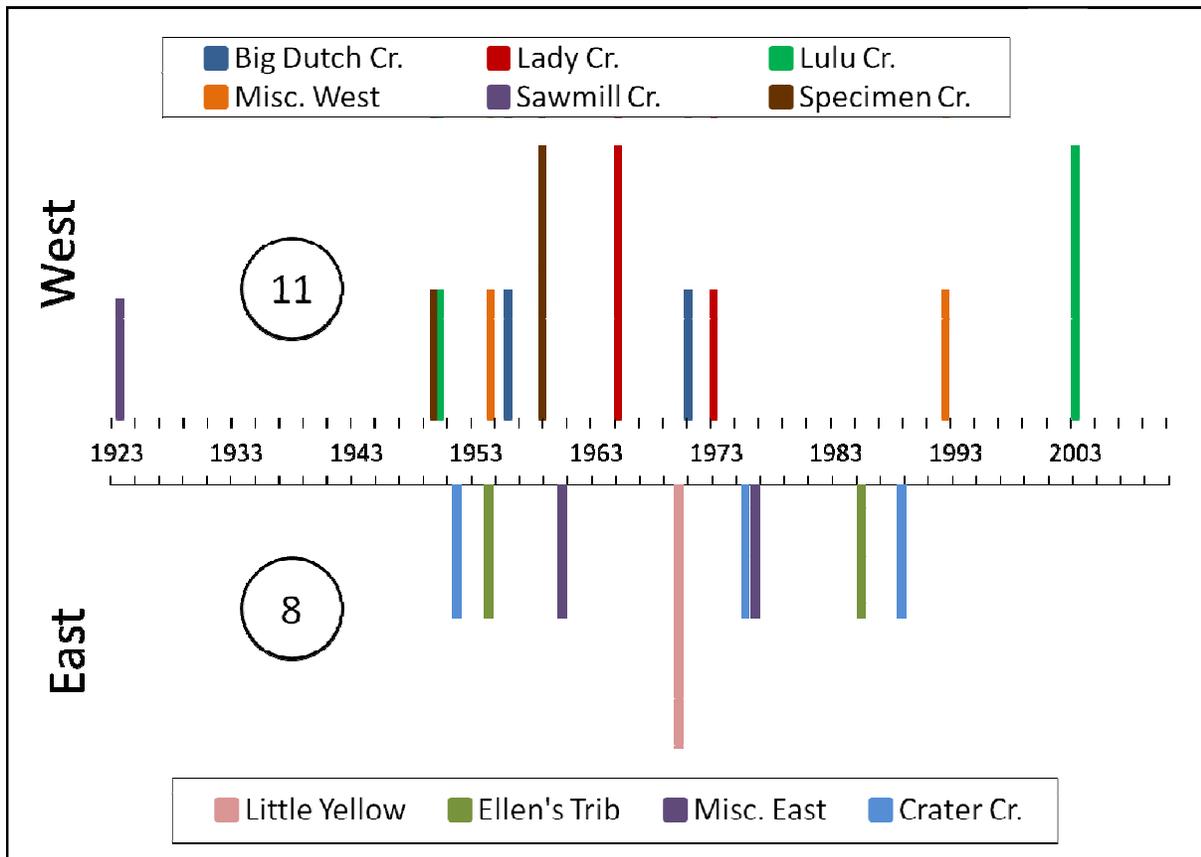
Figure 11: Timing of debris flow occurrence on the west (above axis) and east (below axis) sides of the Colorado River valley. Height of vertical bars distinguishes between 'large' debris flows (tall bars), that result in widespread deposition along the Colorado River, and 'small' debris flows (short bars), that do not. Circled numbers 11 and 8, on the west and east side of the Colorado River, indicate the total number of debris flows documented during this study.

The record of mapped debris flows extends back 89 years, with the oldest debris flow along Sawmill Creek in 1923 (Figure 11). The remaining 18 documented debris flows all took place in the past

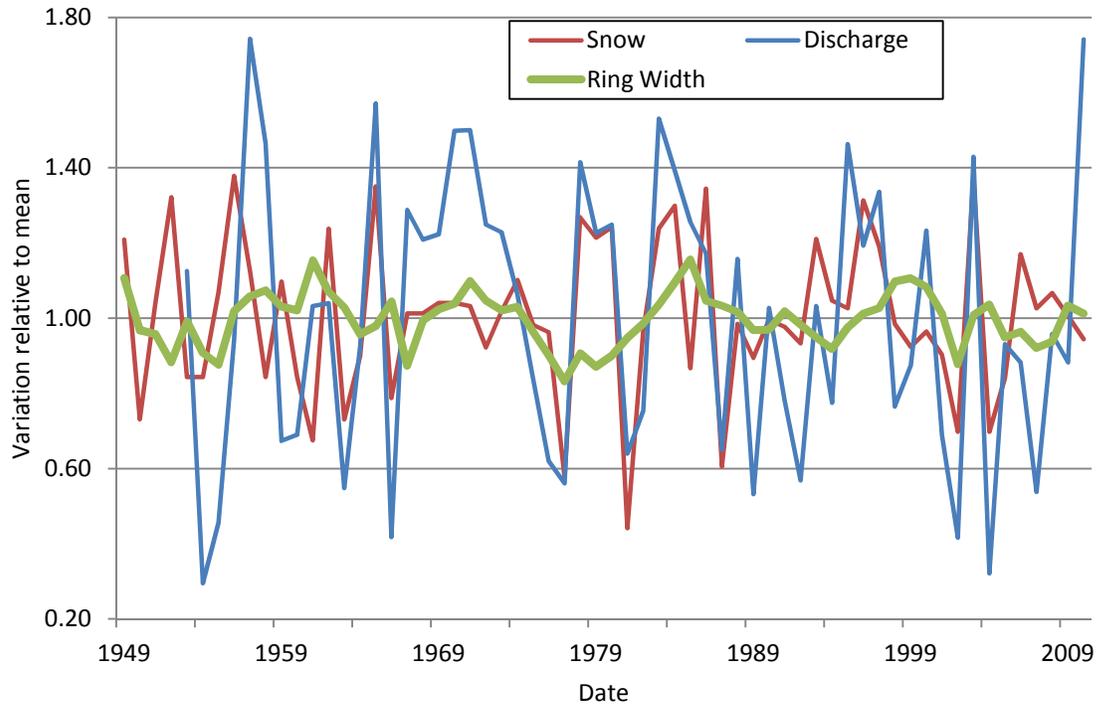
Figure 12: Annual snow depth records (averaged from Long Draw and Grand Lake Snowtel sites), annual peak discharge (from Baker Gulch USGS gage), and site-representative ring widths derived from tree core samples collected during the study.

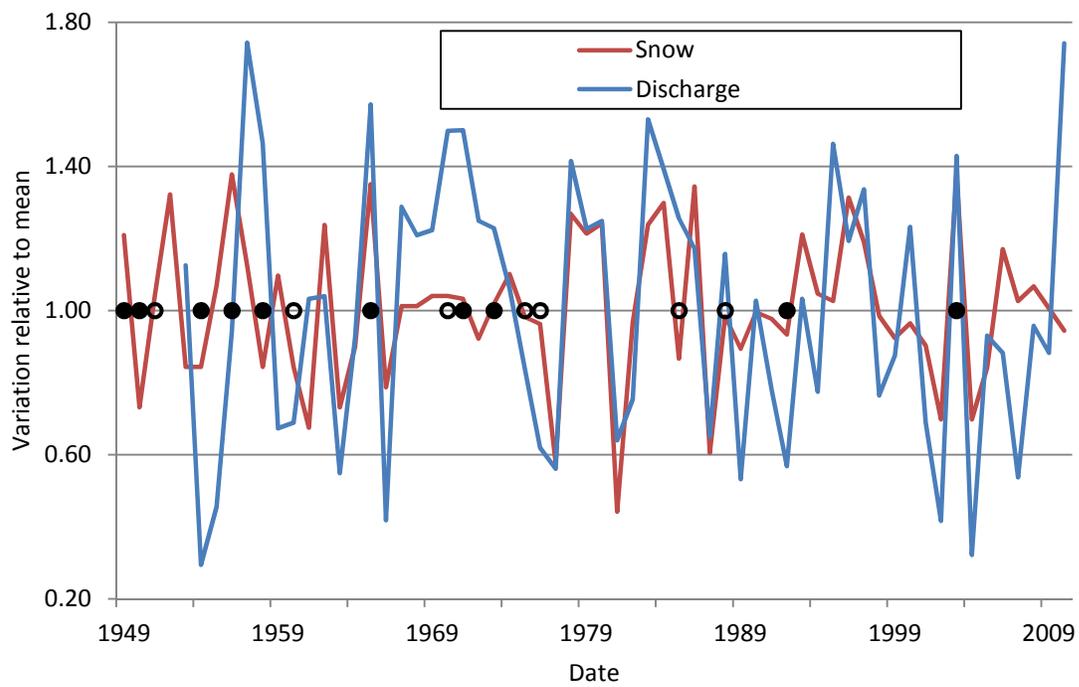
Figure 13: Years of debris flow occurrence on the east and west sides of the Colorado River valley overlain on snow depth and annual peak discharge records.

Debris flow ages were compared to snow depth and discharge records (Figure 13). Cross-correlation between years of debris flow occurrence on (1) the east, (2) west, and (3) total on both sides of the valley with snowpack and with peak discharge indicates little correlation in most cases (Table 4).

The strongest correlation, and the only one significant at the .05 level, is observed between debris flow occurrence on the west side of the valley and snowpack ($r = 0.28$). The apparent lack of a relationship between measures of wetness and debris flow occurrence may reflect the small magnitude

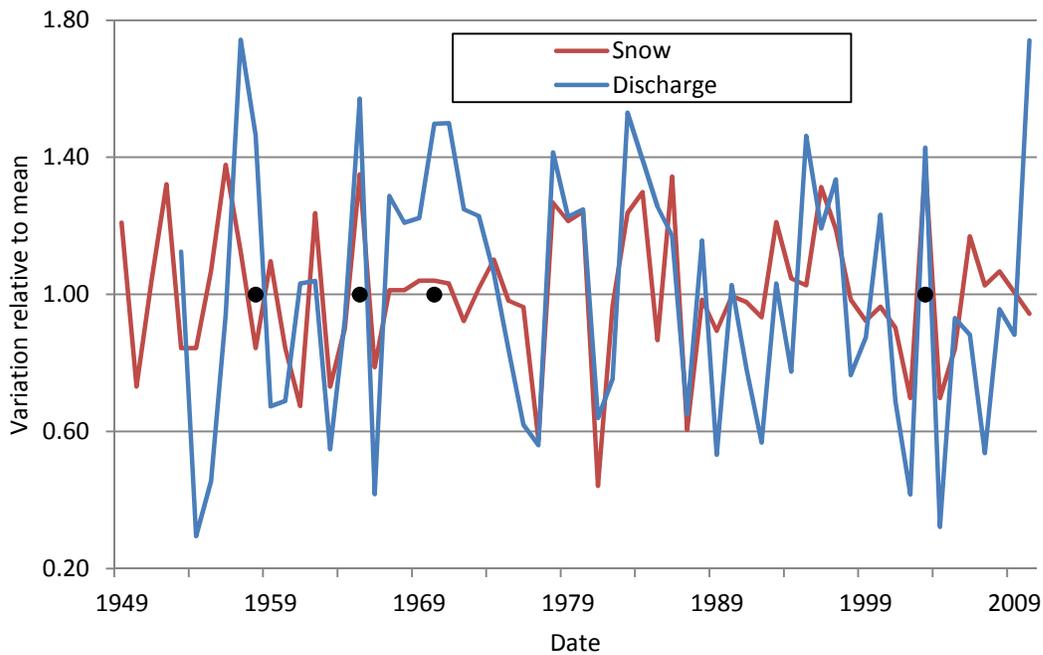
Figure 14: The four most significant recent debris flows along Specimen Creek (1958), Lady Creek (1965), Little Yellow (1970), and Lulu Creek (2003) overlain on snow depth and annual peak discharge records.

of many of the debris flows represented in this chronology. When only the four largest recent debris flows that have significant deposition along the Colorado River are plotted (Figure 14), a much stronger association with discharge is observed, with debris flows only occurring in years with at least 140% of mean discharge. No such relationship is observed between the four large debris flows and snowpack, which is somewhat surprising. However, peak discharge may be a better proxy in this case for the

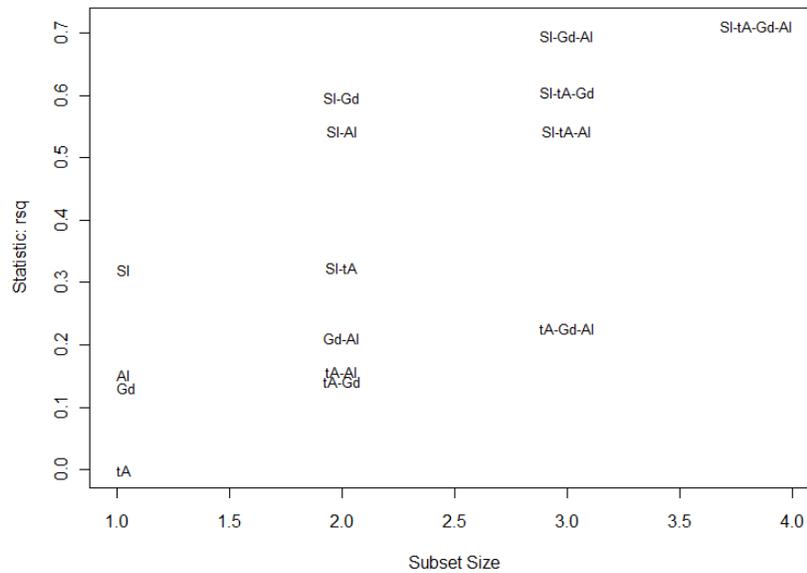
Figure 16: R-squared values for all possible subsets of the four variables used in the regression analysis.

Analysis of best subsets for the regression reveals that two- and three-variable models can explain almost as much variance as the model with all four variables (Figure 16). In particular, the model

including slope, Grand Ditch, and alteration explains 70% of the variance in debris flow volumes, while the model including just slope and the Grand Ditch explains 60% of the variance (Table 6).

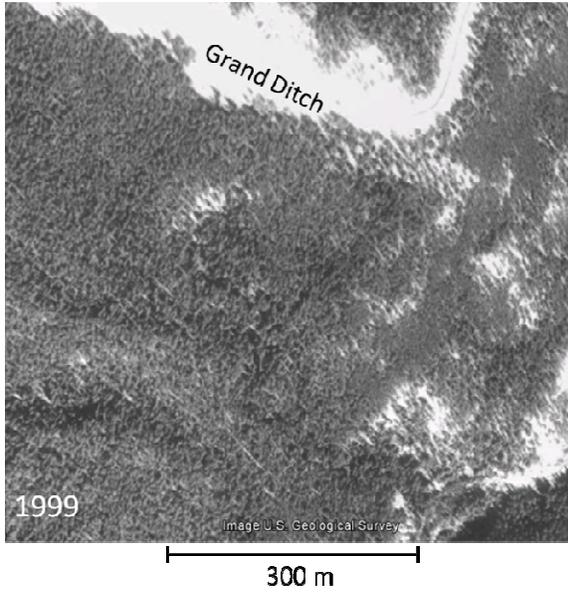
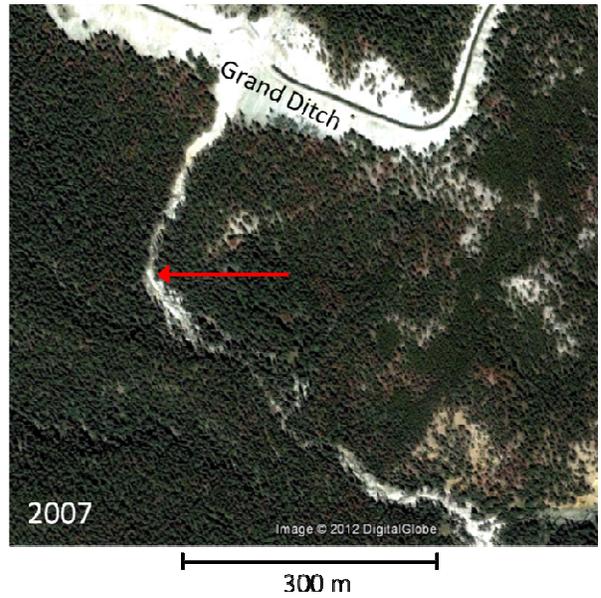
Lulu Creek

arrow on the 2007 image

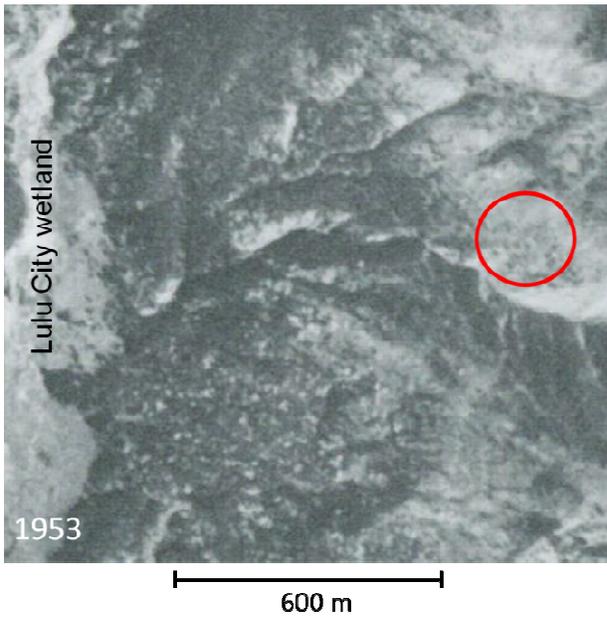
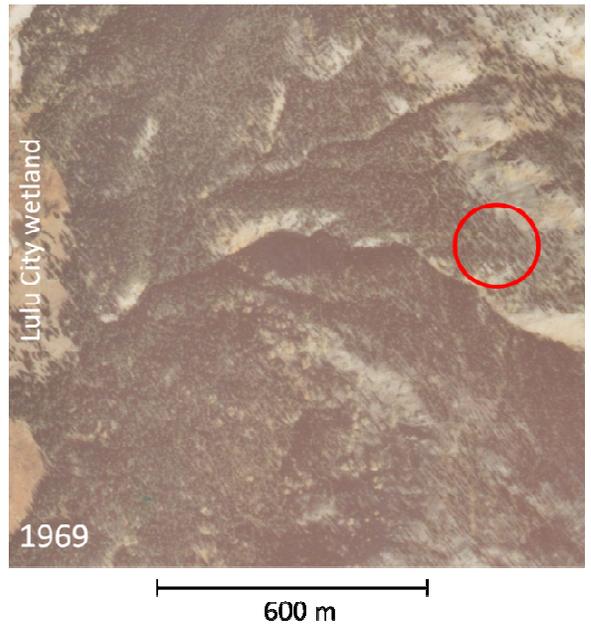
Crater Creek

arrowed area between the 1953

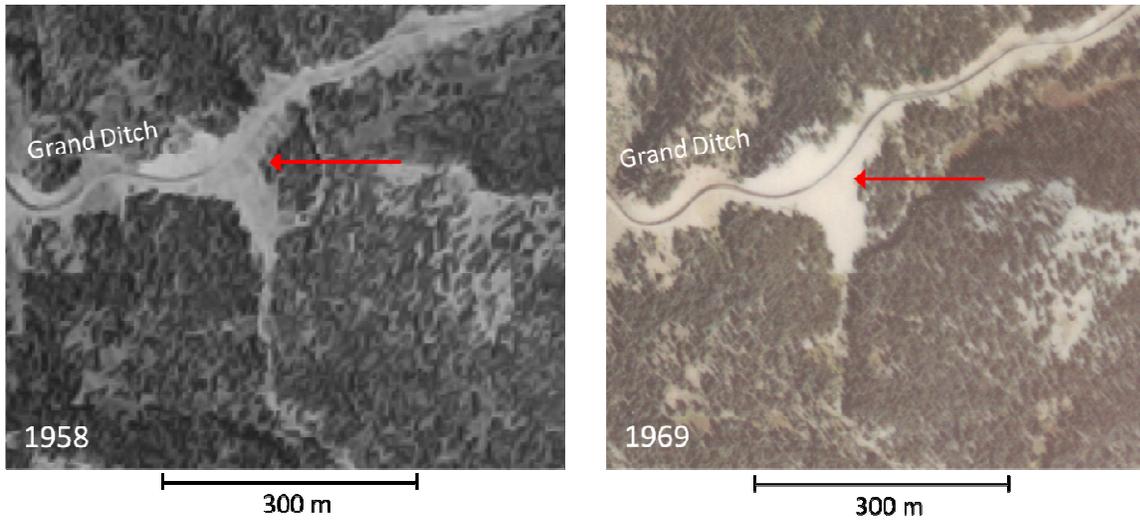
Across from Specimen Creek

Figure 21: Aerial photographs of the tributary across from Specimen Creek from 1958, and 1969. Loss of trees marked by the red arrows indicates a disturbance between 1958 and 1969 (scale 1:10,000).

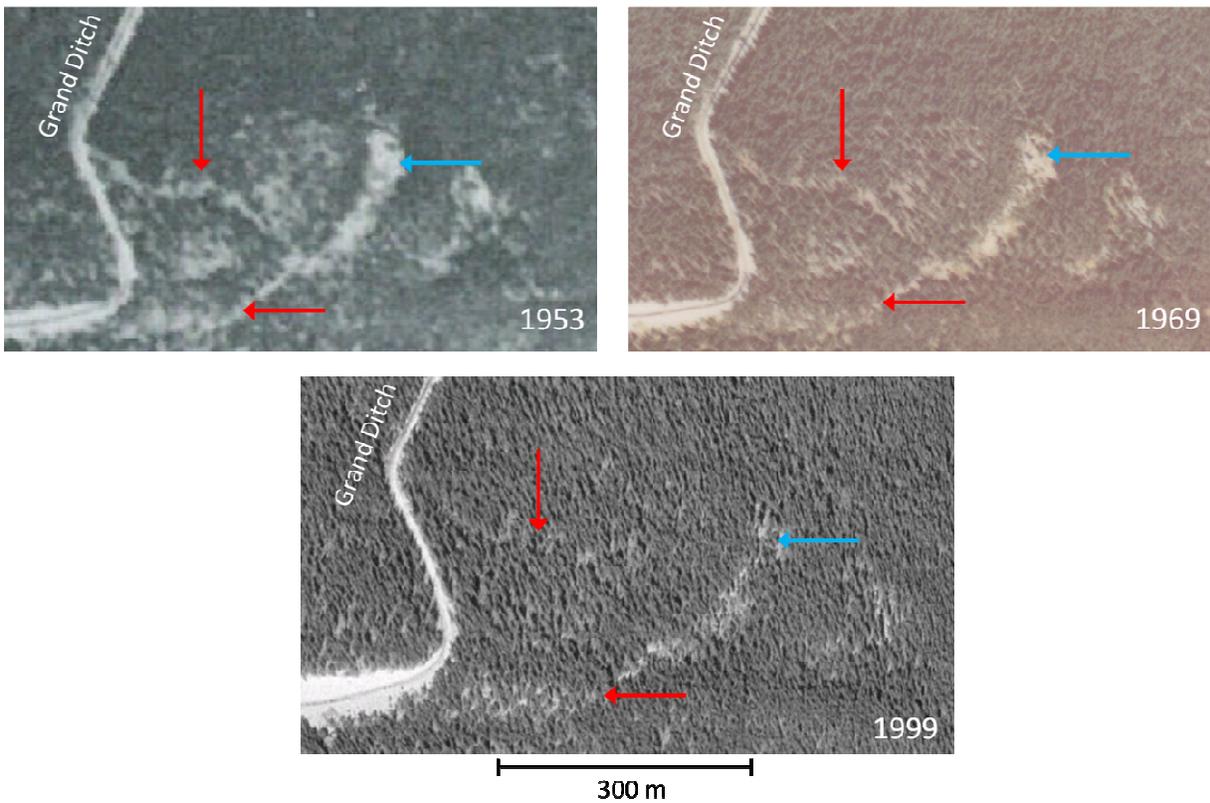
Figure 22: Aerial photographs of Big Dutch Creek below the Grand Ditch from 1953, 1969, and 1999. Gradual recovery of trees in paths indicated by the arrows indicate disturbance before 1953. The blue arrow signifies a disturbance that does not appear to be related to the Grand Ditch (scale 1:10,000).
