IMPERVIOUS SYNTHETIC LINING OF DETERIORATED CONCRETE CANALS — WHAT ARE THE REAL COST AND BENEFITS TO IRRIGATION DISTRICTS?

HID Canal Rehabilitation Sections

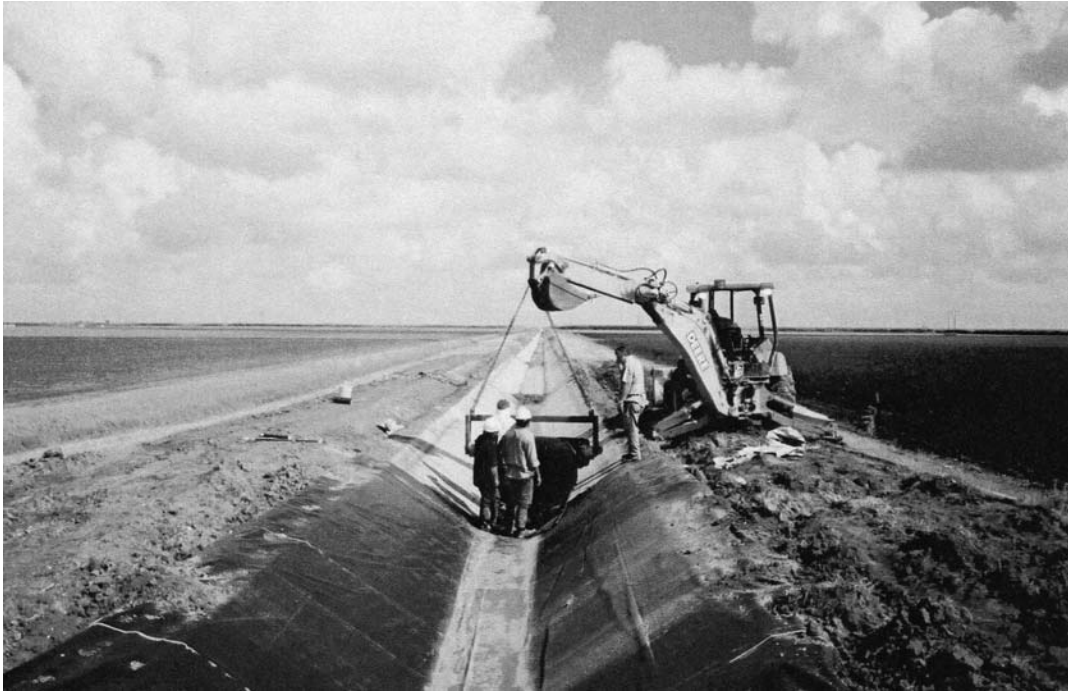
Photo 1. Typical Condition of Deteriorated Concrete Canal Section

The 2.45 mile irrigation canal section that was lined was an original concrete-lined canal built in 1917 and lined in the late 1950s with significant cracking and some deteriorated reaches and known high seepage loss in excess of 30% .

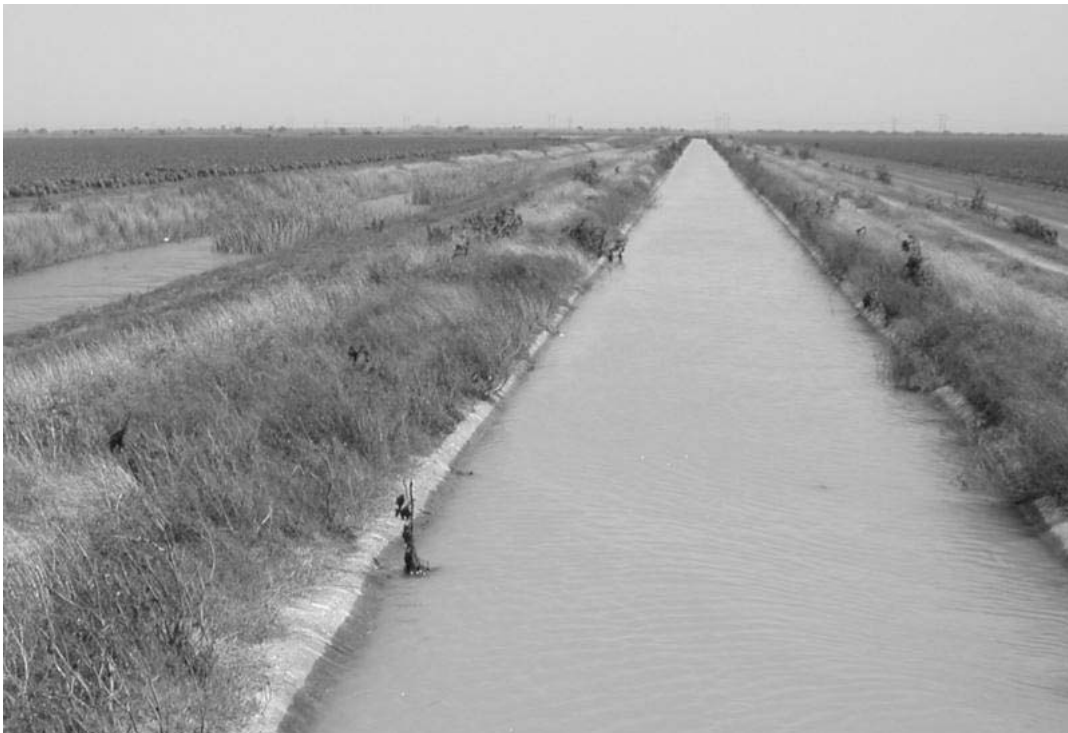
Photo 2. Example of Seepage Adjacent to Cracked Concrete Irrigation Canal

Historically, the irrigation district has faced loss of deliverable water due to high seepage rates in unlined and old concrete lined canals and laterals, approaching over 30 percent. This, in addition to the drought conditions here and in other irrigation districts, has prompted the federal government to initiate a program for the selection and installation of low-cost lining systems that can be installed and maintained by the irrigation district personnel without the need for specialized installers or contractors. Materials must be capable of being installed in harsh, rough conditions, resist animal traffic and be left exposed in excess of 20 years. Federal Government requests for proposals on the use of impervious linings for canal rehabilitation have traditionally focused on the following areas:

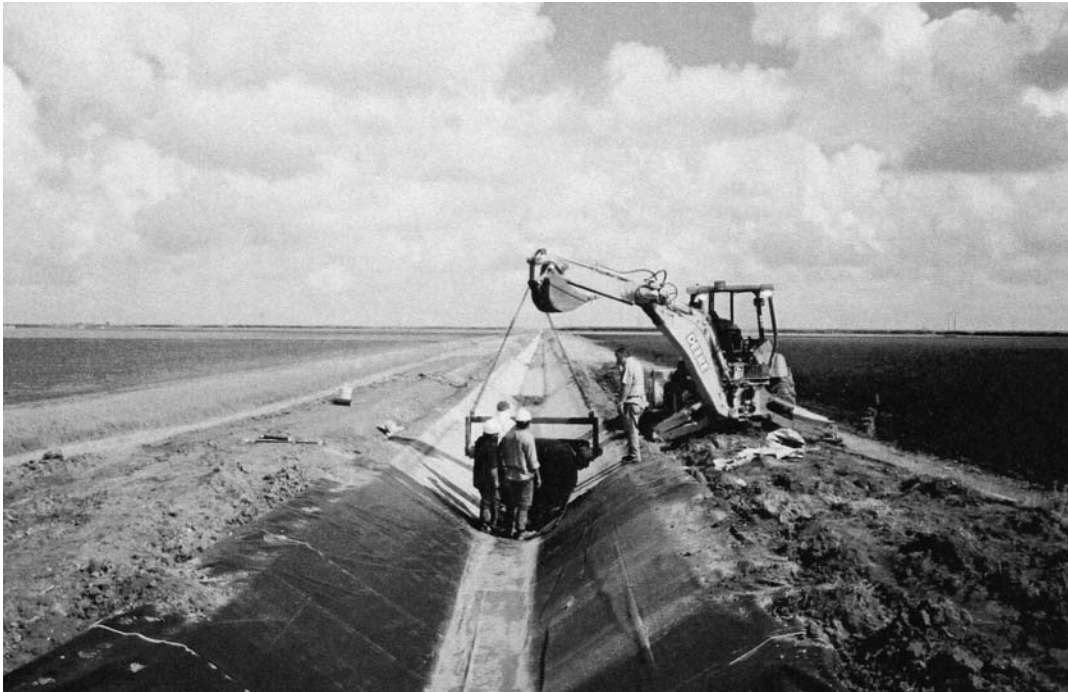
Photo 3. Placement of EPDM Panels by the Irrigation District

EPDM factory panels were manufactured by the Firestone Building Products Company, Carmel, Indiana. The panels were custom-sized for the HID to 30 ft. in width by 200 ft. in length, folded along the length and then rolled for delivery and handling on site. Once the rolls of panels were delivered to the site, the HID deployed the panels using their own equipment and 8 person crew. District personnel fabricated a custom lifting bar which was suspended by cable from the bucket of a backhoe. The rolls of EPDM were lifted, positioned in the channel bottom and unrolled along the channel by advancing the backhoe along the channel access road.

Once the panels were unrolled and unfolded up the side slopes, they were positioned and placed into the anchor benches on both sides of the channel section. The ends of the panels were then overlapped a minimum of 6 in. and the overlap area was cleaned and primed with Firestone QuickPrime Plus. The overlap area was then tacked without wrinkles and Firestone QuickSeam tape, an adhesive tape seam system, was applied by the HID crew. The field fabricated seams were composed of prefabricated 6 in. wide rolls of partially vulcanized Firestone cover strips with adhesive backing. Once the strip was placed and centered on the overlap, it was pressed down onto the two adjacent panels with constant hand roller pressure to ensure complete adhesion.
