THESIS

STRENGTH AND CONSOLIDATION BEHAVIOUR OF REMOLDED REDBED
CLAYSTONE FROM THE MAE MOH LIGNITE MINE

Colorado State University

Fall 2024

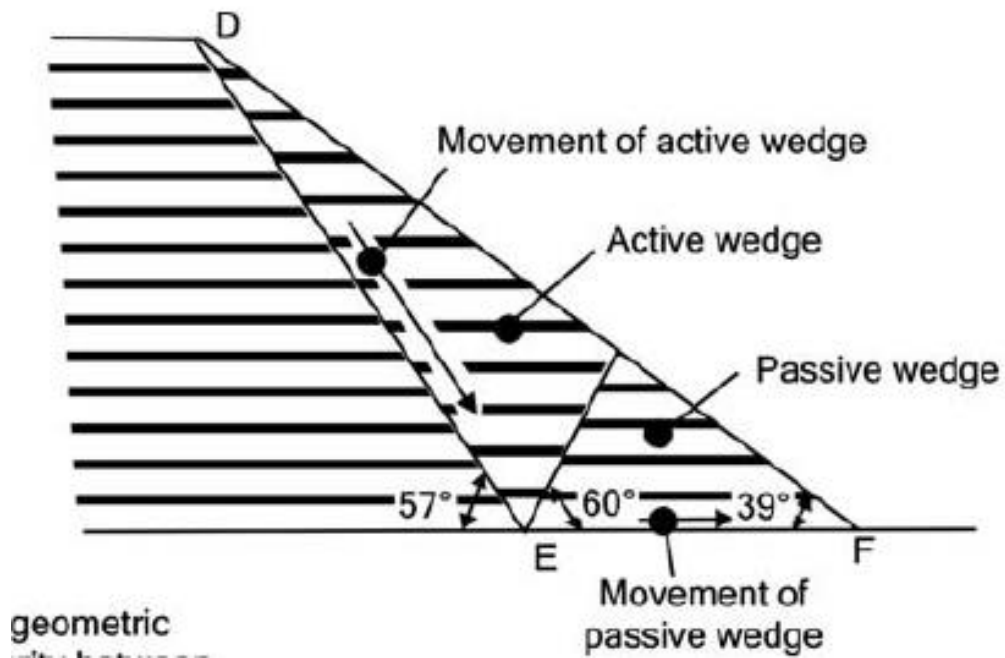
Figure 2-3 Schematic of a “first-time” failure of a waste rock pile (Blight 2009)

The geometry of a typical “first-time failure” in waste rock piles is shown in Figure 2-3. Based on physical model experiments, first-time failures were observed to involve formation of an active wedge that displaces the passive wedge along a horizontal plane in the foundation (G. E. Blight, 2009).

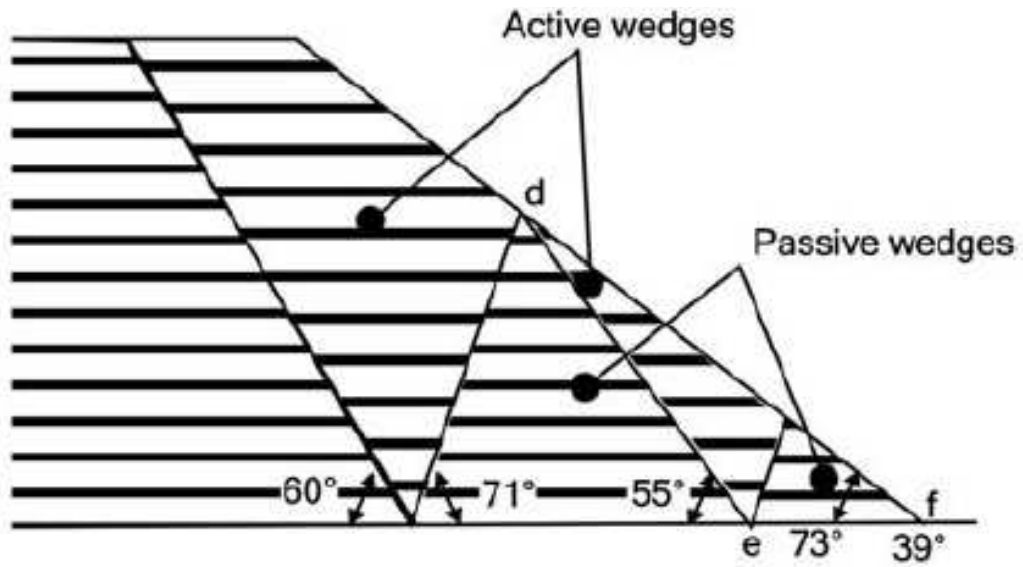
Figure 2-5 Schematic of a “subsequent” failure of a waste rock pile (Blight 2009).

A schematic of a subsequent failure over a previously failed section is shown in Figure 2-5. The failure surface in this case is composed of alternating active and passive wedges and is much more complex than a first-time failure.

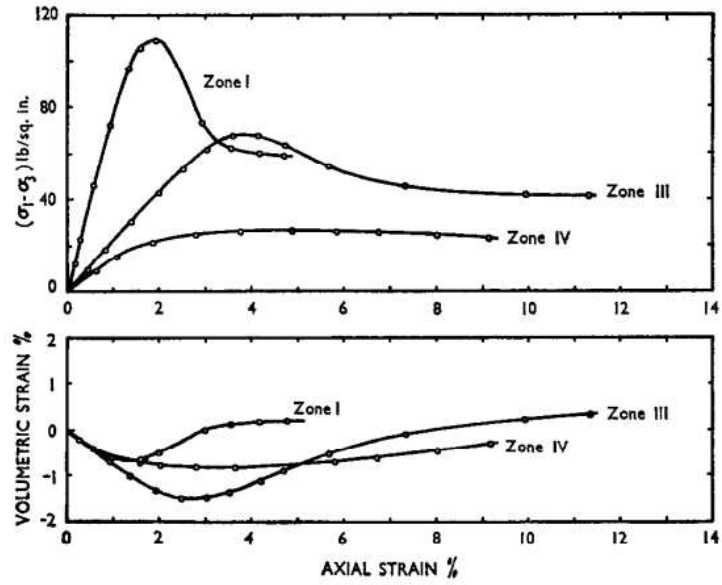
Figure 2-9 Stress-strain relations for different marls in drained triaxial compression tests.(Chandler, 1969)

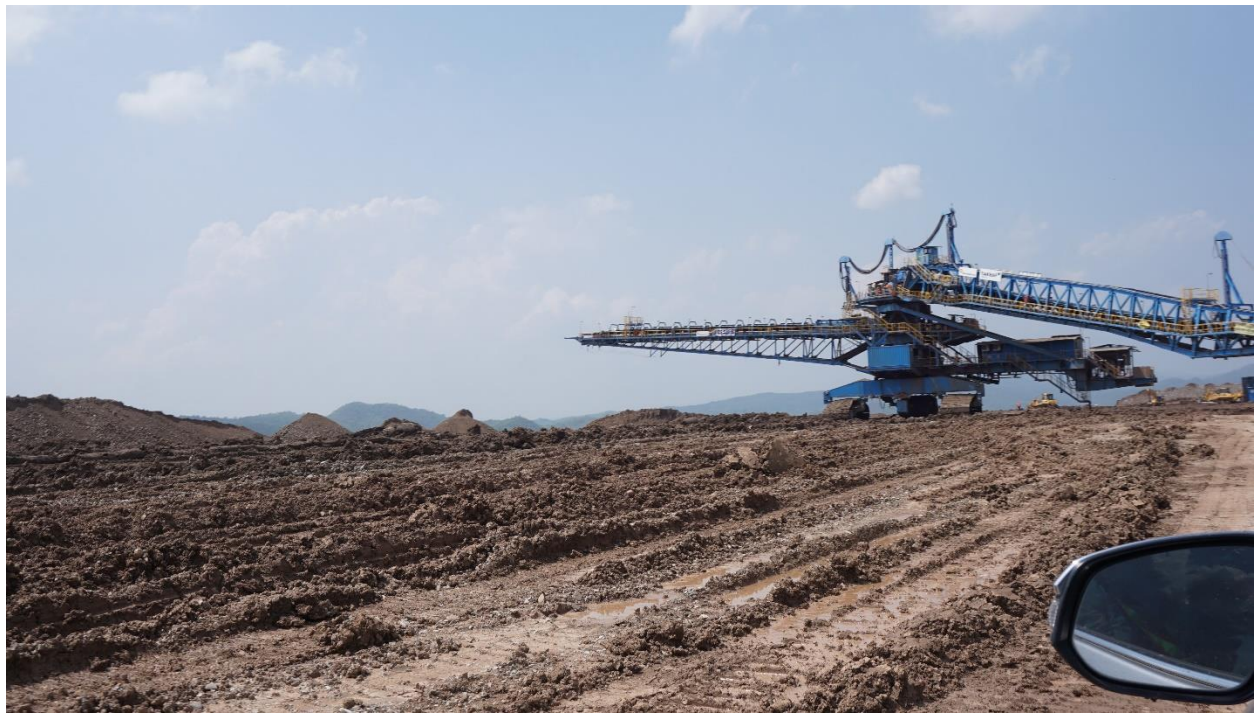
Figure 3-2 Surface condition at the top of the waste dump (Picture taken in May 2023).

During a site visit, the surface of the dump was observed to consist of uncompacted clay as shown in Figure 3-2 as opposed to claystone that was extracted to access the coal seam. This observation supports the hypothesis that the claystone waste rock disintegrated upon exposure to the climatic conditions present at the mine and transformed into a soil like material.

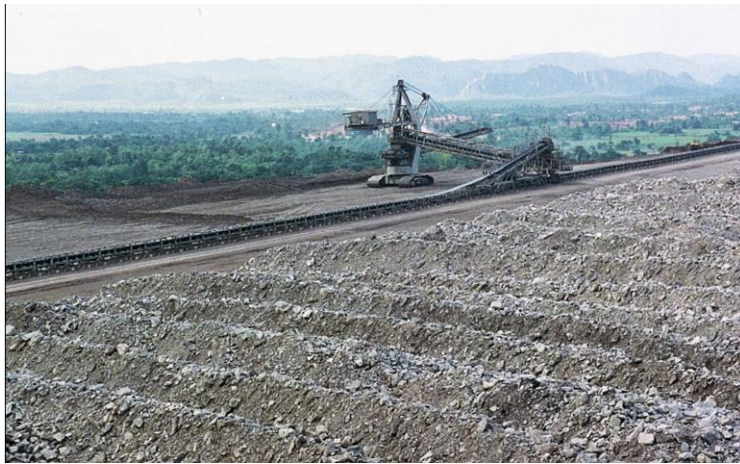
Figure 3-3 Early dumping activities at the northwestern waste rock dump (Pells Sullivan Meynink Engineering Consultants, 2018).

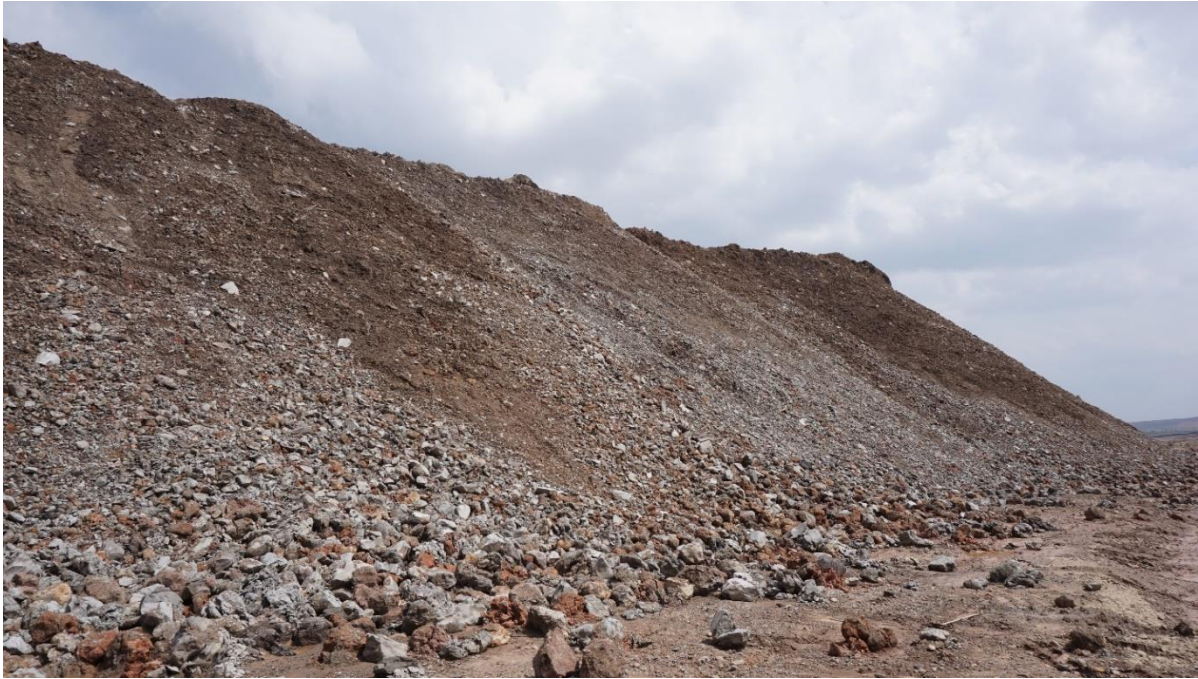
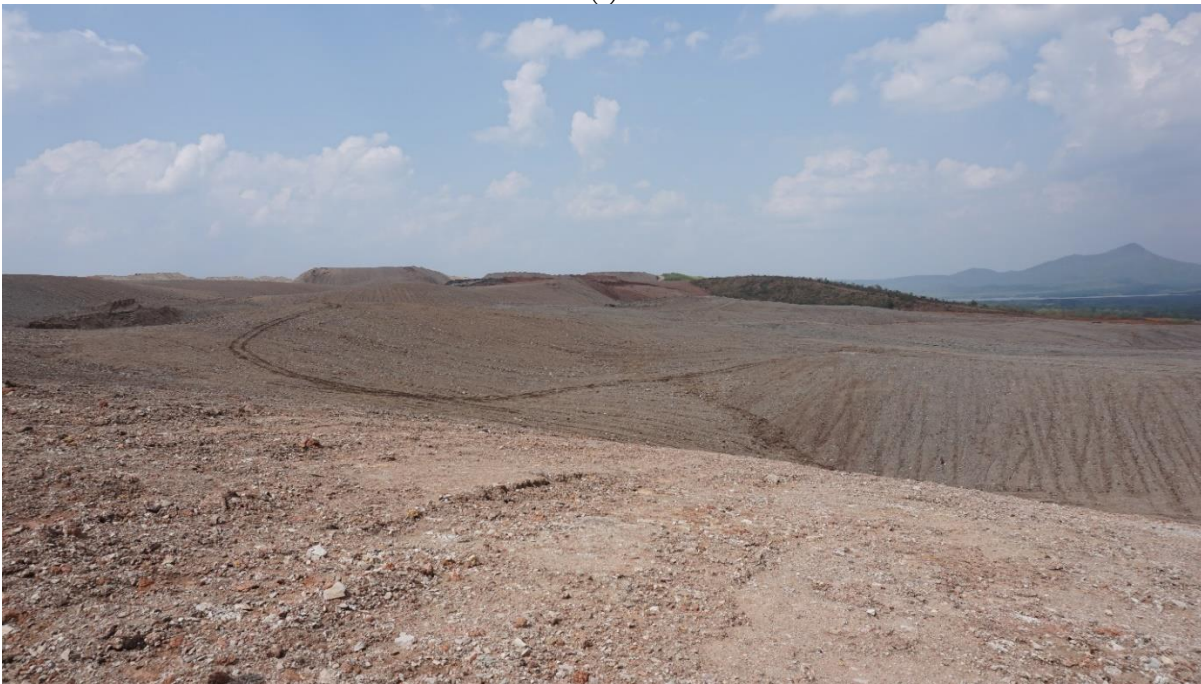
Figure 3-4 (a) Waste rock dumped before spreading and (b) disintegrated rock on the dump.
