THESIS

EVALUATING THE LONG-TERM DURABILITY OF FIBER REINFORCED
POLYMERS VIA FIELD ASSESSMENTS OF REINFORCED CONCRETE
STRUCTURES

Colorado State University

Fall 2011

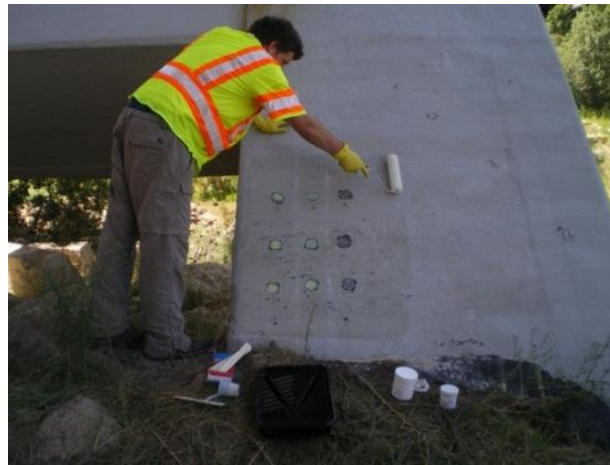
Figure 3.56. Applying a primer coat to the areas for repair

Once the holes were filled with epoxy, the 3 areas of pull-off tests and the 2 areas of removed CFRP (debonded regions) were prepared for a repair process. First these areas were washed using a non-toxic, biodegradable, soap and water, then they were cleaned with 70% Isopropyl alcohol to remove any remaining soap film. CFRP patches must overlap a minimum of 6”; therefore primer was applied to the affected

areas of the arches plus a minimum of 6" in each direction. The primer used for the repair was a two part epoxy made by HJ3, STRONGHOLD Primer Epoxy (STR-BW-200A). The mix ratio was 2 parts of the PC-200 Primer Resin, Part "A", to 1 part of the PC-200 Primer Hardener, Part "B". Once the two-part epoxy was well mixed, the primer was distributed to the repair areas using 9" rollers as seen in the photograph below.

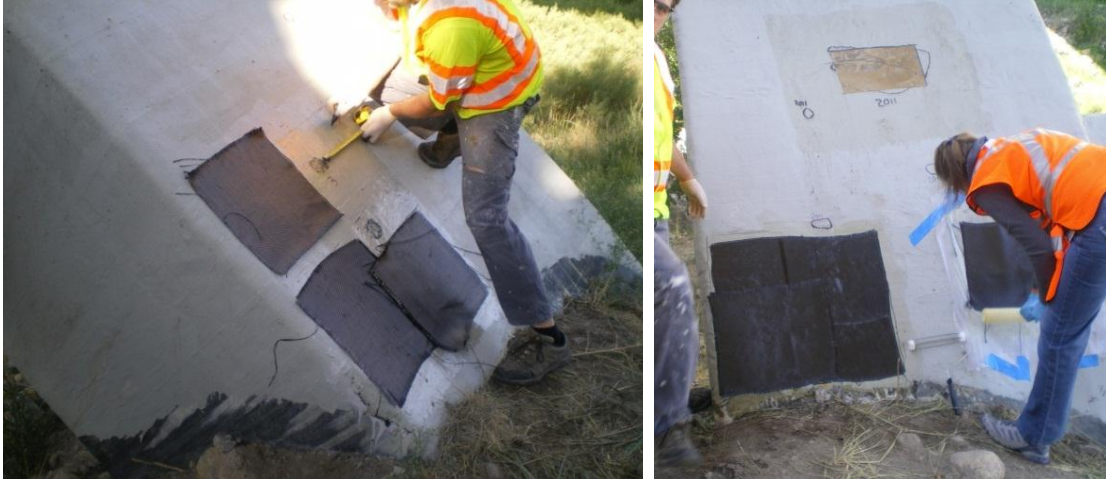
Figures 3.57 and 3.58. Allocating fabric for repair and applying the second layer of CFRP to the area of pull-off tests on the east arch

The CFRP fabric was saturated by applying a well-mixed two part epoxy, two parts of HJ3 SRS-400-A Resin and one part HJ3 SRS-400-B Hardener, to both sides of the fabric. The two part epoxy was also applied to the repair areas identical to that of the primer. The saturated fabric was then placed on the arch and the use of hand pressure and rollers eliminated air bubbles and pockets between the fabric and the substrate. Unidirectional CFRP fabric was used to repair the area where the patches were removed. Proper alignment of the fiber direction in the transverse direction was necessary to repair the transverse wraps. The pull-off tests were conducted closer to the edge of the arches damaging both transverse and longitudinal sections. Therefore, biaxial patches were used to repair these areas. This process is represented in the photographs below.

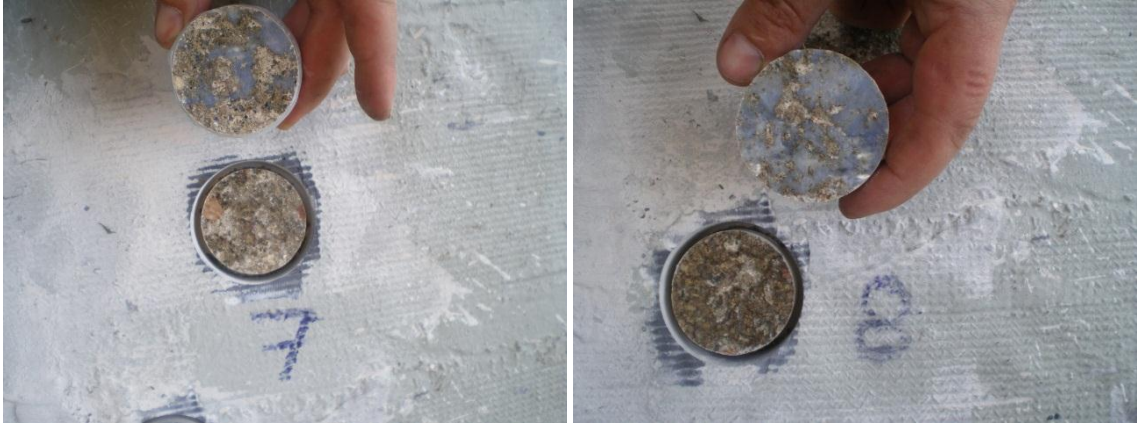
Figures B6 and B7. Test No.7 and Test No.8, weak bond strength
