MANAGING A LARGE IRRIGATION SYSTEM UNDER EMERGENCY CONDITIONS: HIRAKUD PROJECT CASE STUDY, INDIA

STRUCTURAL DISTRESS/PARTIAL COLLAPSE OF THE DANTA AQUEDUCT

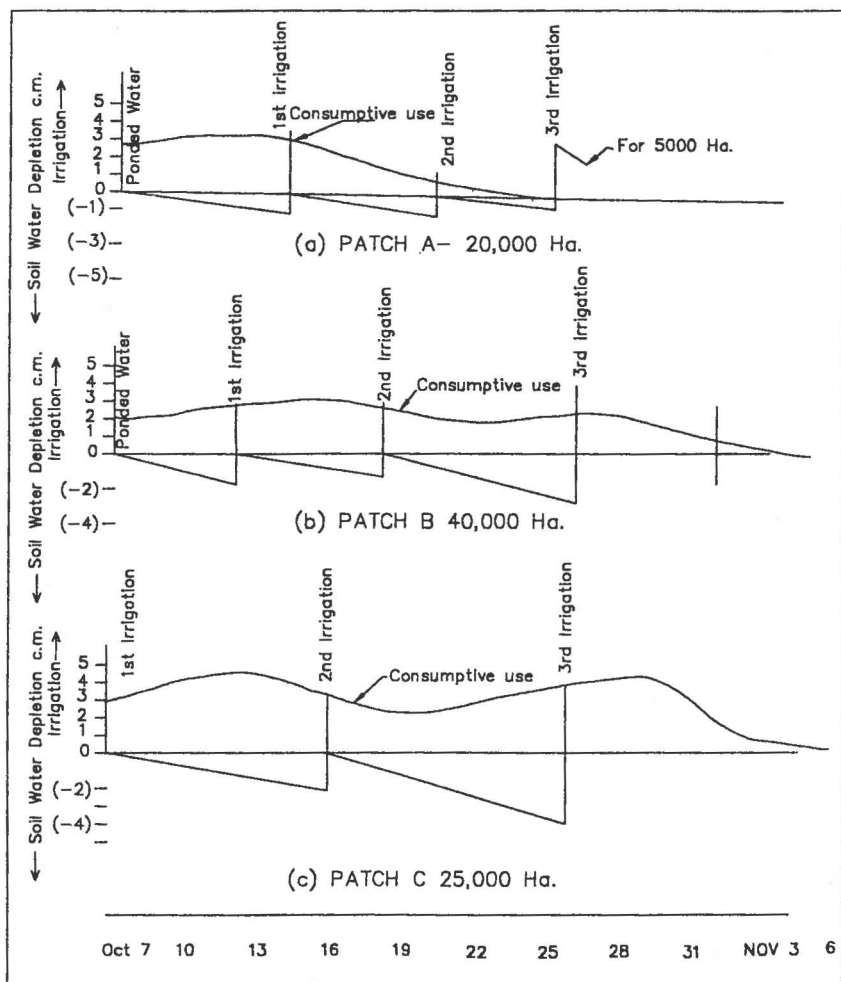
Figure 3. Schematic Description Between Soil-Water Depletion, Actual Irrigation and Crop Consumptive Use (Paddy)-October 7th through November 6

The flowering and milk ripe stage of maturity has the highest ET need of 3 to 5 cm and any reduction of water would cause disproportionately large reduction in crop yield. Based upon the crop stage, the soil-water depletion, consumptive use and irrigation application quantity were decided as shown in Figures 3a, b, and c.

For Patch B, in a staggered fashion, 2 cm was given to the upper 20,000 ha from October 13. For the lower 20,000 ha of Patch B and about 15,000 ha of Patch C water was allowed just to keep the surface wet, to prevent development of shrinking cracks. By October 20, the entire reservoir over the canal network dried up, but with the rainfall almost 40,000 ha in Patches A and B had minimal need (less than 1 cm as milk ripe stage was reached).
