Performance of RCC Used for Overtopping Protection and Spillways

Kenneth D. Hansen, P.E.¹, and Thomas J. Fitzgerald, P.E.²

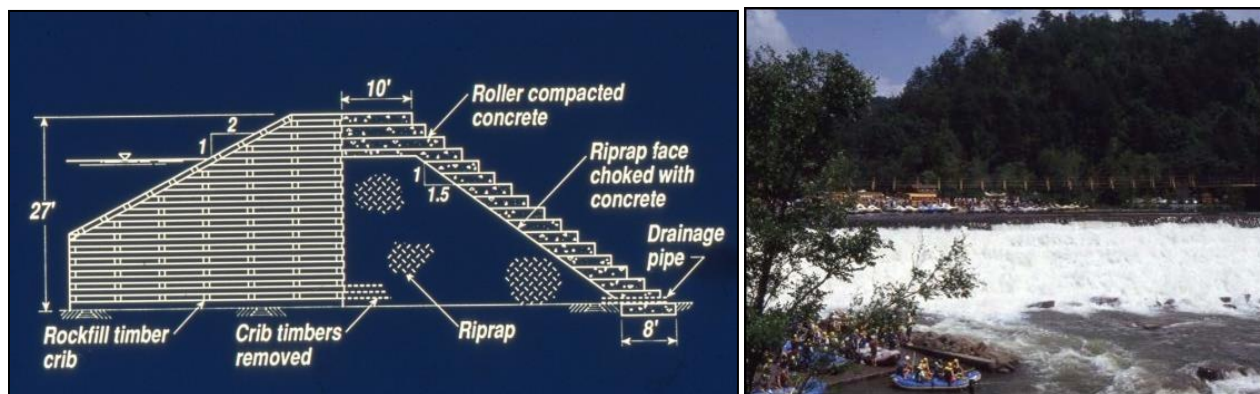
The 27-foot high dam was modified in 1980 to accommodate white water rafting companies. RCC was placed on the downstream slope in a stair-stepped fashion over some rock infill to allow the dam to be intentionally overtopped. See Figure 1 for a typical cross section of the modified dam.

Figure 1. Ocoee No. 2 Dam, TN – Typical Section and Flow Over RCC Protection

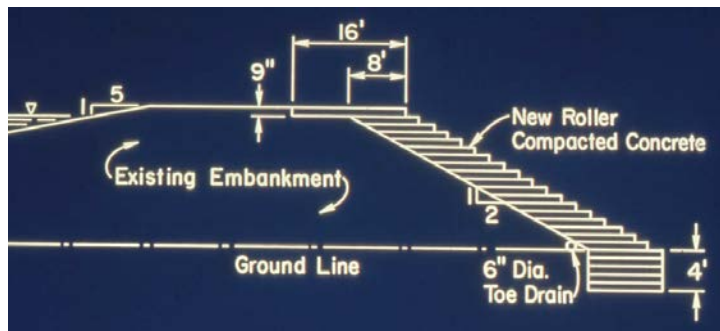
The first earth dam to receive an RCC overlay to increase spillway capacity was a dam at the Brownwood Country Club golf course. The RCC overtopping protection increased the spillway width from 65 feet to 300 feet and in the process increased the spillway capacity from 2,600 cfs to 11,600 cfs. A typical section of the dam is shown in Figure 3 which was designed for a maximum depth of overflow of 5.5 feet.

Figure 3. Brownwood Country Club Dam, TX
– Typical Section

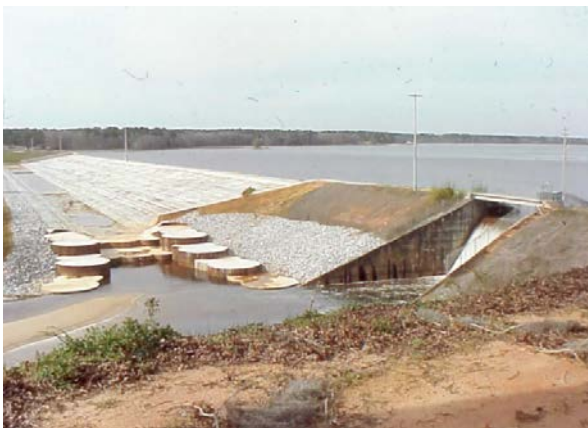
The RCC overtopping protection was first tested in September of 2004 when it experienced an estimated flow depth of 3 feet due to Hurricane Ivan and again in March 2005 when it overtopped by 1.5 feet. (See Figure 5). The condition of the RCC steps in 2014 after about ten overtoppings is shown in Figure 6. It has been observed to be in excellent condition with only a slight polishing of the RCC surface.

Figure 5. Lake Tholocco Dam, AL
– During Overtopping

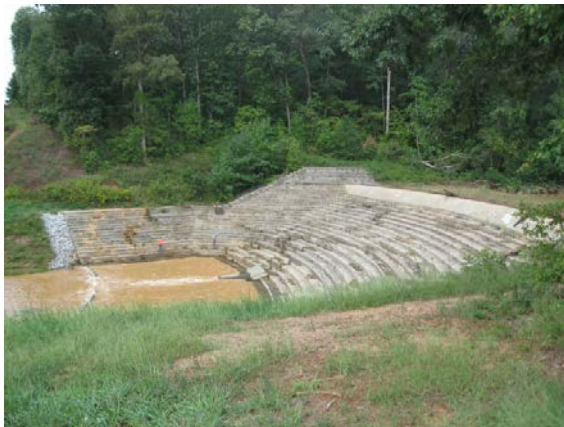
The Y14 Dam with a maximum height of 39.5 feet was designed to accommodate the full PMF flow and would start overtopping due to the 100-year flood. The structure had an ogee crest for the converging stepped and exposed RCC chute that was curved in plan. See Figure 7.

Figure 7. Y14 Dam, GA – Before Overtopping

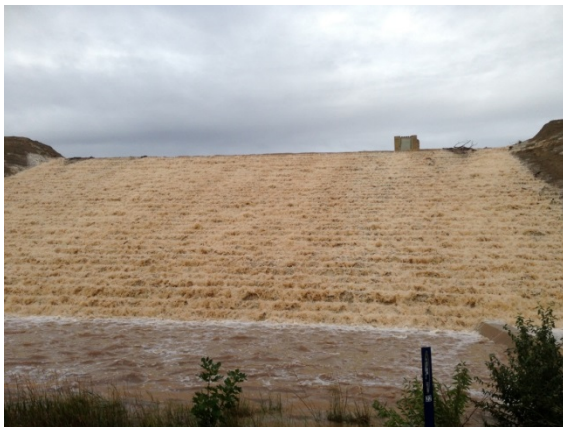
The primary spillway which is located at the right abutment started to spill just before noon on Friday, September 13, 2013. The RCC protected auxiliary spillway whose crest is six inches higher than the principal spillway started to overtop that night. Flow continued over the RCC surface for a week which is the longest duration of overflow for an RCC protection project subjected to an extreme rainfall event. See Figure 12.

Figure 12. Left Hand Valley Dam, CO
– During Overtopping

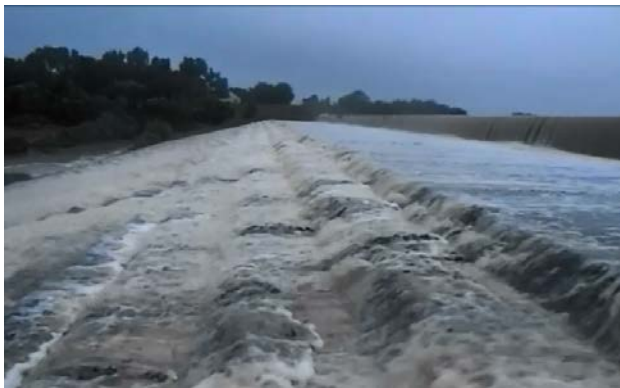
Because Leyden Dam is located further away from the greatest amount of rainfall that occurred, it was overtopped by a lesser frequency storm for about two days. Still, the overtopping event was greater than the 100 year storm. See Figure 14 for Leyden Dam overtopping.

Figure 14. Leyden Dam, CO
– During Overtopping

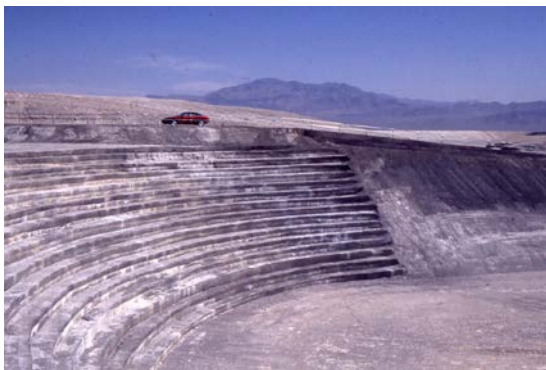
Figure 16. Kyle Canyon – Inlet Structure No. 3

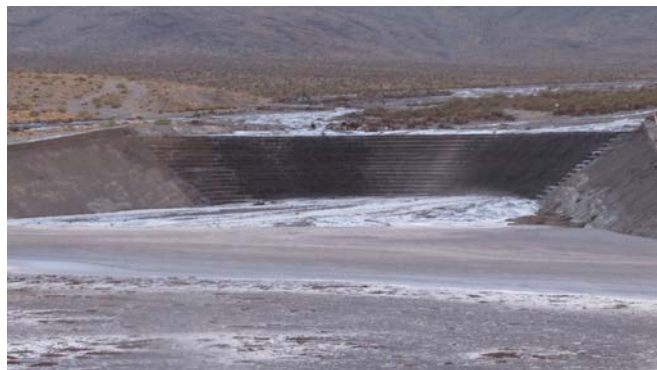
Runoff from the rain produced an estimated maximum flow over Inlet Structure No. 3 of more than 8,000 cfs (40 cfs/foot) and filled the Kyle Canyon basin to a maximum depth of 30 feet. Based on visual observation, the duration of the overflow was less than six hours. See Figure 16 for the stepped RCC inlet prior to and Figure 17 during the overtopping.

Figure 17. Inlet Structure No. 3, Overtopping
