# SYNTHETIC CANAL LINING EVALUATION PROJECT

Eric Leigh<sup>1</sup>  
Askar Karimov<sup>2</sup>  
Guy Fipps, Ph.D., P.E.<sup>3</sup>

## ABSTRACT

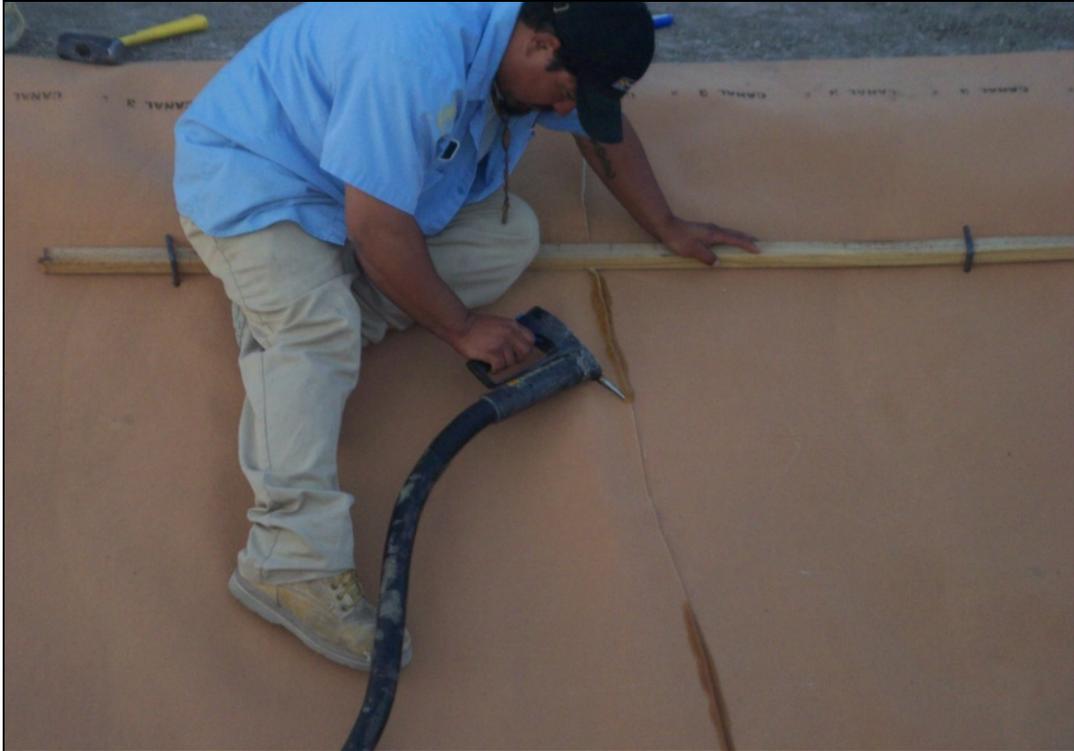
Liners need to be properly installed and stretched in order to prevent wrinkles. Wrinkles not only look unprofessional, but make the liner more susceptible to damage. Glues, liquid rubbers resin, tar and types of metal pins are used to secure the material around the structures and at the joints (Figures 10).

Figure 10. Glues being applied to the joints of a polyester liner.

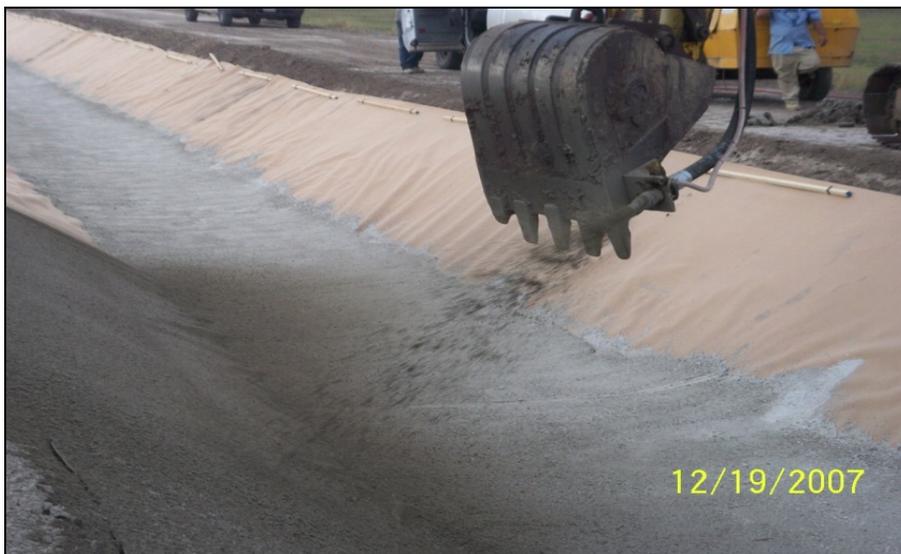
While the initial costs of a lining project using a use of a protective barrier such as shotcrete are higher, these costs may be offset by the reduction in costs of maintenance and repairs over the life of the project. An important consideration is the ability shotcrete to adhere to the liner. The polyester material has small fibers (similar to the harden side of Velcro) to which the shotcrete will stick when sprayed on to the liner (Figure 15). On the other hand, the PVC liner has a smooth texture to which the shotcrete will not stick, and a wire mesh needs to be used on the top of the liner to provide grip and added reinforcement. This application also increases labor and cost.

Figure 15. Shotcrete being sprayed onto the fibrous polyester liner
