TECHNICAL REPORT N-70-10

SURVEY OF GULF COAST  
STRUCTURAL DAMAGE RESULTING FROM  
HURRICANE CAMILLE, AUGUST 1969

M. E. Criswell, R. S. Cummins

April 1970

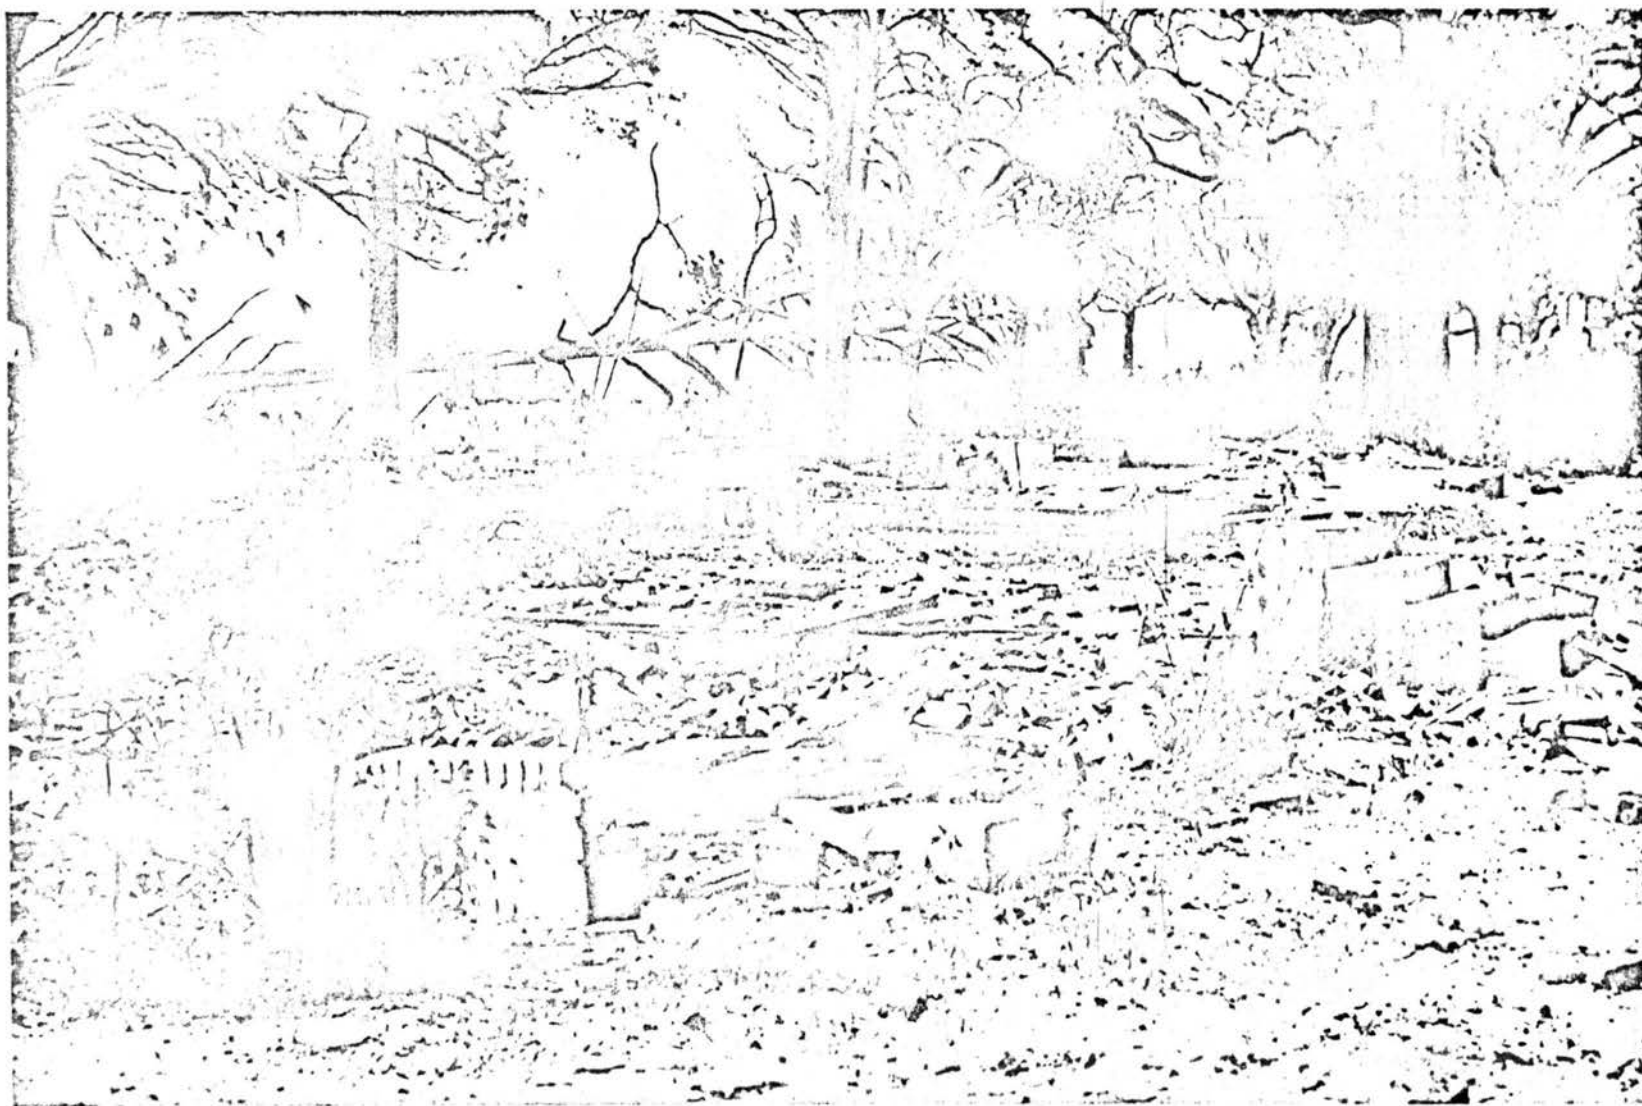
Figure 2.35 Residence near Long Beach, Mississippi.

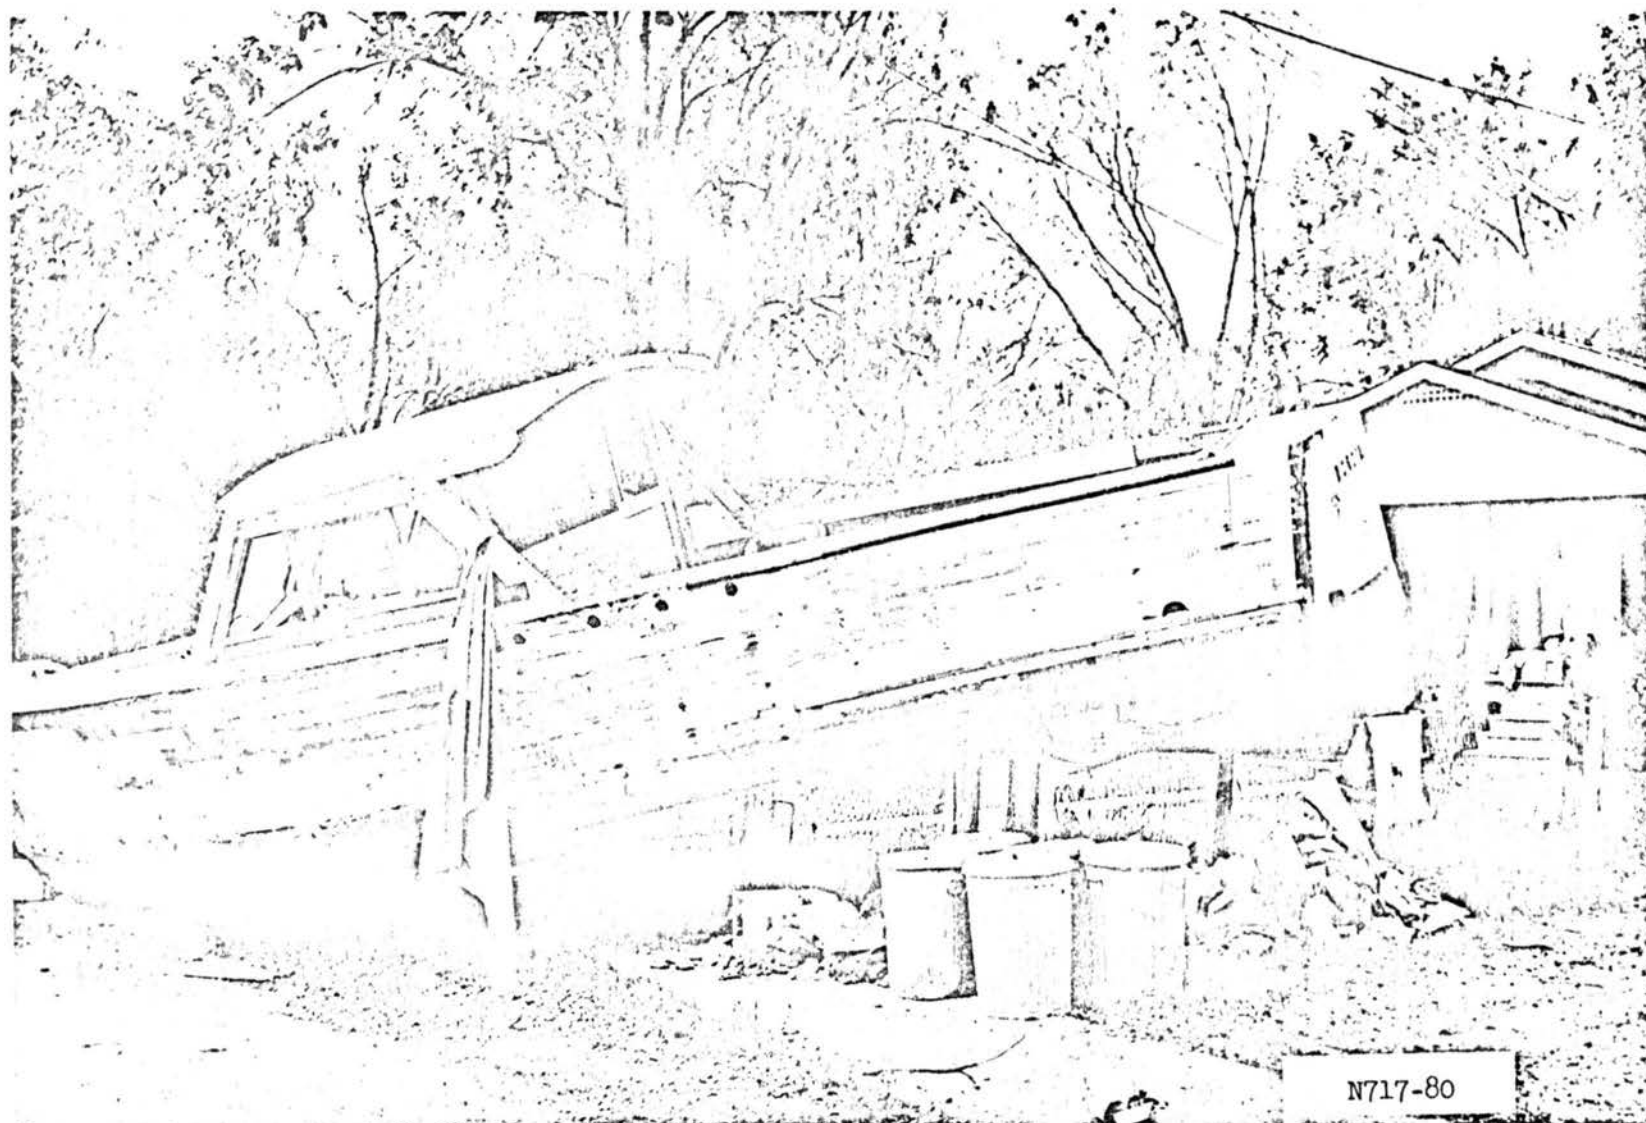
Figure 2.36 Boat ashore, east end of Biloxi, Mississippi.

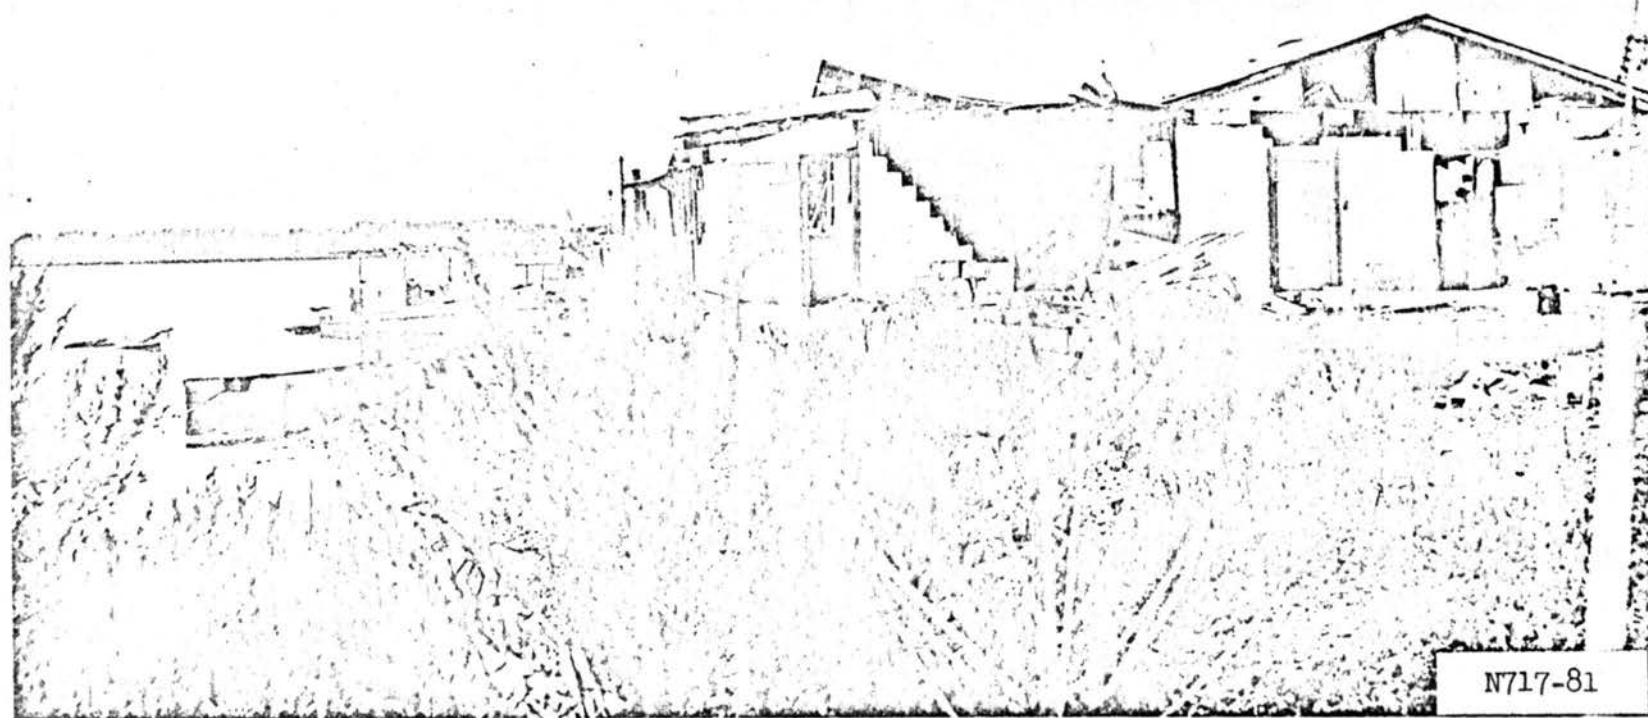
Figure 2.37 Commercial building, Back Bay of Biloxi, Mississippi.

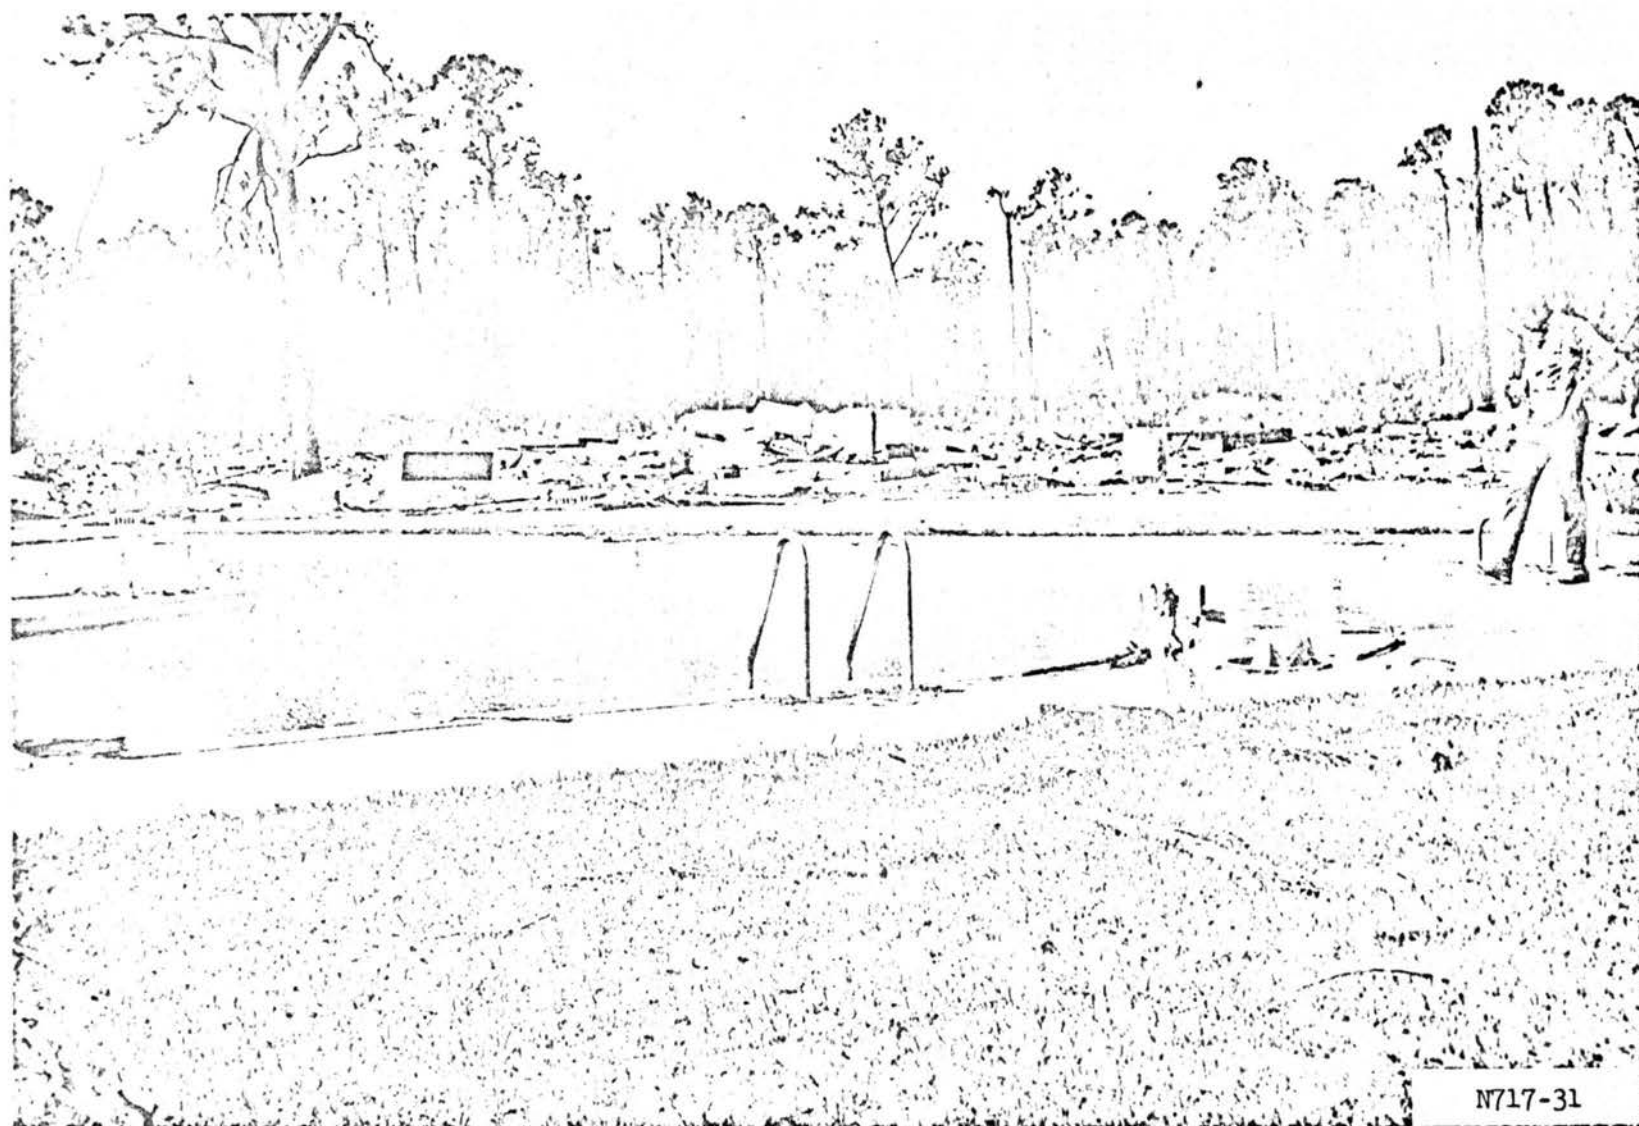
2.3.1 Masonry Block Structures. Many motels, apartments, gasoline stations, and small businesses along the Gulf shoreline were constructed of block and/or brick bearing walls, and these structures generally fared very poorly. An appreciable number collapsed totally with little evidence remaining to indicate how they looked before the storm. Almost all buildings of this type were totally destroyed in the area along the coast from Gulfport to Bay Saint Louis. Figures 2.40 through 2.46 show the remains of some buildings of this type.

Figure 2.42 Motel or apartment house, Long Beach area.

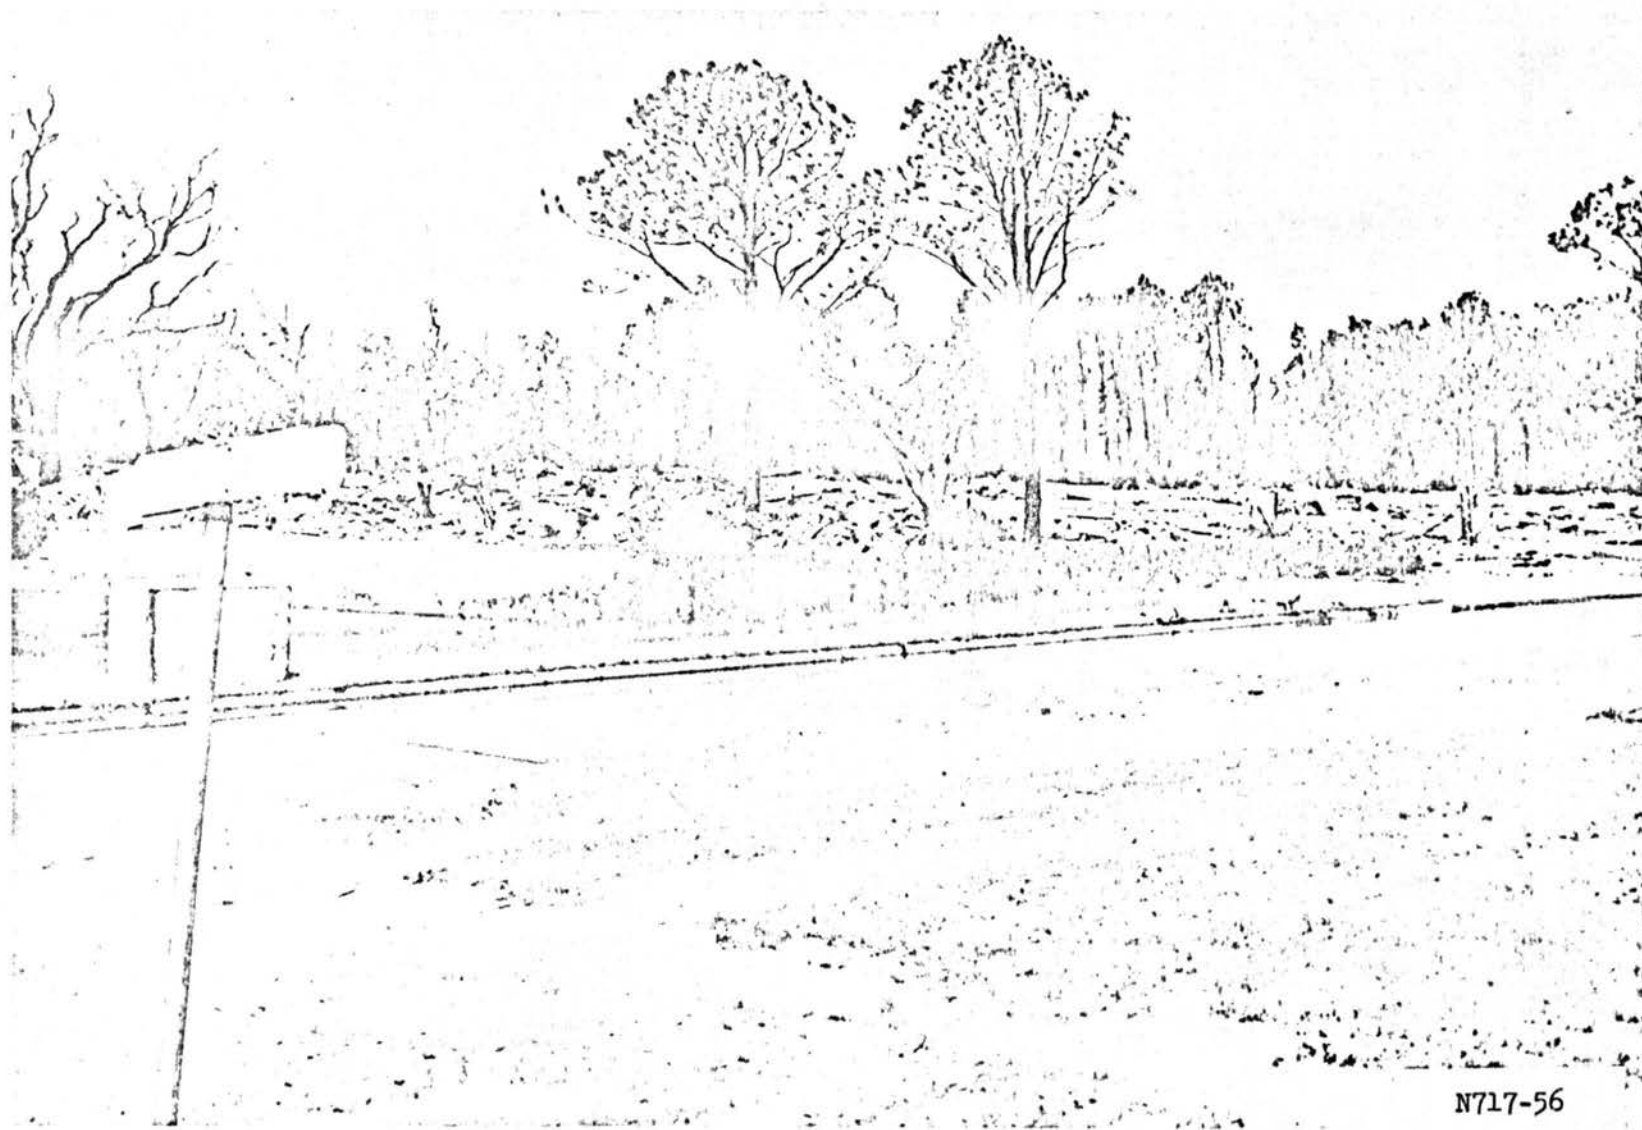
N717-56

Figure 2.43 shows the remains of the Richelieu Apartments, where 23 people died after ignoring repeated warnings by local authorities to vacate the building.

Figure 2.43 Richelieu Apartments (23 dead), Pass Christian, Mississippi.

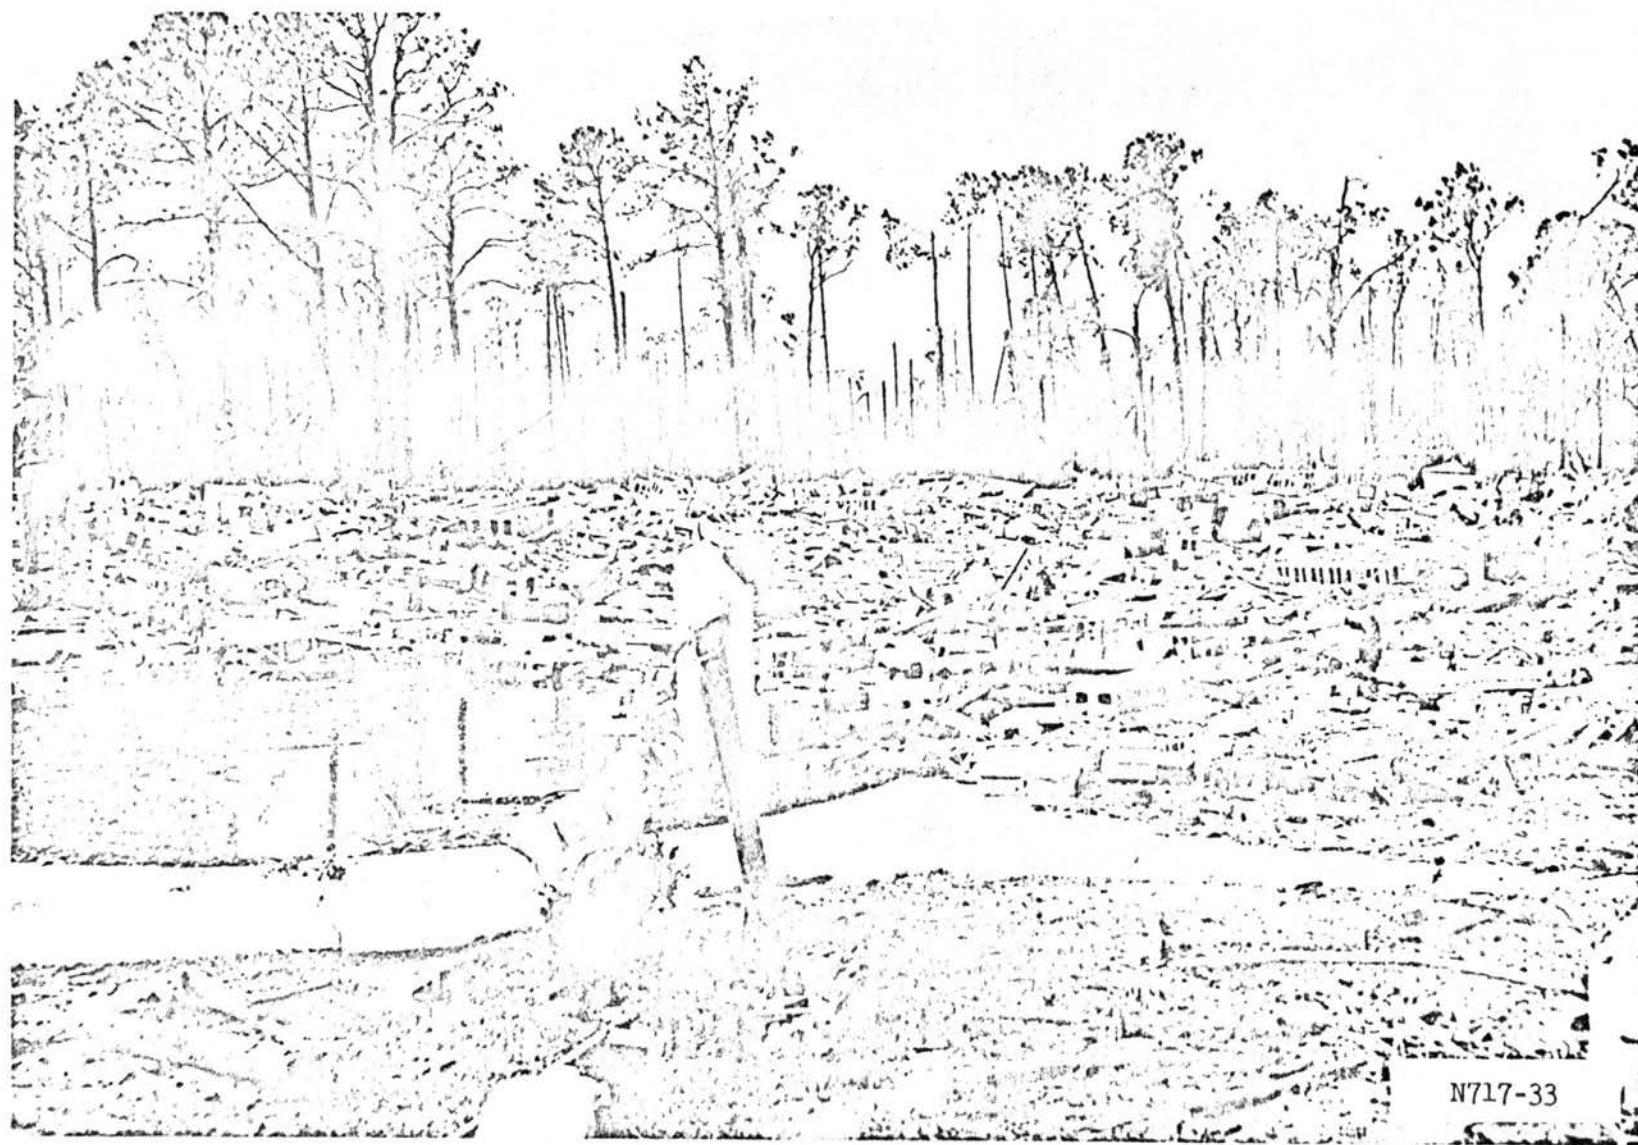
Figure 2.45 Gulf Villa Apartments, Long Beach area.

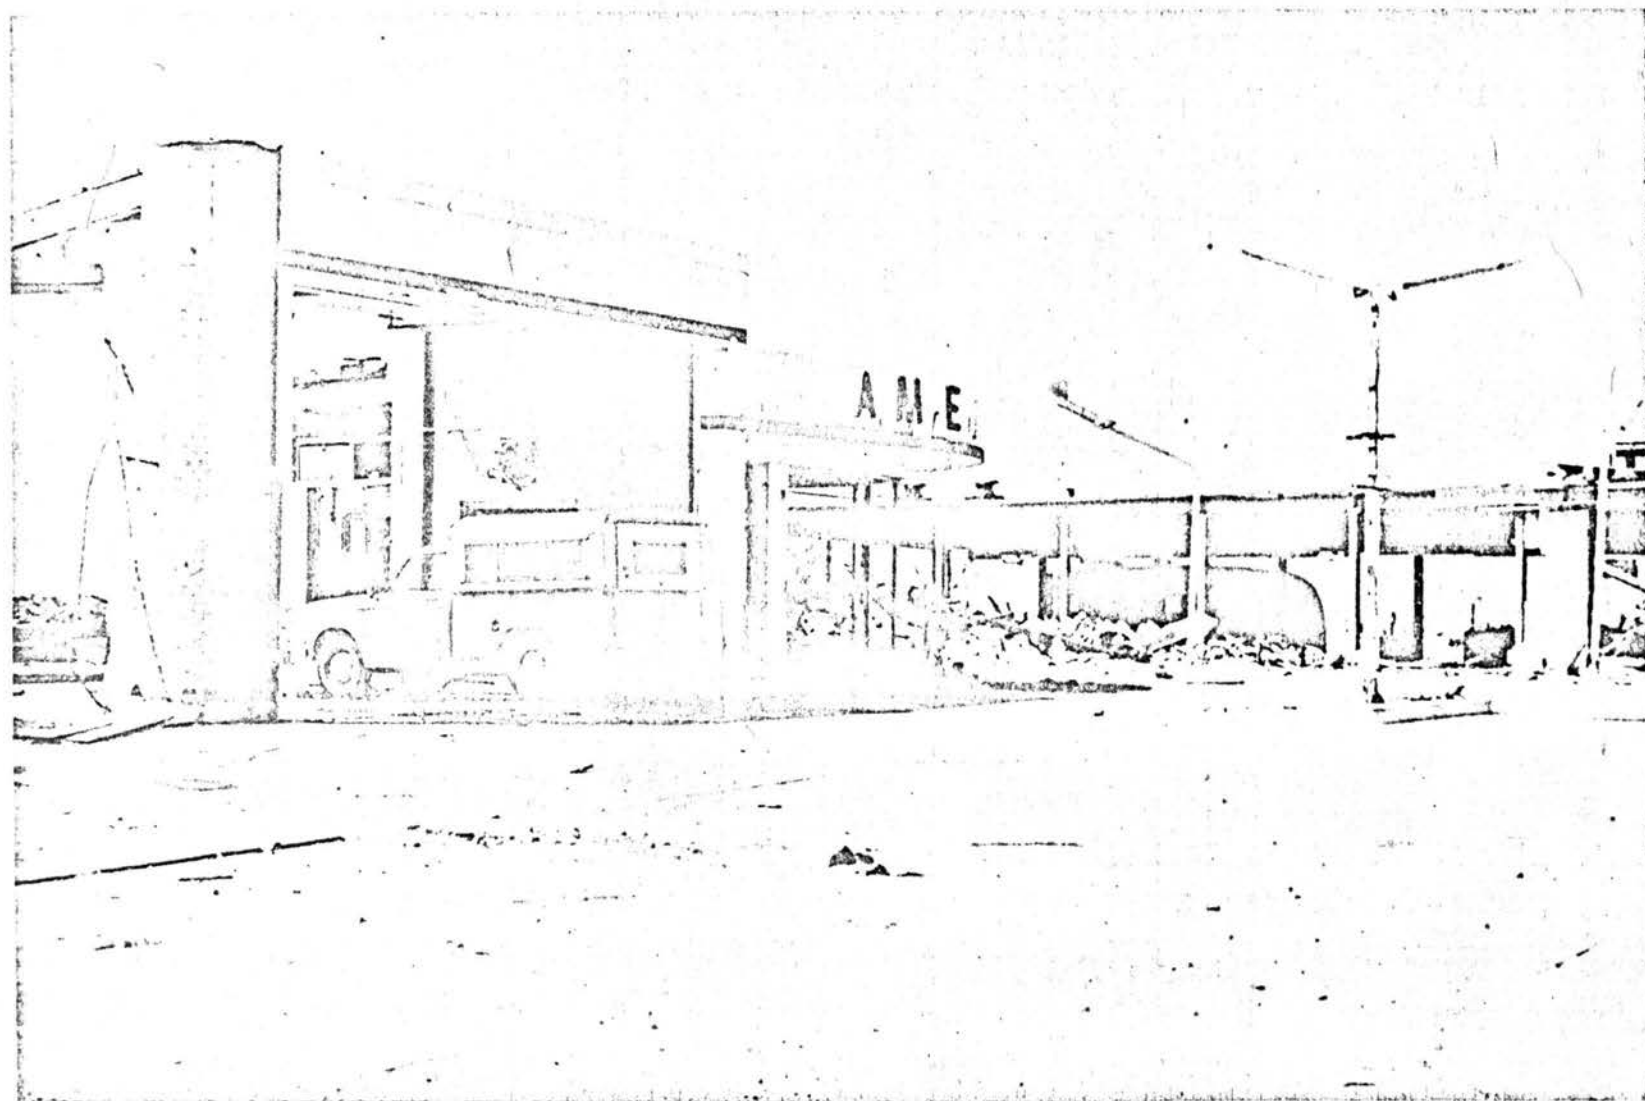
Figure 2.46 Service station, west Gulfport area.

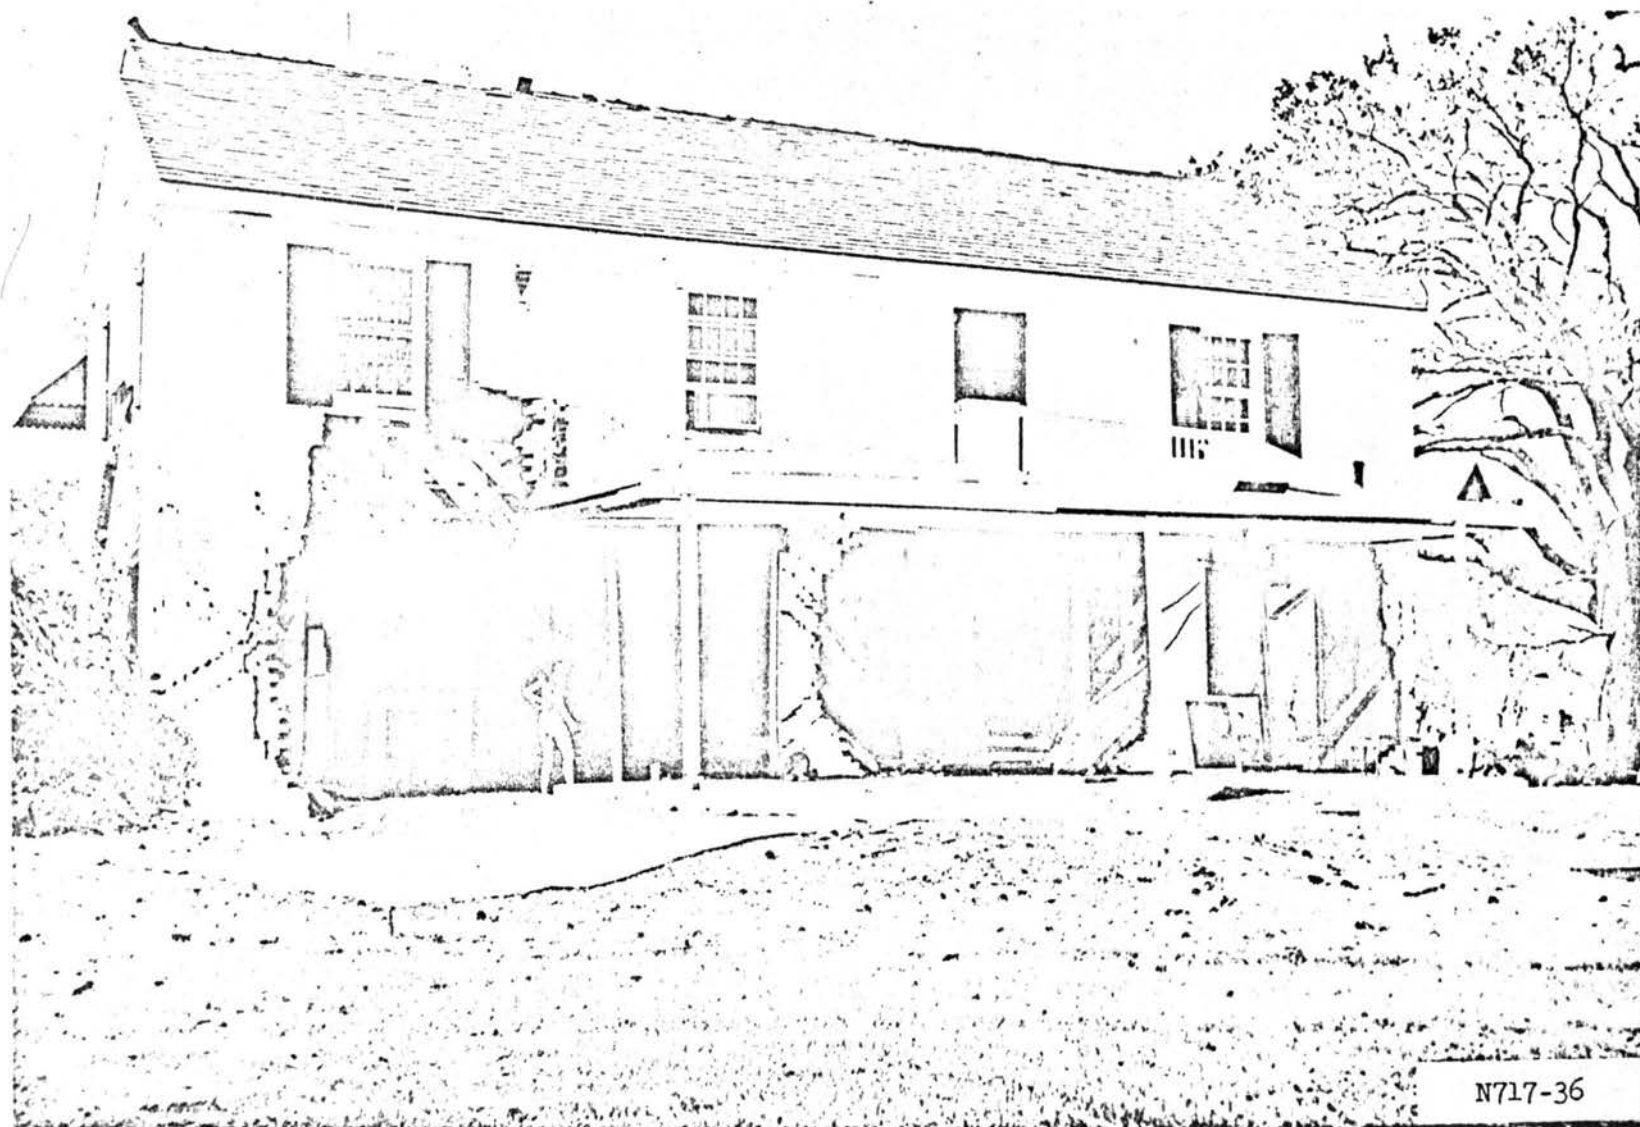
Figure 2.49 Residence, Long Beach, Mississippi.

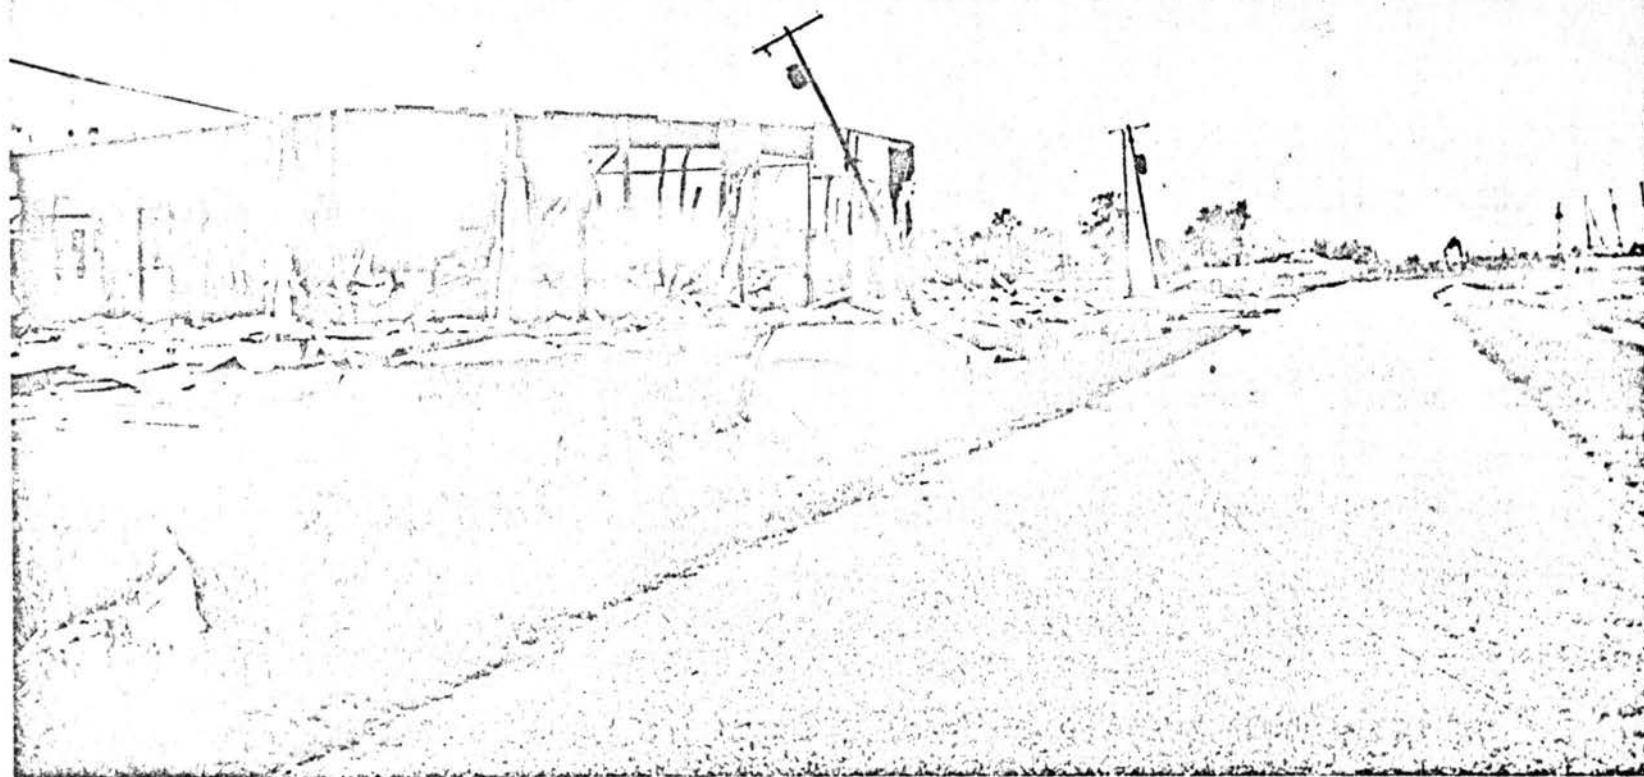
Along the coastline, the walls of most of these buildings failed before the frame itself, and the contents of the building were washed out. The bare frame was often left, sometimes with the steel columns noticeably out of plumb. Figure 2.50 shows a steel frame building in Gulfport. Some frames and portions of the roofs collapsed when bar joists supporting the roofs were not adequately connected at their ends.

Figure 2.50 Steel frame recreation hall, Jones Memorial Park, Gulfport.

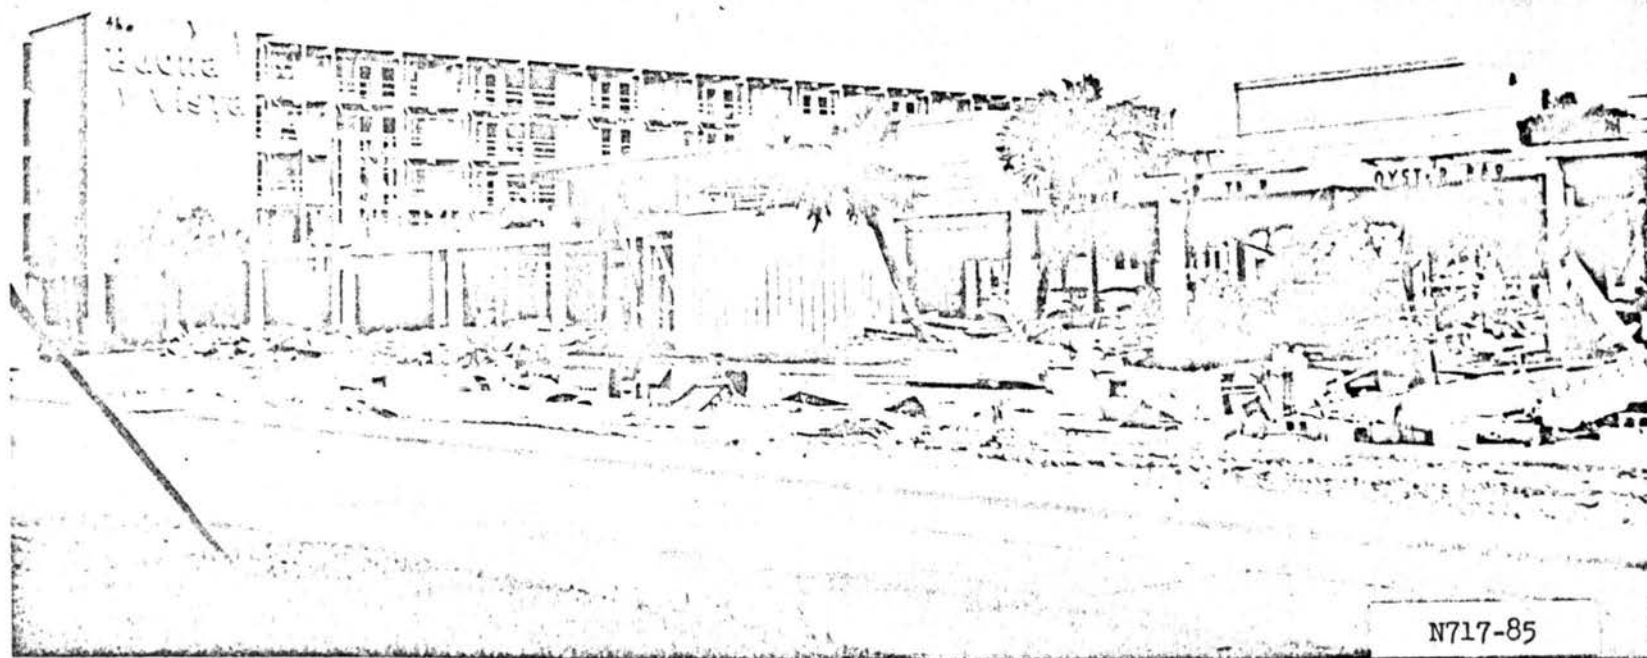
Figure 2.51 Frame restaurant structure, Biloxi, Mississippi.

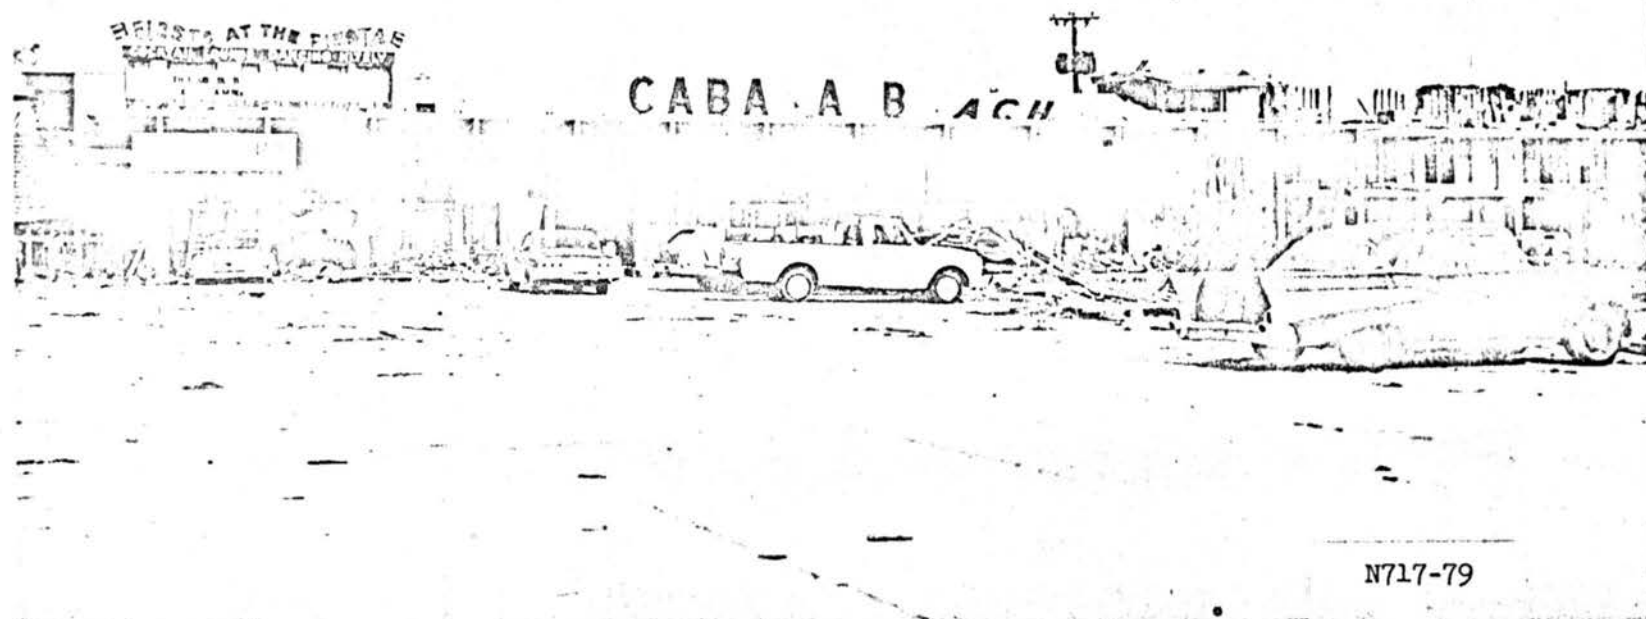
Figure 2.52 Frame motel structure, Biloxi, Mississippi. There had been fire damage before the storm to the building shown at the right.

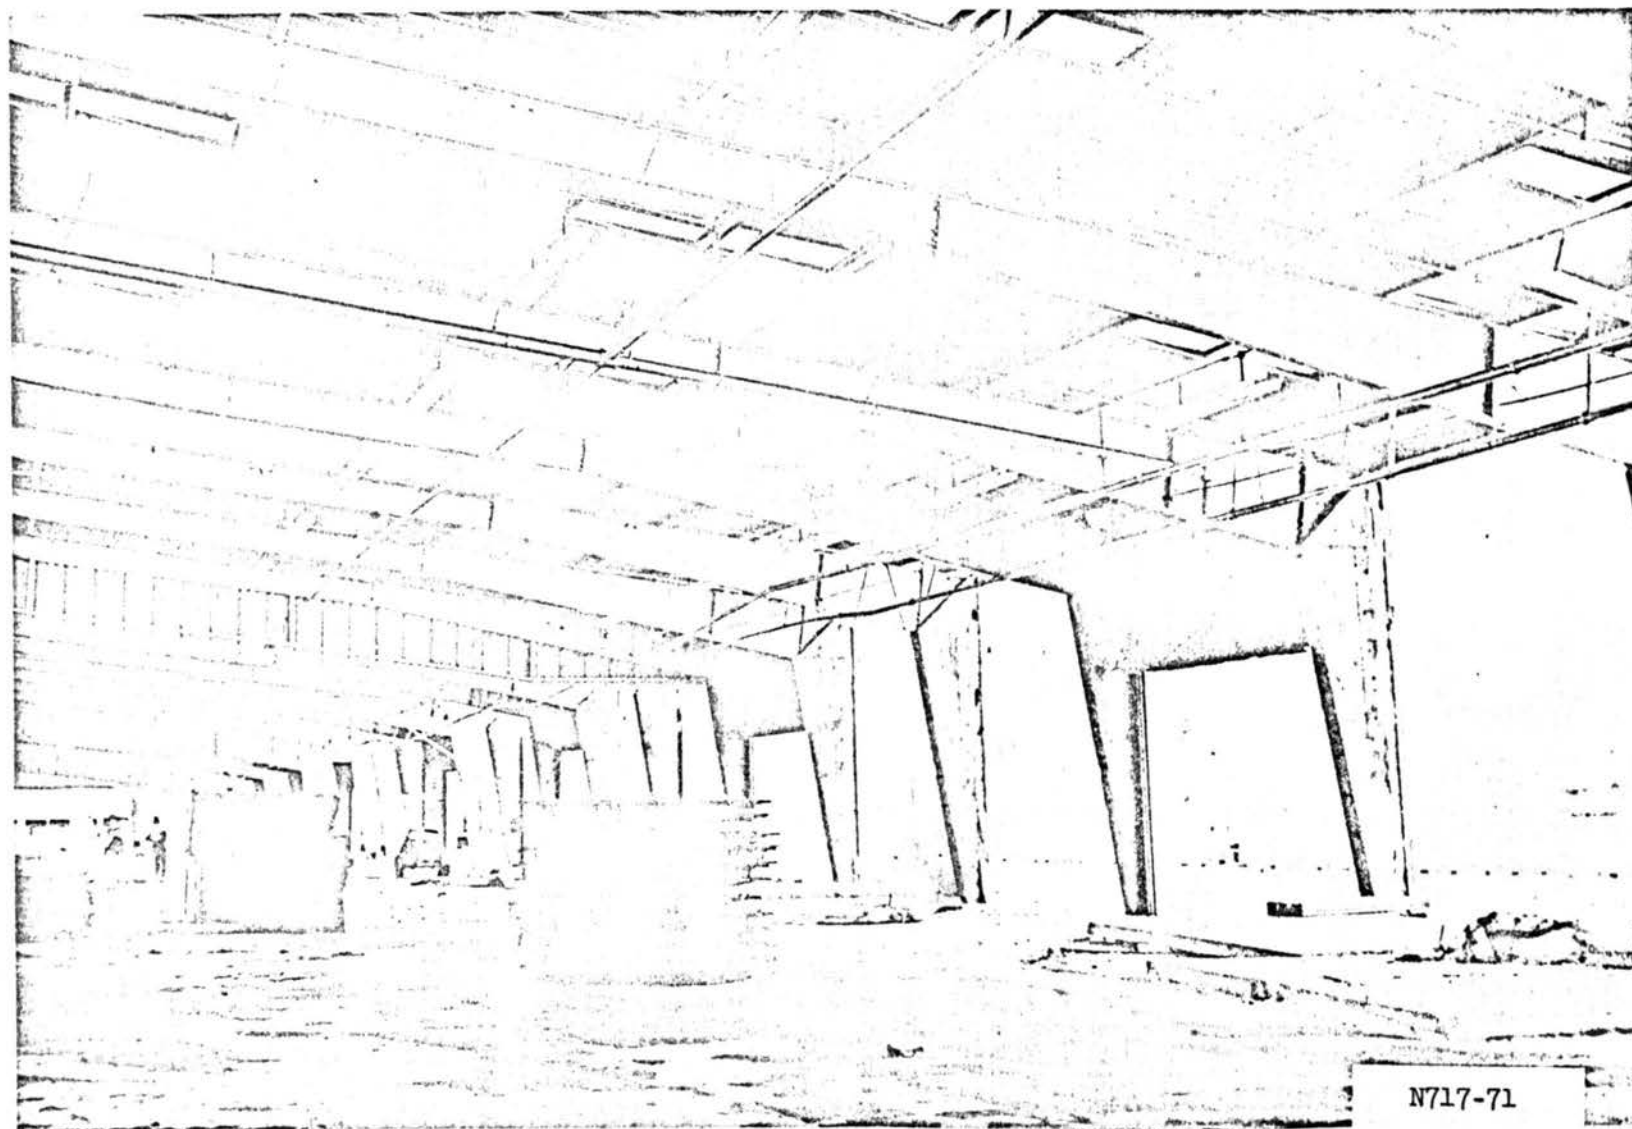
This building is a large clear span (span of about 125 feet) warehouse located at the southern tip of the Port of Gulfport. It is of rigid-frame construction with combination columns (steel sections encased in structural concrete) and with tilt-up concrete wall panels about 20 feet square by 6 inches thick and roll-up doors forming the walls. Light sheet metal purlins run along the length of the building and support a sheet metal roof. The columns appeared to have been cast in two steps, one to encase the steel section and the second to key in the tilt-up walls. The general construction is shown in Figures 3.1 and 3.2.

Figure 3.1 Close-up view of general construction of State Dock.

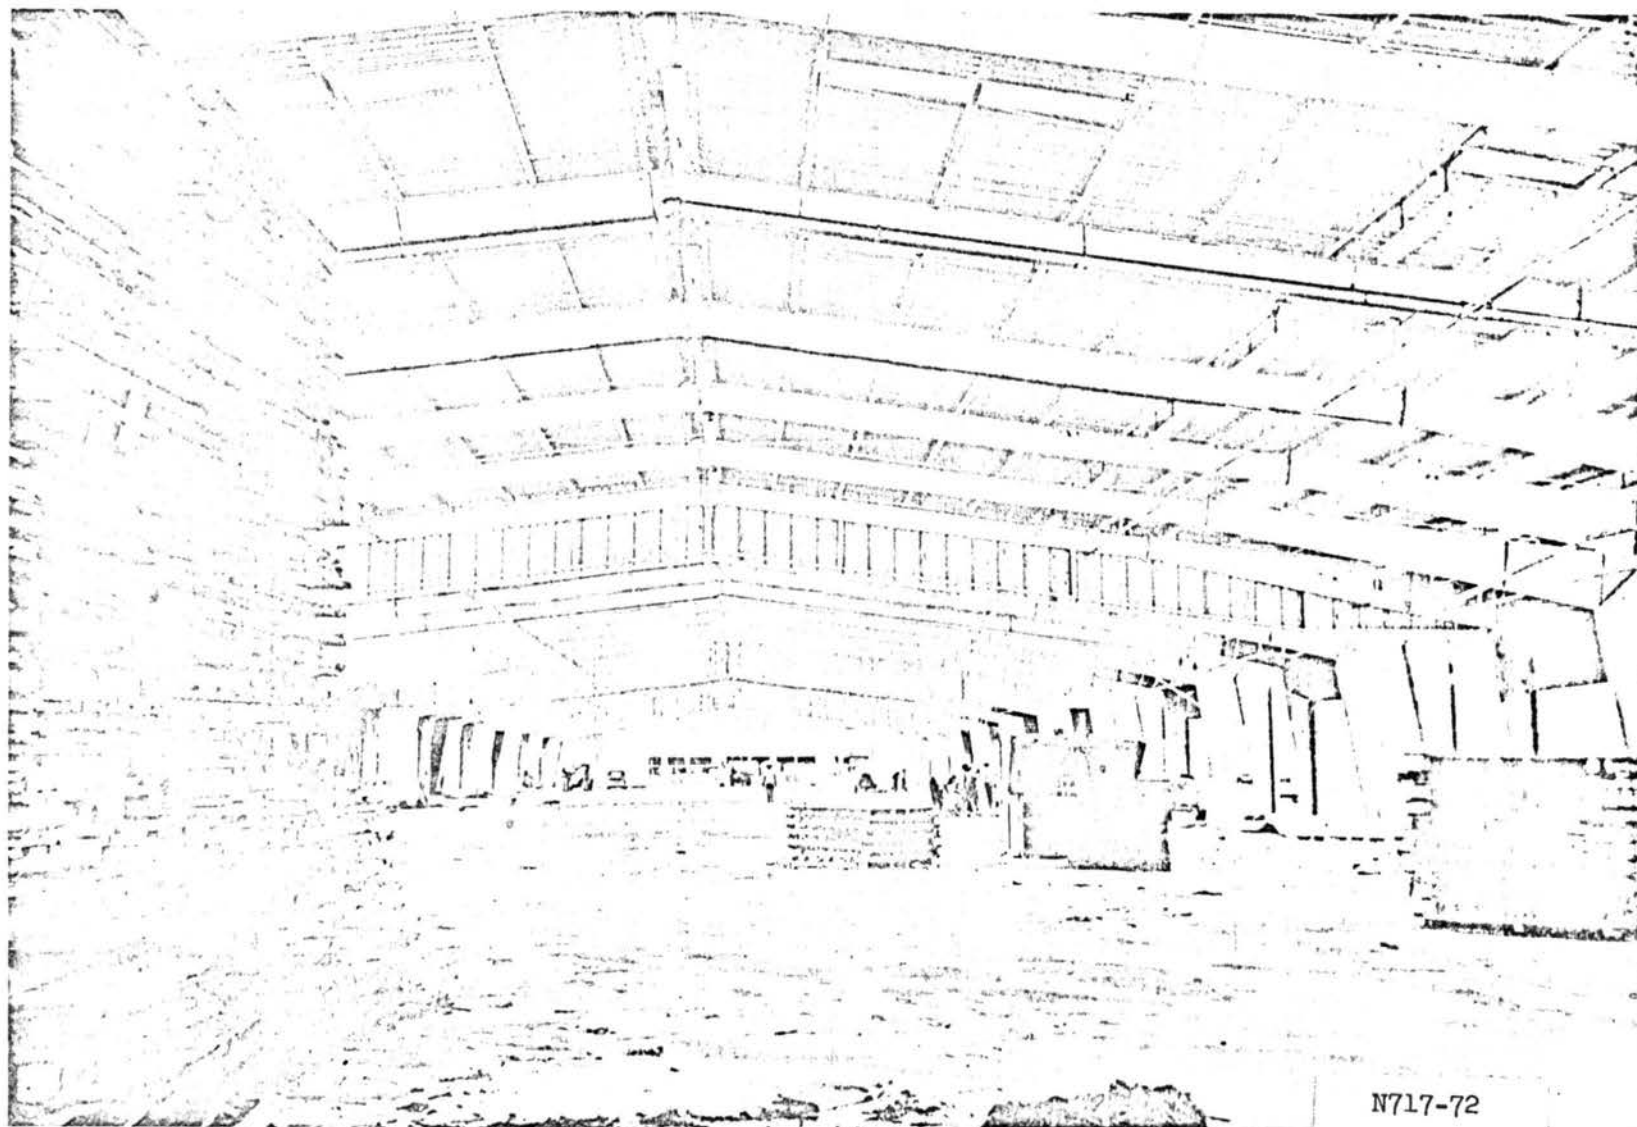
N717-72

Figure 3.2 General view of State Dock.

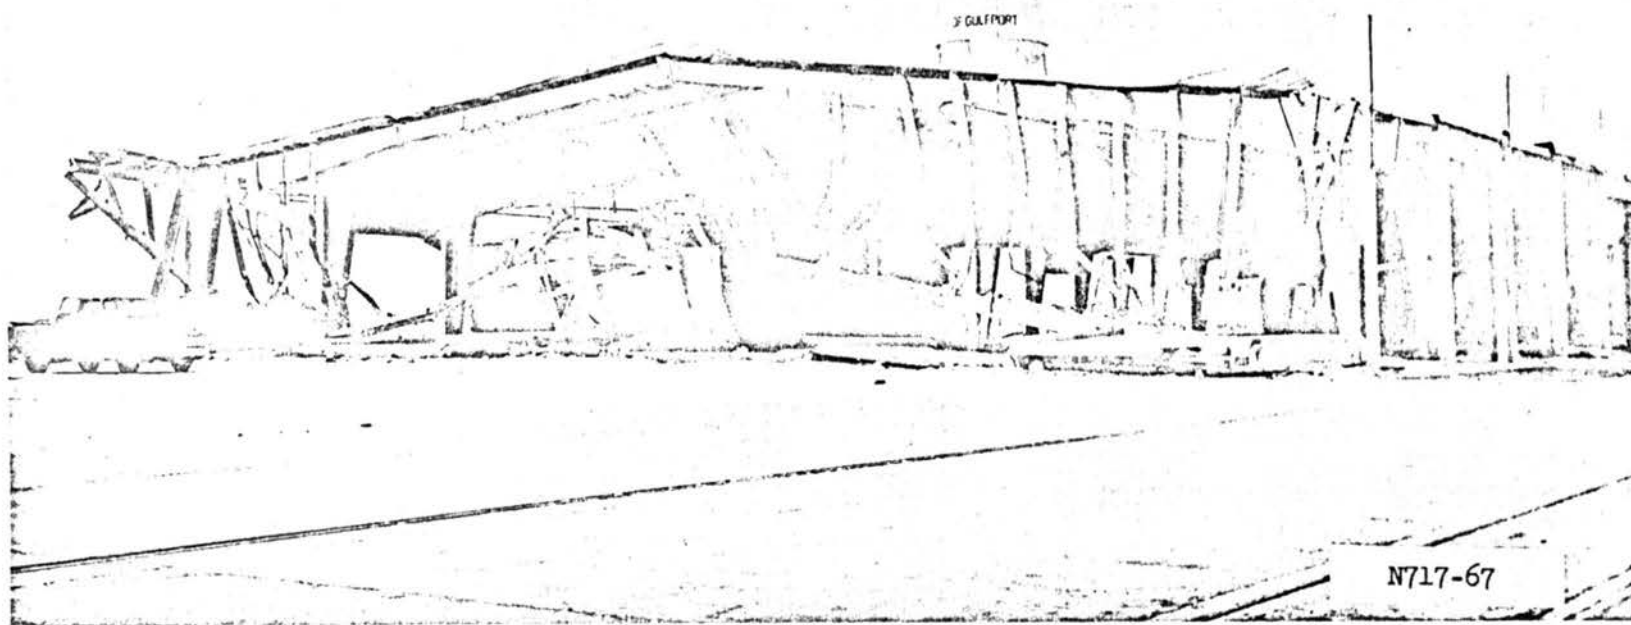
As shown in Figures 3.3 through 3.5, the end facing south-southeast and the first bent collapsed into the building with the tilt-up panels of this end wall falling with the columns. The tilt-up panels along the east side of the building were pushed into the structure, and those along the west side fell away from the structure. Like many other structures along the coast, this building was subjected to loadings far above those probably anticipated in their design.

The end wall probably received only small lateral support along its top from the small roof purlins and effectively functioned as a large slab simply supported at both ends and along the bottom. This structure could not resist the extremely large lateral loadings from the storm, probably failed first near the top center, and fell into the building.

Figure 3.3 Collapsed end wall of State Dock.
