TECHNICAL REPORT N-70-10

SURVEY OF GULF COAST  
STRUCTURAL DAMAGE RESULTING FROM  
HURRICANE CAMILLE, AUGUST 1969

M. E. Criswell, R. S. Cummins

April 1970

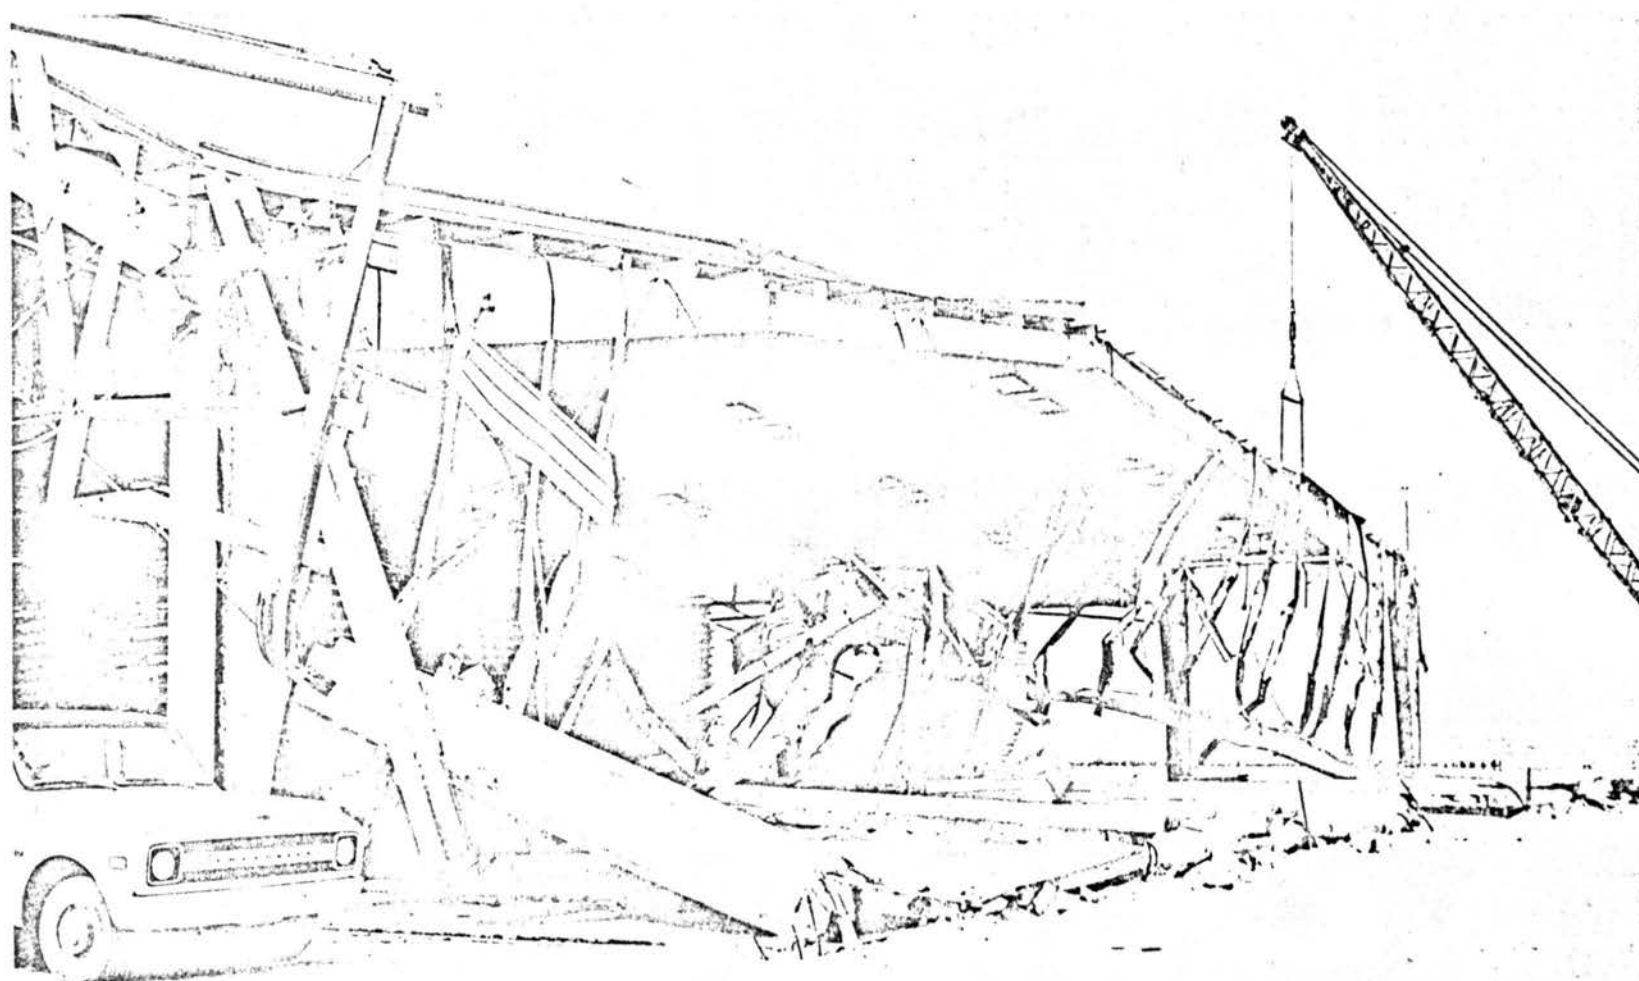
N717-74

As shown in Figures 3.3 through 3.5, the end facing south-southeast and the first bent collapsed into the building with the tilt-up panels of this end wall falling with the columns. The tilt-up panels along the east side of the building were pushed into the structure, and those along the west side fell away from the structure. Like many other structures along the coast, this building was subjected to loadings far above those probably anticipated in their design.

Figure 3.4 Close-up view of collapsed end wall of State Dock.

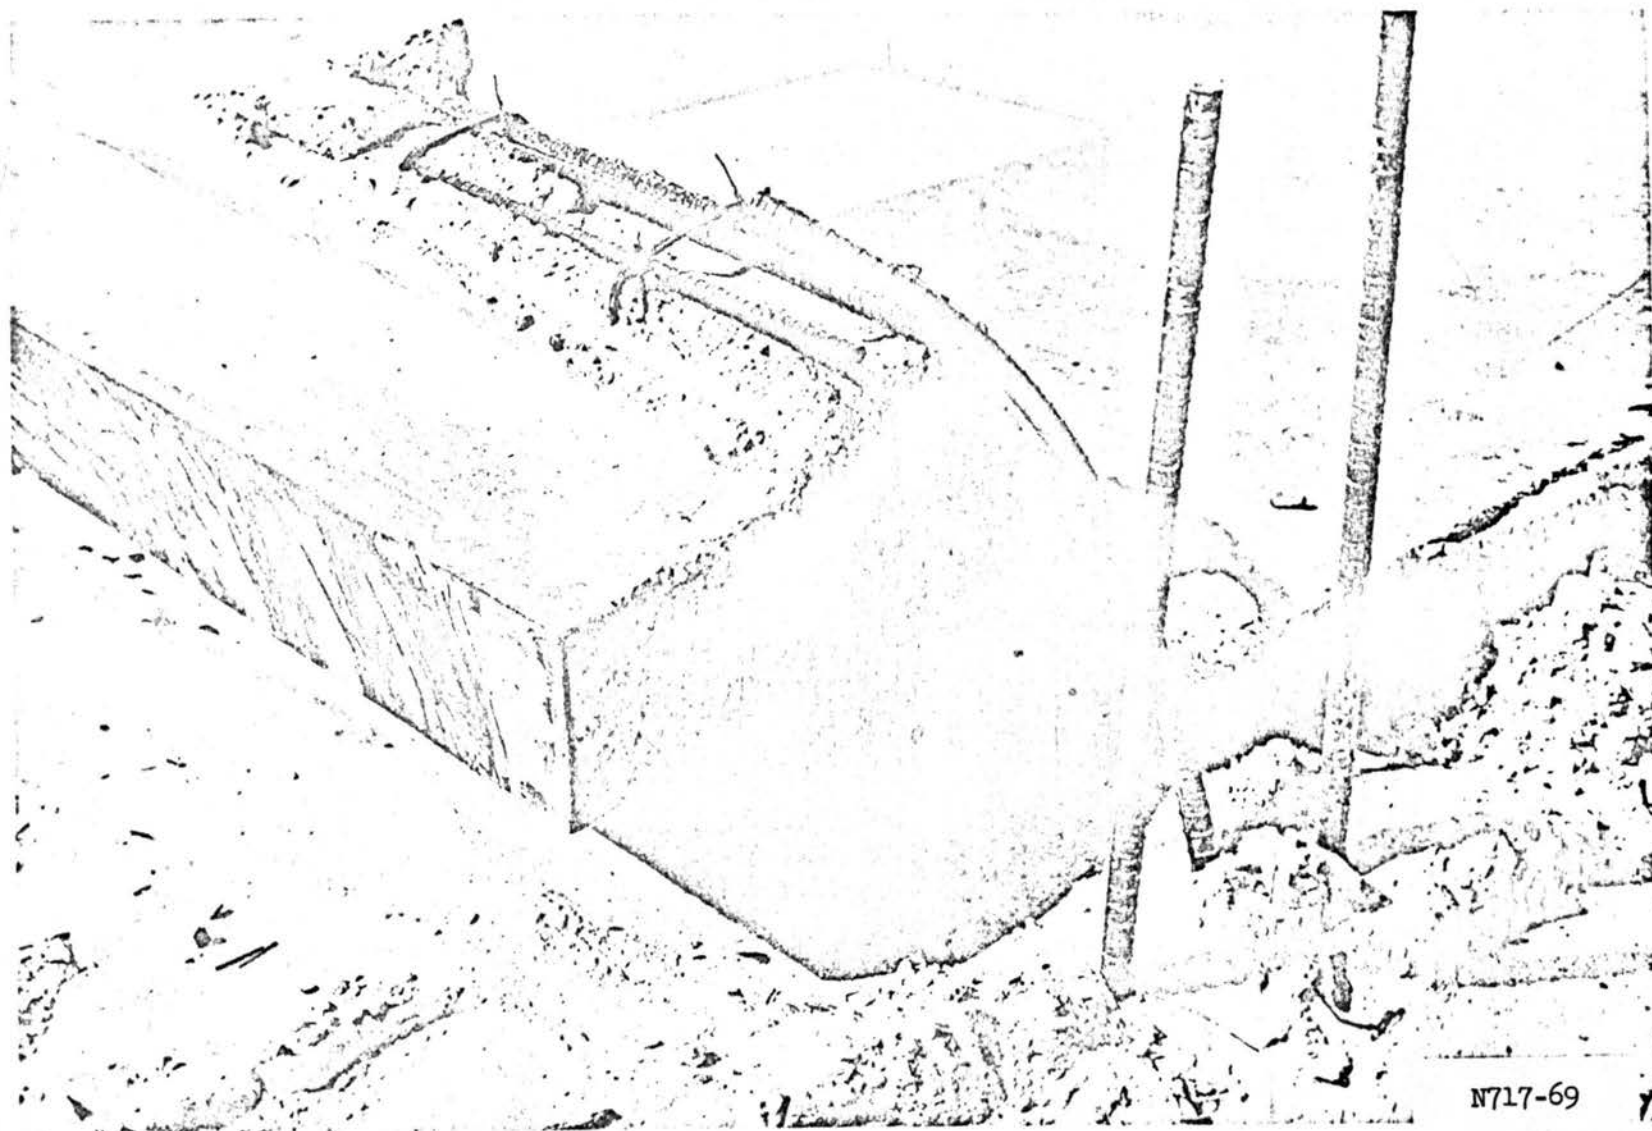
N717-69

Dowels in at least one column were placed outside of the reinforcing cage and were able to break out of the column without even bending (Figure 3.9). Cold joints were found at the base of some columns. Only one broken reinforcing bar was seen at the column bases along the collapsed end wall.

Figure 3.9 Dowels at base of end-wall column, State Dock.

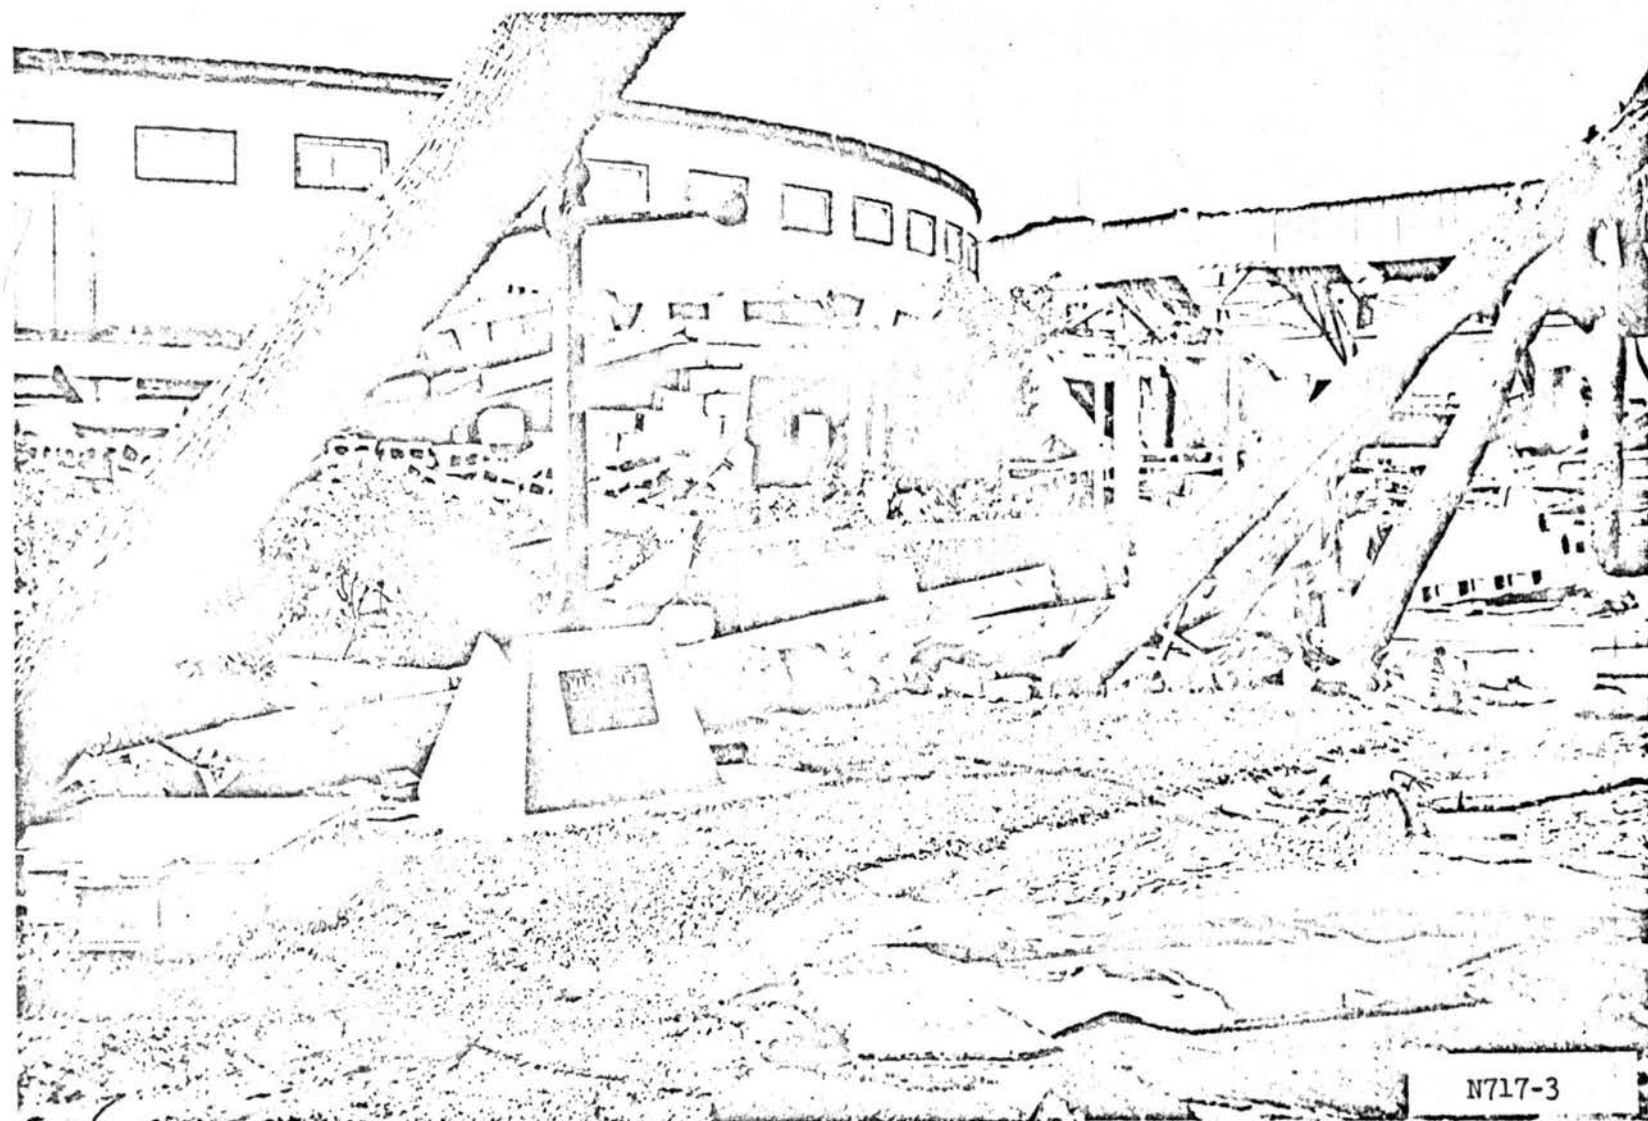
Marine Life consisted of a group of various structures (Figure 3.12). A large steel arch which this team was told was designed for 120-mph winds sheltered a display tank and a concrete seating area. A small (30 to 50 spaces) NFSS shelter was located under this seating area. A concrete floor and block wall structure surrounded the large display tank to the east of the arch.

Figure 3.12 Marine Life Aquarium.

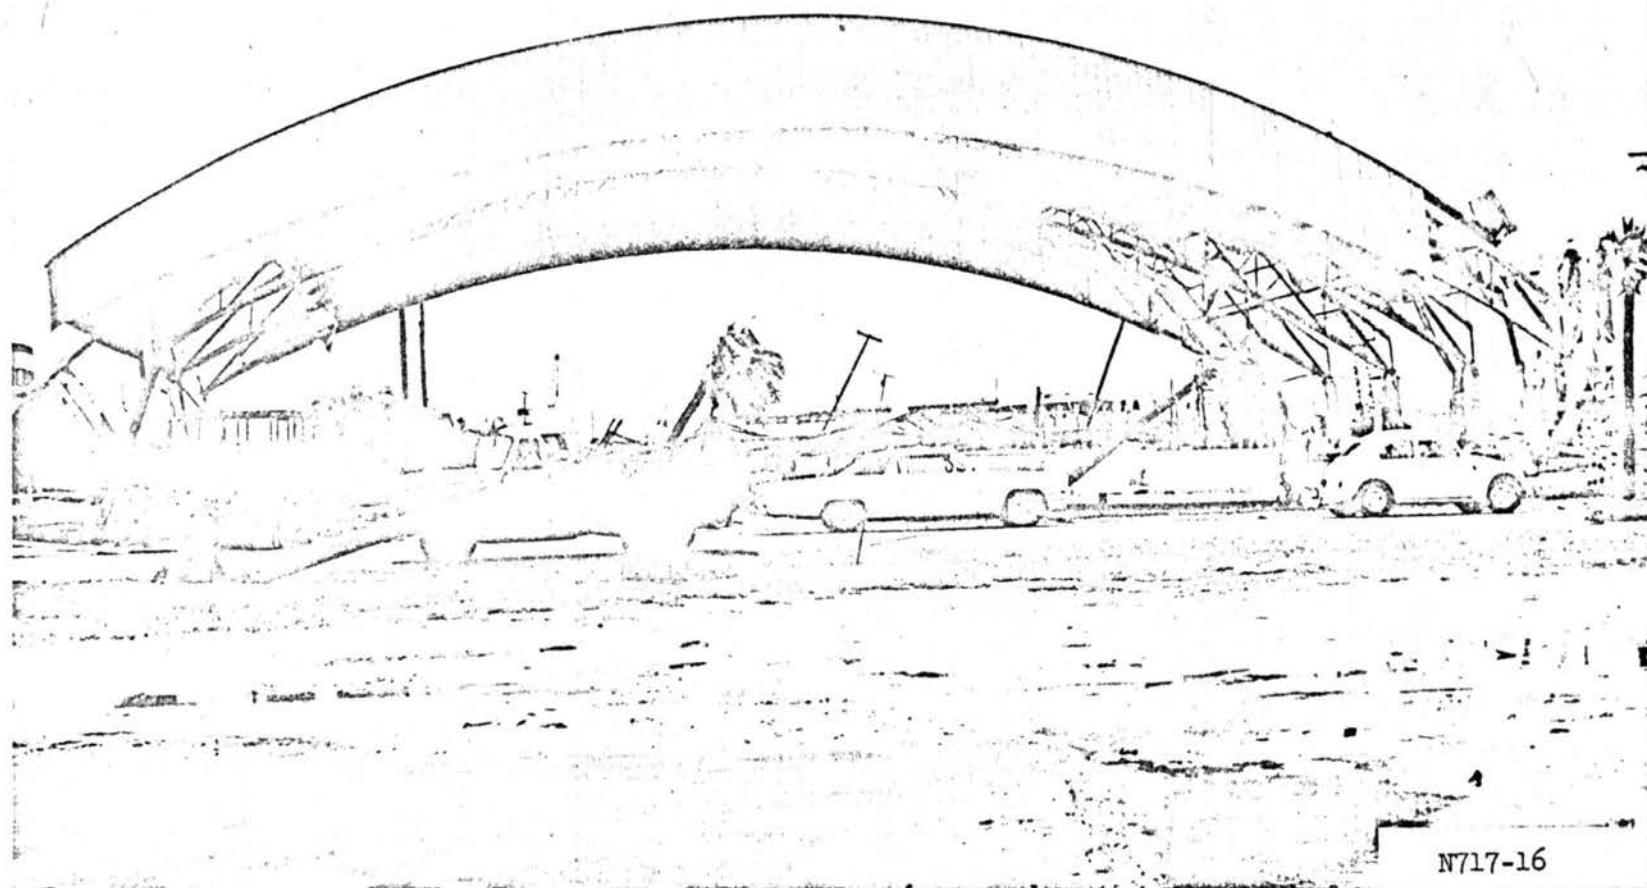
The steel arch remained standing despite the loss of two pipe column supports at the northeast corner (corner nearest the camera and to the left in Figure 3.13) and the dropping of the other three columns on the east side. Some roofing was torn off the west side of the arch (Figure 3.14). The middle pier supporting the west end of the arch was badly damaged

Figure 3.13 Marine Life steel arch.

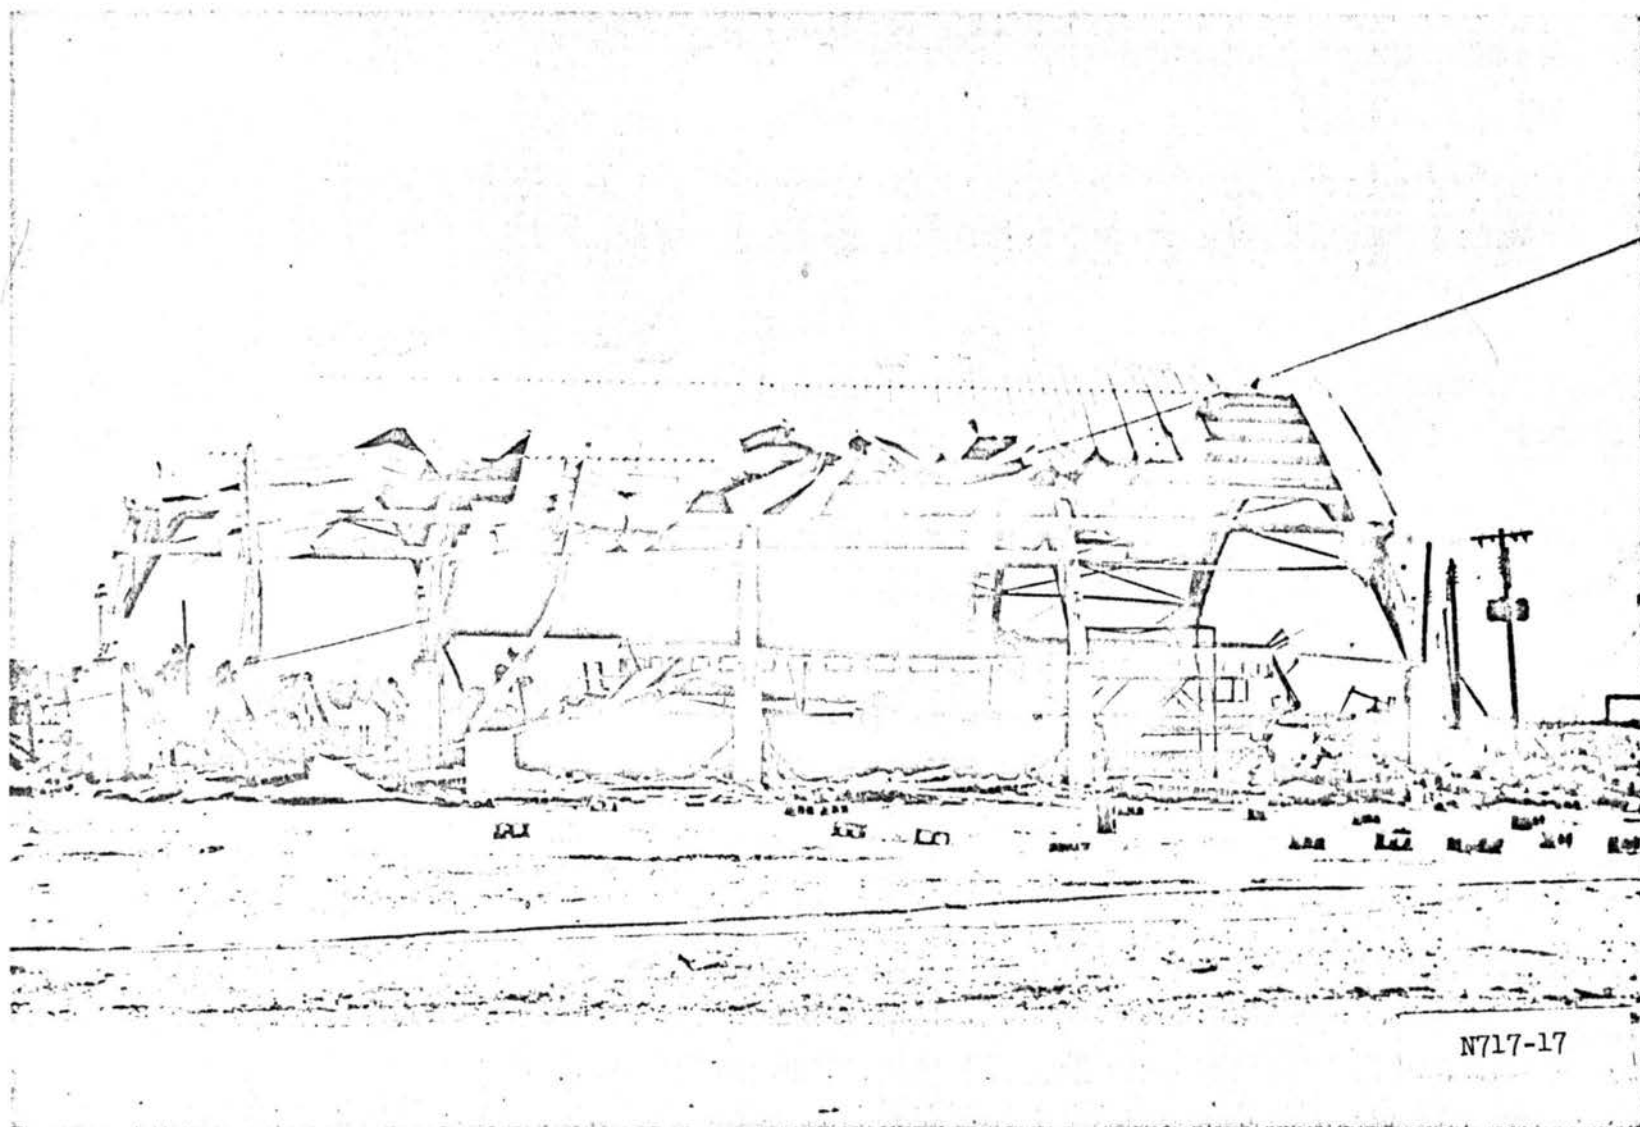
Figure 3.14 Marine Life arch.

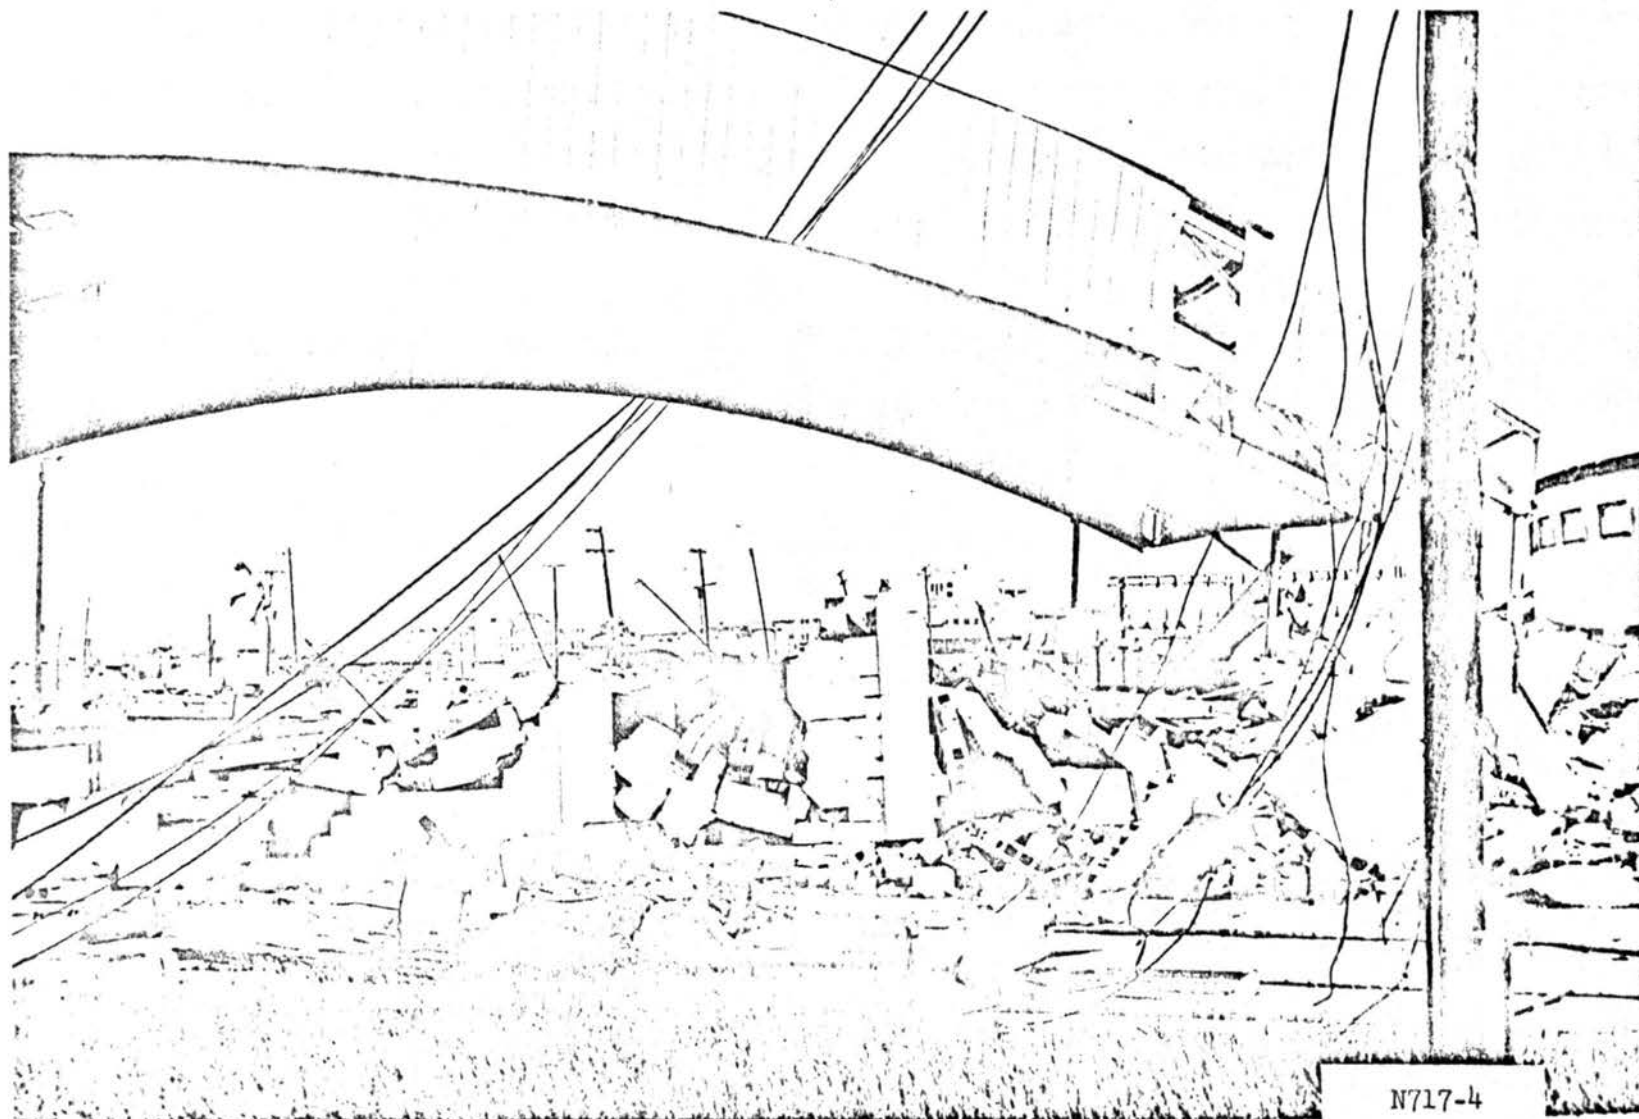
N717-4

The approximate maximum water wave level during Hurricane Camille is the top of the bent cladding on the arch (see Figure 3.16).

Figure 3.16 Southeast corner of Marine Life arch.

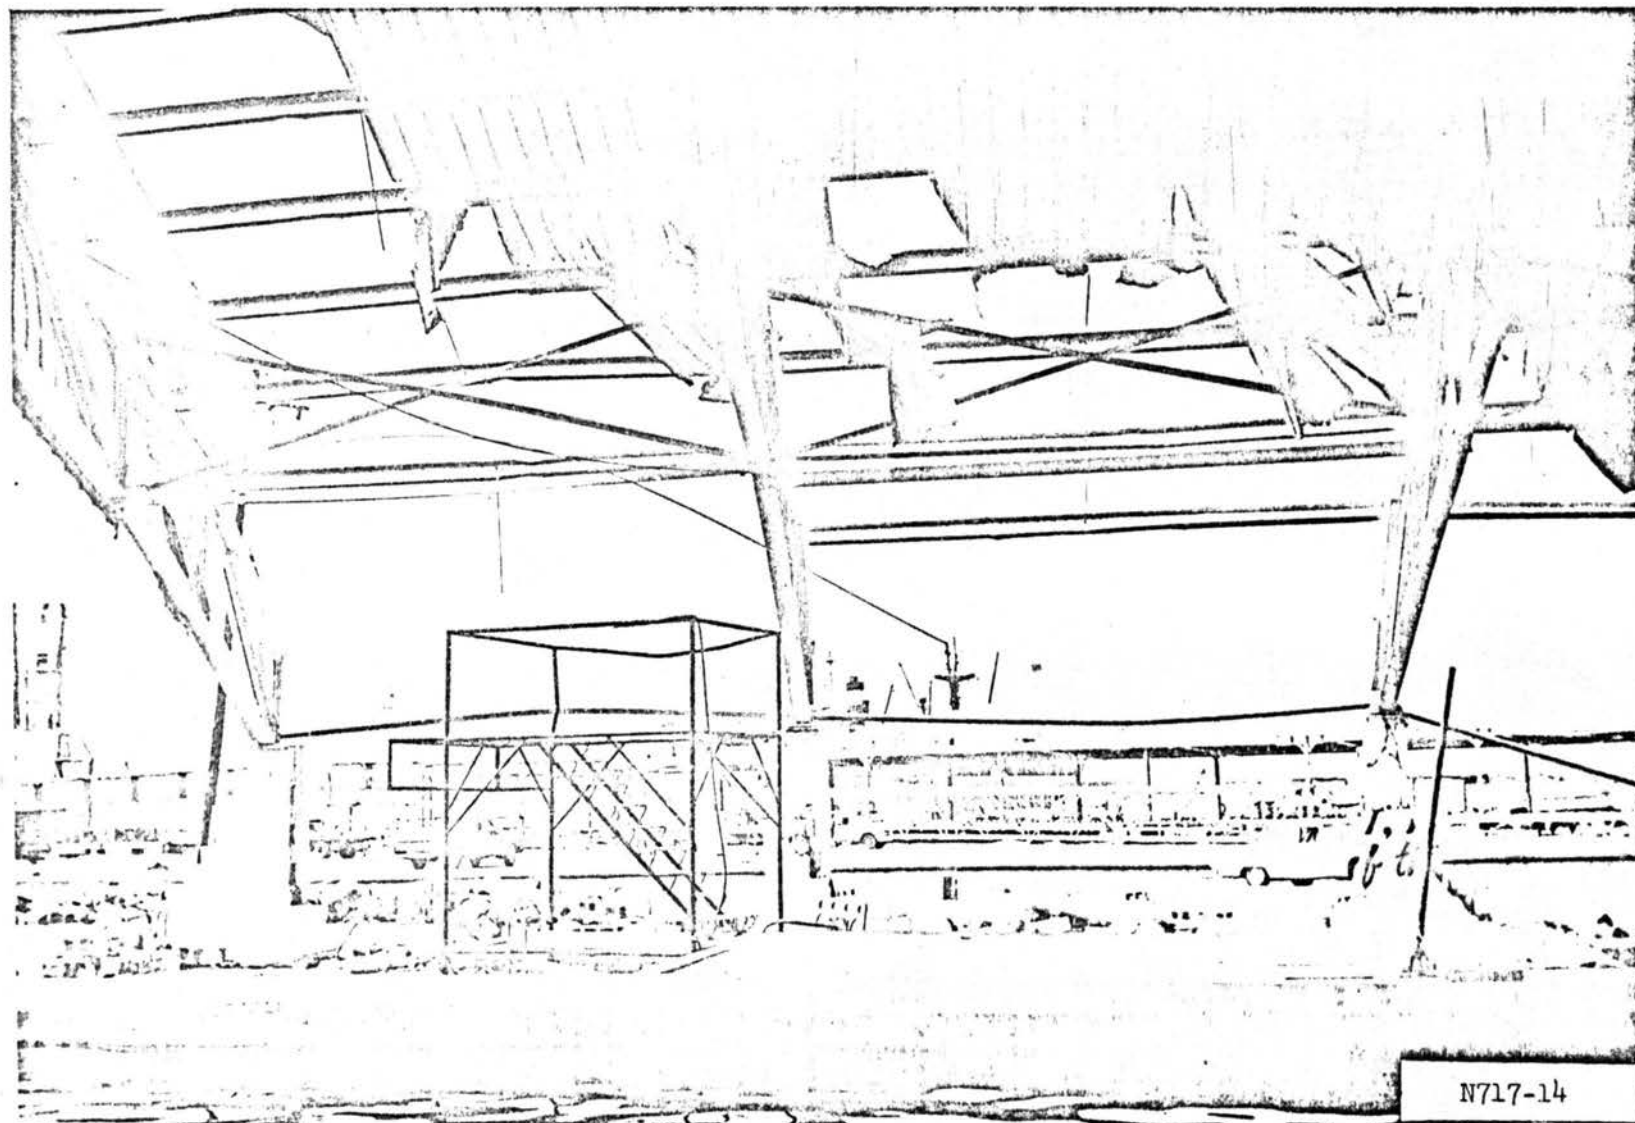
The block wall along the west side of the arch was almost completely destroyed (Figure 3.17).

Figure 3.17 West end of Marine Life arch.

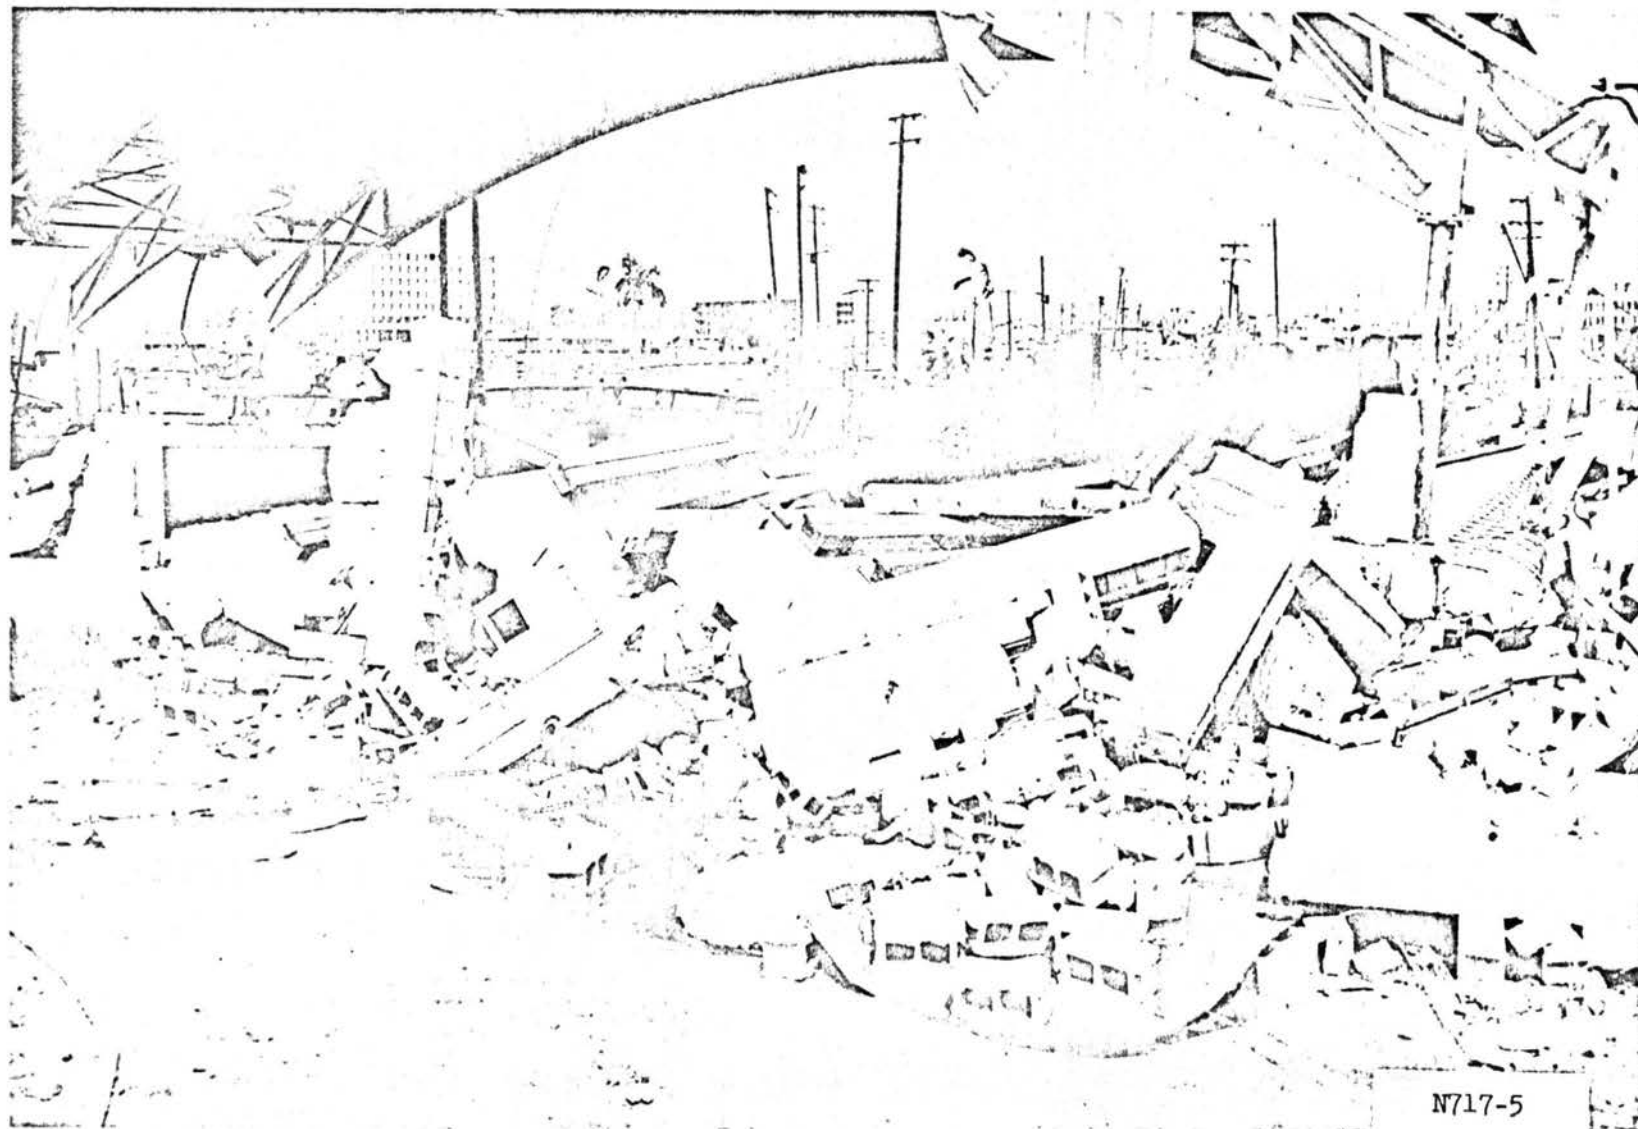
N717-5

This seating area under the east side of the arch was completely collapsed (Figures 3.18 and 3.19). The seating area appeared to have failed when the water lifted the seating and dropped it onto the walls crushing some block and failing the beams of the seating portion at the supporting walls, thus transforming the beams into essentially simply supported spans which then fell (Figures 3.20 through 3.22). It was not clear whether these beams had been designed for continuity; the steel arrangement, but not the splice length, suggests that they were.

Figure 3.18 Seating area under Marine Life arch.

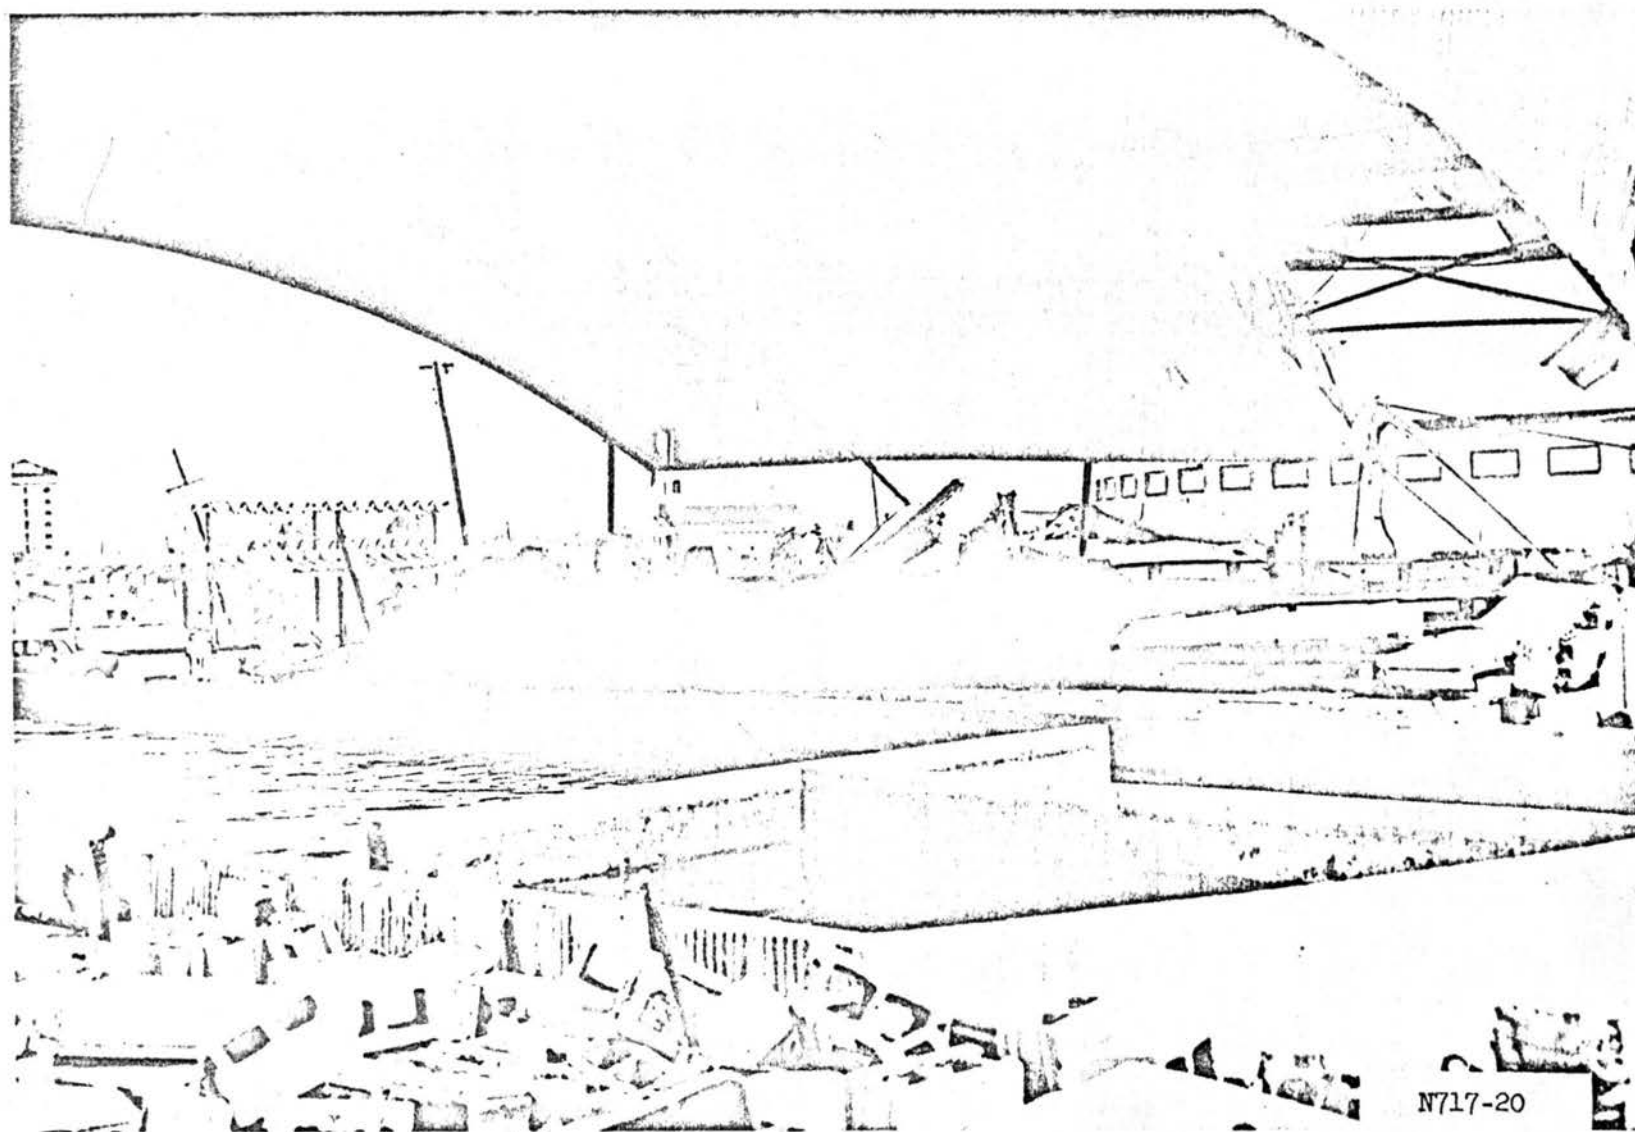
N717-20

Figure 3.19 Seating area and arch at Marine Life.
