FOREST STEWARDSHIP PLAN

**Horsetooth Tract
Colorado State University Research Foundation
PO Box 483
Fort Collins, CO 80522
970-482-2916**

**Prepared by:
Jamie M. Dahl
Fort Collins District
Colorado State Forest Service
Foothills Campus, Building 1052, CSU
Fort Collins, Colorado 80523-5075
(970) 491-8660**

September 2010

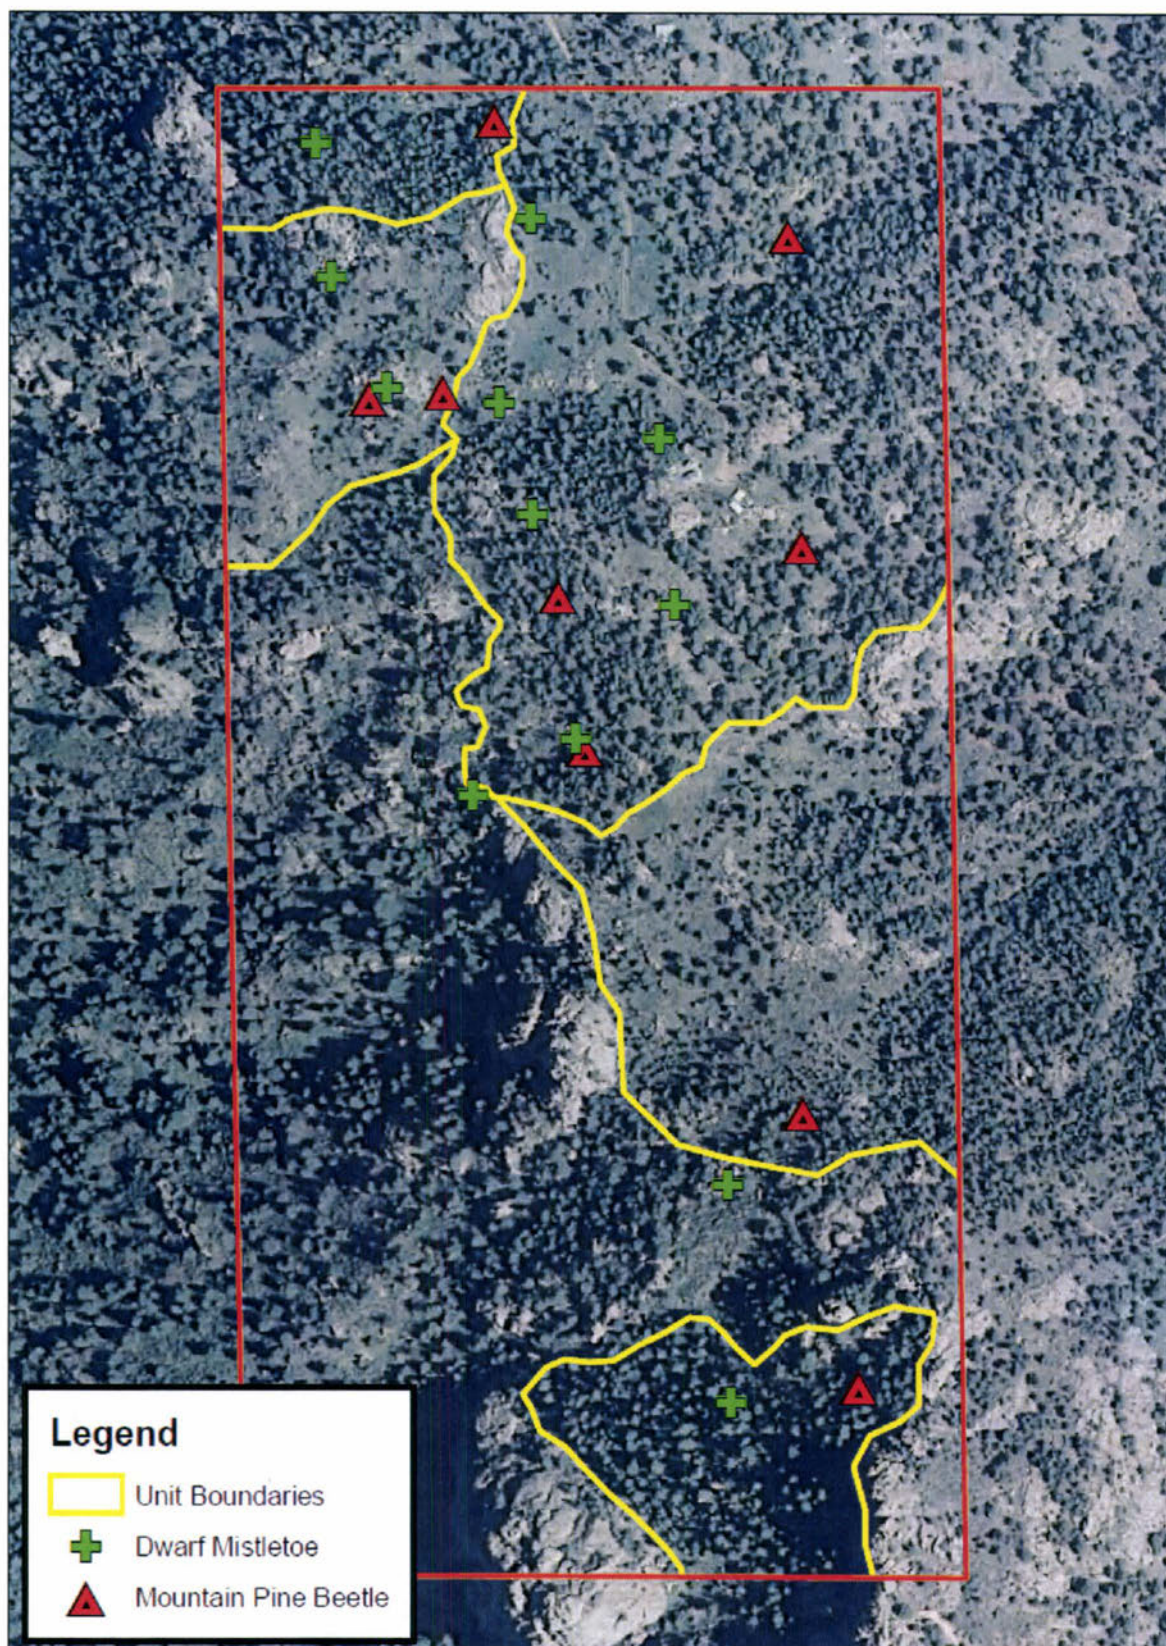
Map 3: Horsetooth Tract, 80 Acre, Insects and Disease

Dead trees may begin to fall 5-15 years after mortality, and possibly even earlier. Some dead trees with old beetle infestations where the beetles have already flown from the trees may be left for wildlife uses. However, if there are a significant number of these trees they should be removed to reduce the wildfire hazard. The property should be monitored yearly for further activity.

Dwarf mistletoe spreads through seed distribution. Seeds travel 30 feet on average to reach and infect a tree. It is recommended that all pine trees within 50 or more feet inside the perimeter of the area of infection be removed. A 50 foot buffer area will help contain the infestation until the entire area can be treated; however this may not be feasible given the aggressiveness of the parasite on this property. Pruning infested branches and/or planting resistant species are alternative options, though they are much less feasible on a large scale. Refer to the individual management units for the presence and treatment of the dwarf mistletoe. Focus on the areas where dwarf mistletoe is most aggressive and continue to monitor for dwarf mistletoe throughout the property. Refer to Appendix G for more information on detection and biology of dwarf mistletoe.

In addition to treating infested wood, there are a few things you can do to increase the chance of survival for currently un-infested trees. Thinning is often recommended. This reduces competition for resources between the trees allowing them to stay healthy and thus less attractive to bark beetles, and more likely to pitch beetles out if they are attacked. See the individual Management Units for thinning recommendations. Also, do not stack firewood or pile slash (branches and tree removal waste) against live trees. This attracts the beetles to those trees. Chipping or lopping and scattering are the best ways to deal with slash so it is the least attractive to beetles. Also, watch for flying beetles or fresh beetle attacks when cutting between July 1st and September 1st, since the mountain pine beetle flight occurs during this time. Lastly, there are preventive sprays available for your most susceptible and highest value trees. For more information on identification, treatment, and prevention of mountain pine beetle see Appendix G.

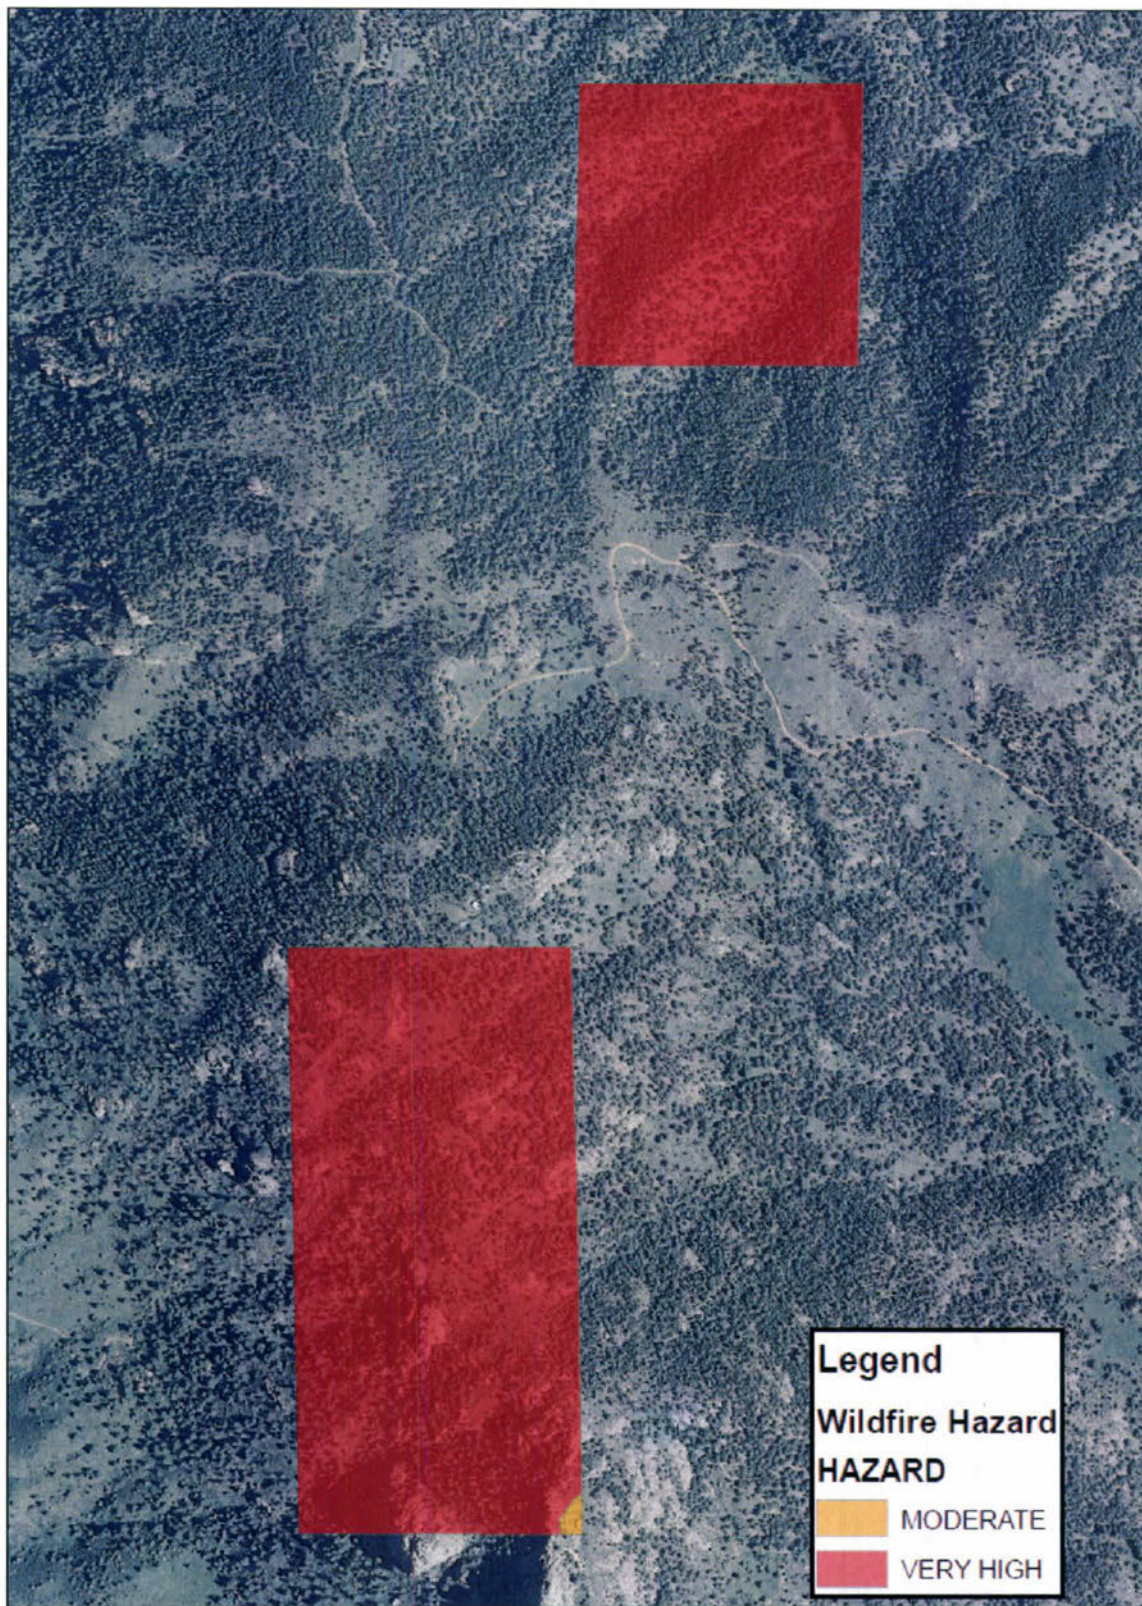
Map 5: Horsetooth Tract Wildfire Hazard

Wildfire hazard on this property is mapped from moderate to very high hazard (see Map 5). These hazards are mapped based on the expected fire behavior which is determined by vegetative cover type and habitat structural stage. However, if the aspect is south or southwest, and/or if the slope is greater than 30 percent, increase the hazard class one category. Also, if slash is present and in significant quantities, increase the hazard class one category. Most of the Horsetooth Tract is mapped as very high fire hazard.

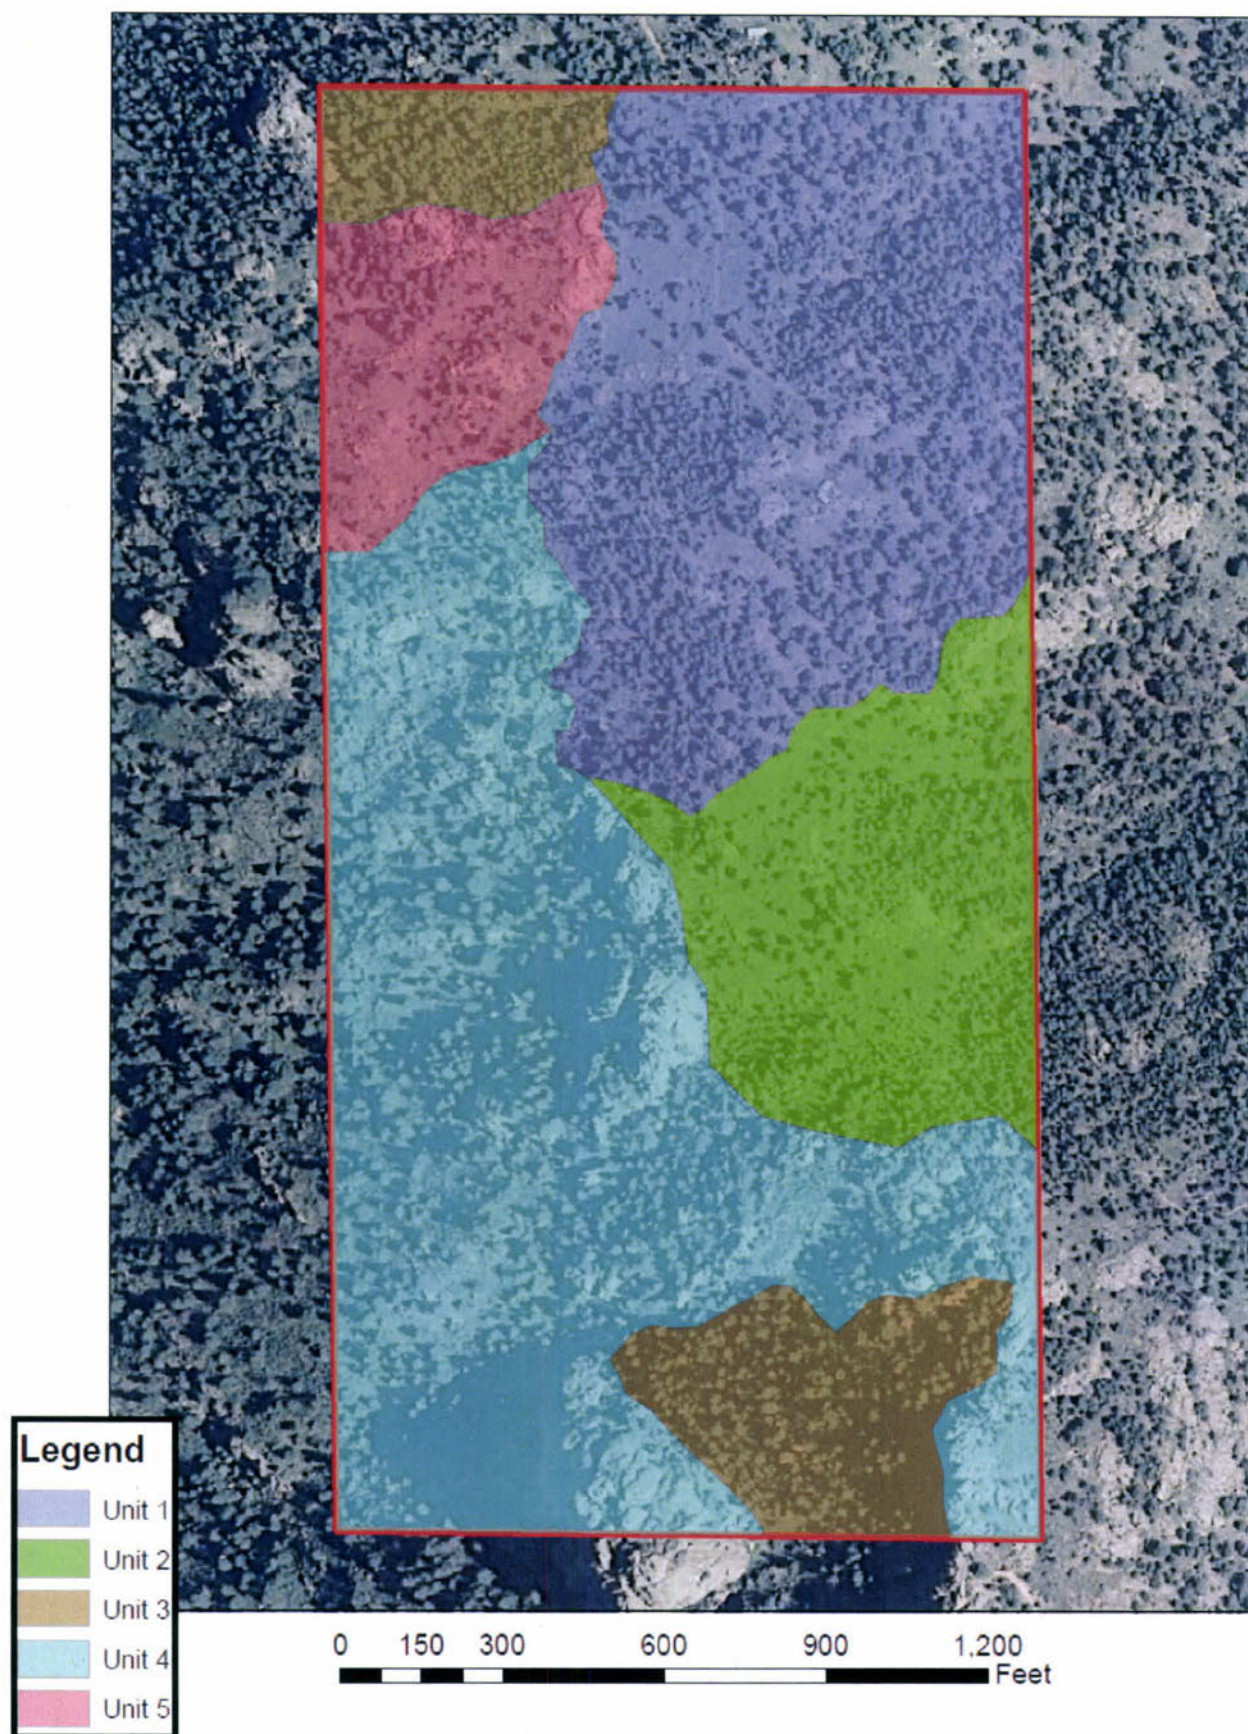
Map 7: CSU Horsetooth Management Units

Map 7 illustrates the management units in the 80 acre piece of Horsetooth Tract and Map 8 shows the units in the Mill Creek area. These 7 units will be described in the following section. The statistics given are for trees that are 3" DBH or greater unless otherwise noted. Thinning and/or fuels reduction treatments that have occurred over the past 10 years within a unit will be noted, as well as any future management needs.

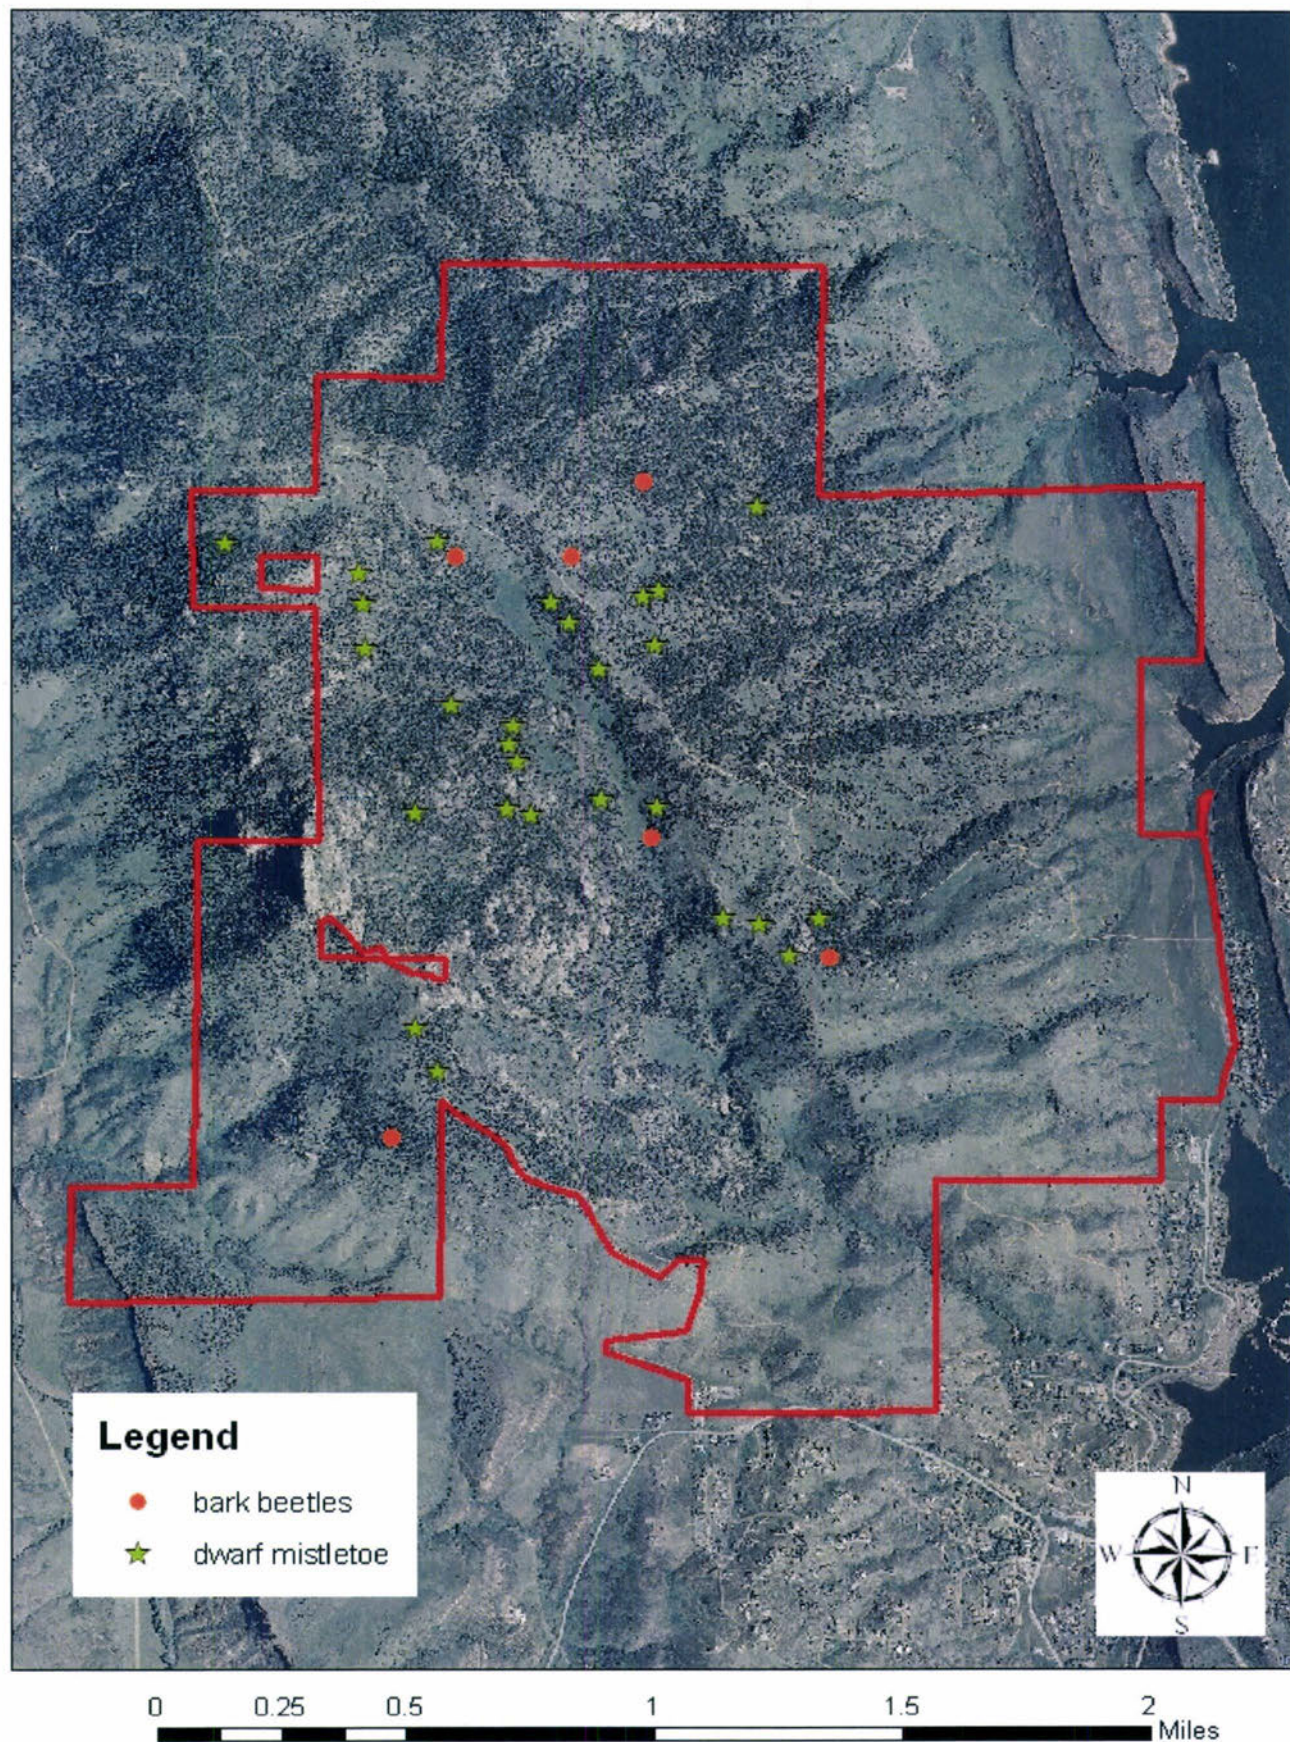
Map 3. Insects and Disease

Refer to Map 3 for locations of beetle and dwarf mistletoe infestations centers. Additional information on common forest insects and disease can be found in Appendix G.

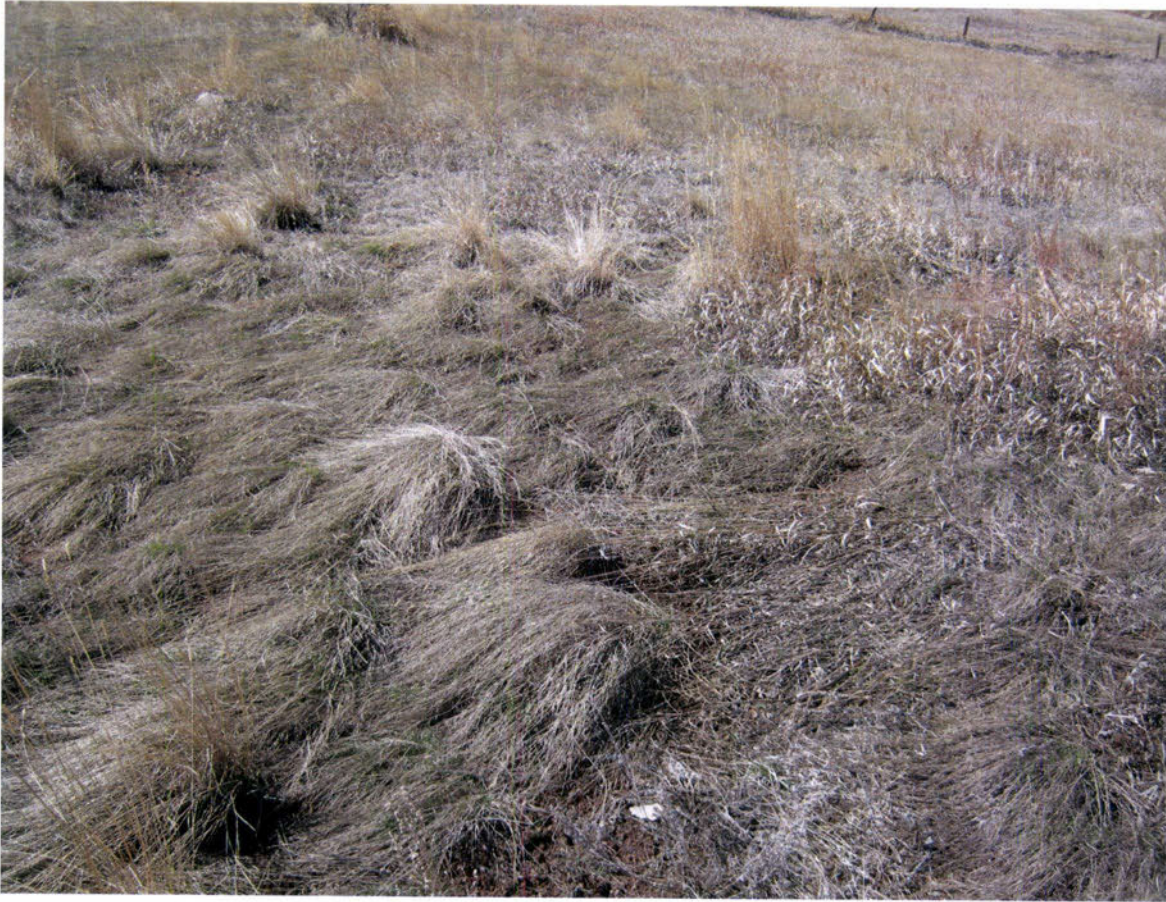
Management Unit 9

Description: Open grassy slopes with scattered pockets of low density ponderosa pine. No inventory plots were taken in this unit because it is not forested.

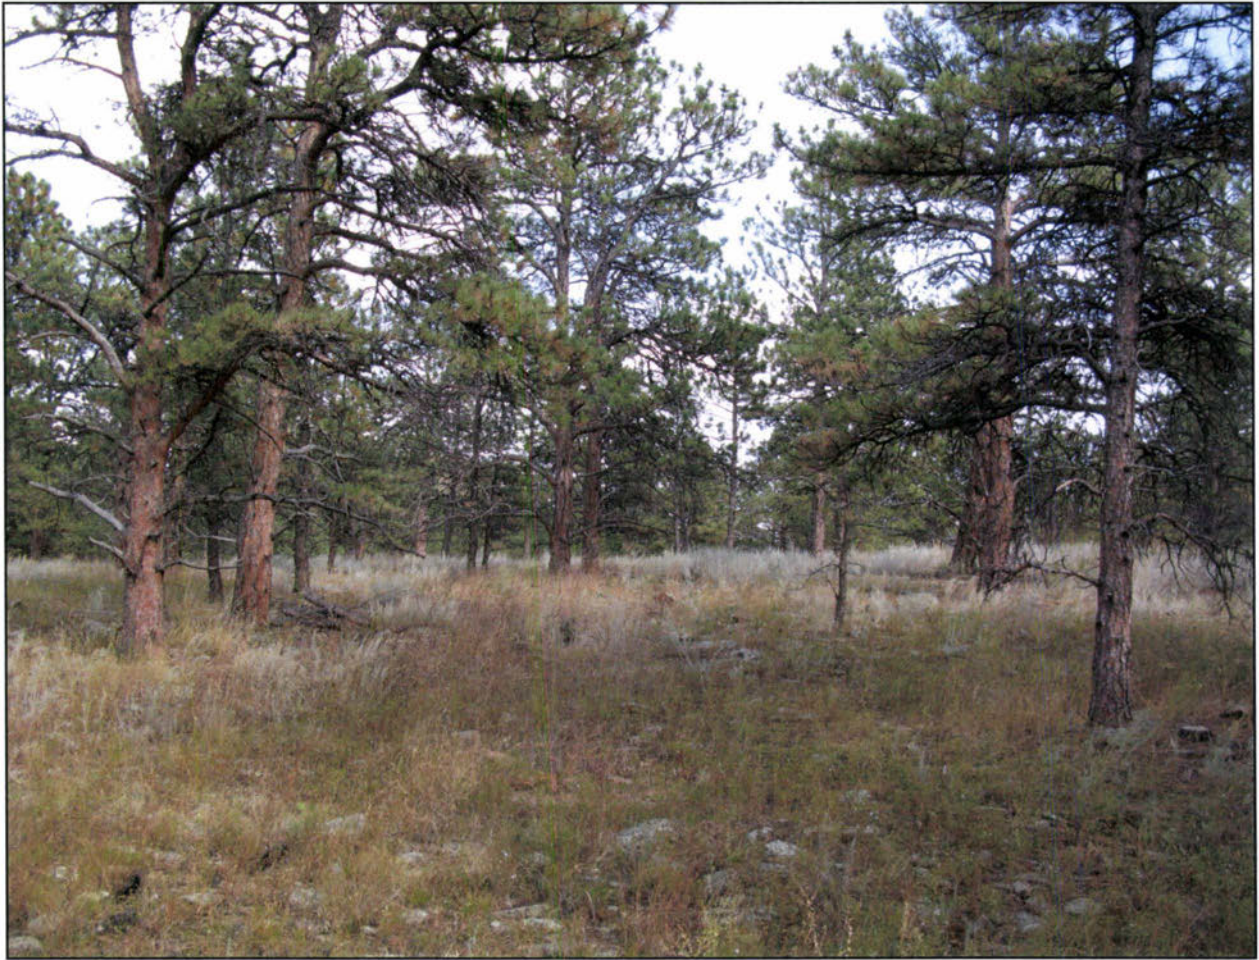
Management Unit 11

Description: Unit 11 is located on the Culver Open Space. There is a separate management plan for this unit.

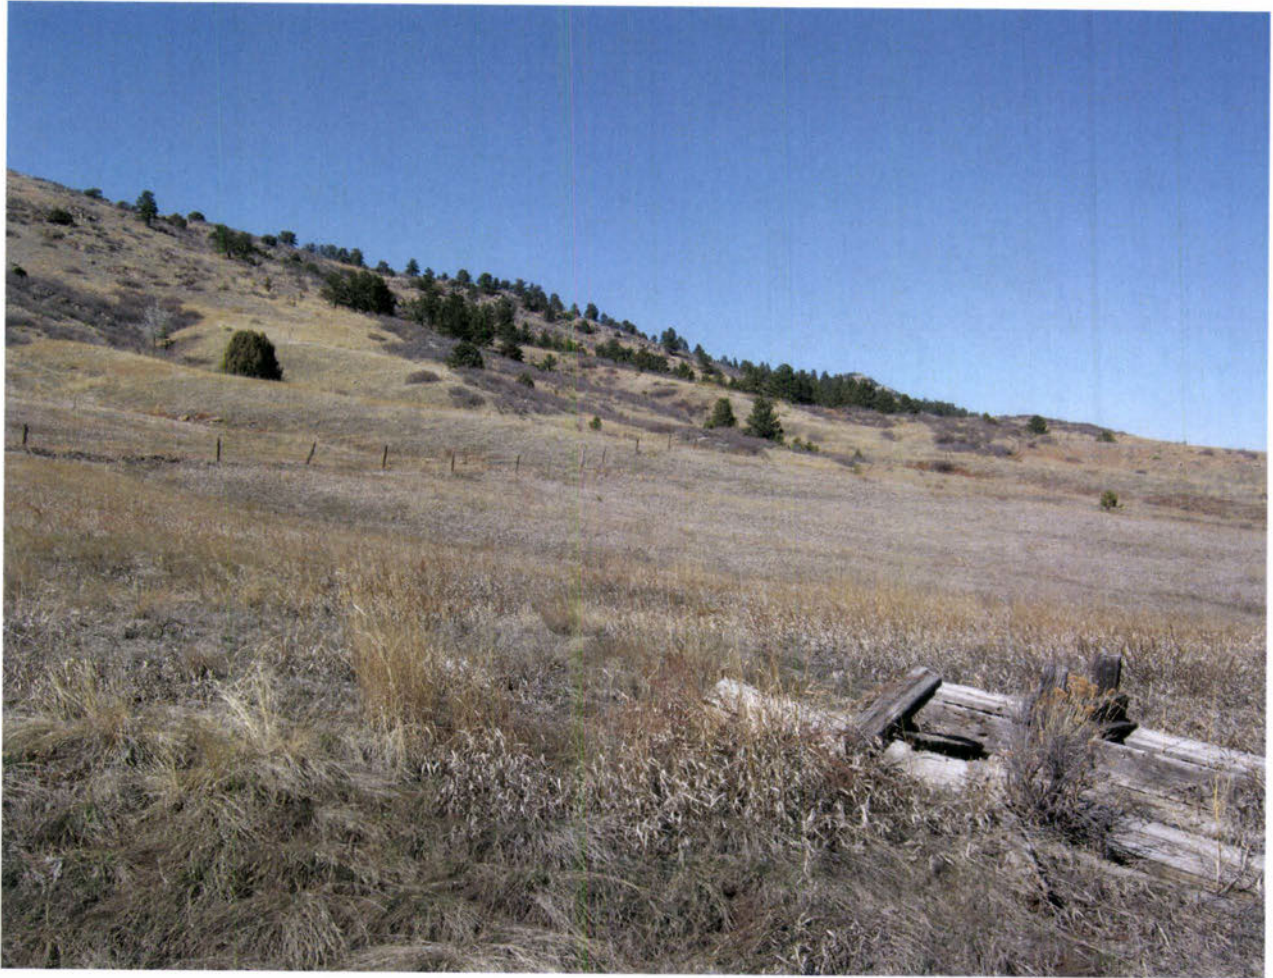
Management Unit 14

Description: Open grassy slopes with scattered pockets of low density ponderosa pine. No inventory plots were taken in this unit because it is not forested.
