Flood of 31 July 1976 in Big Thompson Canyon, Colorado

D. B. Simons, J. D. Nelson, E. R. Reiter, and R. L. Barkau

Committee on Natural Disasters
Commission on Sociotechnical Systems
NATIONAL RESEARCH COUNCIL

National Academy of Sciences Washington, D.C. 1978

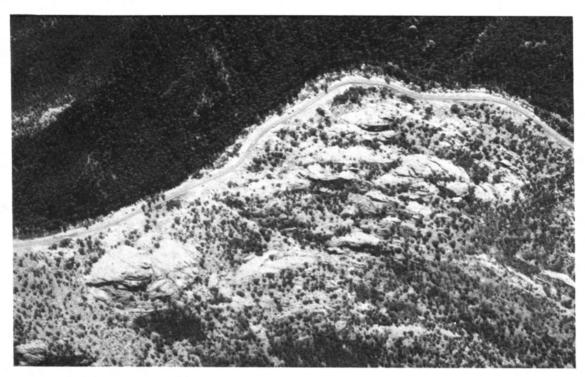
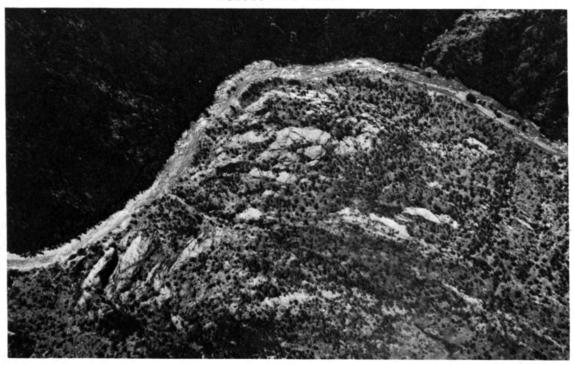
FIGURE 23 Severe Scour along the Big Thompson River above Waltonia

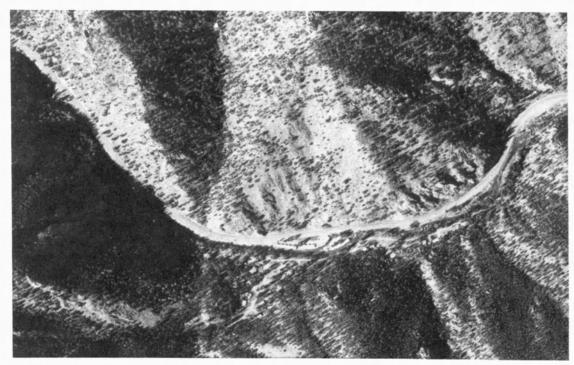
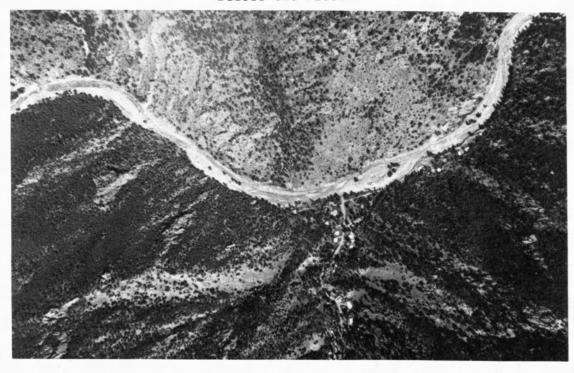
After the Flood
FIGURE 24 Waltonia Area

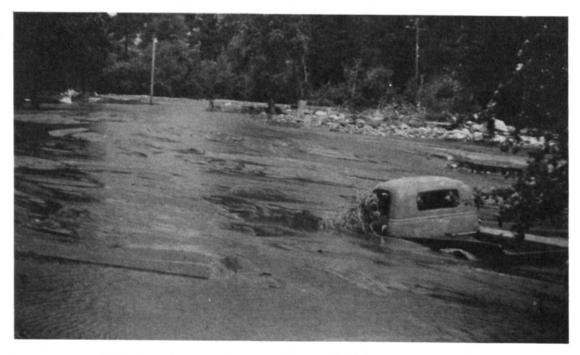
NF-1:--This reach is characterized by heavy deposition around Glen Haven. Much of this material came from Devils Gulch to the south, which showed signs of severe scour. Aerial photographs showed little activity from the North Fork, Fox Creek, or West Creek, west of Glen Haven. Figure 26 provides an idea of the depth of sediment which was deposited at Glen Haven.

FIGURE 26 Sediment Deposited in the Glen Haven Area

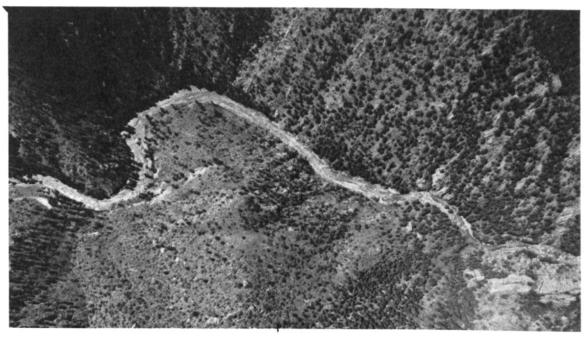
NF-4:--Along this reach the gradient again increases to about 200 feet per mile, and the valley width decreases to about 100 feet. This reach experienced severe scour with stream competence including boulder sizes. Figure 27 shows a length of this reach. Note that the roadway which had paralleled the river was eroded away.

FIGURE 27 Scour along the North Fork

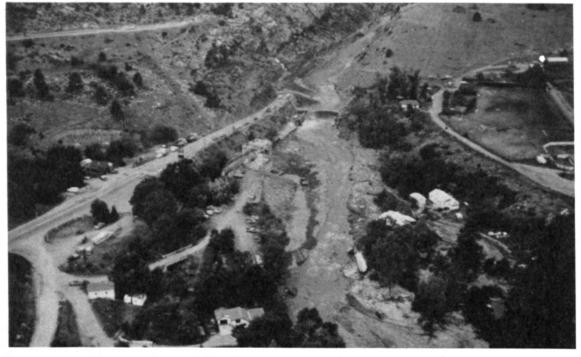
BT-9:--As the floodwaters moved out onto the plains, the discharge and velocity was quickly attenuated by overbank storage, resulting in the deposition of large amounts of material in overbank areas. As an illustration of the change in velocity, the average velocity measured 4 miles downstream at site 24 was 12 fps. The width of the flood plain along this reach ran from 500 feet to well over 1,000 feet, and the slope averaged about 40 feet per mile. As a result, large amounts of sands and silt materials were deposited in overbank areas. Figure 34 shows deposits just below the mouth of the canyon and Figure 35 shows deposits in an overbank area further downstream. Several channel changes occurred when the momentum of flow shortened the length of the channel by cutting off a bend.

FIGURE 34 Deposits below the Mouth of the Canyon

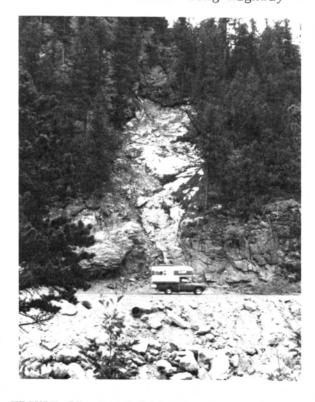
FIGURE 57 Landslide in Residual Soil

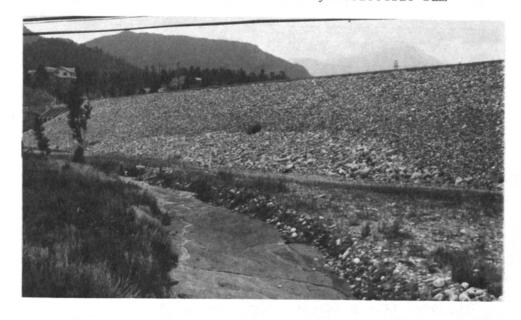
One potentially drastic occurrence is illustrated in Figure 65, showing the Olympus dam in Estes Park. The light colored zone of rock at the toe of the dam was eroded by the floodwaters flowing down Dry Gulch in the foreground of the photograph. Olympus dam is 47 feet high and is located a short distance above the mouth of the Big Thompson canyon in Estes Park. If that dam had failed the effects of the flood would have been much worse.

FIGURE 65 Olympus Dam
