INVESTIGATION OF THE CANDLESTICK PARK WIND PROBLEM

Volume III

Conclusions, Recommendations
and Summary of Investigation

Prepared for Department of Public Works
City of San Francisco

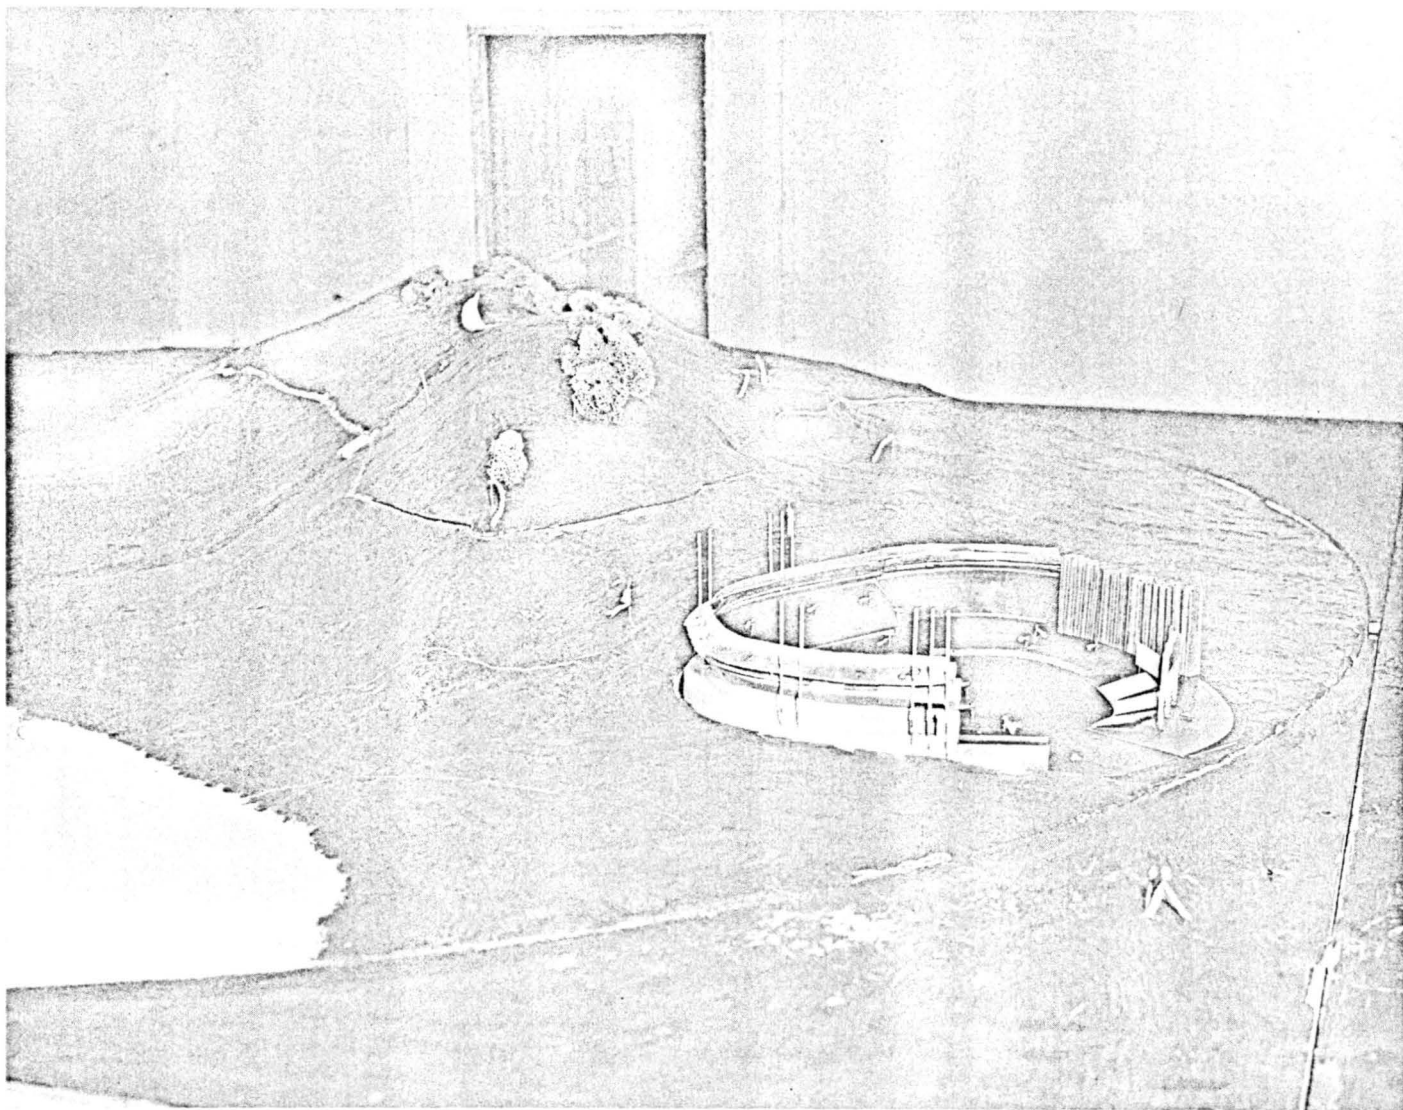
All model studies were conducted in a low speed recirculating wind tunnel with a test section 6 x 6 x 30 feet using wind speeds 18 to 30 mph. For most of the observations a 1:768 model was used which included the stadium, parking lot and all of Bay View Hill, as shown in Figs. 1 and 8. On this scale the stadium is approximately one foot across and the entire model is 6 x 6 feet. A 1:384 model of the stadium without Bay View Hill was used for those measurements requiring greater stadium detail and also to verify that the results obtained were independent of the scale used. Both models were mounted on a rotating platform in the tunnel floor in order to study the effect of wind direction.

Fig. 1--Scale model of stadium and Bay View Hill placed in wind tunnel. The 1:768 model is shown with vanes attached to the rim for vertical deflection and vanes across the left field opening for horizontal deflection.

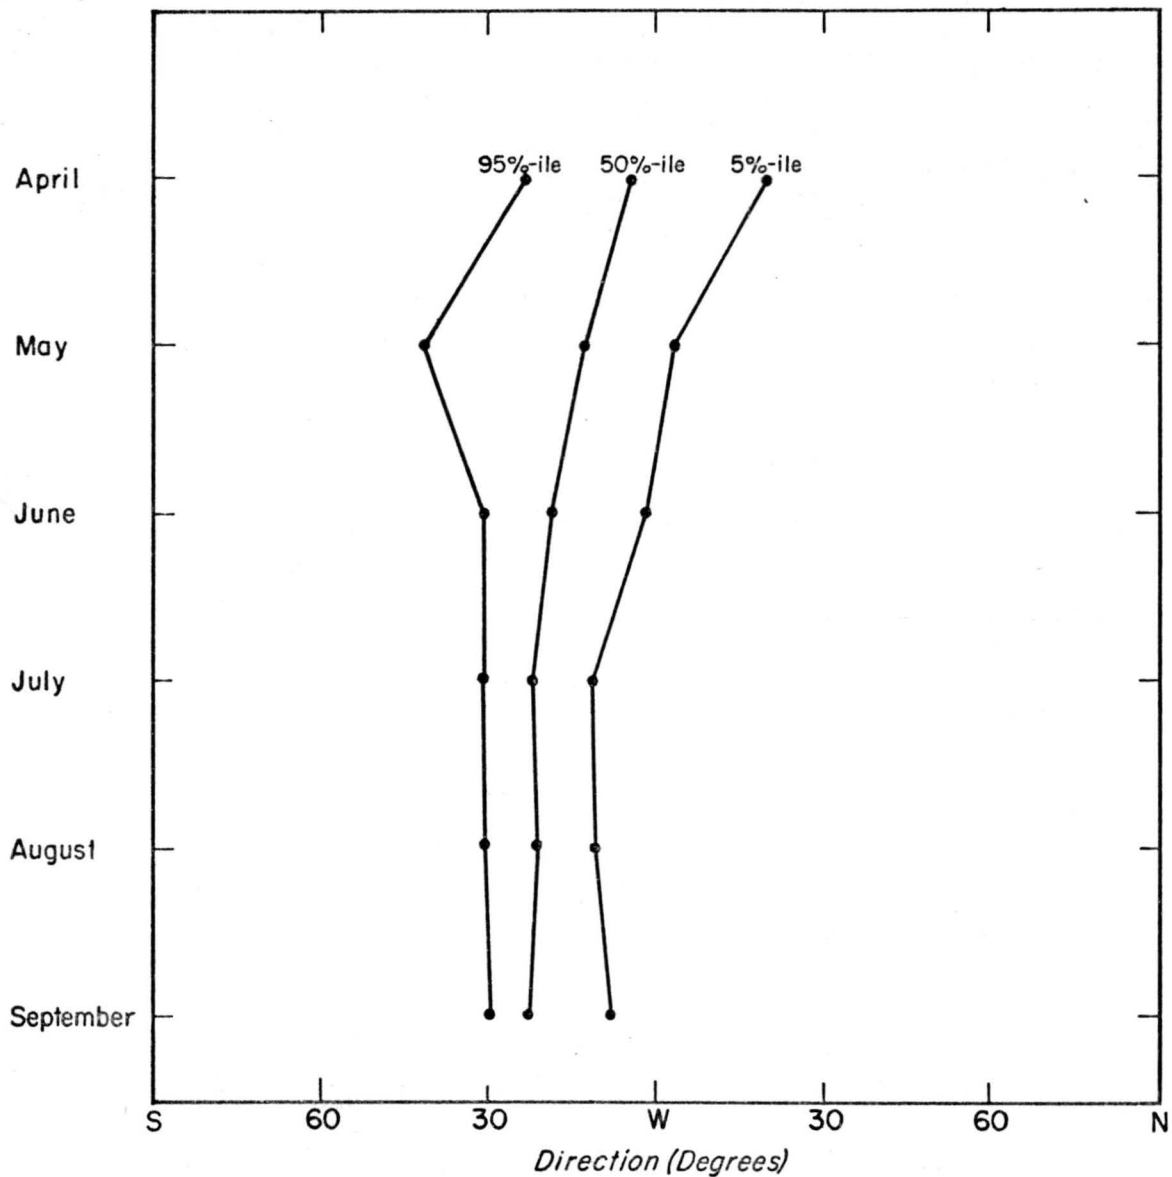
Results obtained at the McLaren Tank meteorological reference station clearly show that the air approaching the stadium complex is remarkably uniform in direction during the afternoon hours throughout the baseball season. These results are summarized in Fig. 2 in terms of the median (50%-ile) direction and range of directions based on half-hourly averages between 1300 and 1800 hours PDT. The median direction and direction of maximum frequency are equivalent for practical purposes. As shown, the direction range for each month includes 90% of all cases, i.e. the 5%-ile to 95%-ile limits. The following points may be noted in connection with these results.

Fig. 2--Afternoon wind direction and direction range for air approaching Bay View Hill during the baseball season. Distribution of half-hourly average wind directions for each month between 1300 and 1800 hours PDT is given in terms of the median (50%-ile) and 90% limits. For example, the median direction during August was 21° south of west and 90% of the time the direction was between 11° and 30° south of west. Directions measured at McLaren Tank.

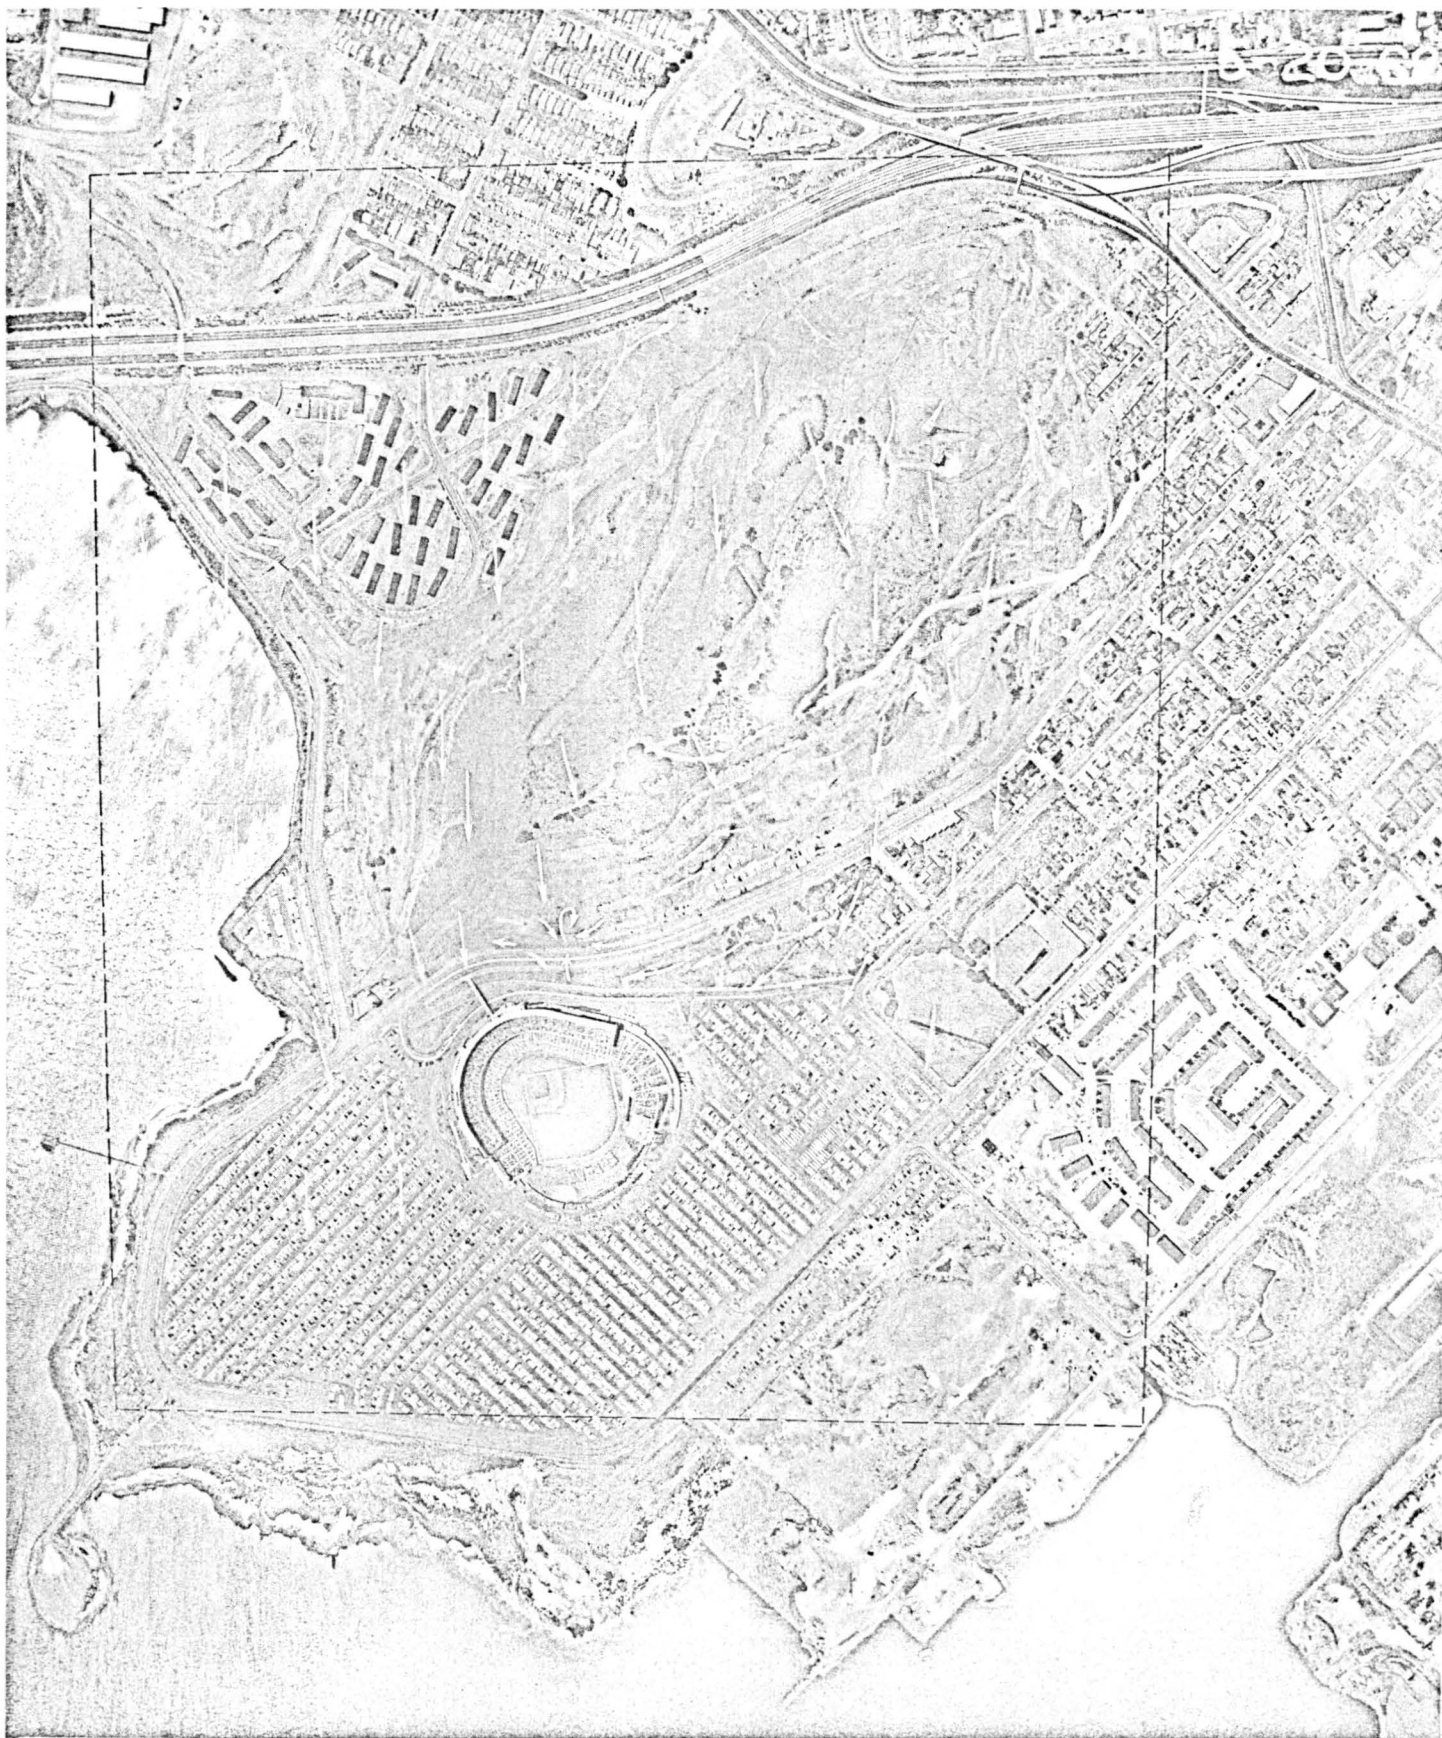
Model tests included wind speeds from 10-30 mph and directions from 16° to 31° south of west. A typical comparison between model and prototype observations is shown in Fig. 8 for conditions corresponding to Left-Field Control.

Fig. 8--Characteristic wind flow pattern around Bay View Hill based on model measurements at a mean wind direction of 16° south of west. The stream lines are superimposed on an aerial photograph of the prototype for comparison with Fig. 3. At 16° south of west the characteristic Left-Field Control wind pattern develops within the stadium model. Approximate boundary of entire model is shown by dashed line.

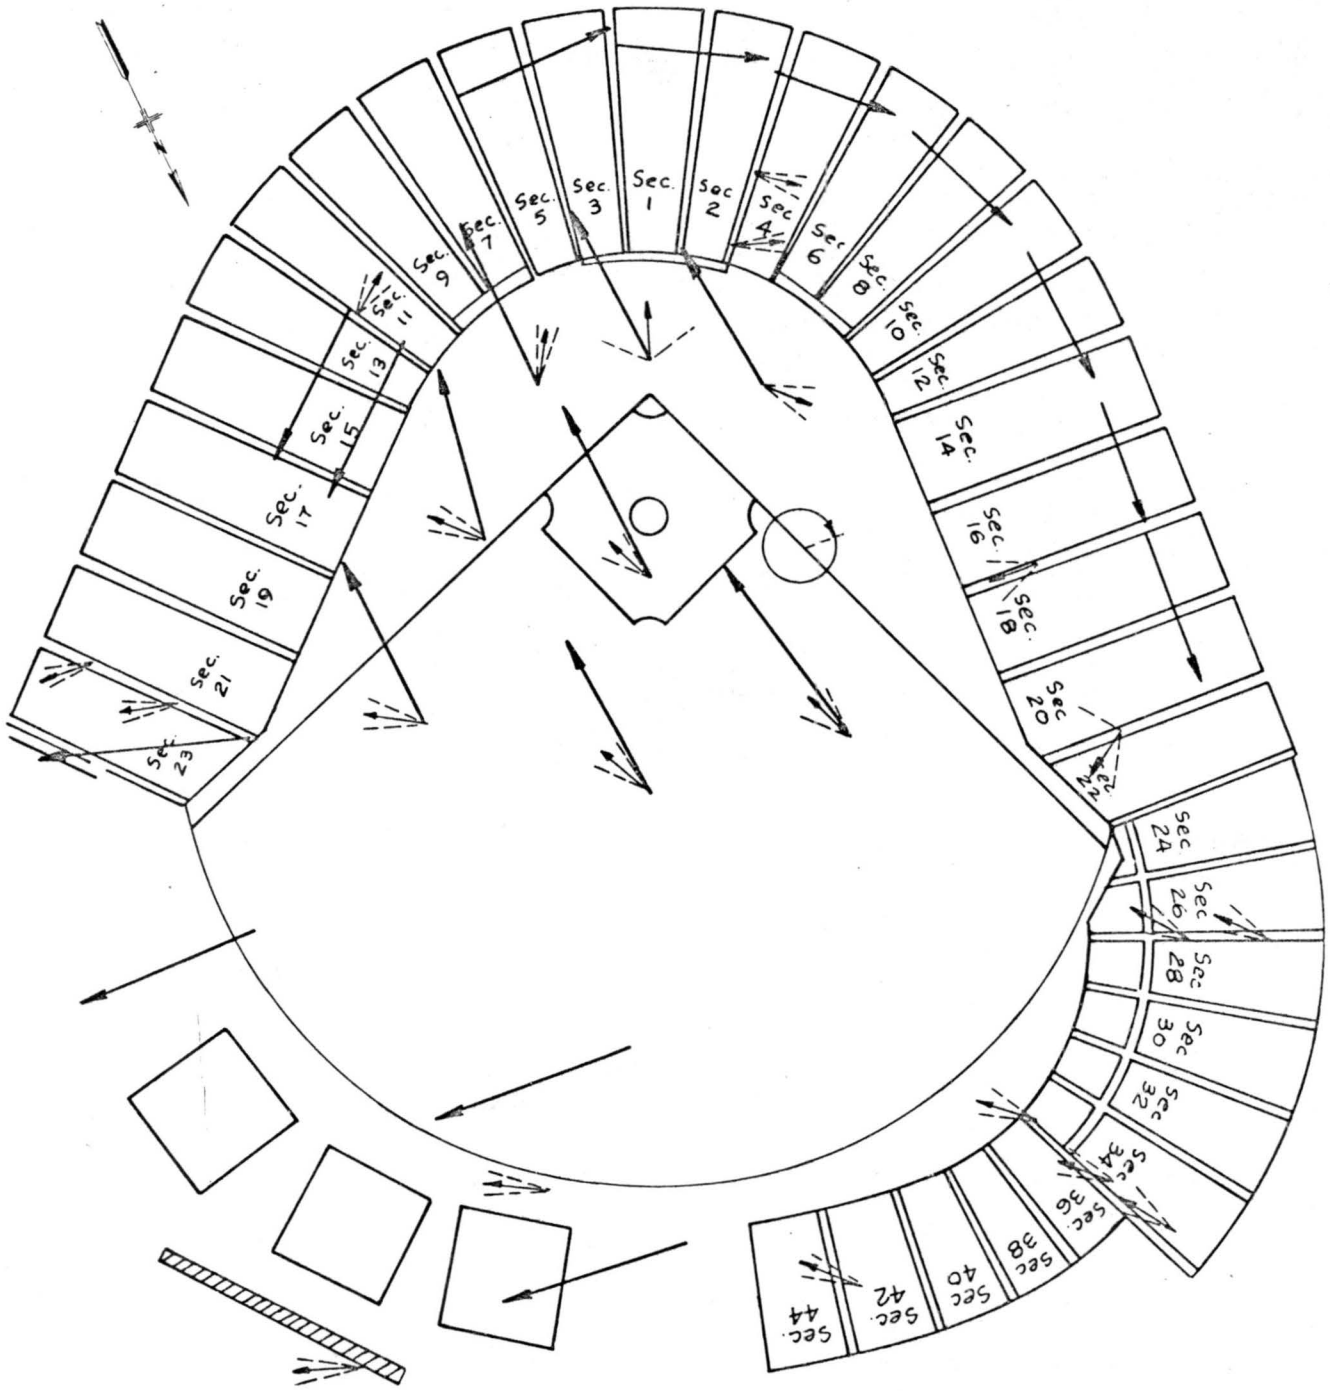
LOWER STAND

Streamers were placed at various locations on the playing field and stands in both the model and prototype. Figure 9 shows the average direction of these streamers on the playing field and lower stands for the typical Left-Field Control flow (mean wind $W16^\circ S$ in model). Comparison of the wind directions for model and prototype as indicated by the arrows reveals excellent correlation in the general circulation pattern. Local differences in direction for the streamers between home plate and the stands is not significant because the extreme variability of winds in this region make the directions indicated somewhat uncertain.

Fig. 9--Comparison between observed prototype and model wind flow patterns in the lower stands under Left-Field Control conditions.

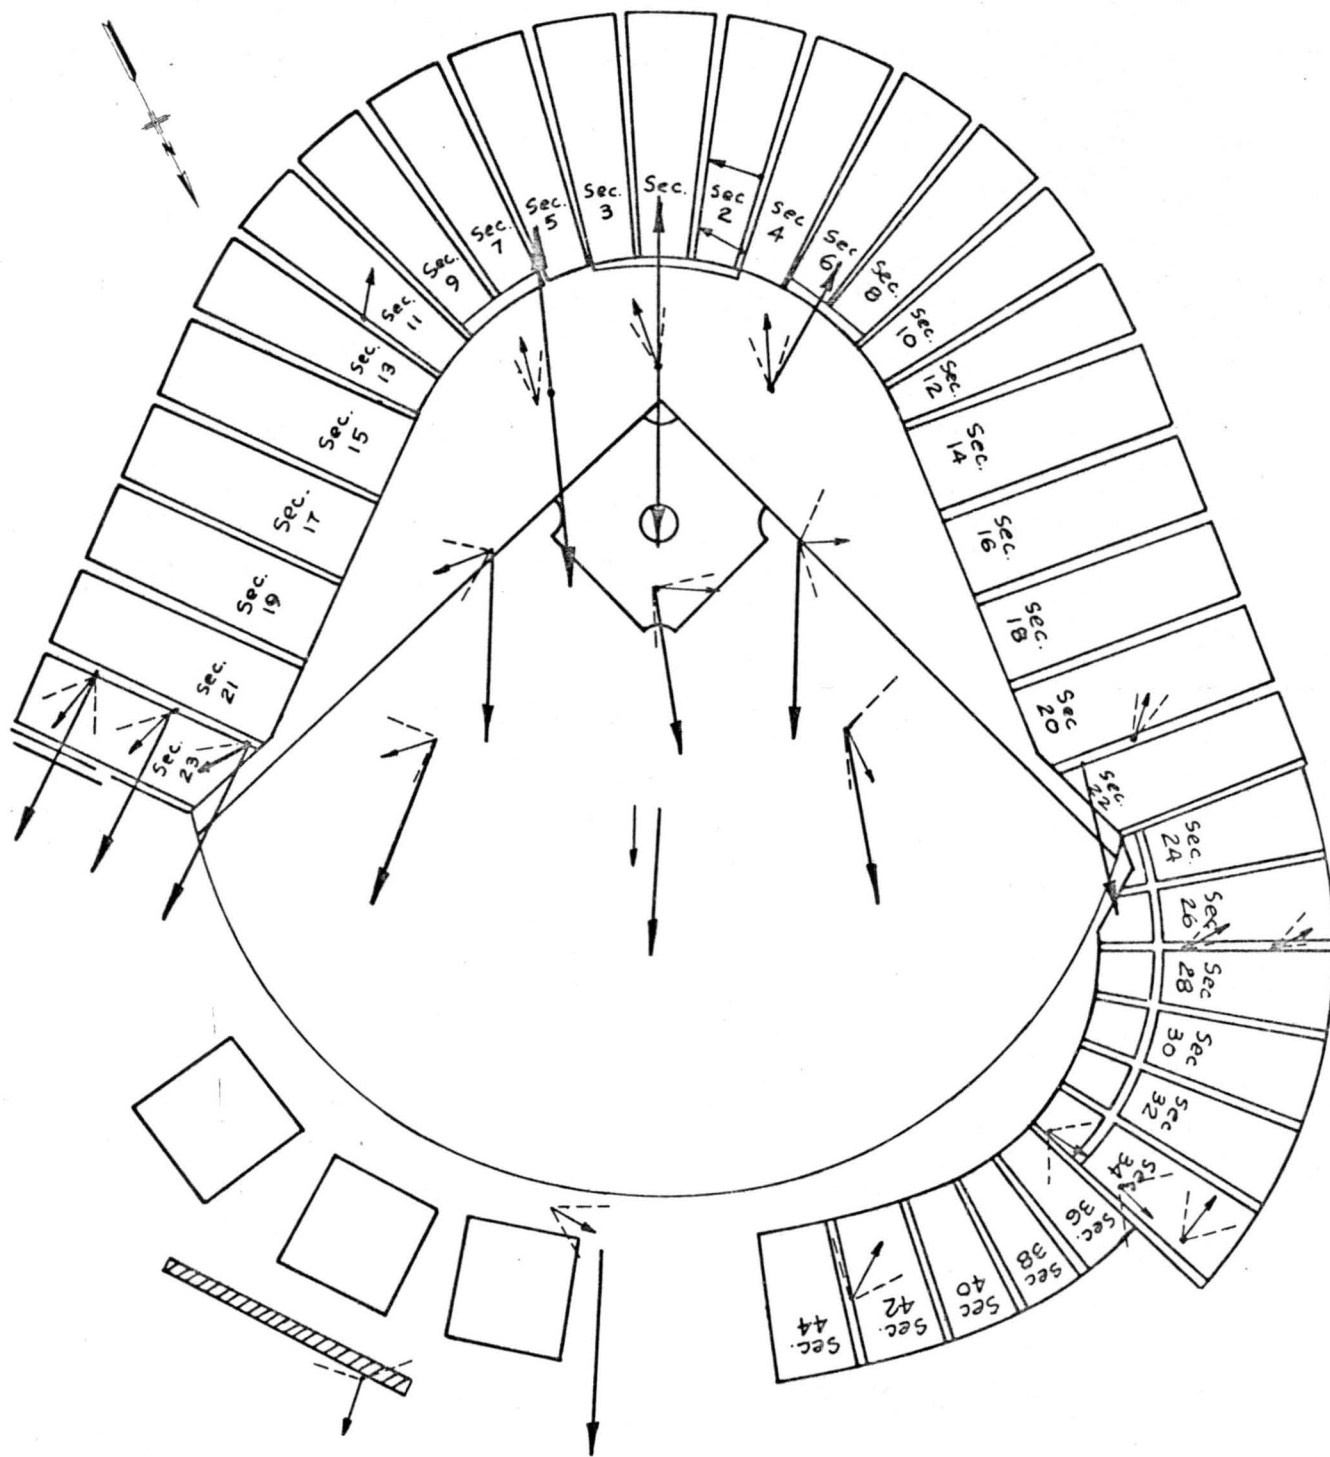
LOWER STAND

Figure 10 illustrates the ballpark flow pattern for the case of the Southerly Control flow (mean wind $W31^\circ S$ in model). Again there is excellent agreement between the model and prototype flows. Some differences appear to exist in the infield, but these are again judged to be insignificant because of the extreme variability of winds in this region.

Fig. 10--Comparison between observed prototype and model wind flow patterns in the lower stands under Southerly Control conditions.
