Survey of Seeps and Springs on Bureau of Land Management lands in northern Hinsdale County 2006-2007

Prepared for: Bureau of Land Management, Gunnison Field Office 216 N. Colorado Gunnison, Colorado 81230

Prepared by: Stephanie Neid, Delia Malone, and Jennifer Jones

> > March 1, 2008

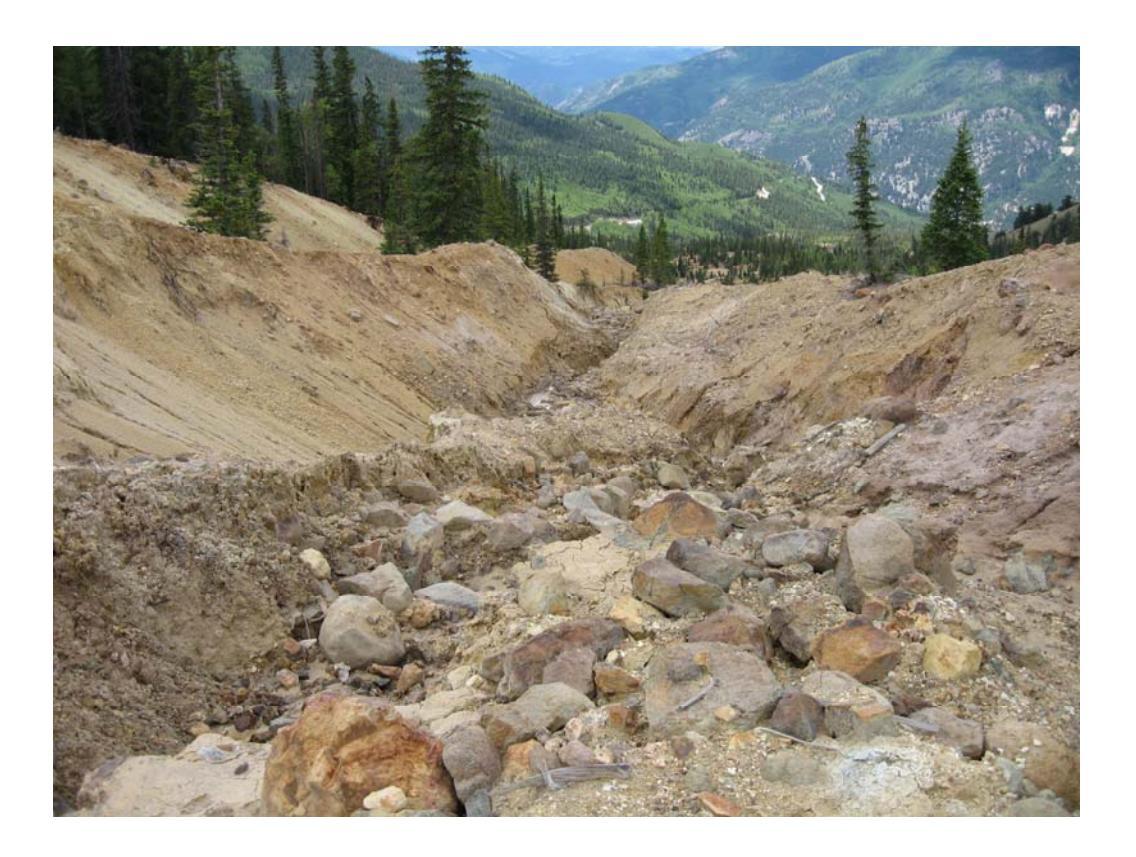
Slumgullion Slide Standard Checklist Non-Functional

Potential (ecological status that can be attained without above limiting factors or without limiting factors what is the ultimate goal for assessment area) Seep indicated by BLM not a functioning wetland. There is no consistent hydrologic regime present and no stable vegetation. Soils are highly erodible with little structure to support wetland vegetation.

County: Hinsdale	Quadrangle: Lake San Cris	tobal BLM Code: B989
UTM Coordinates NAD 83:	E301954 N4207477	Elevation: 10,460ft
ID Team Observers: JJones	, JDavin	Date: August 18, 2006

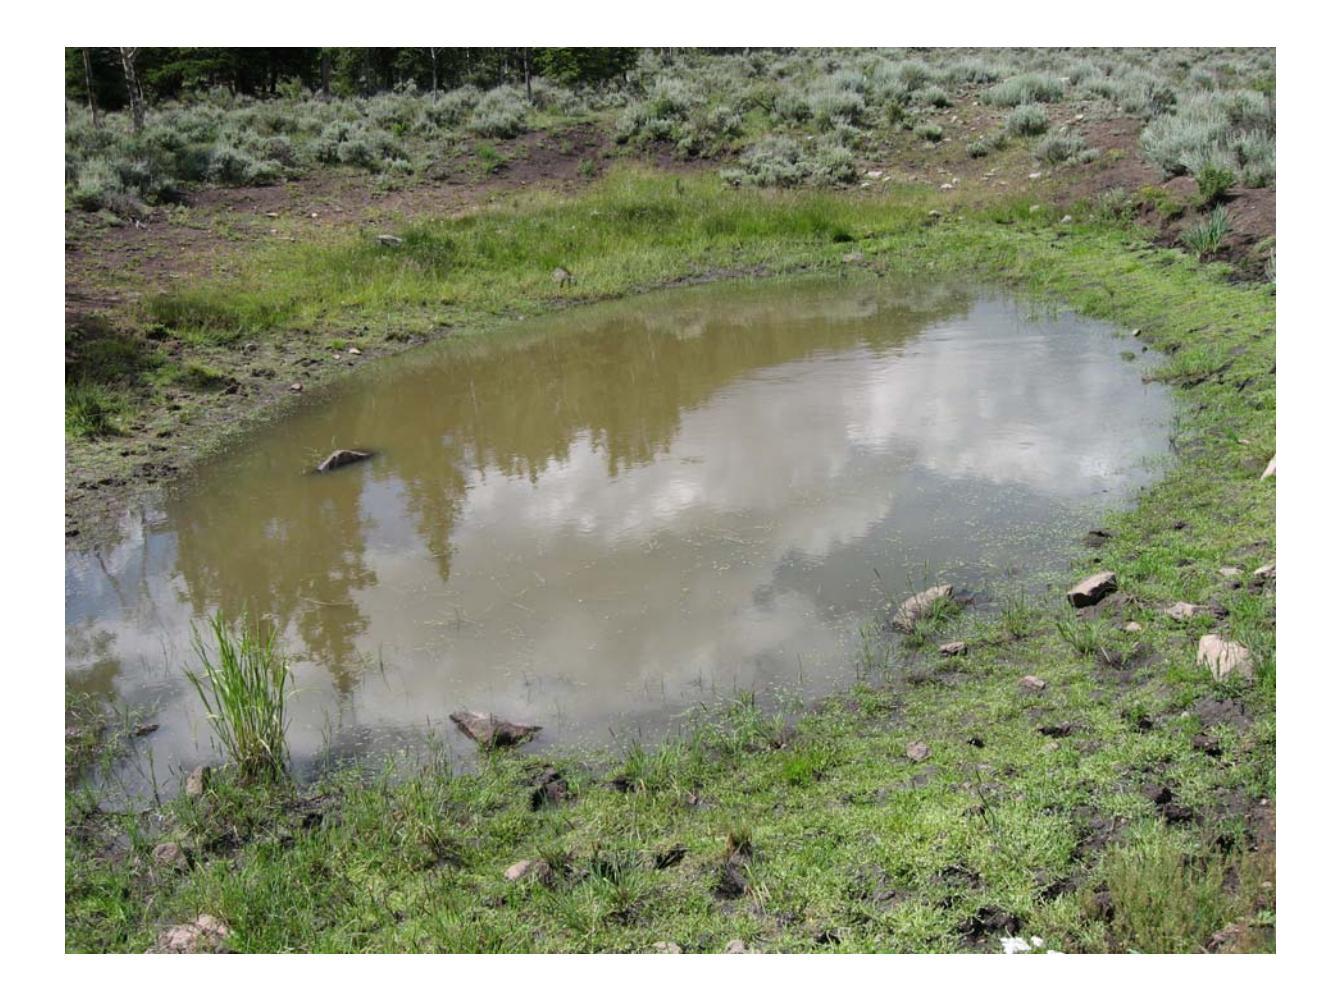
Spring Creek Springs Lentic Standard Checklist Proper Functioning Condition

County: HinsdaleQuadrangle: Mineral MountainBLM Code: C729AUTM Coordinates NAD 83:E323265 N4217383Elevation: 9,300ftID Team Observers:JJones, JDavinDate: July 8, 2006

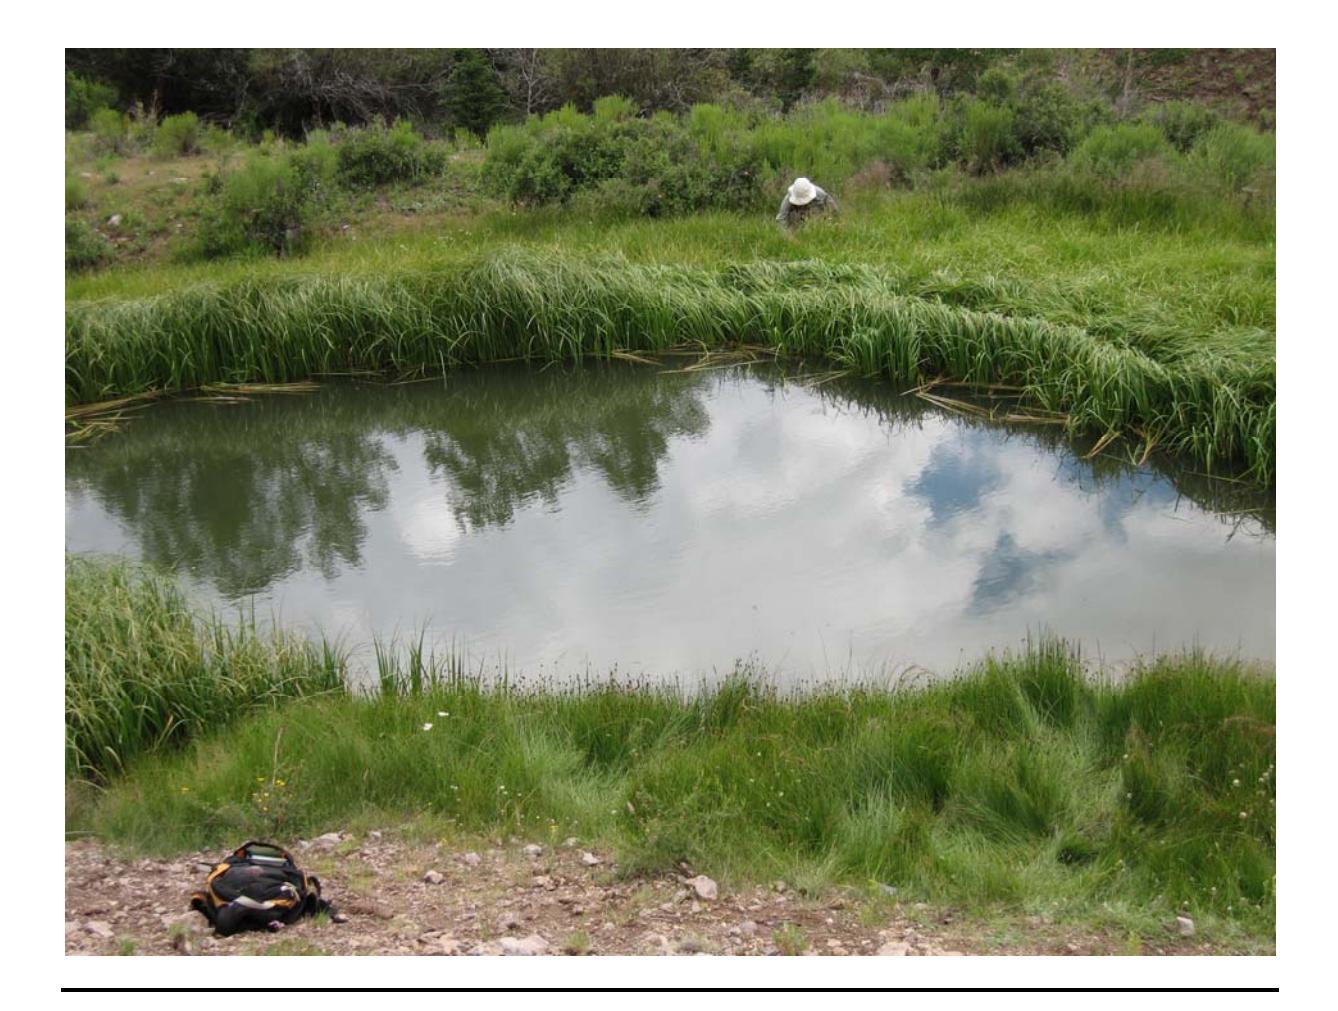
Spring Creek Springs Lentic Standard Checklist Proper Functioning Condition

County: HinsdaleQuadrangle: Mineral MountainBLM Code:C729BUTM Coordinates NAD 83:E323247N4217361Elevation: 9,300 ftID Team Observers:JJones, JDavinDate:July 9, 2006

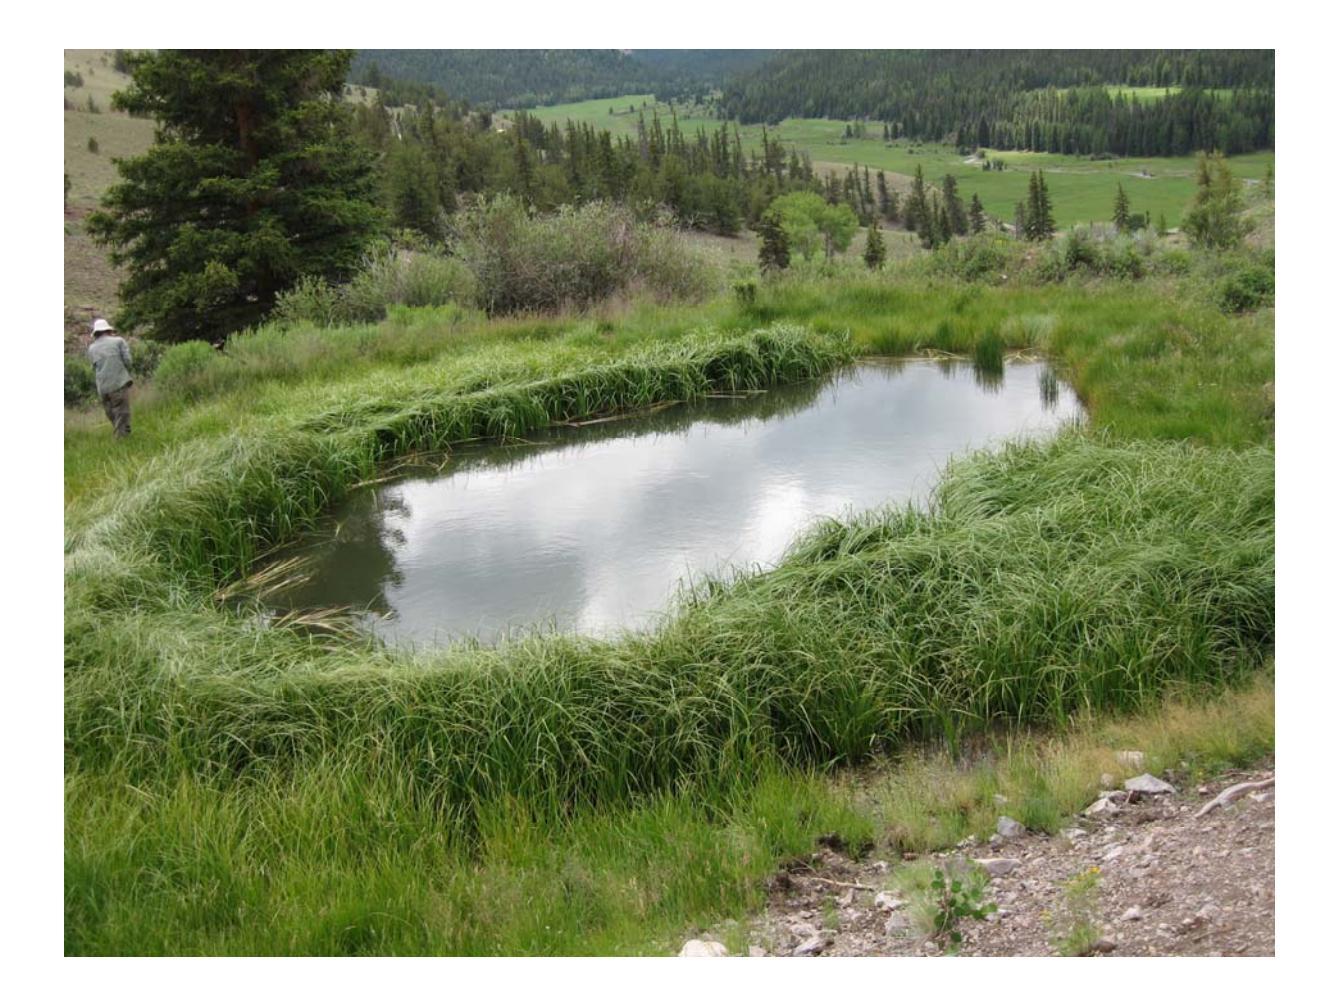
Spring Creek Seeps Standard Checklist Functional-At Risk

County: Hinsdale	Quadrangle: Mineral Moun	tain BLM Code: C731
UTM Coordinates NAD 83:	E323870 N4217945	Elevation: ft
ID Team Observers: JJones	, JDavin	Date: July 8, 2006

Potential (ecological status that can be attained without above limiting factors or without limiting factors what is the ultimate goal for assessment area) Wetland is functioning near its potential natural community.

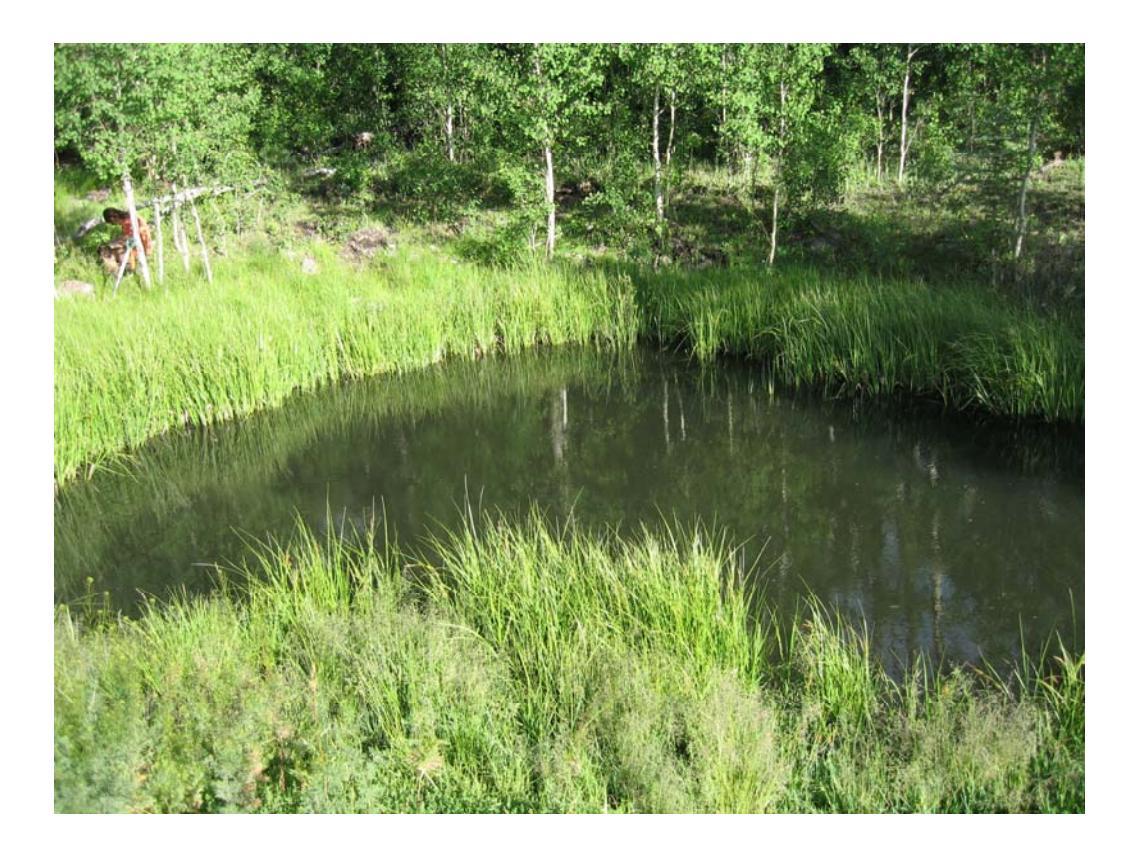
Rambuoillet Park Seeps Standard Checklist Proper Functioning Condition

County: HinsdaleQuadranglUTM Coordinates NAD 83:E302419 N		Quadrang 3: E302419	e: Lake San CristobalBLM Code: C964N4202293Elevation: 11,460ft
ID Team Obse	ervers: JJor	nes, JDavin	Date: July 17, 2006
Yes	No	N/A	HYDROLOGY
Х			1) Floodplain above bankfull is inundated in "relatively frequent" events
		Х	2) Where beaver dams are present they are active and stable
Х			3) Sinuosity, width/depth ratio, and gradient are in balance with the landscape setting (i.e., landform, geology, and bioclimatic region)
Х			4) Riparian-wetland area is widening or has achieved potential extent
Х			5) Upland watershed is not contributing to riparian-wetland degradation

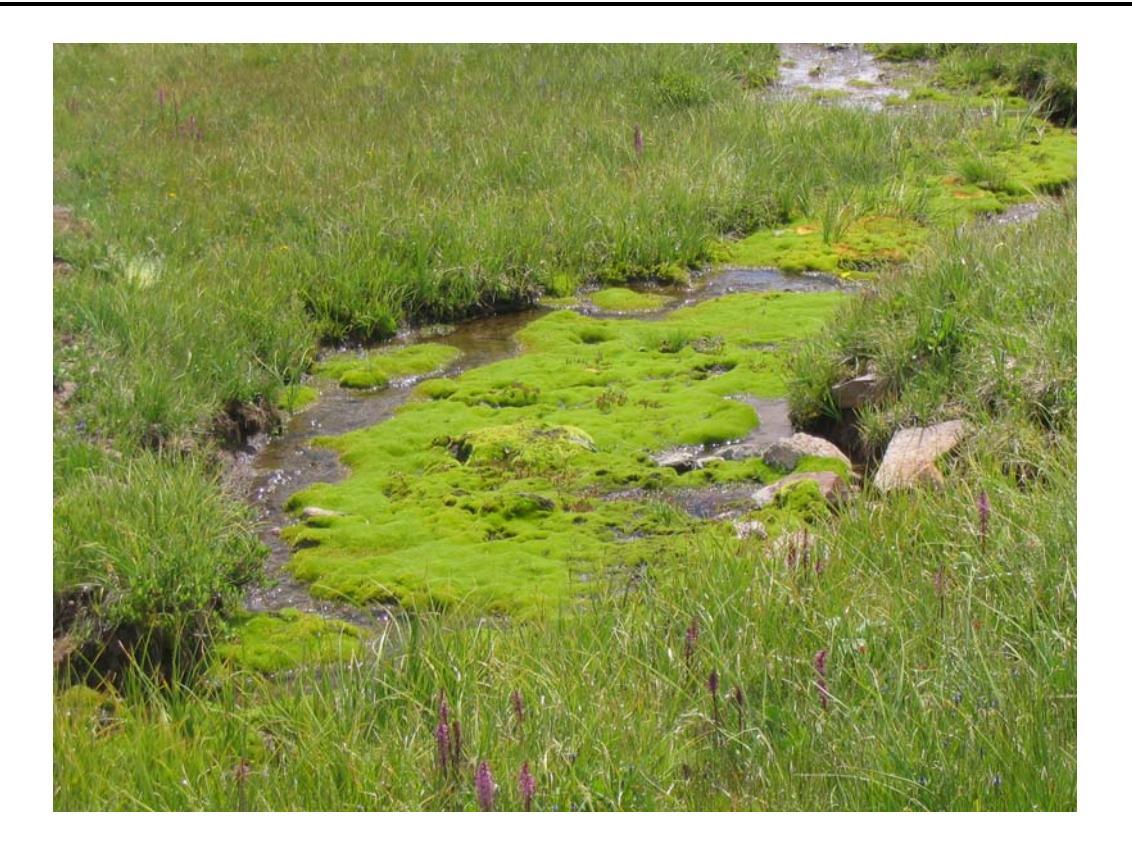
Hill Seventyone Seeps Standard Checklist Proper Functioning Condition

County: HinsdaleQuadrangle: Lake San CristobalBLM Code:C966UTM Coordinates NAD 83:E301301N4202957Elevation:11,400ftID Team Observers:JJones, JDavinDate:July 17, 2006

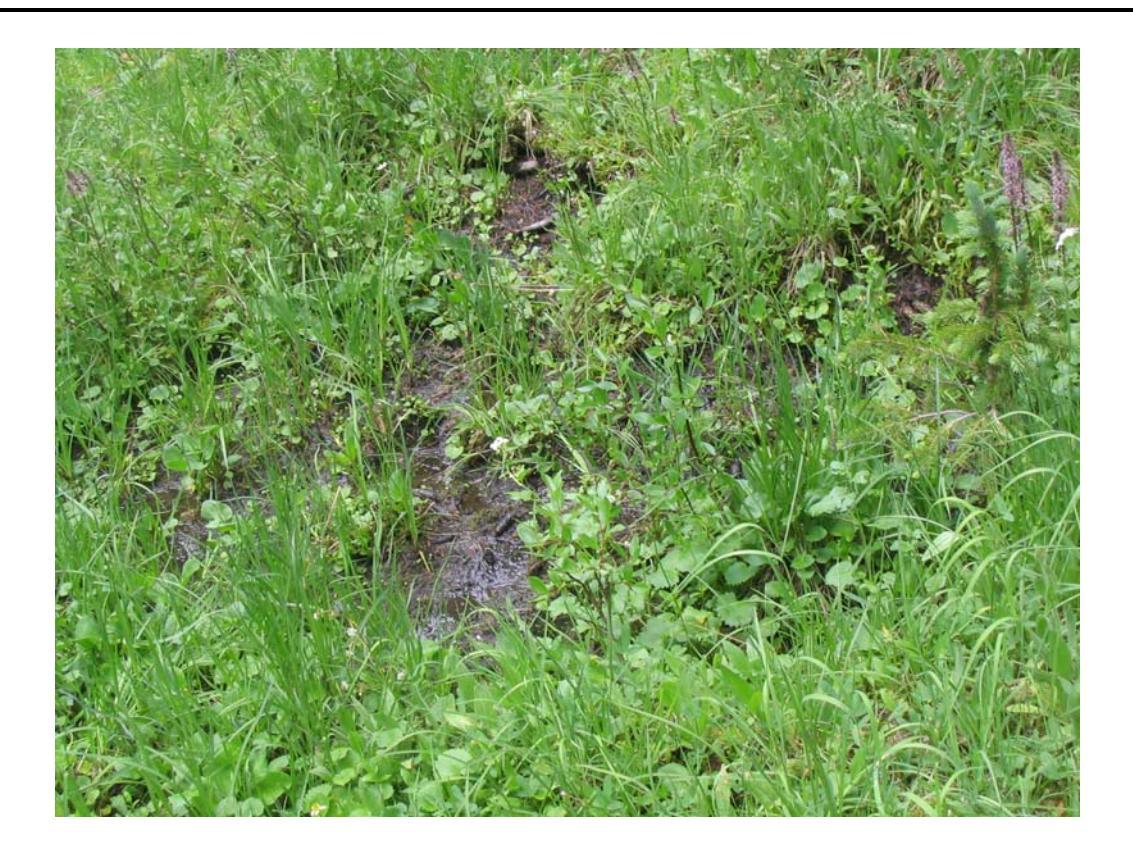
Hill Seventyone Seeps Standard Checklist Proper Functioning Condition

County: HinsdaleQuadrangle: Lake San CristobalBLM Code: C967UTM Coordinates NAD 83:E301209N4203157Elevation: 11,285ftID Team Observers:JJones, JDavinDate:July 17, 2006

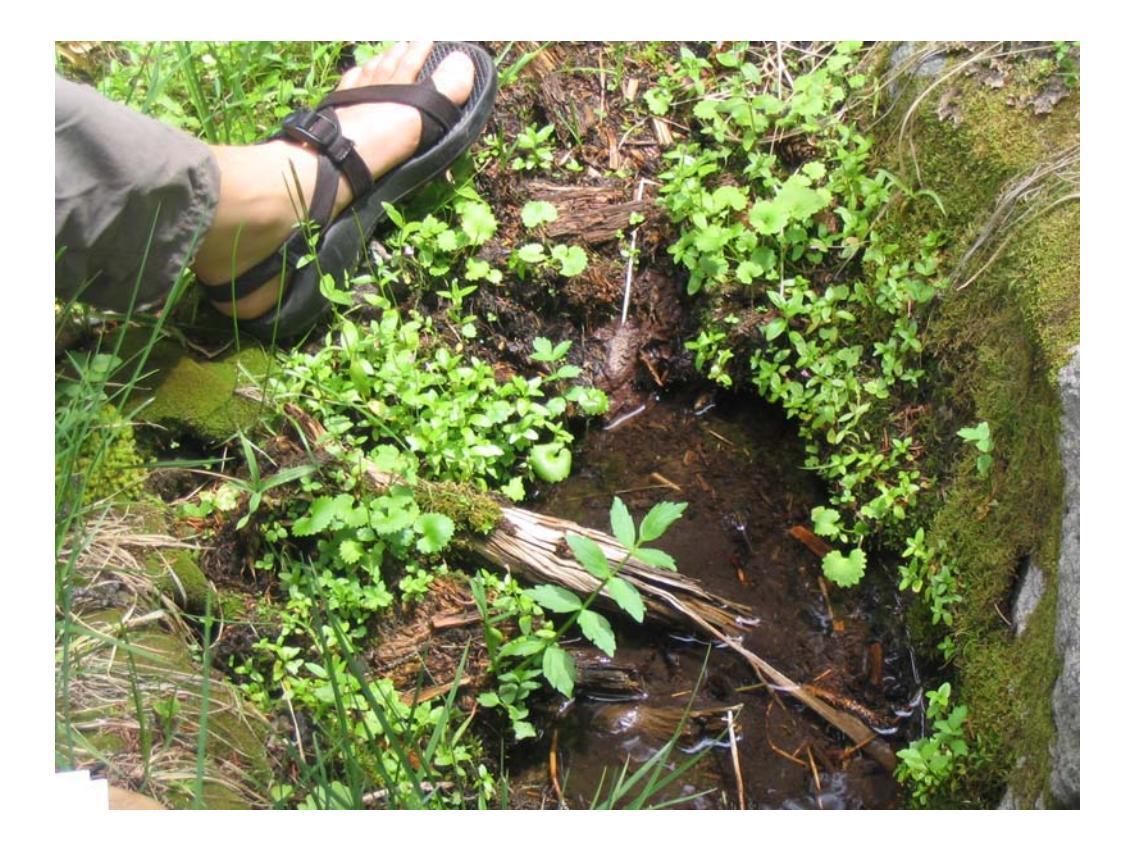
Hill Seventyone Springs Standard Checklist Functional – At Risk

County: HinsdaleQuadrangle: Lake San CristobalBLM Code: C989UTM Coordinates NAD 83:E301202N4203124Elevation: 11,285ftID Team Observers:JJones, JDavinDate:July 17, 2006

Proper Functioning Condition (adequate veg., landform, or debris is present to dissipate energies, filter sediment, improve groundwater recharge, develop root masses to stabilize shoreline, restrict percolation, provide wildlife and fish habitat, support biodiversity) Functional-At Risk *_____X Non-Functional _____ Unknown ***Trend for Functional At Risk:** Upward _____ Downward _____ Not Apparent Are factors contributing to unacceptable conditions outside BLM's control or management? Yes X No If yes, what are those factors? X_DewateringMining activitiesWatershed conditionDredging activitiesX_Road encroachmentLand ownership ___X_Dewatering Other (specify e.g., grazing, irrigation, agriculture activities)

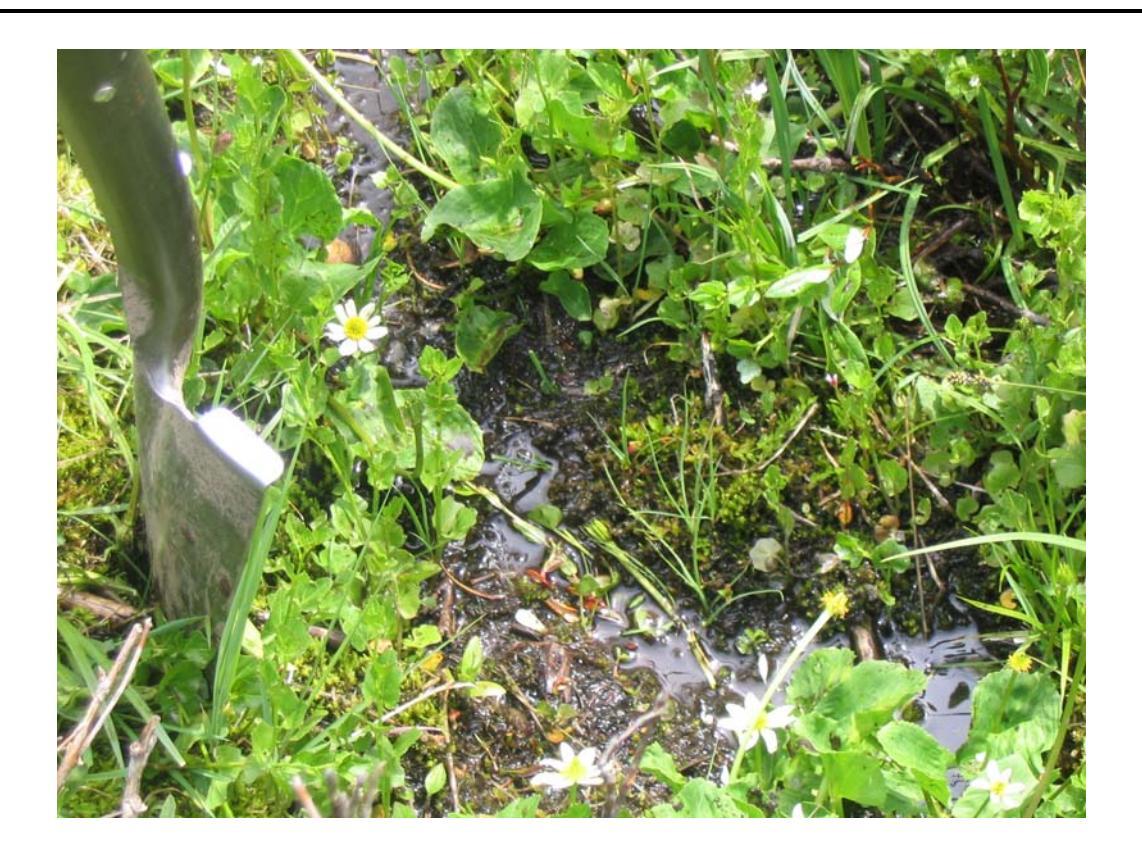
Cooper Creek Fen Standard Checklist Proper Functioning Condition

County: Hinse UTM Coordin	dale ates NAD 8	Quadrangl 3: E285232 N	e: Redcloud PeakBLM Code: noneN4205639Elevation: 11,695ft
ID Team Obse	ervers: JJor	nes, JDavin	Date: July 29, 2006
Yes	No	N/A	HYDROLOGY
Х			1) Floodplain above bankfull is inundated in "relatively frequent" events
		Х	2) Where beaver dams are present they are active and stable
Х			3) Sinuosity, width/depth ratio, and gradient are in balance with the landscape setting (i.e., landform, geology, and bioclimatic region)
Х			4) Riparian-wetland area is widening or has achieved potential extent
Х			5) Upland watershed is not contributing to riparian-wetland degradation

Potential (ecological status that can be attained without above limiting factors or without limiting factors what is the ultimate goal for assessment area) Wetland is functioning at its potential natural community. There is very little evidence of anthropogenic disturbance in the area and no factors currently limiting the areas potential or causing unacceptable conditions.

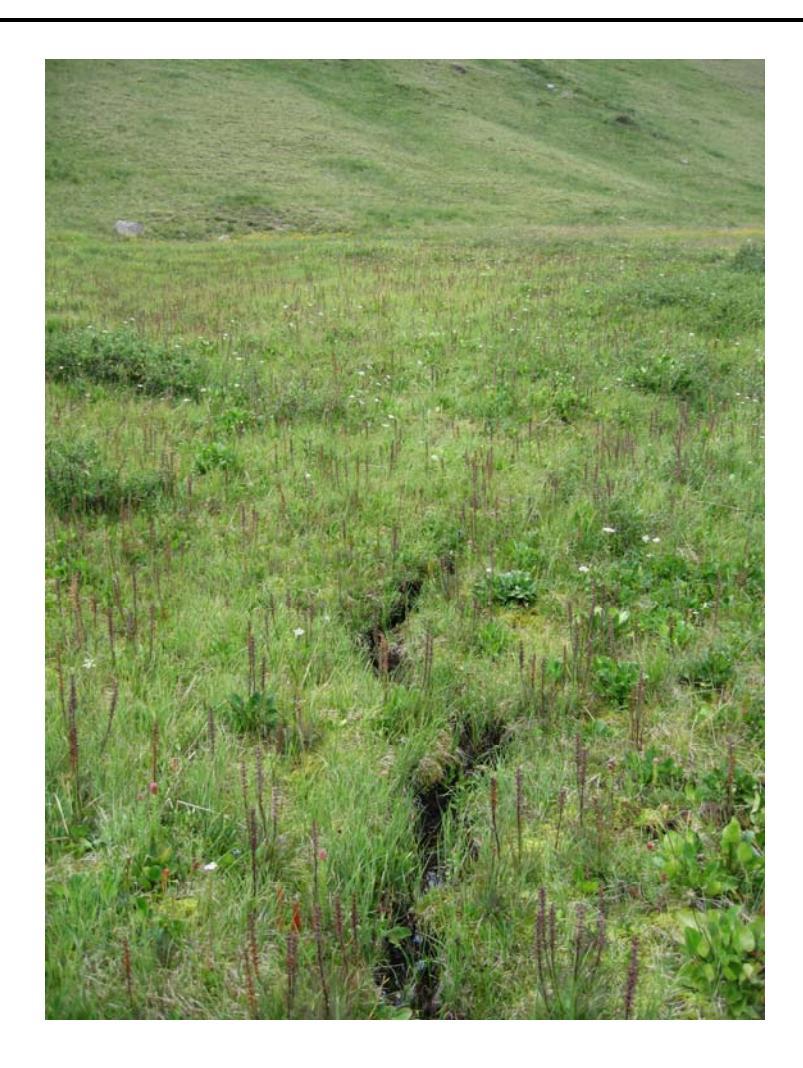
Cooper Creek Seep Standard Checklist Proper Functioning Condition

County: HinsdaleQuadrangle: Redcloud PeakBLM Code: noneUTM Coordinates NAD 83:E284937N4205310Elevation: 11,605ftID Team Observers:JJones, JDavinDate:July 29, 2006

Potential (ecological status that can be attained without above limiting factors or without limiting factors what is the ultimate goal for assessment area) Wetland is functioning at its potential natural community. There are few anthropogenic disturbances in the area and no factors limiting the sites potential or causing unacceptable conditions. Past mining in surrounding watershed may impact site hydrology and water quality, but does not appear to be impacting the site at present.

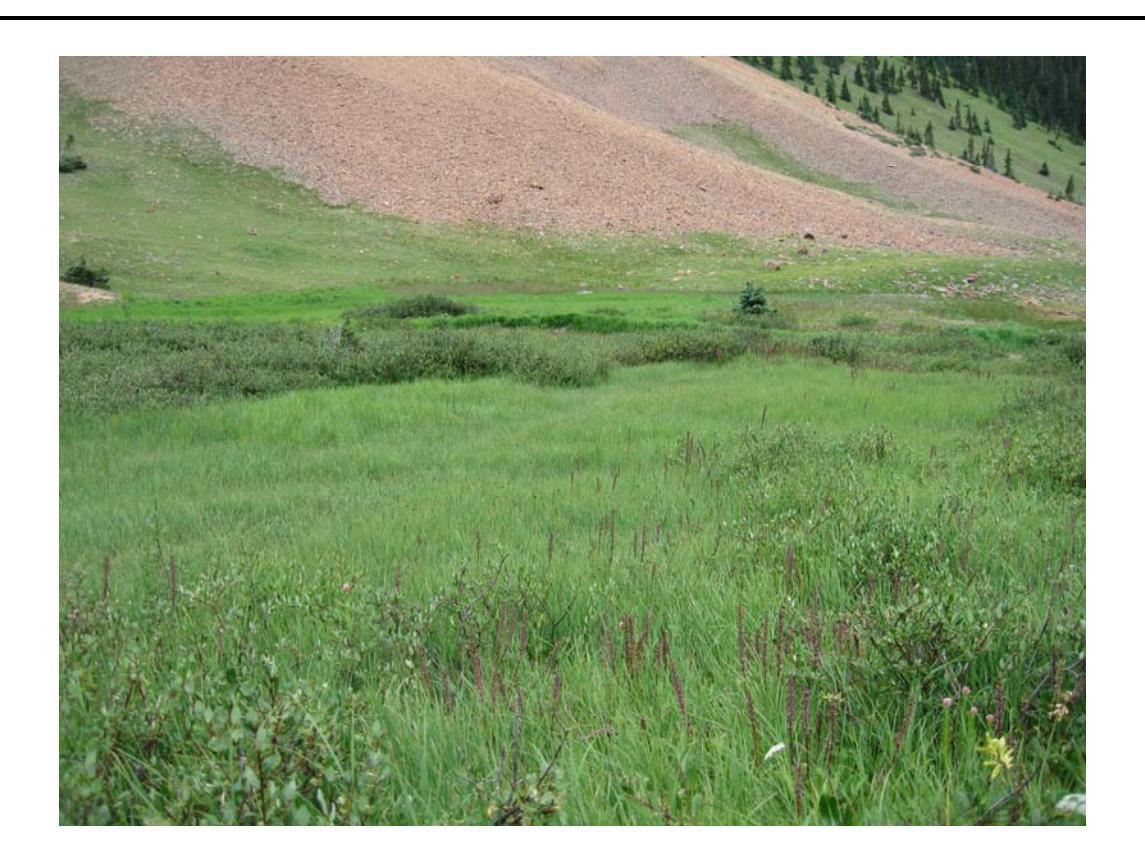
Hill Seventyone Seeps Standard Checklist Proper Functioning Condition

County: HinsdaleQuadrangle: Lake San CristobalBLM Code: D110UTM Coordinate NAD 83:E301211N4203266Elevation: 11,320ftID Team Observers:JJones, JDavinDate: July 17, 2006

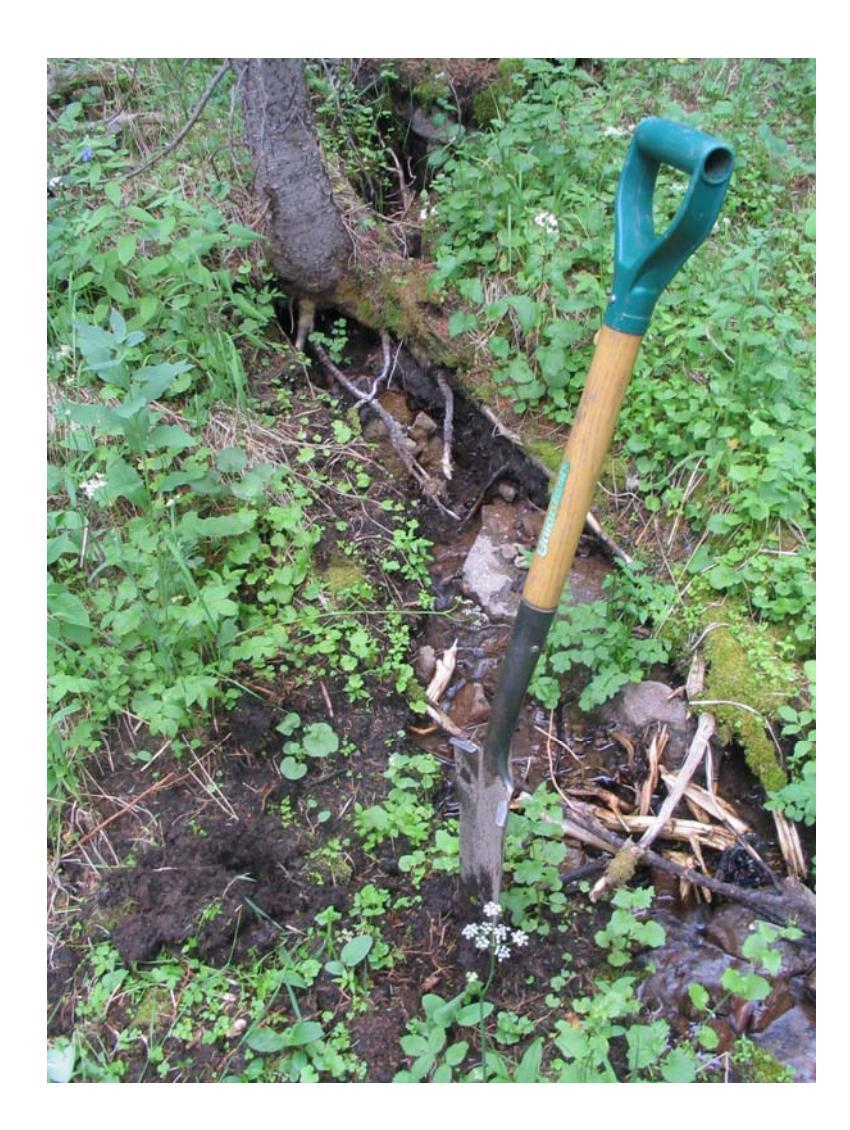
Upper Cleveland Gulch Standard Checklist Functional – At Risk

County: HinsdaleQuadrangle: Handies PeakBLM Code: D155, D156, D157UTM Coordinates NAD 83: E277861 N4202813Elevation: 12,260ft

Potential (ecological status that can be attained without above limiting factors or without limiting factors what is the ultimate goal for assessment area) Site is functioning at its potential natural community. Hydrology and water quality may have been altered by mining activity in the drainage. Old roads and mines are evident throughout the drainage. Currently there is little anthropogenic use aside from occasional recreational use, but no established trails lead into the basin.

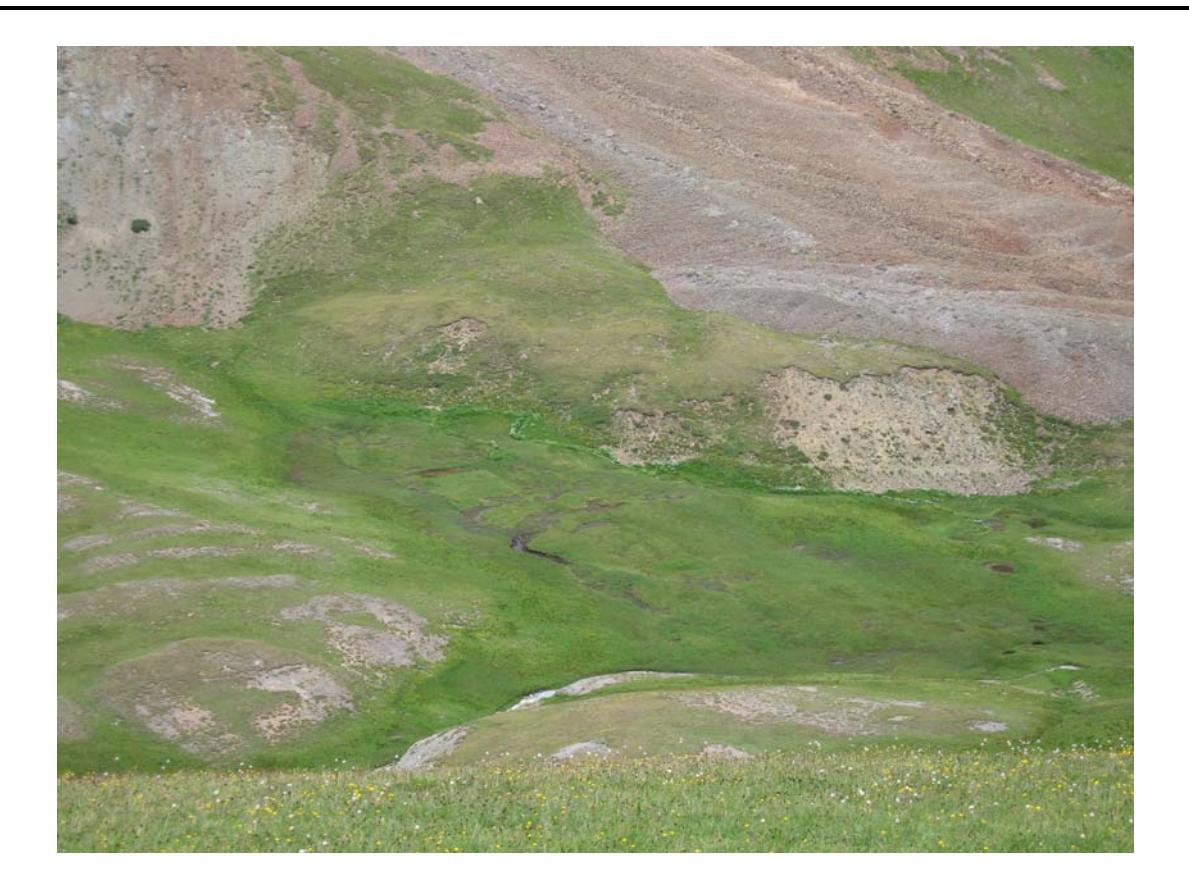
Upper Cleveland Gulch Standard Checklist Proper Functioning Condition

County: Hinse	dale	Quadrangl	e: Handies Peak	BLM Code: D160
UTM Coordinates NAD 83: E277852 N				N4202934	Elevation: 12,314ft
ID Team Observers: JJones, JDavin					Date: July 28, 2006
	Yes	No	N/A		HYDROLOGY
	Х			1) Floodplain abov	e bankfull is inundated in "relatively
-	X X	INO	IN/A	1) Floodplain abov	e bankfull is inundated in "relativel

Potential (ecological status that can be attained without above limiting factors or without limiting factors what is the ultimate goal for assessment area) Site is functioning at its potential natural community. Hydrology and water quality may have been altered by mining activity in the drainage. Old roads and mines are evident throughout the drainage. Currently there is little anthropogenic use aside from occasional recreational use, but no established trails lead into the basin.

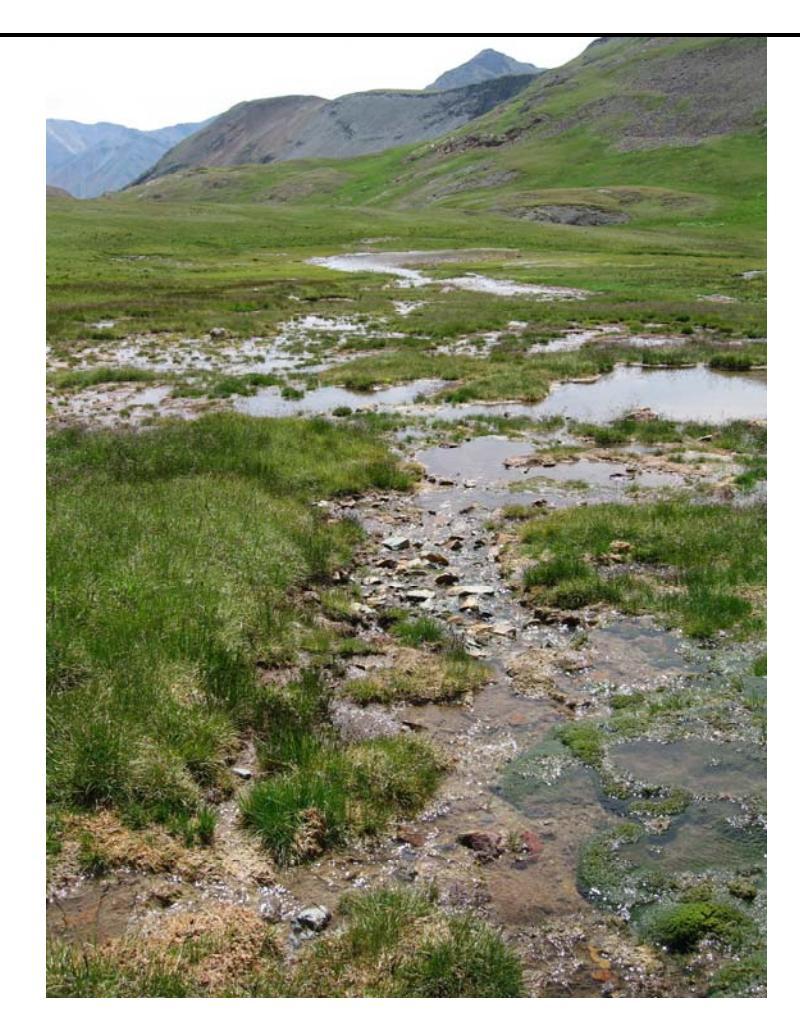
Upper Cleveland Gulch Standard Checklist Proper Functioning Condition

County: Hinse	dale	Quadrangle	e: Handies Peak	BLM Code: D162
UTM Coordin	ates NAD 8	3: E 277973	N4202970	Elevation: 12,280ft
ID Team Obse	ervers: JJon	ies, JDavin		Date: July 28, 2006
T 7		N .T.(.)

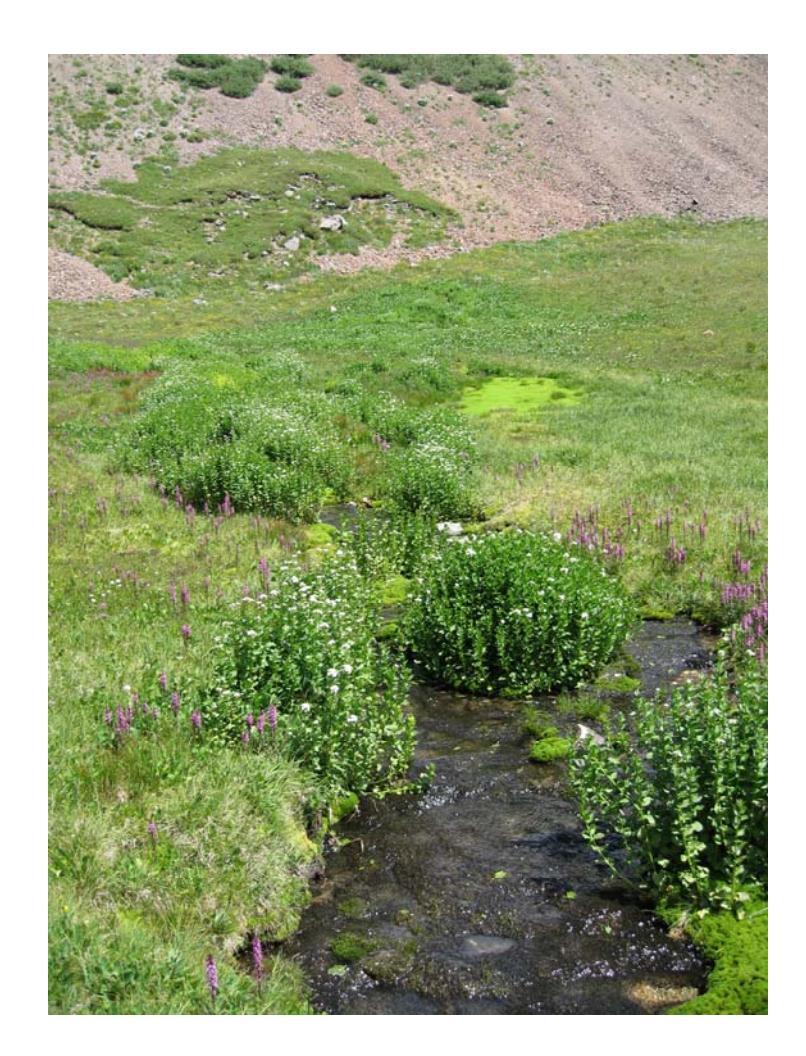
Upper Cleveland Gulch Standard Checklist Proper Functioning Condition

with the landscape setting (i.e., landform, geology, and bioclimatic region)
Х		4) Riparian-wetland area is widening or has achieved potential extent
	Х	5) Upland watershed is not contributing to riparian-wetland degradation – Old road and mining may be contributing sediment, toxins, and mineral deposits to the site

Potential (ecological status that can be attained without above limiting factors or without limiting factors what is the ultimate goal for assessment area) Site is functioning at its potential natural community. Hydrology and water quality may have been altered by mining activity in the drainage. Old roads and mines are evident throughout the drainage. Currently there is little anthropogenic use aside from occasional recreational use, but no established trails lead into the basin.

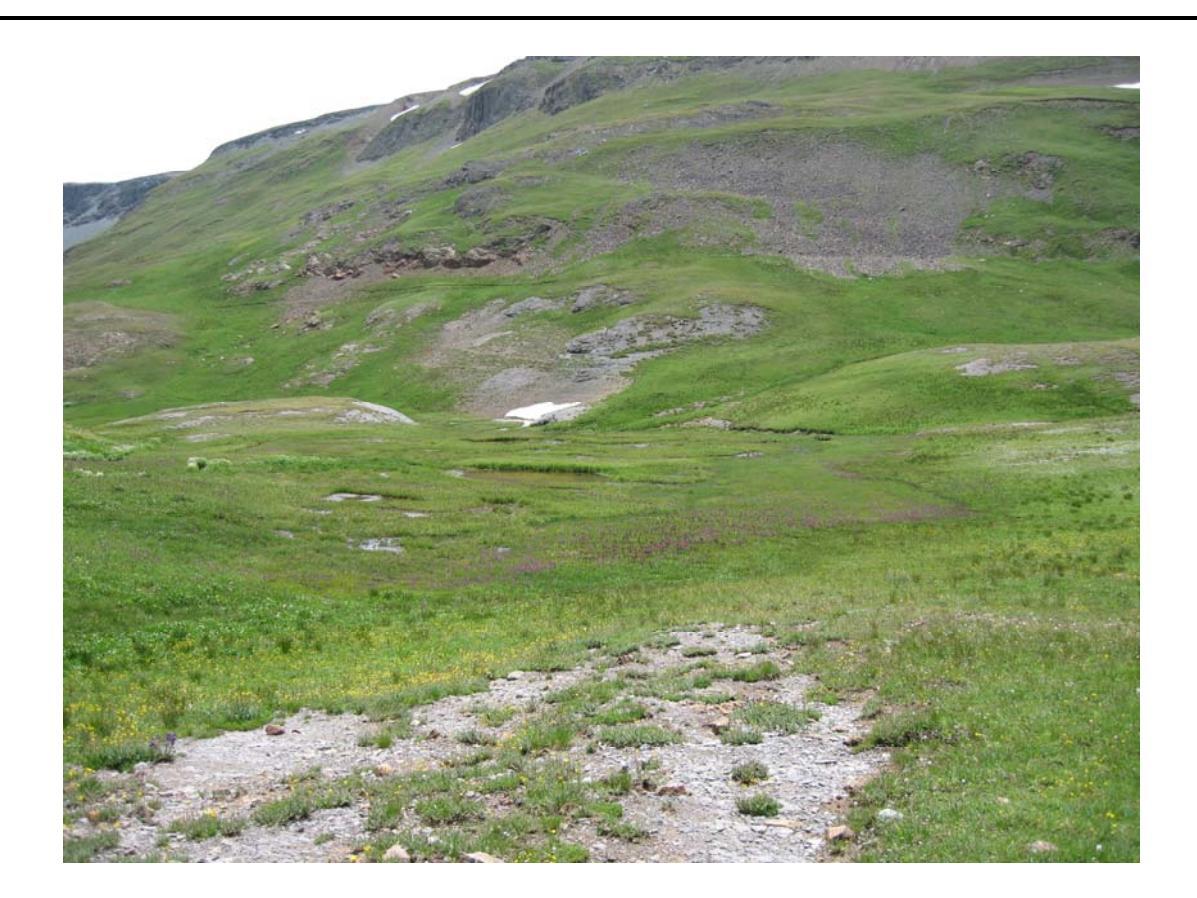
Upper Cleveland Gulch Standard Checklist Functional – At Risk

Yes	No	N/A	HYDROLOGY
X			1) Floodplain above bankfull is inundated in "relatively
			frequent" events
		Х	2) Where beaver dams are present they are active and stable
Х			3) Sinuosity, width/depth ratio, and gradient are in balance with the landscape setting (i.e., landform, geology, and bioclimatic region)
Х			4) Riparian-wetland area is widening or has achieved potential extent
	X		5) Upland watershed is not contributing to riparian-wetland degradation - Old road and mining may be contributing sediment, toxins, and mineral deposits to the site

Potential (ecological status that can be attained without above limiting factors or without limiting factors what is the ultimate goal for assessment area) Site is functioning below its potential natural community due to impacts from mining along the upper slopes of the drainage. Water quality has obviously been altered as evident in photo. Old roads and mines are evident throughout the drainage. Currently there is little anthropogenic use aside from occasional recreational use, but no established trails lead into the basin.

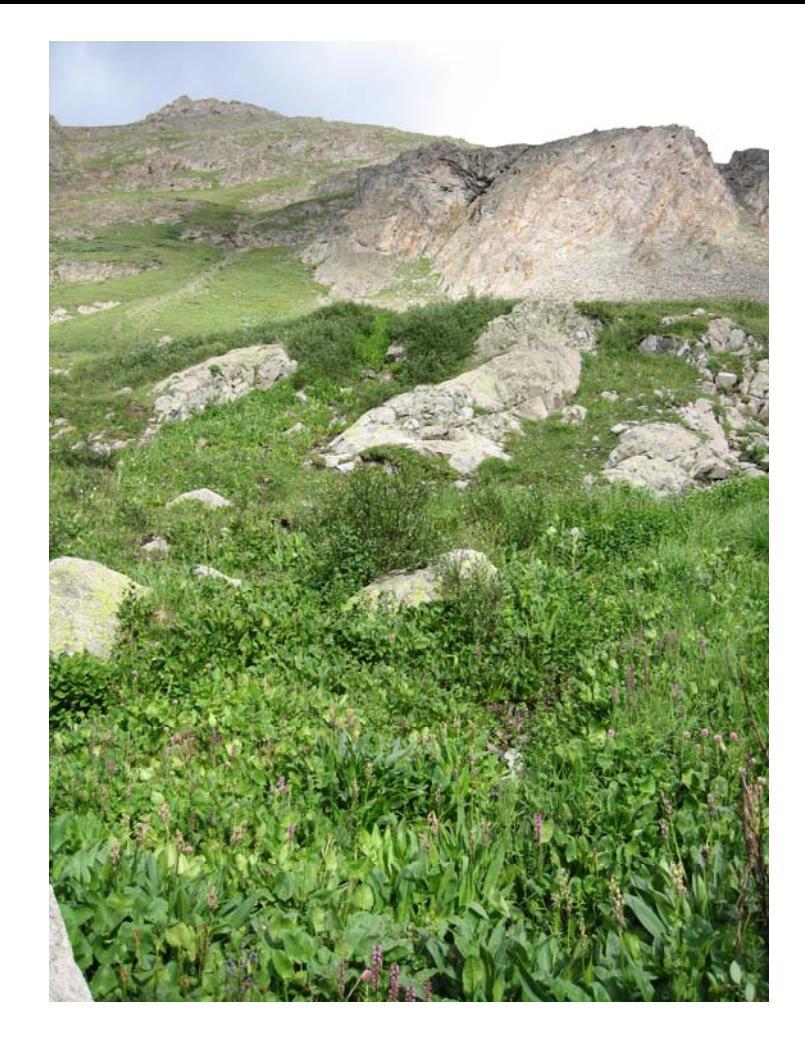
American Basin Standard Checklist Proper Functioning Condition

Quadrangle : E278802 N	Handies PeakBLM Code:D2634199662Elevation:11,766ft
s, JDavin	Date: July 27, 2006
N/A	HYDROLOGY
Х	1) Floodplain above bankfull is inundated in "relatively
	frequent" events – This small seep wetland does have a
	developed floodplain
Х	2) Where beaver dams are present they are active and stable
	3) Sinuosity, width/depth ratio, and gradient are in balance
	with the landscape setting (i.e., landform, geology, and
	bioclimatic region)
	4) Riparian-wetland area is widening or has achieved
	potential extent
	5) Upland watershed is not contributing to riparian-wetland
	degradation
	Quadrangle : E278802 N s, JDavin N/A X X

Potential (ecological status that can be attained without above limiting factors or without limiting factors what is the ultimate goal for assessment area) Wetland is functioning at its potential natural community. Disturbances in the area include recreational use and past mining which do currently not appear to impact the wetland.

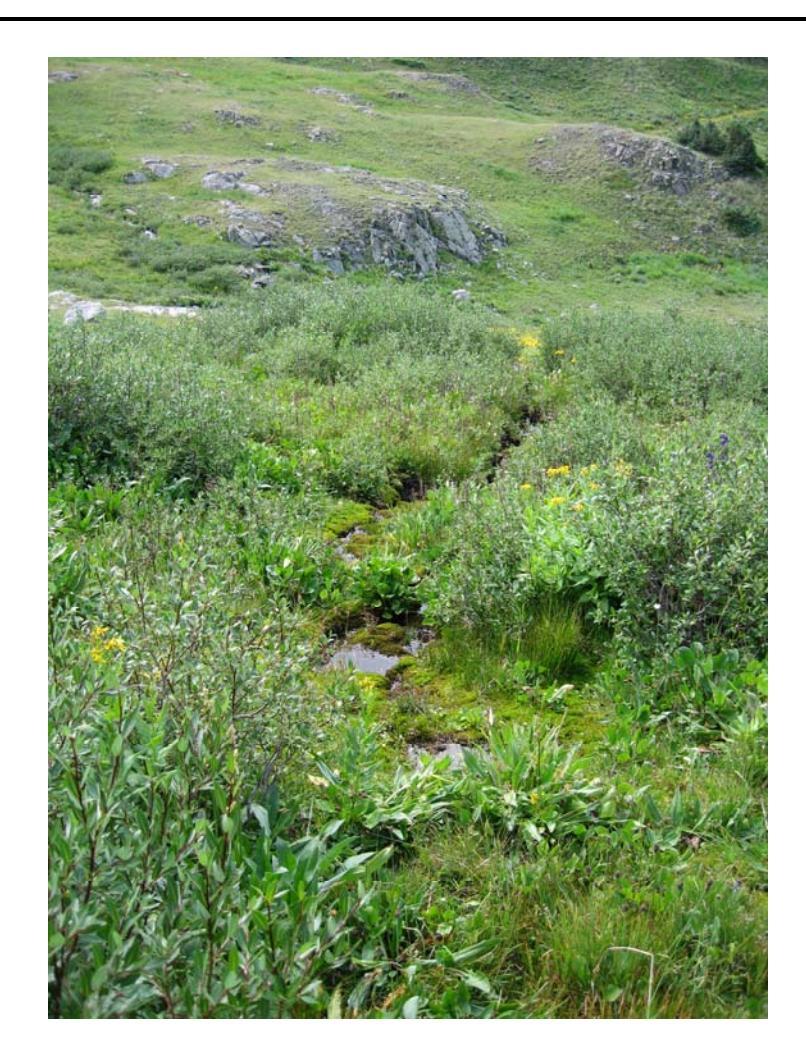
American Basin Standard Checklist Functional – At Risk

CI VCI 5. 5501	105, 5Duvin	Date: July 20, 2000
Yes	No	N/A	HYDROLOGY
X			1) Floodplain above bankfull is inundated in "relatively
			frequent" events
		Х	2) Where beaver dams are present they are active and stable
Х			3) Sinuosity, width/depth ratio, and gradient are in balance
			with the landscape setting (i.e., landform, geology, and
			bioclimatic region)
Х			4) Riparian-wetland area is widening or has achieved
			potential extent
	X		5) Upland watershed is not contributing to riparian-wetland
			degradation - Hydrology originates from draining adit

Plants: Mesic vegetation creates a narrow band along small, sinuous stream corridor. Vegetation at upper reaches just below adit composed of bryophyte species with little vascular vegetation. Lower reaches support moderate area of peat soils and vigorous wetland species. The most common (15-25%) species along lower reaches is Carex nova. Eriophorum altaicum is also present in moderate cover with some 500+ individuals covering a 40 X 15 meter area. Other species (1-10%) include Calamagrostis canadensis, Juncus castaneus, Juncus tracyi, Deschampsia caespitosa, and Cardamine cordifolia.

Potential (ecological status that can be attained without above limiting factors or without limiting factors what is the ultimate goal for assessment area) Wetland is functioning below its potential natural community due to mining and reclamation activities adjacent to the site. Vegetation appears to be healthy and vigorous, but disturbance has likely altered hydrology and water quality in the wetland. Other disturbances in the area include recreational uses which do not appear to currently impact the site.

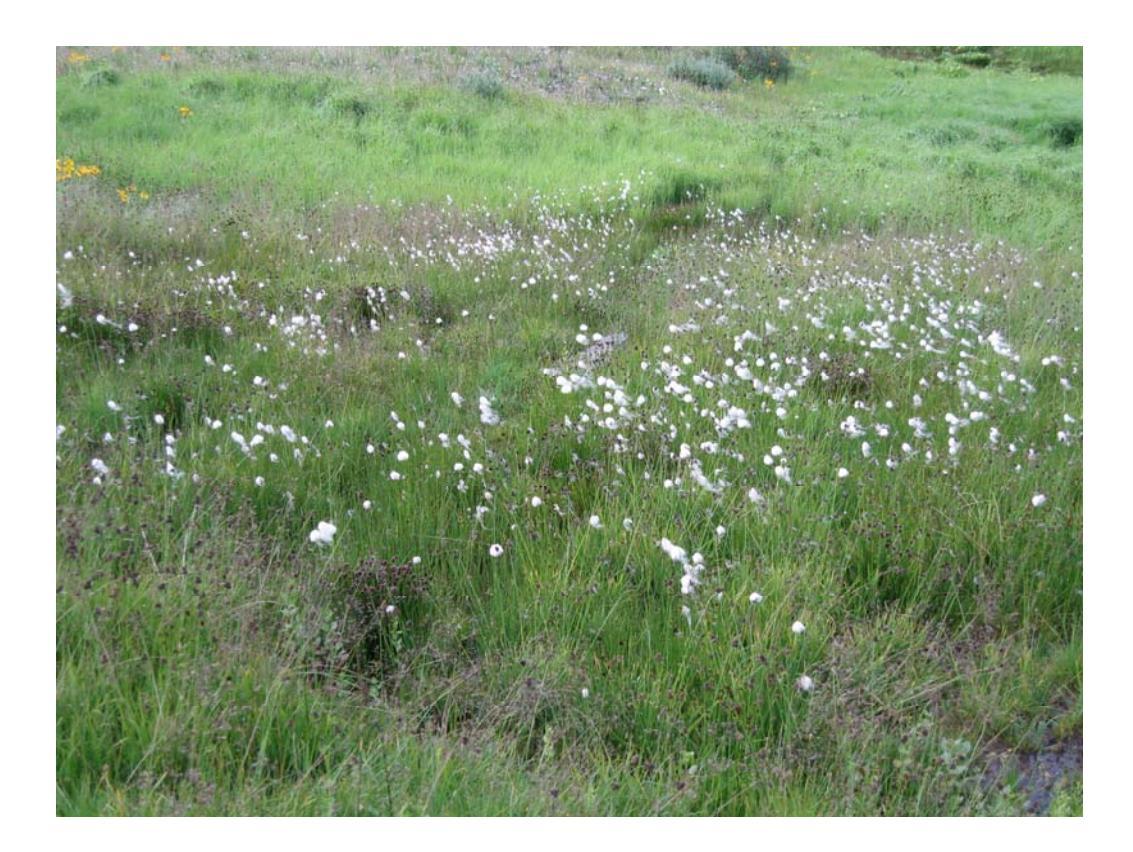
Cinnamon Pass Seeps Standard Checklist Proper Functioning Condition

Potential (ecological status that can be attained without above limiting factors or without limiting factors what is the ultimate goal for assessment area) Wetland is functioning at its potential natural community. Despite old roads and past mining use in the area, there are currently few disturbances in the area and none that appear to impact the wetland or create unacceptable conditions.
