Survey of Seeps and Springs on Bureau of Land Management lands in northern Hinsdale County 2006-2007

Prepared for: Bureau of Land Management, Gunnison Field Office 216 N. Colorado Gunnison, Colorado 81230

Prepared by: Stephanie Neid, Delia Malone, and Jennifer Jones

> > March 1, 2008

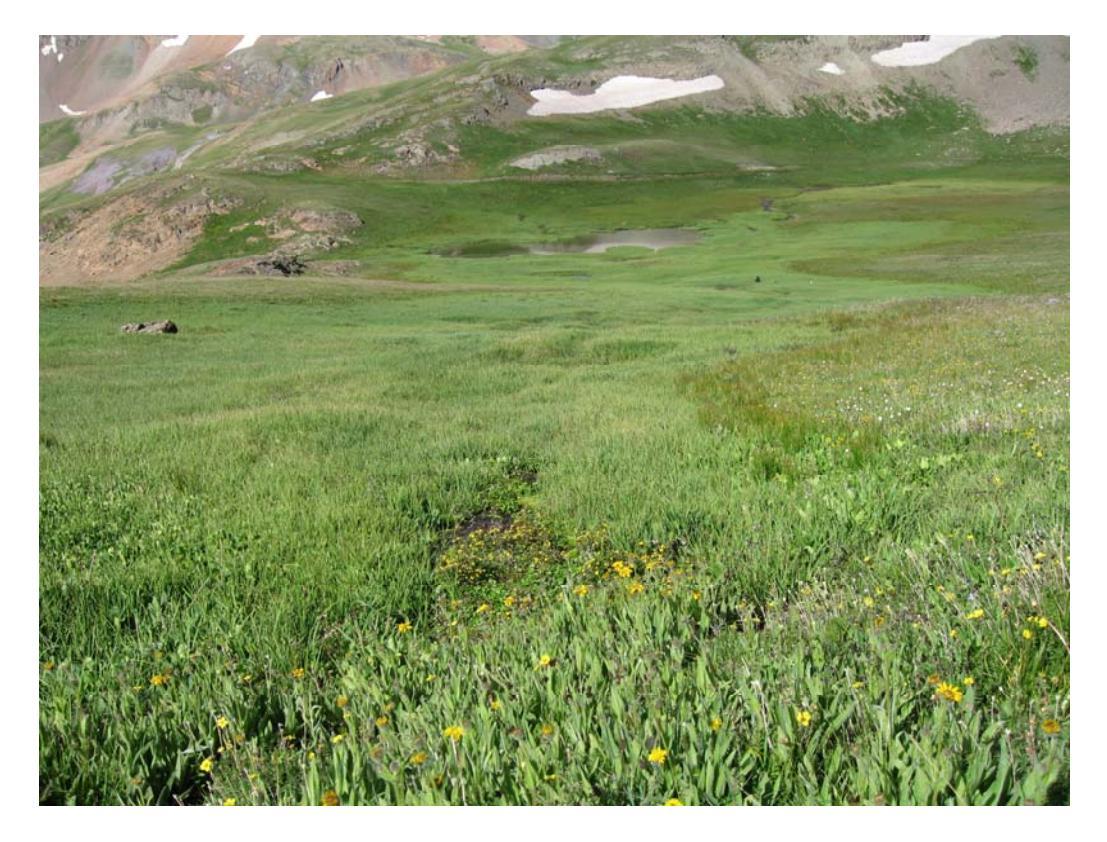
Cinnamon Pass Seeps Standard Checklist Proper Functioning Condition

Potential (ecological status that can be attained without above limiting factors or without limiting factors what is the ultimate goal for assessment area) Wetland is functioning at its potential natural community. Despite old roads and past mining use in the area, there are currently few disturbances in the area and none that appear to impact the wetland or create unacceptable conditions.

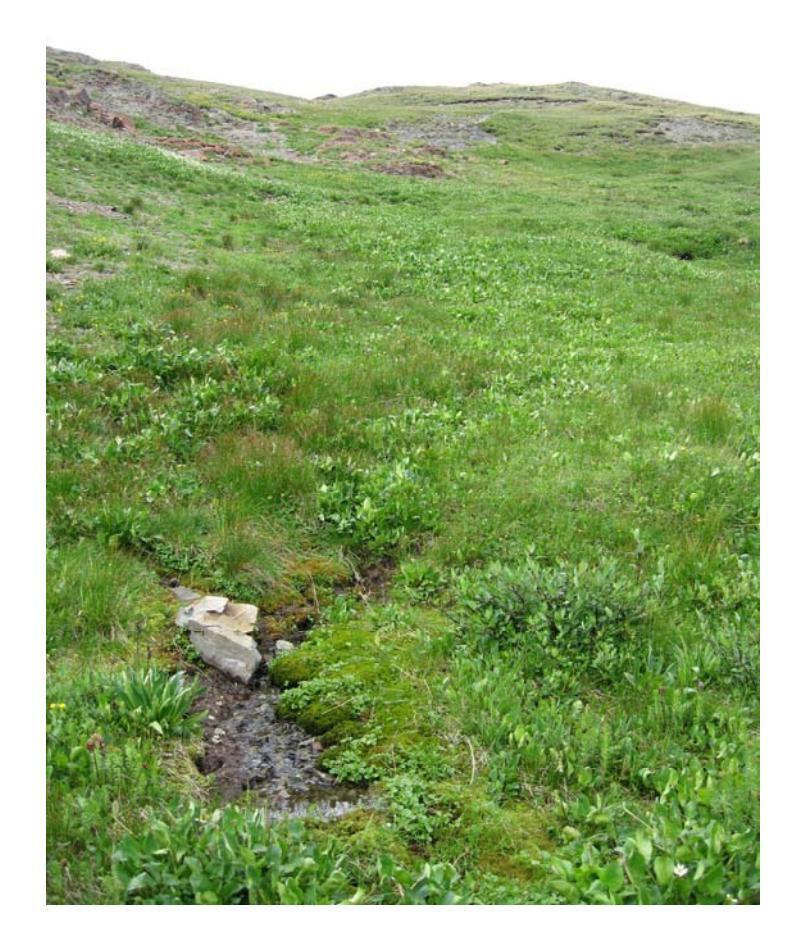
Cinnamon Pass Seeps Standard Checklist Proper Functioning Condition

Potential (ecological status that can be attained without above limiting factors or without limiting factors what is the ultimate goal for assessment area) Wetland is functioning at its potential natural community. Despite old roads and past mining use in the area, there are currently few disturbances in the area and none that appear to impact the wetland or create unacceptable conditions.

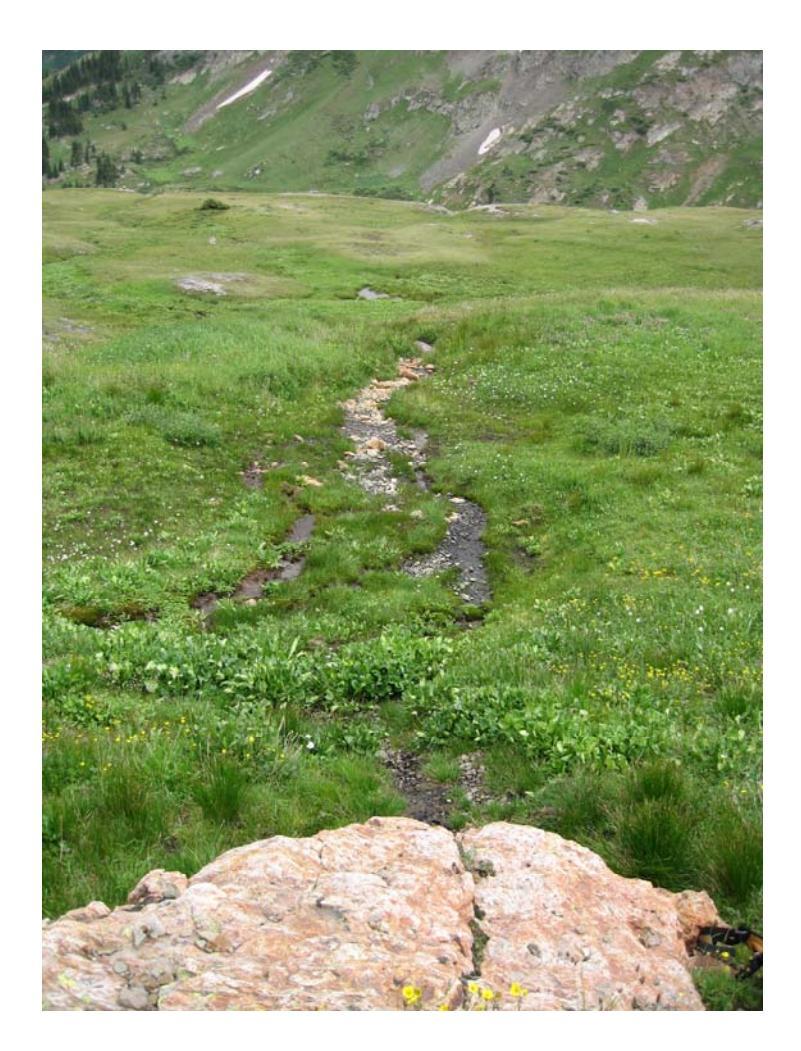
American Flats Standard Checklist Proper Functioning Condition

Plants: The majority of the area is dominated by xeric alpine vegetation with patches of mesic vegetation in late snowmelt, mesic contours, seep areas, and along small drainages. Vegetation adjacent to drainage is dominated by mesic forbs with Caltha leptosepala (35-45%) being most common. Other common (5-15%) forbs species include Podistera eastwoodiae, Cardamine cordifolia, and Saxifraga odontoloma. Common (5-10%) mesic graminoids include Deschampsia caespitosa, Juncus drummondii, Carex scopulorum, and Carex vernacula. Other species found in low cover (<5%) include Veronica wormskjoldii, Mimulus guttatus, and Primula parryi. Mesic vegetation is concentrated along small seep drainage grading into mesic to xeric alpine vegetation.

Potential (ecological status that can be attained without above limiting factors or without limiting factors what is the ultimate goal for assessment area) Wetland is functioning at its potential natural community with few disturbances in the area and no disturbances causing unacceptable conditions.

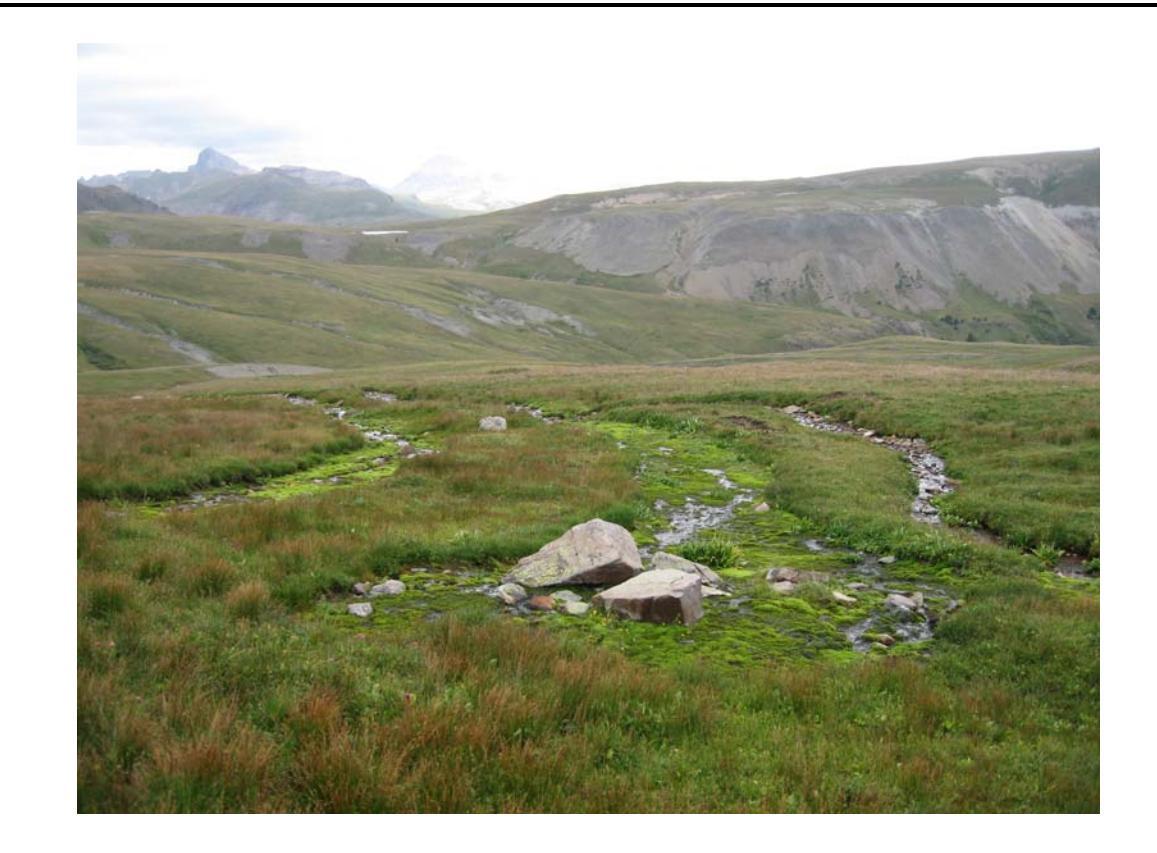
American Flats Standard Checklist Non-Functional

Potential (ecological status that can be attained without above limiting factors or without limiting factors what is the ultimate goal for assessment area) Site indicated by the BLM seeps and springs map is not a functioning wetland. Area does not exhibit signs of consistent hydrology, supports few wetland indicator species, or soils indicative of wetland hydrology. Site occurs on a small bench and may hold water in wet years and during spring snowmelt.

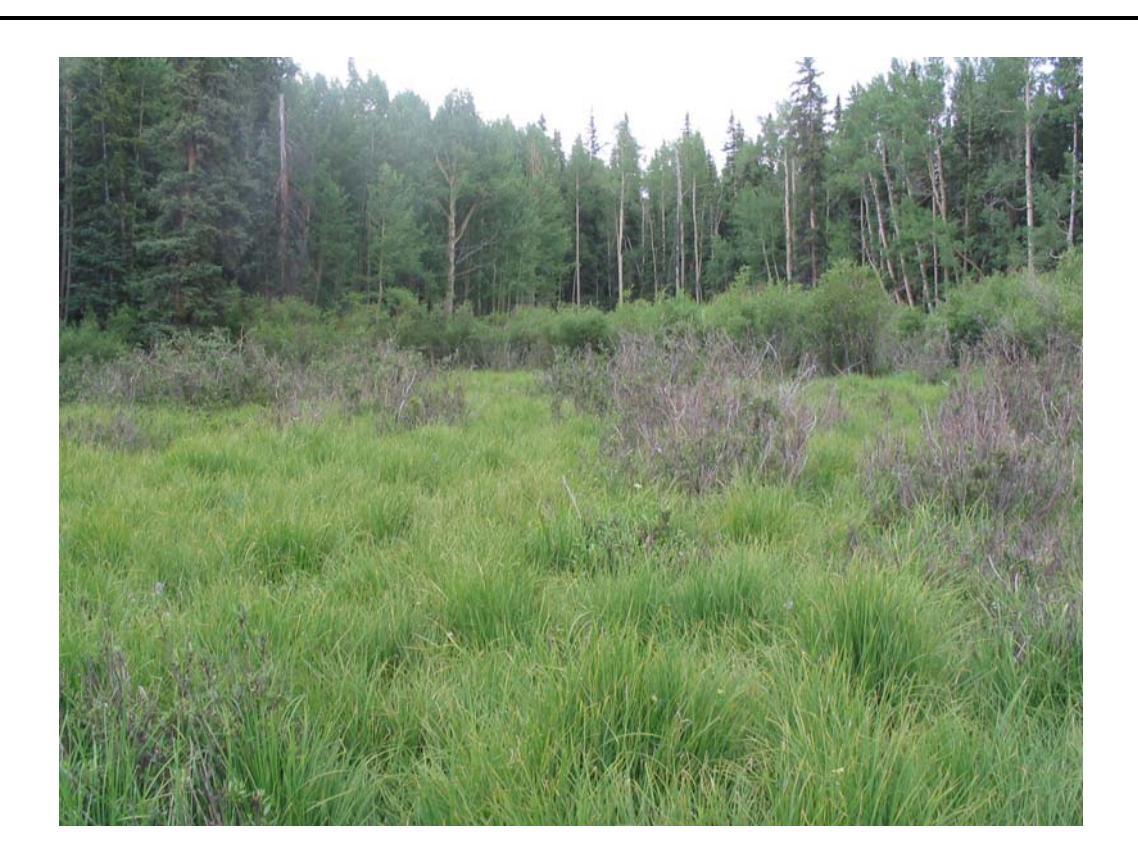
Schafer Gulch Standard Checklist Proper Functioning Condition

Plants: Vegetation is dominated by mesic herbaceous species. Carex aquatilis (10-15%), Caltha leptosepala (35-45%), and Carex illota (25-35%) are the most common species throughout. Descahmpsia caespitosa, Juncus drummondii, and Calamagrostis canadensis are also common (5-15%). Other species present (<5%) in the wetland include Packera dimorphophylla, Veronica nutans, Rhodiola rhodantha, Eriophorum altaicum, Pedicularis groenlandica, Phleum alpinum, and Craex egglestonii.

Soils: Soils consist of fibric to mucky peats to 40cm+. Soils are moist to inundated throughout the site. Drier areas support a histic epipedon of 20cm+ over clay and sandy clay (10YR 4/1).

Potential (ecological status that can be attained without above limiting factors or without limiting factors what is the ultimate goal for assessment area) Wetland is functioning at its potential natural community with few current disturbances in the drainage. Drying appears to be natural and not from disturbance. Disturbances in the area including sheep grazing and recreational uses do not appear to be affecting the wetland.

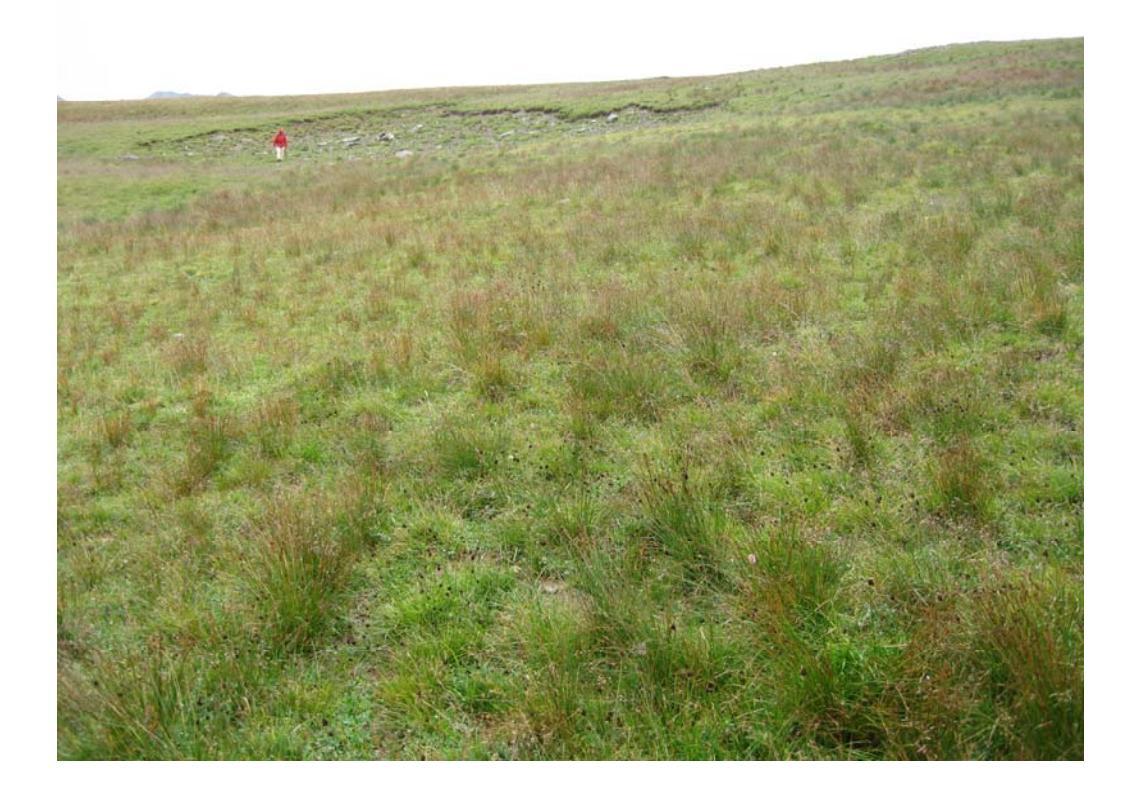
American Flats Standard Checklist Non-Functional

Potential (ecological status that can be attained without above limiting factors or without limiting factors what is the ultimate goal for assessment area) Site indicated by the BLM seeps and springs map is not a functioning wetland. Area does not exhibit signs of consistent hydrology, supports few wetland indicator species, and no soils indicative of wetland hydrology. Site occurs in a small contour and may hold water in wet years and during spring snowmelt.

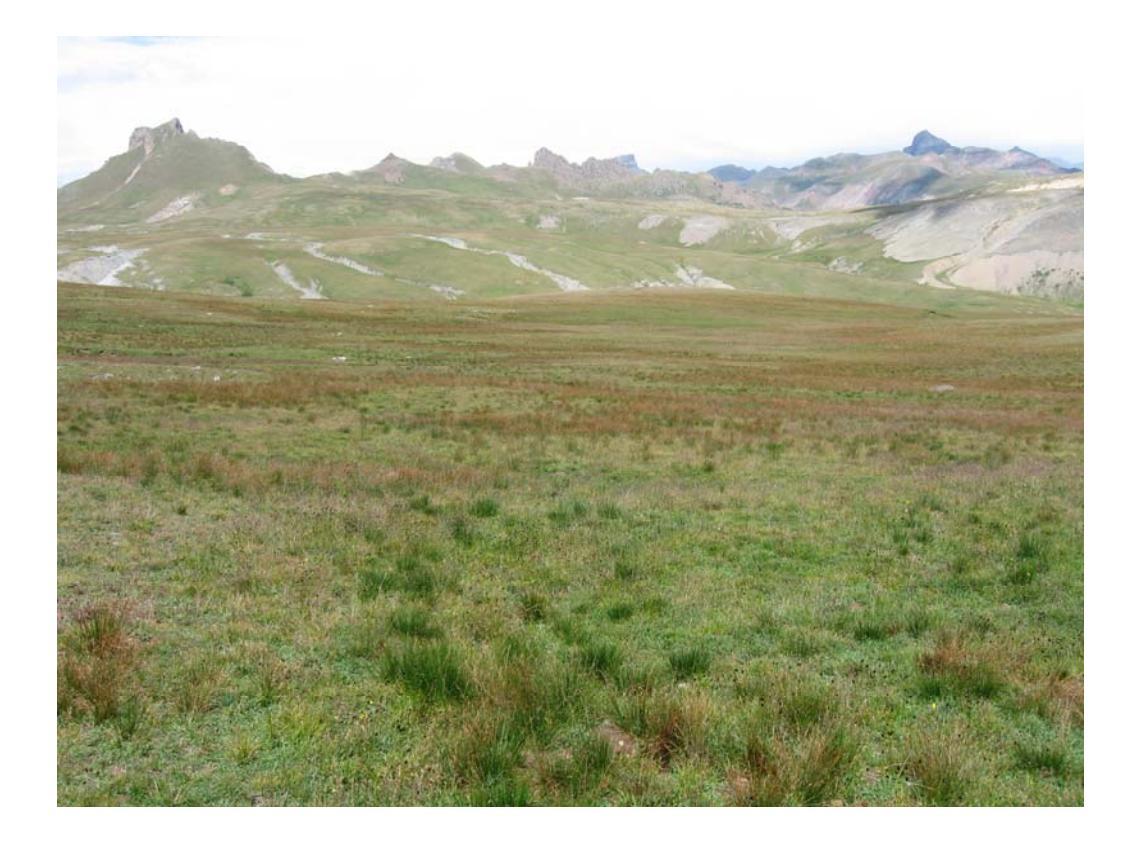
American Flats Standard Checklist Non-Functional

Potential (ecological status that can be attained without above limiting factors or without limiting factors what is the ultimate goal for assessment area) Site indicated by the BLM seeps and springs map is not a functioning wetland. Area does not exhibit signs of consistent hydrology, supports few wetland indicator species, and no soils indicative of wetland hydrology.

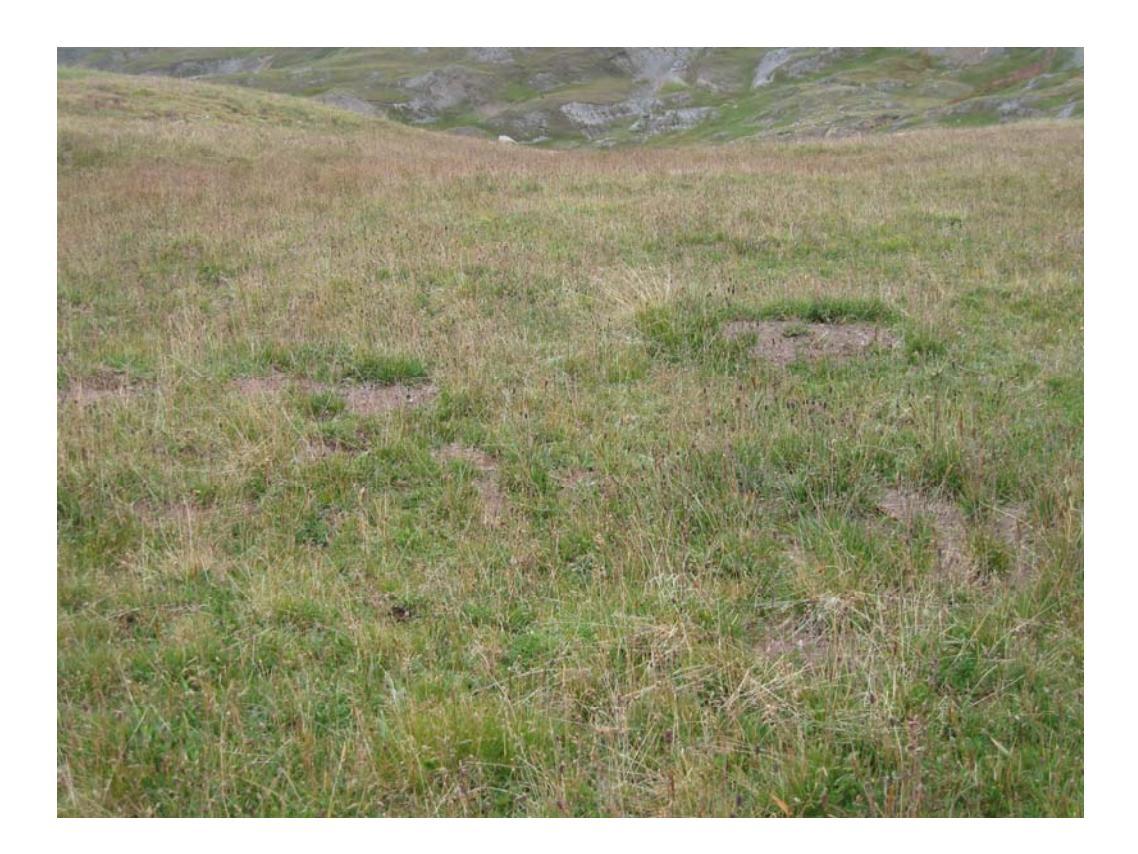
Spring Creek Seeps Lentic Standard Checklist Functioning Condition

Potential (ecological status that can be attained without above limiting factors or without limiting factors what is the ultimate goal for assessment area) Wetland is functioning at its potential natural community. The immediate area has few disturbances or conditions creating unacceptable conditions. Livestock use in the area is not extensive and does not appear to affect the wetland.

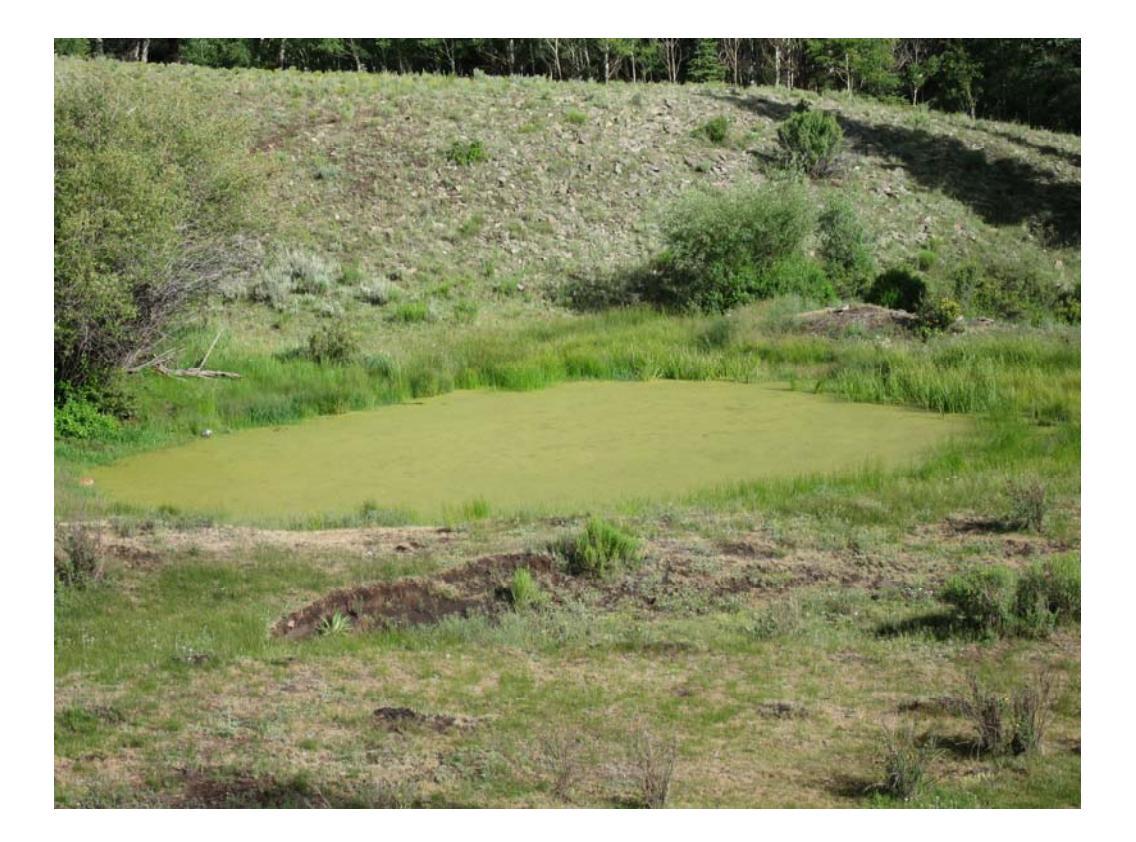
Powderhorn Lakes Trail Standard Checklist Proper Functioning Condition

Plants: Vegetation consists of a moderate band of shrubs and mesic graminoids along the edge of small, lentic wetland. Mesic graminoids dominate the immediate pond edge with shrub dominated areas dominating drier areas up from the pond. Salix planifolia is the dominant shrub at 65-75% cover. Carex aquatilis is the dominant understory species with 15-25% cover. Other common (5-10% cover) species include Calamagrostis canadensis, Senecio triangularis, Caltha leptosepala, and Petasites sagittatus. Small area along southern side of pond is dominated by Carex saxitilis with Carex aquatilis, Calamagrostis canadensis, and Salix planifolia. Callitriche verna is present in moderate cover in pond.

Soils: Soils were sampled along northeastern edge of pond. Soils consist of fibric to hemic peat accumulations greater than 40cm. Soils moist at surface, water at 20cm.

Potential (ecological status that can be attained without above limiting factors or without limiting factors what is the ultimate goal for assessment area) Wetland is functioning at its potential natural community with no disturbances leading to unacceptable conditions. Adjacent trail does not appear to currently affect hydrology or species composition at the site.

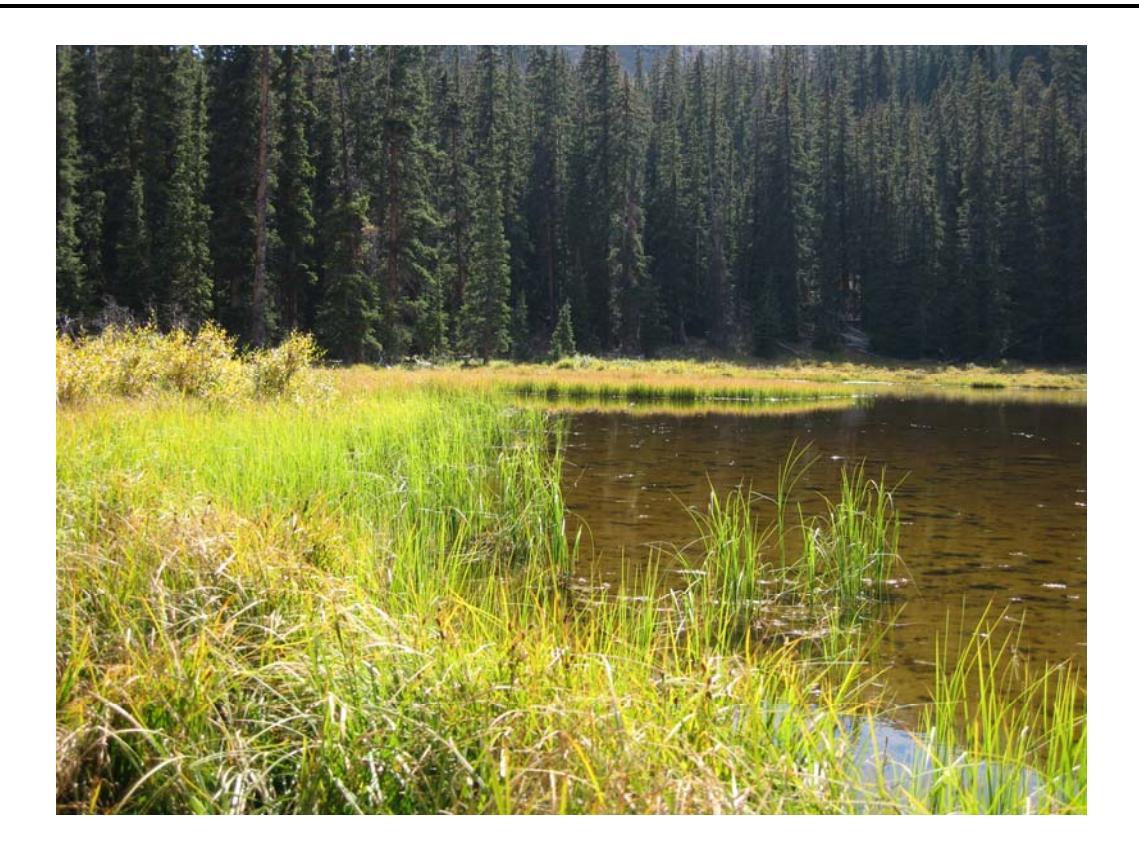
Hidden Lakes Fen Standard Checklist Proper Functioning Condition

Potential (ecological status that can be attained without above limiting factors or without limiting factors what is the ultimate goal for assessment area) Wetland is functioning just below its potential natural community. The predominant disturbance in the area is the adjacent Powderhorn Lakes trail, which surrounds three sides of the wetland. There were no immediate impacts observed by the proximity of the trail, but the adjacent trail may act as a corridor for exotic species and may confine the wetland or increase drying if used by hikers.

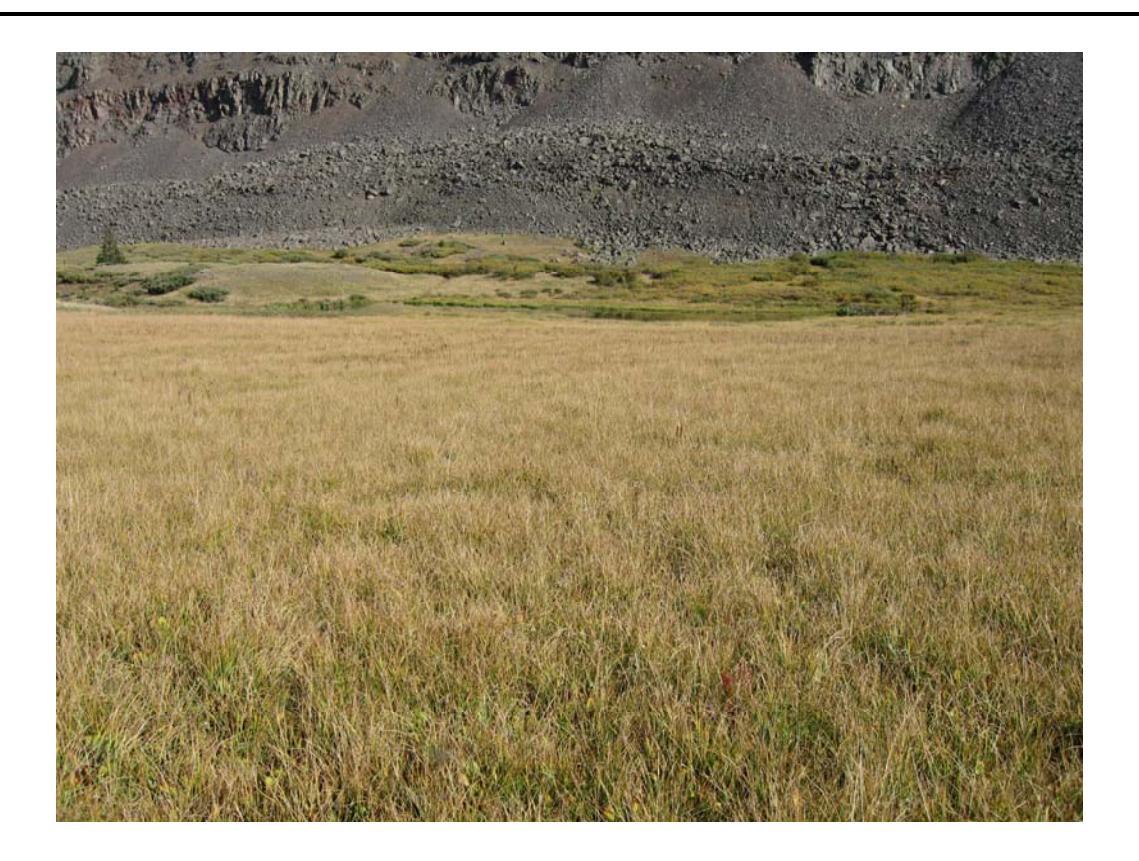
Engineer Pass – Mine Shaft Seep Standard Checklist Proper Functioning Condition

Plants: The majority of the area is dominated by xeric alpine vegetation with patches of mesic vegetation in late snowmelt, mesic contours, seep areas, and along small drainages. Vegetation in the wetland is dominated by herbaceous species with Carex scopulorum (45-55%) and Caltha leptosepala (15-25%) being most common. Other common (5-10%) species include Calamagrostis canadensis, Carex illota, and Carex egglestonii. Other species present (1-5%) in the wetland include Carex nigricans, Podistera eastwoodiae, Deschampsia caespitosa, Phleum alpinum, and Juncus balticus. Vegetation appears to be healthy and vigorous with few disturbances.

Potential (ecological status that can be attained without above limiting factors or without limiting factors what is the ultimate goal for assessment area) Wetland is functioning below its potential natural community due to impacts from mine shaft in the center of the wetland. Other disturbances in area do not appear to be impacting the site or influencing hydrology or species composition.

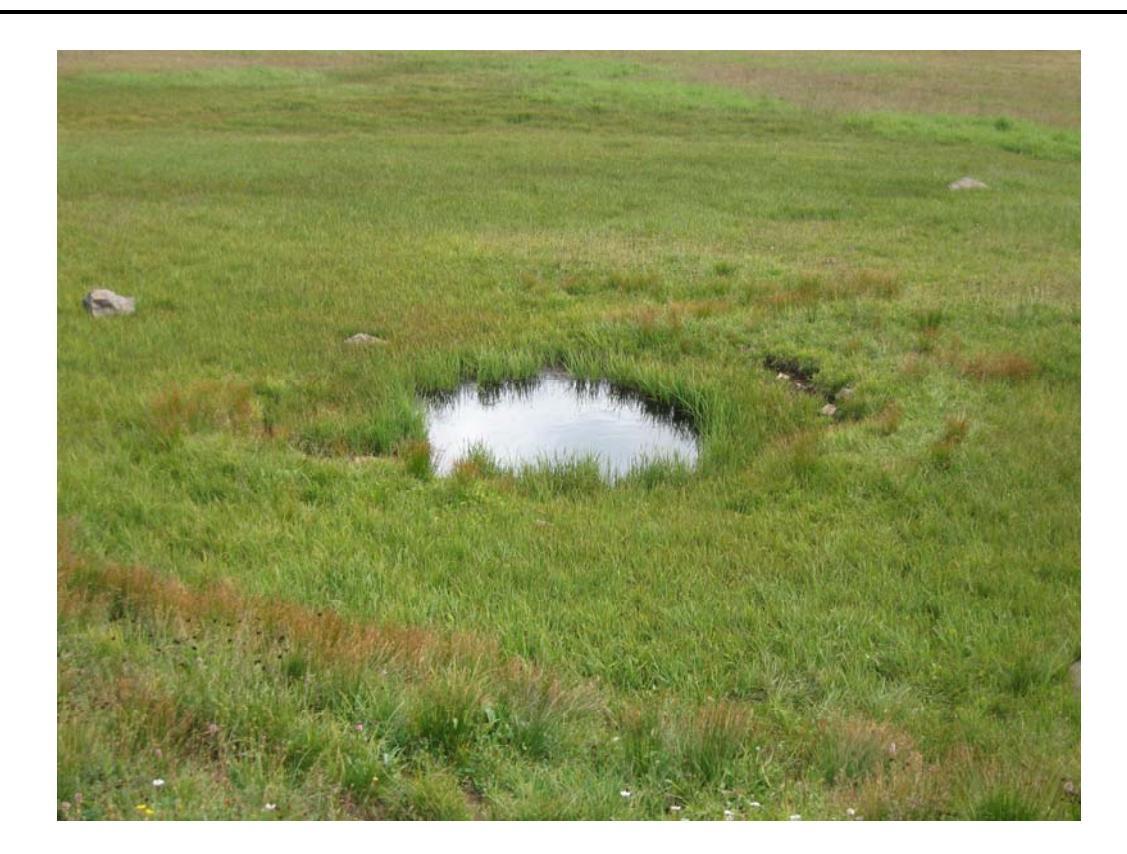
Palmetto Gulch Standard Checklist Functional – At Risk

potential extent
	X		5) Upland watershed is not contributing to riparian-wetland degradation – Wetland located just below draining adit,
			white precipitates present along streambed
Yes	No	N/A	VEGETATION
X			6) There is diverse age-class distribution of riparian-wetland
			vegetation (recruitment for maintenance/recovery)
Х			7) There is diverse composition of riparian-wetland
			vegetation (for maintenance/recovery)
X			8) Species present indicate maintenance of riparian-wetland
			soil moisture characteristics
X			9) Streambank vegetation is comprised of those plants or
			plant communities that have root masses capable of
			withstanding high stream flow events
Х			10) Riparian-wetland plants exhibit high vigor
Х			11) Adequate vegetative cover is present to protect banks
			and dissipate energy during high flows
		Х	12) Plant communities are an adequate source of coarse
			and/or large woody material for maintenance/recovery) -

Plants: Vegetation is dominated by a short shrubland of Salix planifolia (35-45%) with mesic graminoids. Shrubs are stunted which may be due to high mineral content of hydrology, saturation cycles, alpine elevation. Understory is dominated by a mix of mesic herbaceous species including Carex aquatilis, Carex scopulorum, Podistera eastwoodiae, and Calamagrostis canadensis all in low to moderate cover (5-15%). Other species present (<5%) include Rhodiola rhodantha, Juncus drummondii, and Deschampsia caespitosa. Surroudning uplands are dominated by xeric to mesic alpine meadow vegetation.

Potential (ecological status that can be attained without above limiting factors or without limiting factors what is the ultimate goal for assessment area) Site is functioning below its potential natural community due to impacts from adjacent mining activities including draining adit, adjacent road, and reclamation efforts. These activities have likely diminished water quality and altered the hydrologic regime. Wetland is functioning despite these impacts.

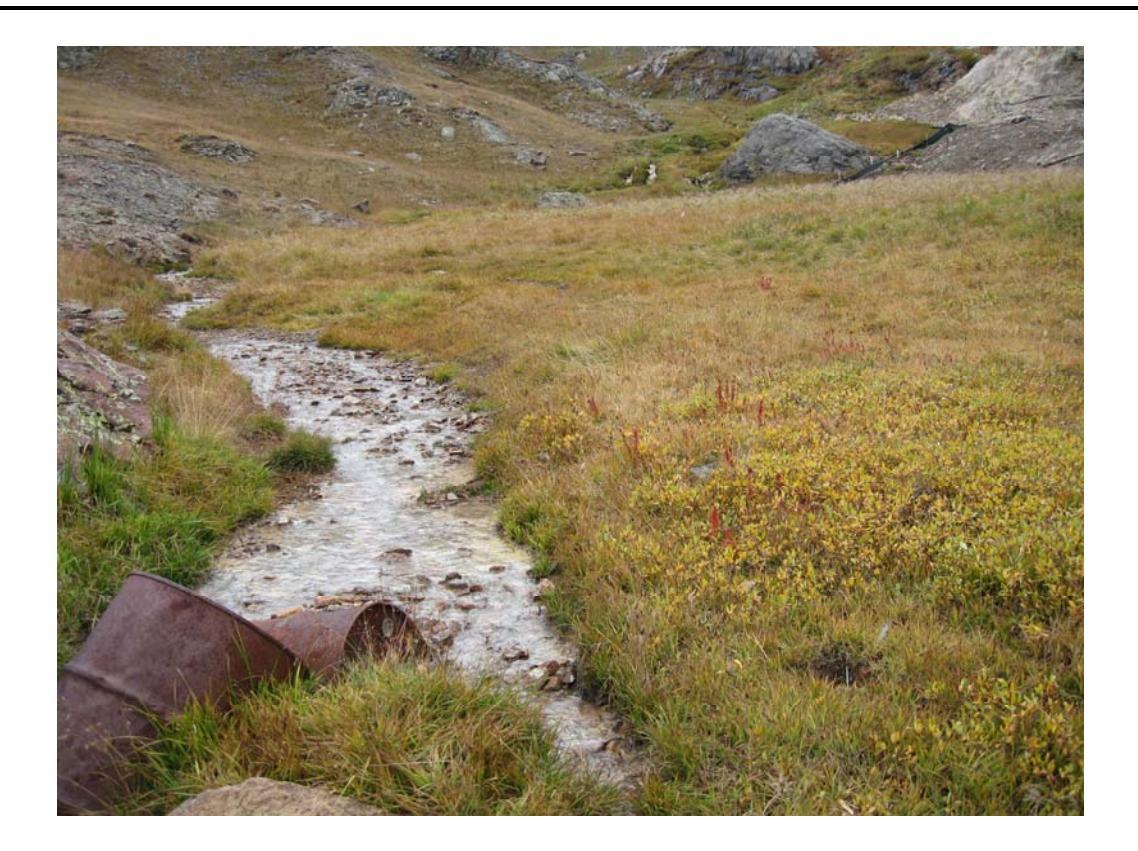
Palmetto Gulch Mine Wash Standard Checklist Functional – At Risk

Non-Functional		
Unknown		
*Trend for Functional At R	lisk:	
Upward		
Downward		
Not Apparent		
Are factors contributing to un	acceptable conditions outsi	de BLM's control or
management?	-	
Yes X No		
If yes, what are those factor	·s?	
X_Dewatering	Mining activities	Watershed condition
Dredging activities	Road encroachment	Land ownership
		1 1 . 1 1. 1
Other (specify e.g., grazing, irrigati	ion, agriculture activities) <u>Dryin</u>	ig may be due to drought conditions

Potential (ecological status that can be attained without above limiting factors or without limiting factors what is the ultimate goal for assessment area) Site is functioning below its potential natural community due to anthropogenic disturbances in the including past mining, sheep grazing, and recreational use. Drying in the area appears to be natural and not caused by disturbance. Natural disturbances in the area include avalanche activity and spring flooding.

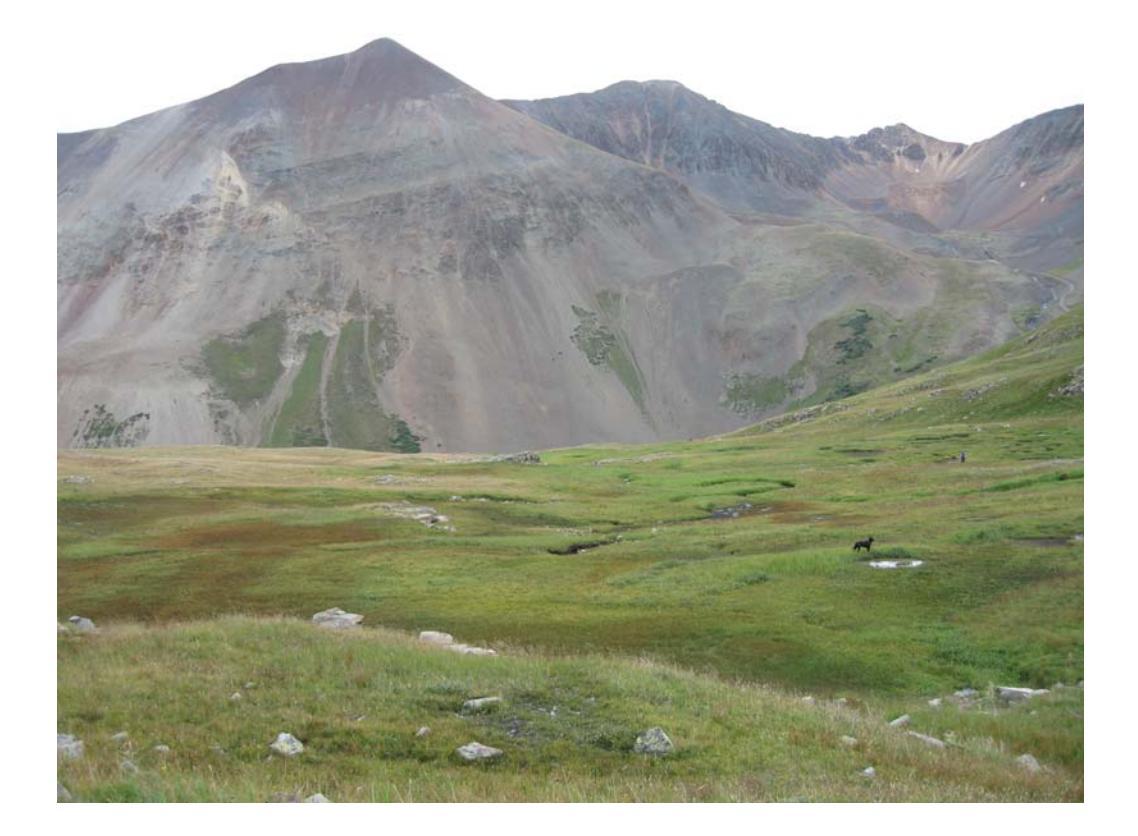
Powderhorn Trail Fen Standard Checklist Proper Functioning Condition

Potential (ecological status that can be attained without above limiting factors or without limiting factors what is the ultimate goal for assessment area) Wetland is functioning at its potential natural community with few disturbances contributing to unacceptable conditions. Powderhorn Lakes trail crosses near the origin of the seep, but does not appear to be affecting hydrology at the site.

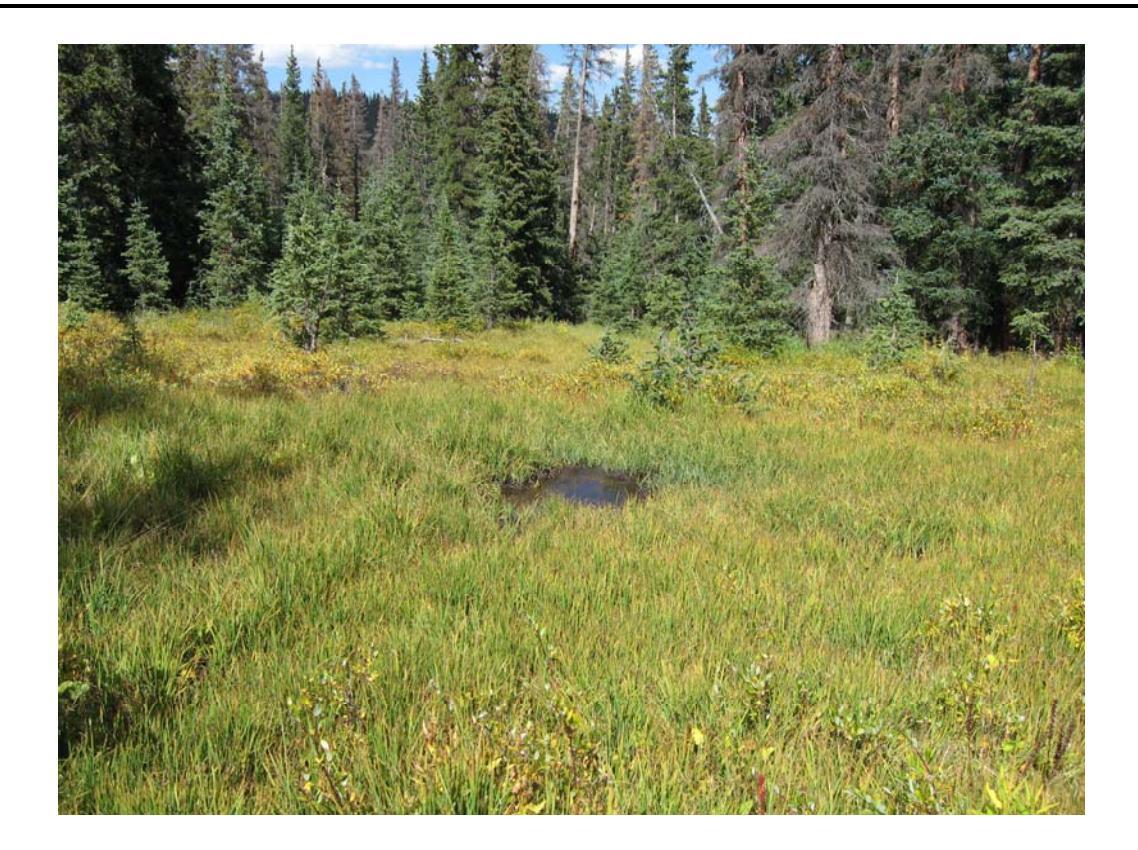
Upper Palmetto Gulch Standard Checklist Functional - At Risk

Potential (ecological status that can be attained without above limiting factors or without limiting factors what is the ultimate goal for assessment area) Wetland is functioning below its potential natural community due to disturbances in the area. Evidence of disturbance can be seen along banks of channel in the form of soil wasting and bare areas. Vegetation appears to be vigorous and hydrology intact despite disturbed soils.

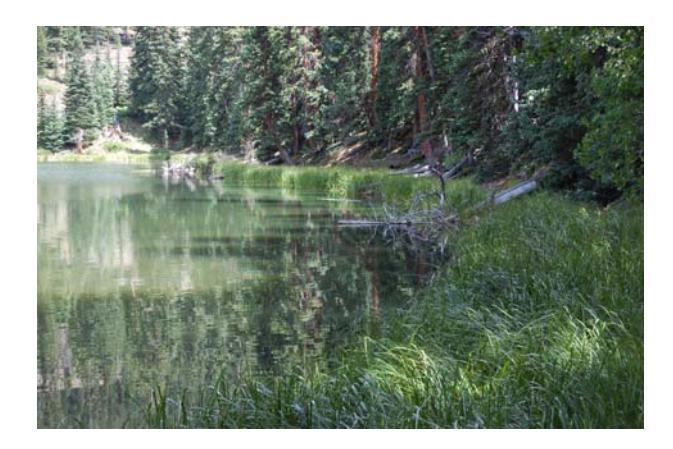
Name of Riparian-Wetland Area:		Henson Creek/Chicago Tunnel			
Date:	9/1/2007		Segment/Reach ID:	AM-2157	
ID Team Observers:			Malone

Site is a beaver pond. Site is not at potential due to recreational vegetation trampling with associated wildlife disturbance which degrades ecosystem sustainability.

Recreational trampling of wetland and bank vegetation and associated wildlife disturbance degrades potential and threatens the sustainability of this site. Some dams are failing due to human trampling impacts and where trampling has destroyed bank vegetation excessive erosion is occurring.

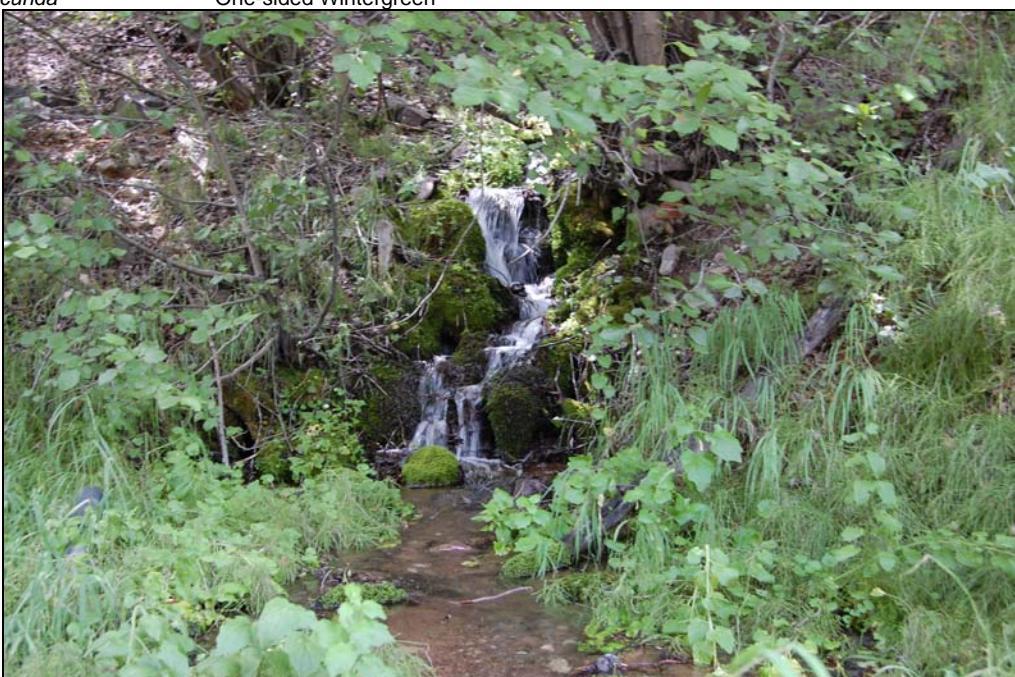
Name of Riparian-Wetland Area:				Gladiator Mine
Date:	8/13/2007		Segment/Reach ID:	AM-2404
ID Team Observers:			Malone

General Description: Mine dump is located on a steep South-facing hillslope and goes for 50m downhill to the bottom of a ravine to where a stream flows in an easterly direction. Precipitation runoff from the dump flows directly into the stream and waste rock is carried into the riparian zone. Adjacent uplands are severely degraded by historic mining activities and current development and recreational activities. South-facing hillslope habitat is characterized by an open Pseudotsuga menziesii forest with and understory that includes shrubs such as Ribes cereum, Shepherdia canadensis and Arctostaphylus uva-ursi, and numerous grasses including Hesperostipa comata and Elymus longifolius.

Riparian habitat is recovering from mining-related activities but the dump inhibits complete recovery. The riparian zone is confined by a narrow ravine and is characterized by a Populus tremuloides-Alnus incana woodland. Herbaceous cover is dominated by mosses which provide essential stream bank stability.

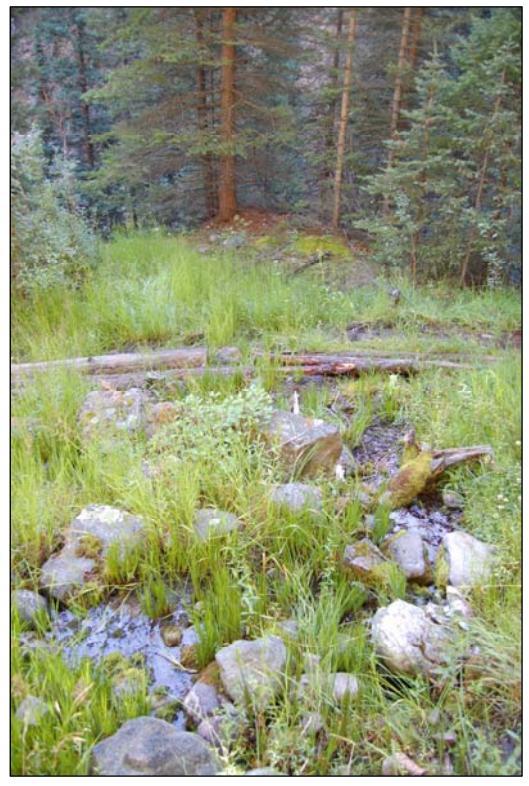
A very heavy growth of ilamentous algae that covers 90% of the channel to a depth of 2-5cm appears as the stream flows to the stream.

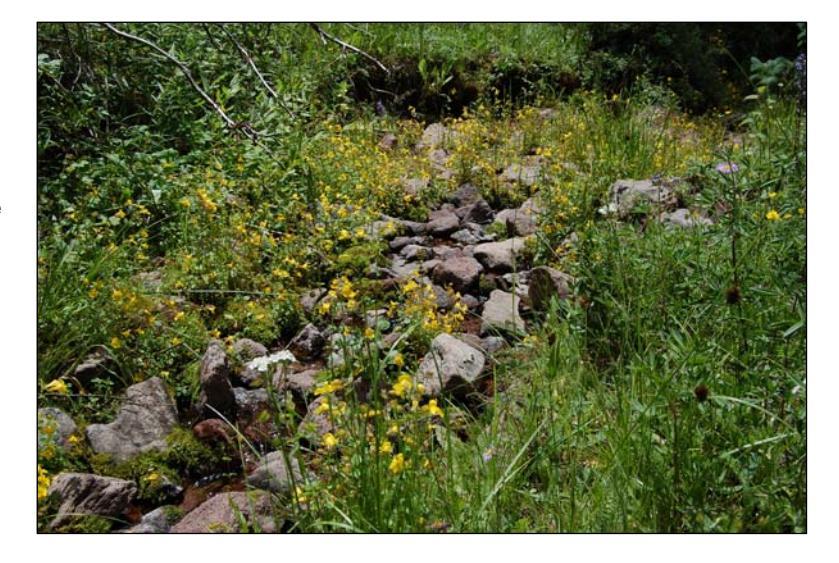
General Description:Seep daylights in gently sloping terrain in an aspen grove and flows southwest for about 12m before being diverted by a roadcut. The seep supports riparian/wetland vegetation on 1-2m on each side of the channel.

Riparian habitat is characterized by a Populus tremuloides/Tall forb woodland. Uplands are characterized by a mosaic of aspen groves interspersed with open, mesic to dry, meadows dominated by mountain lupine, fescue spp. and brome spp.

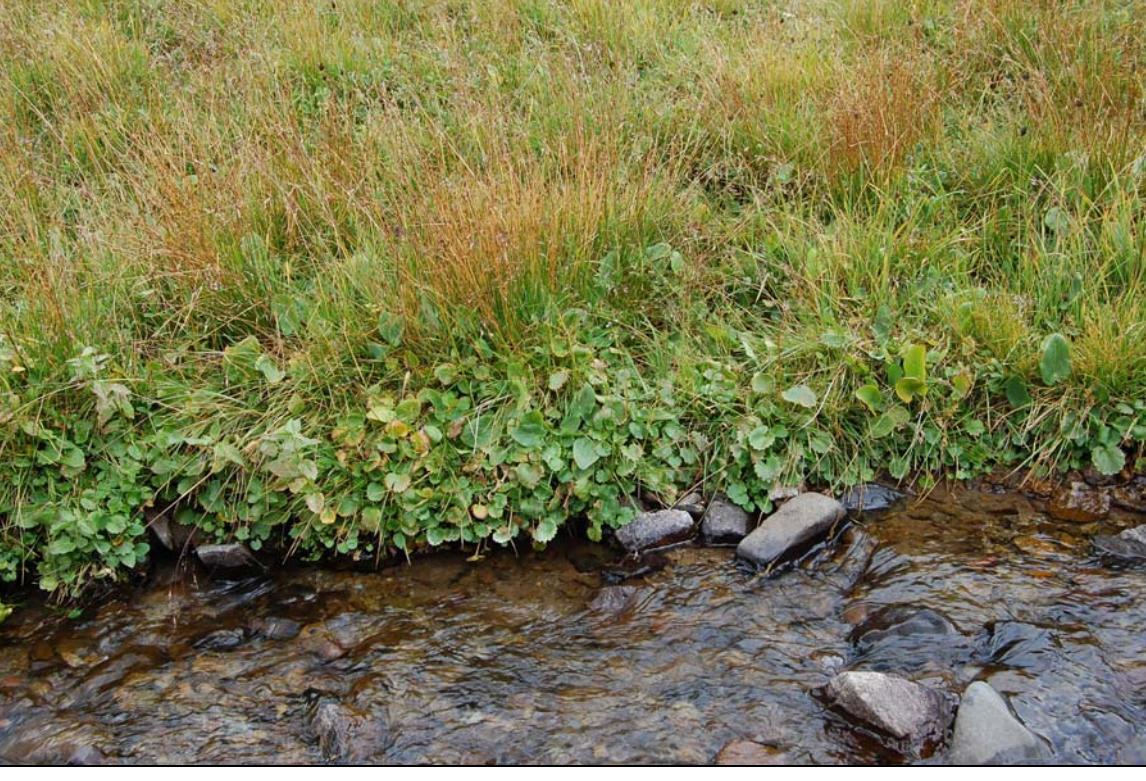
A spring daylights at the base of a rocky outcrop on a steep southeast-facing talus slope. Riparian vegetation at the originn of the seep is sparse with <5% cover. However, by 130m downslope where the seep/stream crosses a trail, riparian zone width has increased to 2m/bank with 90% cover. Vegetation is dominated by herbaceous vegetation (90% cover) characterized by Cardamine cordifolia-Mertensia ciliata-Senecio triangularis Herbaceous vegetation with islands of willow (15% cover) characterized by Salix planifolia/Mesic forb Shrublands.

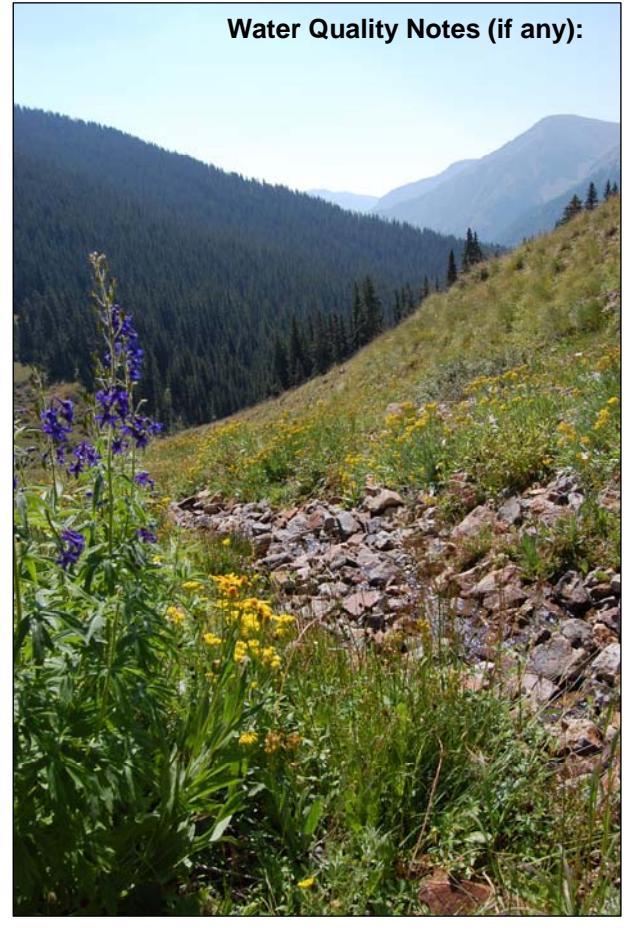
Spring daylights at the base of a south-facing low-gradient slope from under a boulder 5m to the south of Engineer Pass road. Spring discharge flows northward for 5m where it encounters the road and is channeled into a roadside ditch from where it flows east for 380m whereupon flow is channeled into a culvert, under the road and into Henson Creek.

The meadow above the spring is dominated by mesic forbs, grasses and shrubs. Adjacent upland vegetation is dominated by Populus tremuloides. Discharge from the spring and slope discharge supports wetland vegetation along the roadside for 250m. Wetland vegetation is characterized by a mosaic of forb-, sedge- and rush-dominated habitat patches.
