Survey of Seeps and Springs on Bureau of Land Management lands in northern Hinsdale County 2006-2007

Prepared for: Bureau of Land Management, Gunnison Field Office 216 N. Colorado Gunnison, Colorado 81230

Prepared by: Stephanie Neid, Delia Malone, and Jennifer Jones

> > March 1, 2008

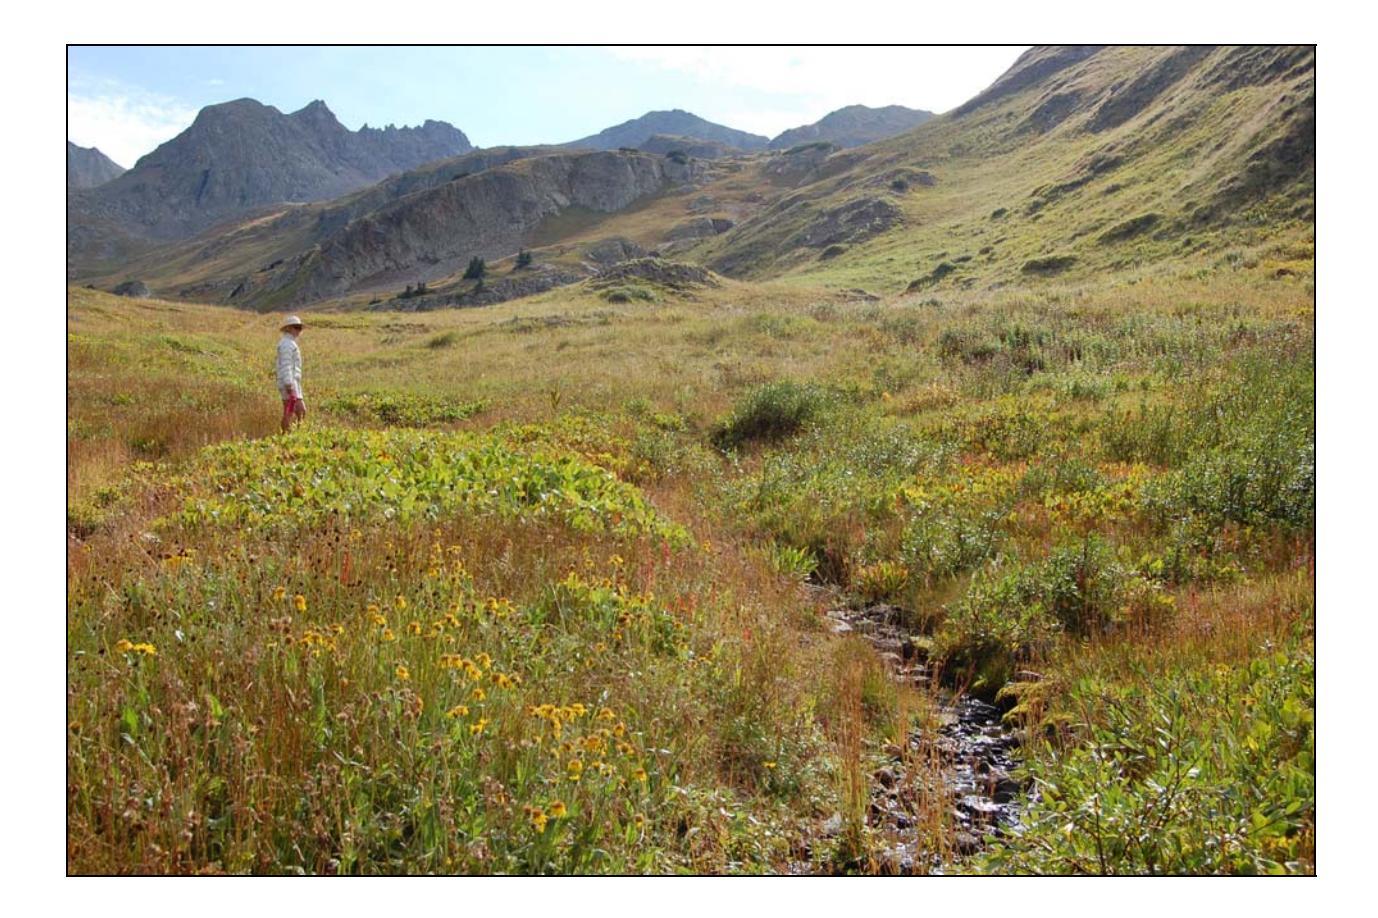
Site is not at potential. Vegetation trampling and cutting at the spring degrades site sustainability.

Spring daylights at the base of a willow and flows SW down a gentle slope toward Henson Creek. Where the gradient flattens, about 10m downstream of the source, the channel widens and a small willow carr (20mx20m) has developed. Vegetation is characterized by a Salix monticola/Mesic forb shrubland with Salix drummondii also common throughout the stand.

A high-use undeveloped campground is located directly north of the spring on a flat open meadow. A stone footpath leads to the spring. Vegetation has been trampled at the spring and the roots of the willow from where the spring discharges have been cut away. A plastic liner has been installed just below the discharge point. The pipe that is pictured in the BLM inventory photo has been removed.

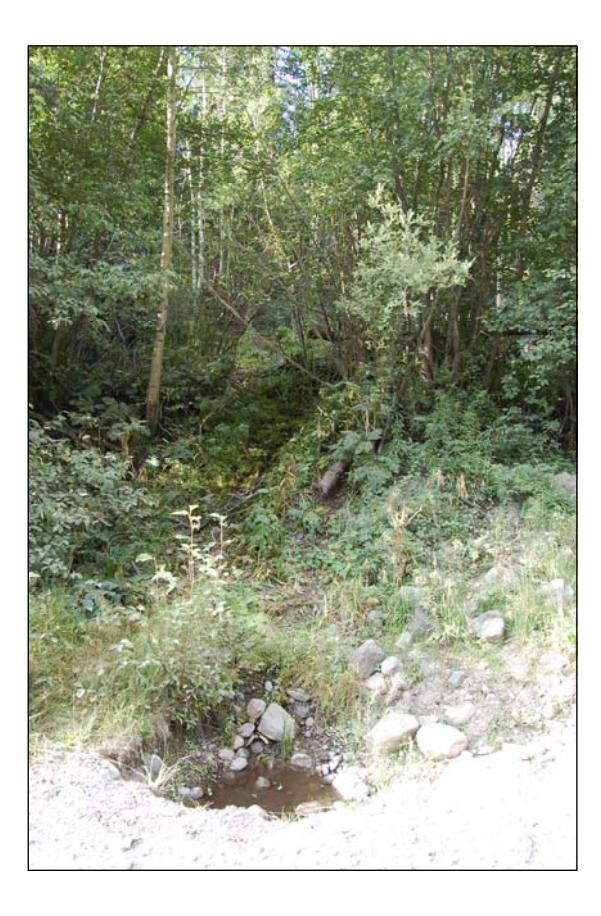
Henson Creek

A seep emerges out of freactured rock on the side of a roadcut that is used to access a historic site and an undeveloped campground. Only a small damp spot on the road indicates the presence of the seep. Riparian habitat is no longer present. Only a few hydrophyllic shrubs and forbs are present to indicate the presence of higher soil moisture. The willows that previously grew at the seep have been cut back to accommodate the road cut and are now dead.

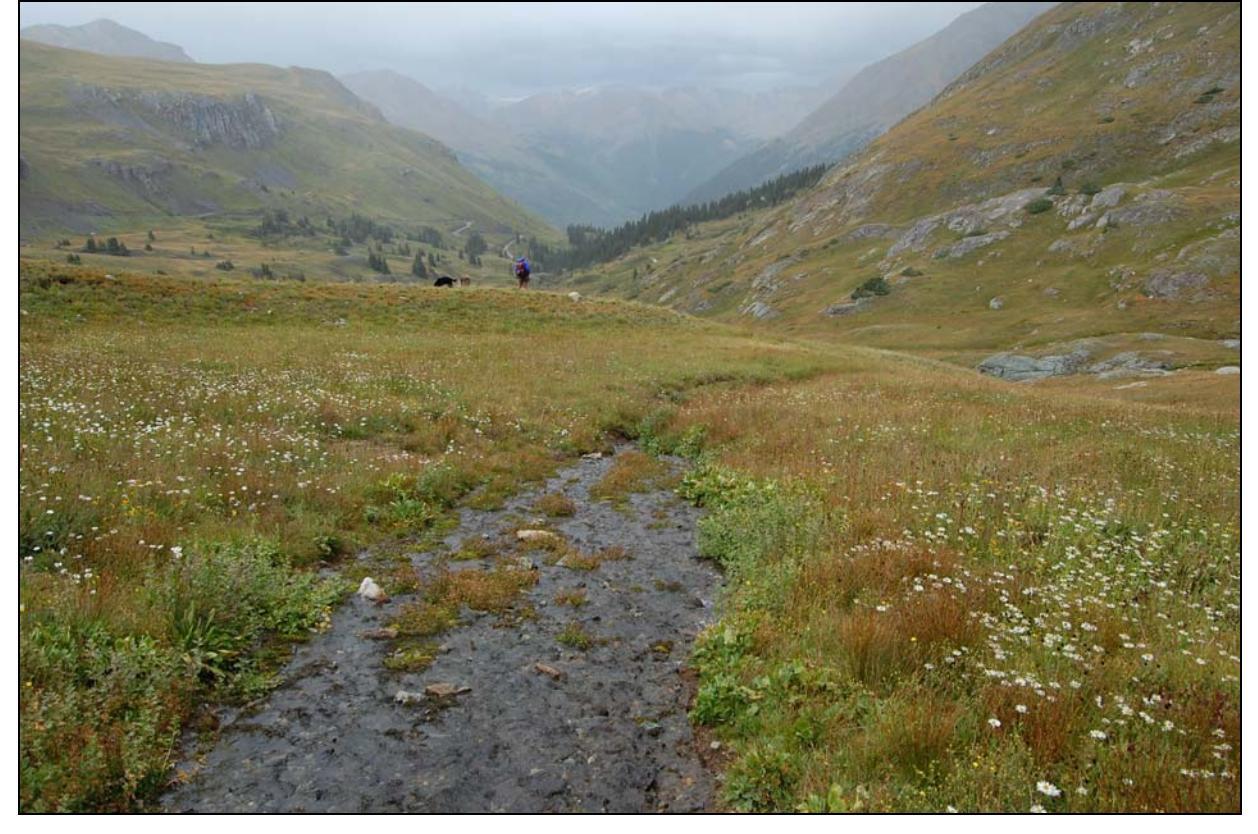
Cinnamon Pass

Riaprian vegetation is characterized by a mosaic of plant communities including Caltha leptosepala and Carex aquatilus Herbaceous Vegetation and Salix planifolia/C. leptosepala Shrubland. Numerous forb and graminod species that tolerate saturated soils are also present including Eriophorum altaicum, Primula parryi and Saxifraga oregana.

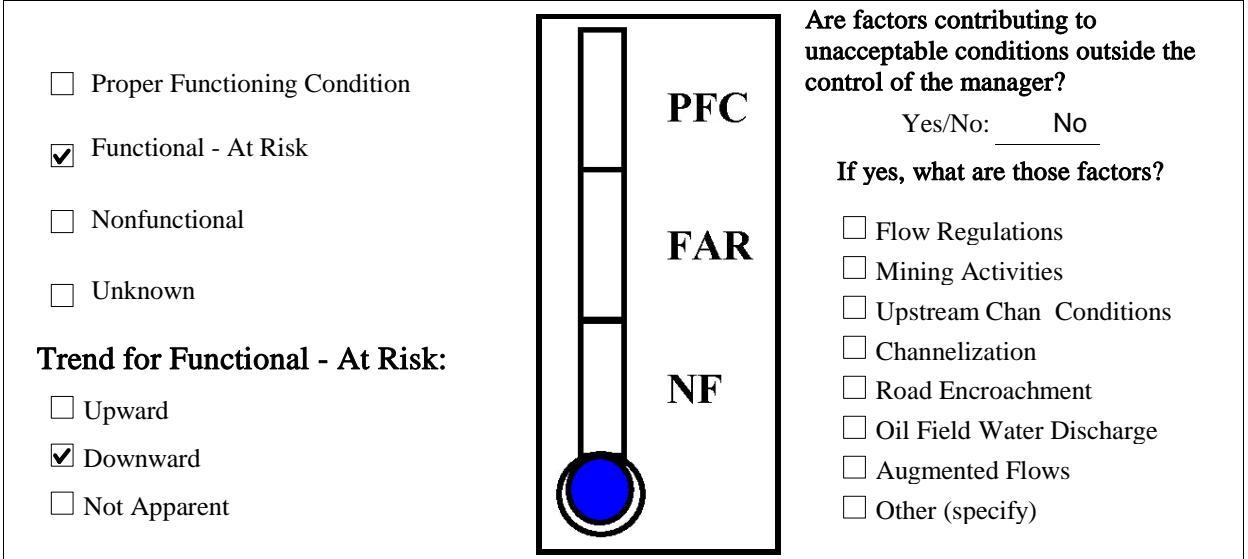
Reach/Segment D-454 Name of Riparian-Wetland

Seep daylights iin alpine tundra on a steep northeast-facing slope. Above ground flow begins 90m below point of origin; many of these high altitude seeps are ephemeral, especially those connected with spring snowmelt and especially since this is a shallow groundwater system.

Domestic sheep grazing is heavy and has altered vegetative cover by trampling and selective grazing.

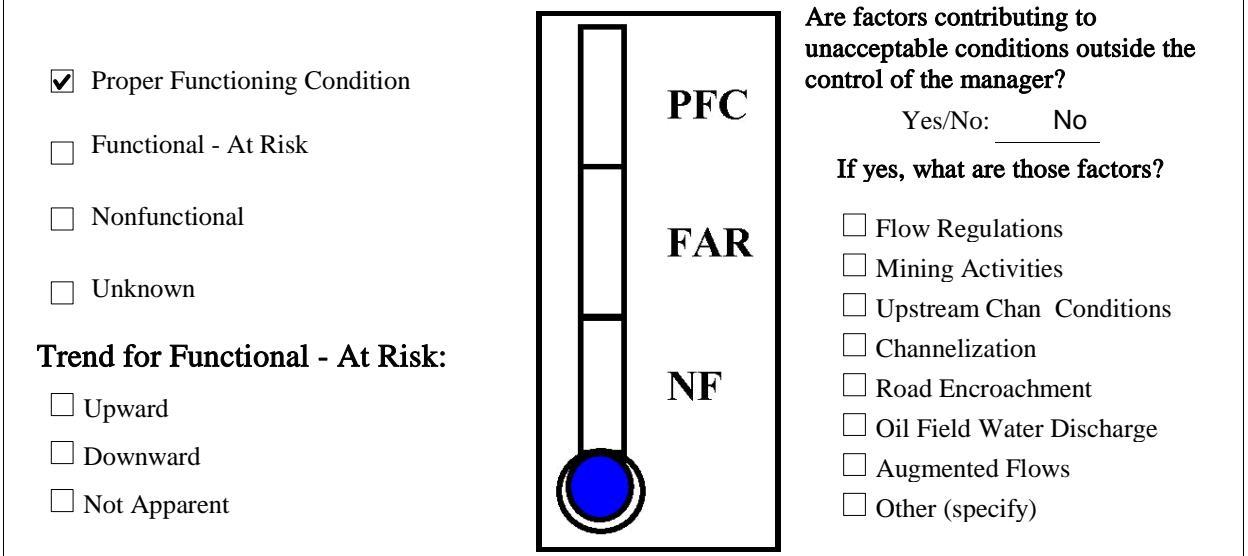
Reach/Segment D-462 Name of Riparian-Wetland

Seep daylights at the base of a southeast-facing slope in an alpine turf meadow. Surface groundwater is high across the length of this slope as indicated by hydrophyllic vegetation, saturated soils and the occurrence of numerous seeps. This seep flows south for 125m where it coalesces with the main channel. Upland habitat is in excellent condition and is characterized by a mosaic of alpine meadows, turfs, fellfields, gopher gardens and snowbed communities. Riparian habitat is in good condition and sustainable; vegetation cover is dense, diversity is appropriately high and plant vigor is high.

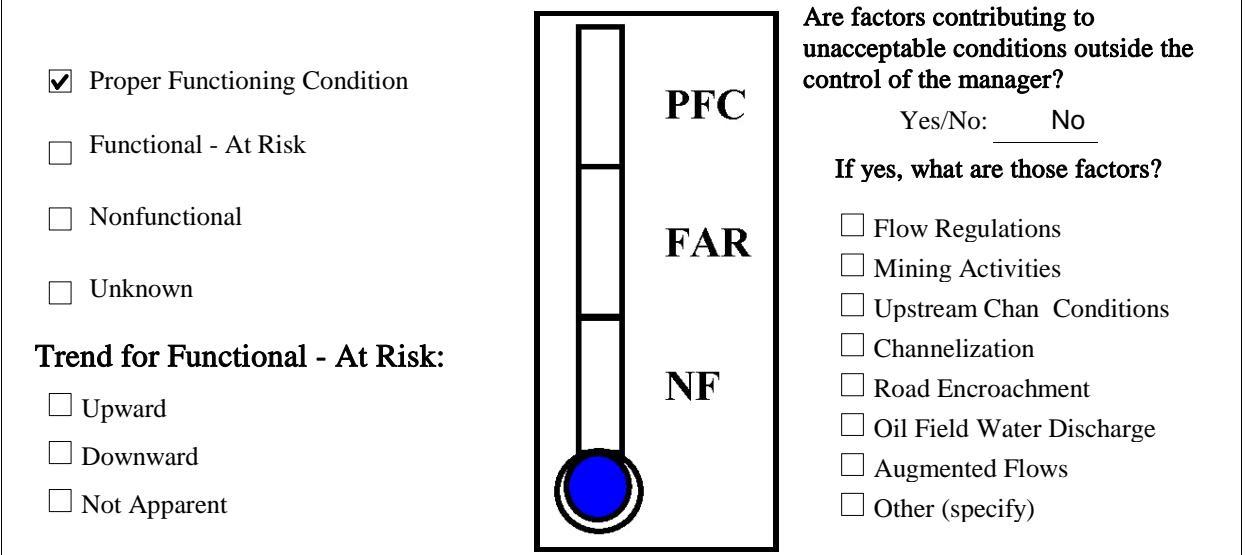
Reach/Segment D-467 Name of Riparian-Wetland

Spring daylights at the base of a northeast facing slope in an alpine turf meadow, flows 10m east to where flows coalesce with the main channel. Upland and riparian habitat are in good condition and sustainable. Riparian plant community is characterized by the classification Cardamine cordifolia-Mertensia ciliata-Senecio triangularis herbaceous vegetation but only C. cordifolia is present. The plant community is rich in other forb, sedge and rush species.

Wildlife use is moderate here but in nearby willow carrs elk use is very high. Observations of the elk herd and browse indicate that this area provides important summer and autumn elk habitat.

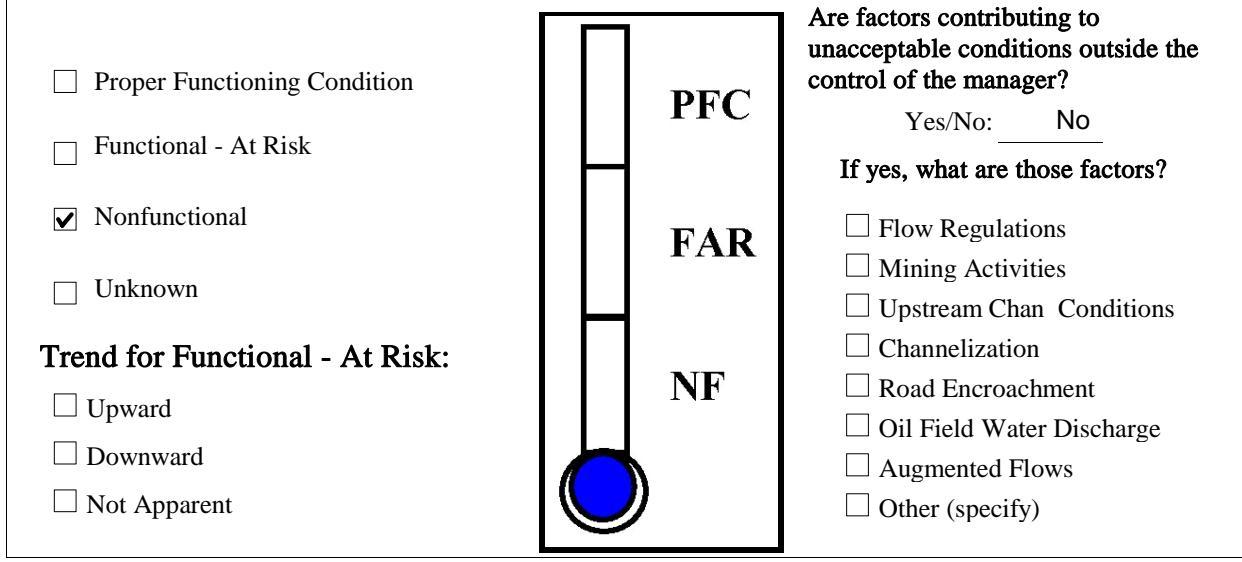
General Description: A seep daylights at the base of a mine dump. Seep flow rapidly creates a stream that flows SW down a steep gradient ravine. Riparian vegetation is mostly absent. Torrential flows are evident and likely due to a lack of vegetation and simplified channel structure that is essential to energy dissipation.

Riparian vegetation is absent. Upland habitat is characterized by a forest dominated by Populus tremuloides and Pseudotsuga menziesii with an understory dominated by Juniperus communis, Shepherdia canadensis, Ribes inerme and Paxistima myrsinites.

Reach/Segment F-276 Name of Riparian-Wetland Deadman Gulch **Additional Observations:** GPS location: Seep origin (bottom of dump) 0299484 E/4208639 N elevation: 10,080' Site Dimensions: Channel 0.3-0.5m wide; riparian 0/bank CNHP plant association(s): Absent **Tree** 0% Shrub 0% Herbaceous 0% Weed cover: 0% **Soil Characteristics:** Water Quality **Characteristics:** Munsell: 10YR,7/6 **pH:** 2.76 soil moisture: saturated **mS:** 2020 **Co:** 15.7 organic content: very low texture: waste rock any): odor: chemical peat formation: none Plants Observed at this Site

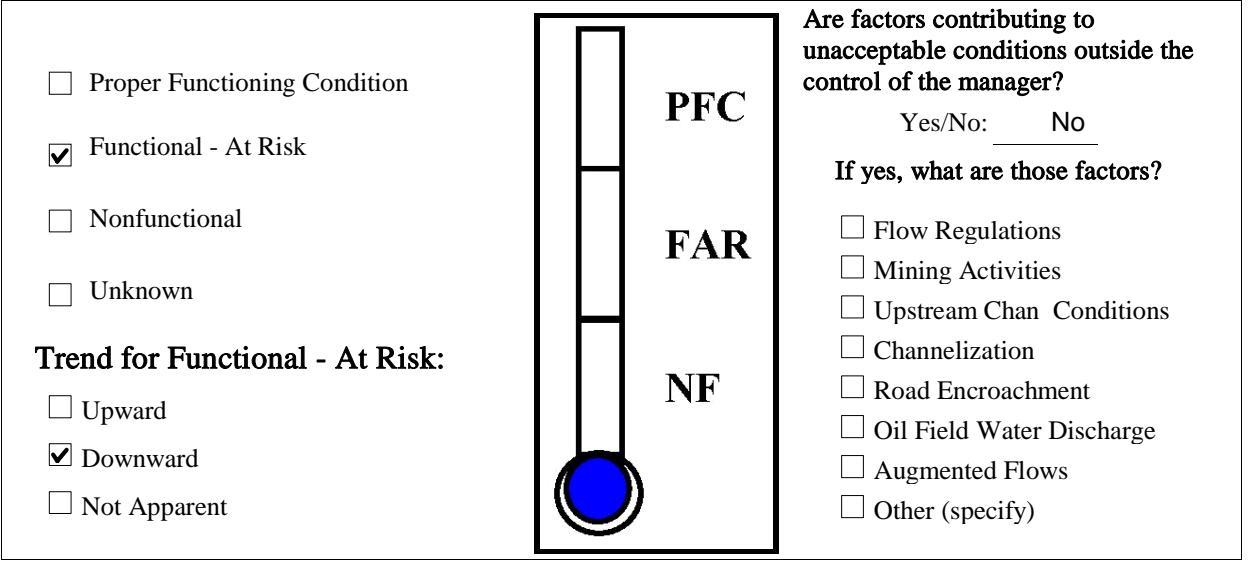
MD-13 Name of Riparian-Wetland Palmetto Gulch wetland

Wetlands are degraded by waste rock from the dump which is carried downslope with precipitation and is smothering wetland vegetation. Domestic sheep grazing is heavy. Browse on willows is moderate to high, 25-50% of 2nd year and older stems are browsed, and likely impacts vigor.

Two wetlands have developed on alluvial fans at the base of a mine dump. The wetlands receive water from surface groundwater discharge and from a stream that has its origins in a basin to the southwest near the Hough Mine; the stream flows northeast from seeps below the Hough Mine, into a culvert, under Engineer Pass road to these dumps and wetlands. This stream eventually coalesces with the Palmetto Gulch stream which coalesces with Henson Creek.

Wetland habitat is characterized by a mosaic of various plant communities including sedge, forb and willow communities. Browse on willows is high and impacts vigor. Vegetation is also impacted by waste rock which is readily carried down from the dump with precipitation and deposited in the wetland.

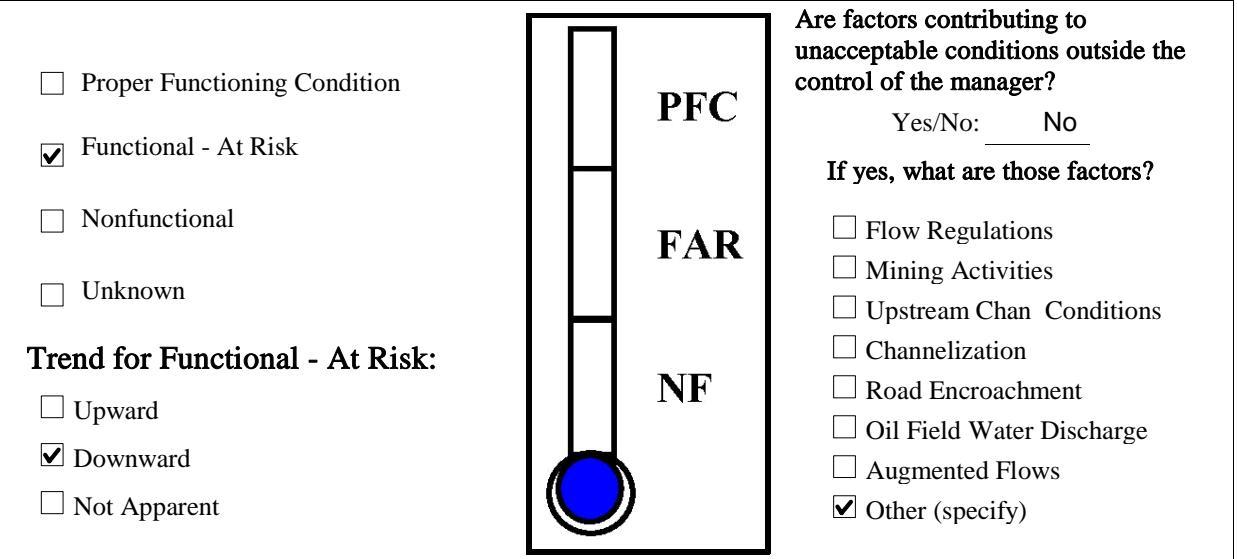
MD-48

Site is not at potential. Site is a mine dump with a draining adit that interruptsf surface groundwater flow with the resulting development of a wetland. Site potential is degraded by weed inundation, by recreational impacts and possibly by water quality.

Site is a mine dump and draining adit that are located at the base of an south-facing slope on a shallow gradient open meadow. Surface groundwater discharges across the entire meadow creating a large mesic to wet meadow. The mine adit interrupts surface groundwater flow resulting in groundwater daylighting to create a small stream and wetland. The stream flows south towards Henson Creek for 30m before dissapearing. Recreational impacts are high with Engineer Pass road on the southern edge of the meadow and North Henson Creek road on the western edge of the site.

Riparian and wetland vegetation is characterized by a habitat mosaic of herbaceous vegetation including communiuties of Carex utriculata, Juncus balticus and Veronica anagallis-aquatica (??). Other species of sedges and rushes and numerous forb species are also present. A few scattered willows occur within the wetland and cottonwood and blue spruce occur at the periphery of the wetland. Noxious weeds including plumeless thistle inundate the entire site and degrade wetland function.
