GEOLOGIC FACTORS IN THE EVALUATION
OF WATER POLLUTION POTENTIAL AT
MOUNTAIN DWELLING SITES

December, 1973

In order to establish the relationship between the geologic setting and the occurrence of water pollution in mountain home developments containing individual sewage disposal systems, three areas in Colorado's Front Range were studied. Two of the areas were known to have biological contamination as confirmed by microbiological tests. Also, each area had adequate rock exposures to allow for detailed geologic study, the absence of thick soil profiles above bedrock and current development for mountain home location. In addition, each of the selected study areas differed in geologic setting, age of development and home density in the development. The extent of water pollution was established by a program of well and surface water testing for total coliform. Fecal coliform and inorganic contaminants were tested in selected wells.

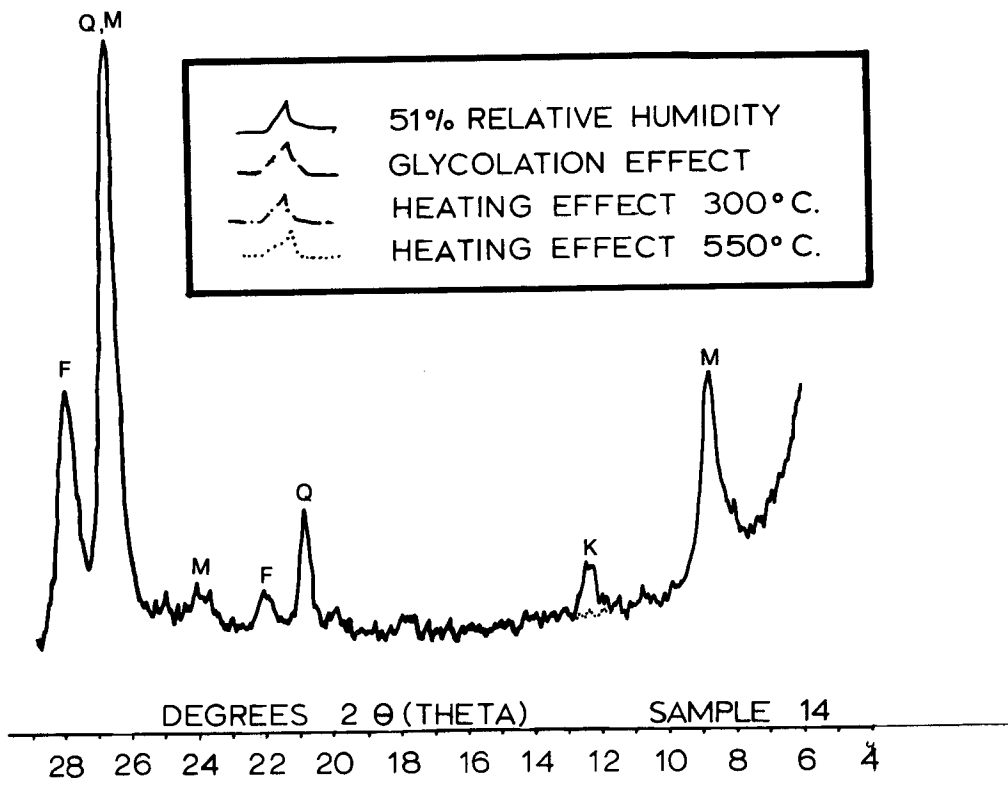
FIGURE 4. X-ray diffraction pattern of oriented clay mount typical of mountain soils containing non-expansive clays.

Q, quartz; M, mica; Ch, chlorite; F, feldspar;
K, kaolinite.

The diffraction scan following each of the above treatments was from 4^o to 26^o 2 θ (two theta). The various clays present were determined from the combined diffraction patterns for each sample and are listed in Table 3. In addition, representative diffraction patterns were reproduced from several clay scans and can be found in Figures 4, 5, and 6, with the major peaks labeled as to the mineral which caused them.

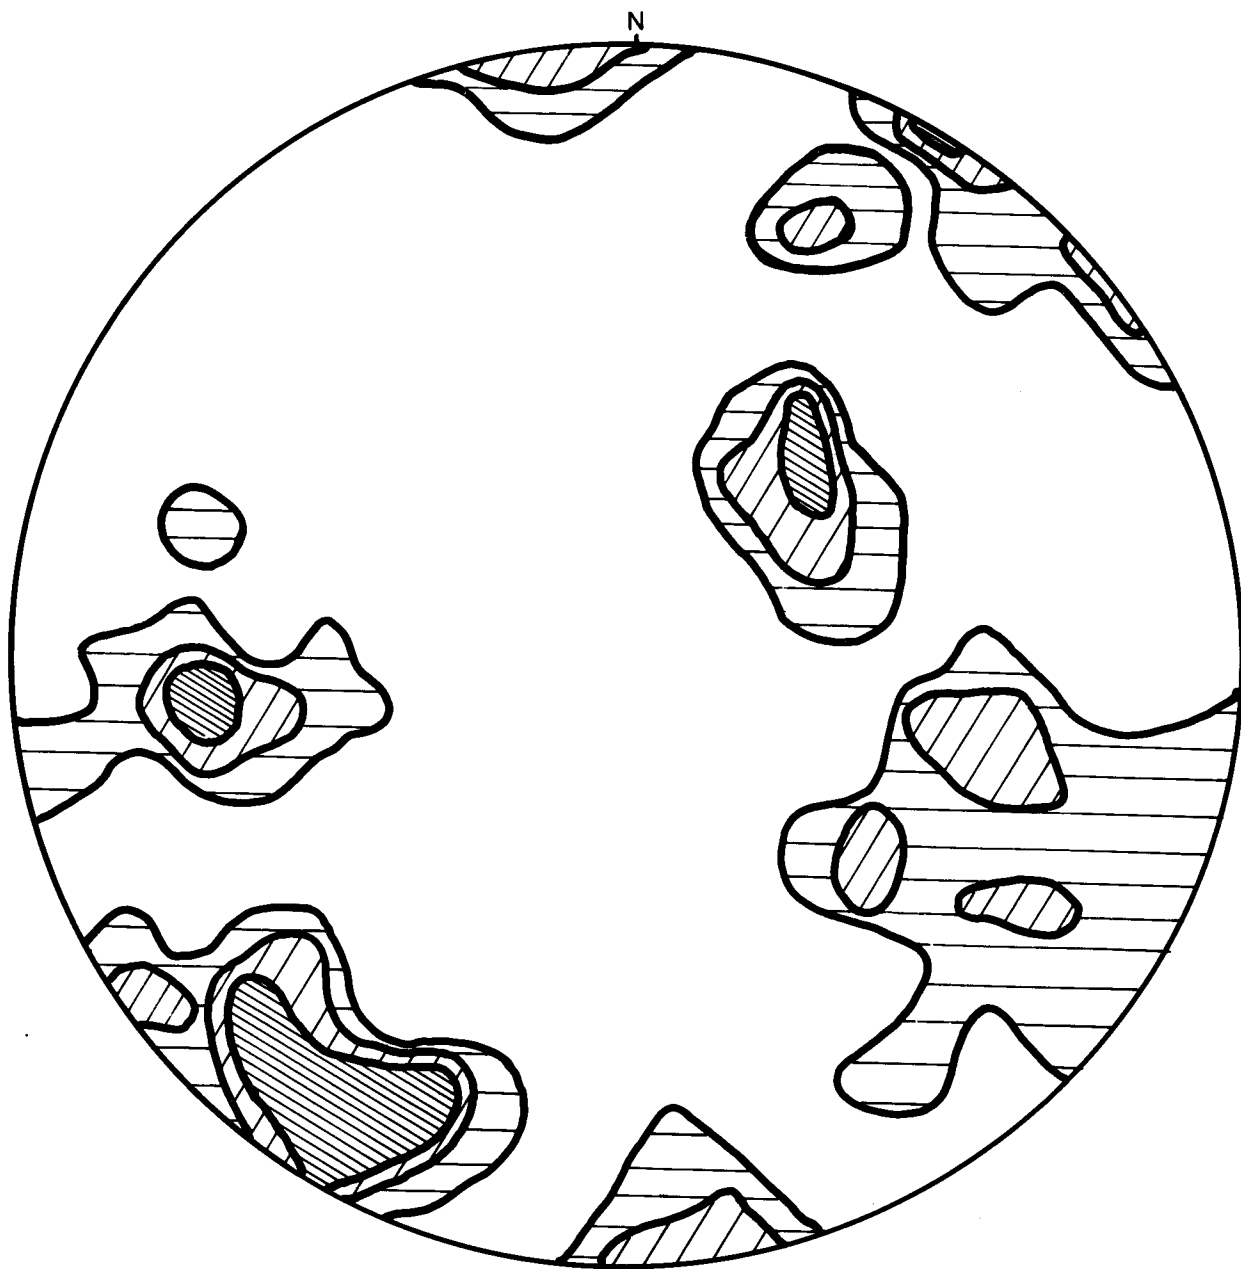
FIGURE 7. Pole plot diagram of Crescent Park joints.

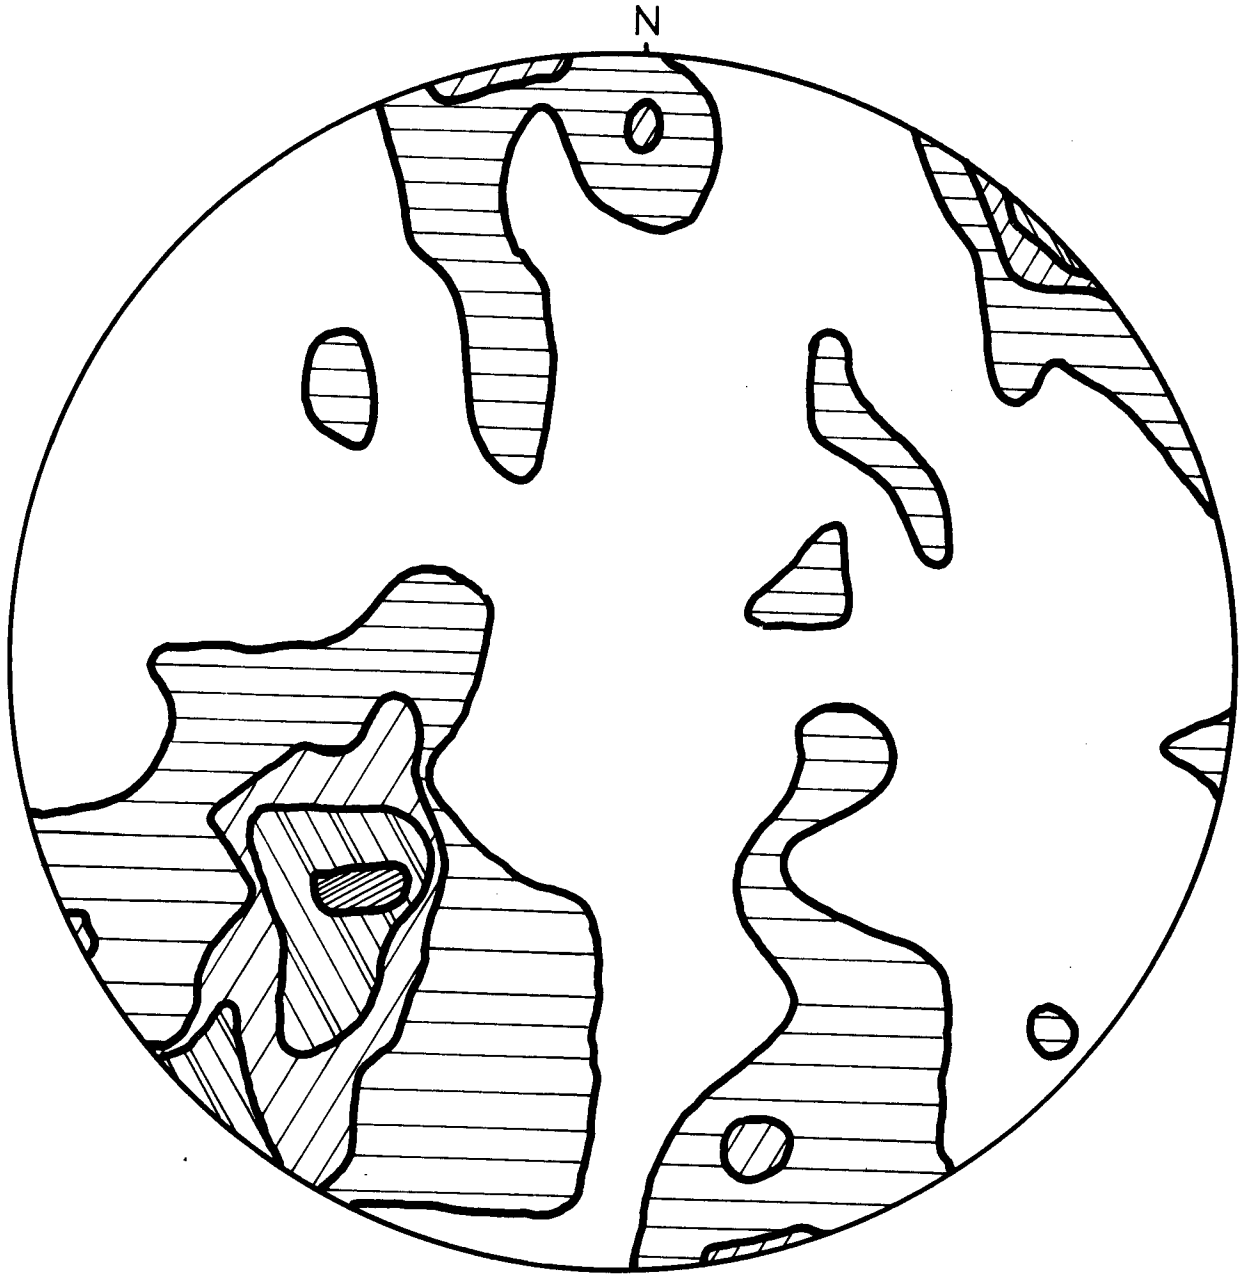
FIGURE 12. Pole plot diagram of Glen Haven foliations.
