HYDRAULIC MODEL STUDY of the KREMASTA DAM SPILLWAY

KREMASTA HYDROELECTRIC PROJECT ACHELOOS RIVER DEVELOPMENT GREECE

FINAL REPORT ON A MODEL STUDY

S. S. Karaki
Hydraulics Laboratory
Colorado State University

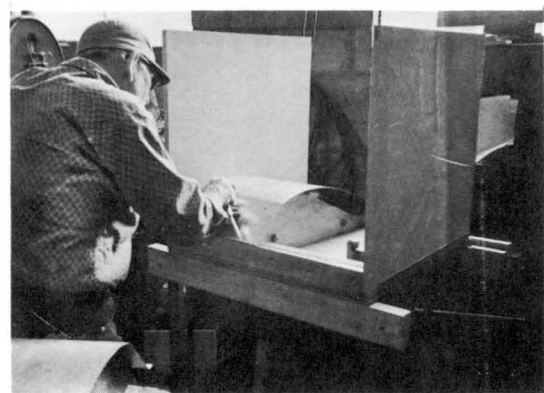
Figure 4. Construction and assembly of the crest structure for the chute model.

The crest was constructed in the manner depicted in Fig. 4. Templates forming the crest were cut with a milling machine and covered with a 24-gauge sheet metal shell as shown in Figs. 5 and 6. Piezometers were installed near the centerline of the left bay at the locations shown in Fig. 7. These piezometers were connected to a manometer board, to measure pressure heads. Piezometers were also installed along the centerline of the vertical curve at the locations shown in Fig. 8. An overall view of the completed model is shown in Fig. 9.

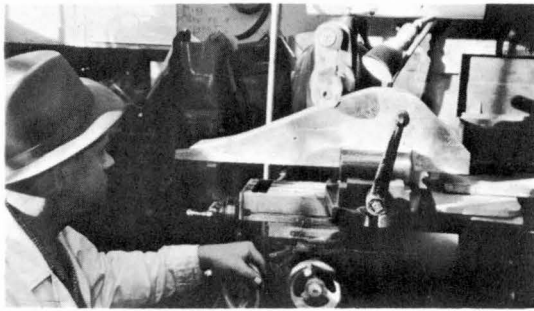
Figure 5. Shaping crest templates.

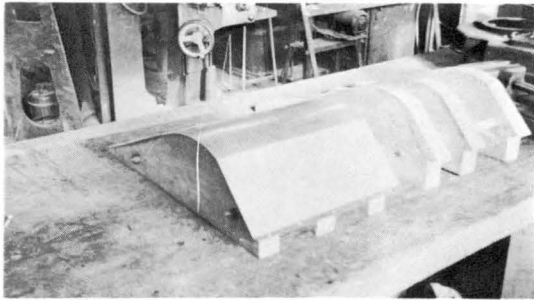
Figure 6. Crest templates formed the foundation for the sheet metal shell which formed the surface of the crest. Lacquer was sprayed on the surface and sanded smooth.

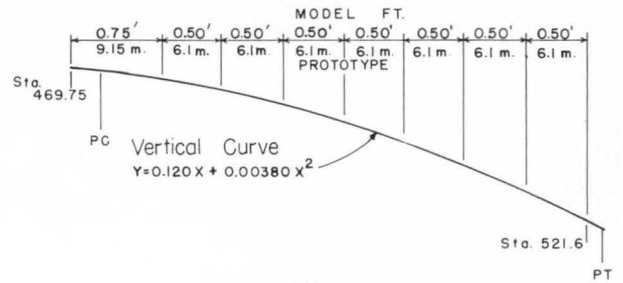
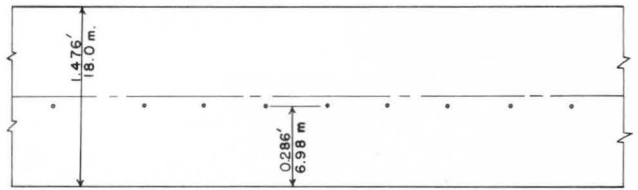
FIGURE 8. LOCATION OF PIEZOMETERS IN VERTICAL CURVE

PROFILE

PLAN

Vertical Curve -- Pressures on the vertical curve were measured at various discharges at the points along the curve indicated in Fig. 8. No negative pressures existed at any of the points of measurement. The data are tabulated in Appendix B.

* For piezometer locations refer to Figure 8

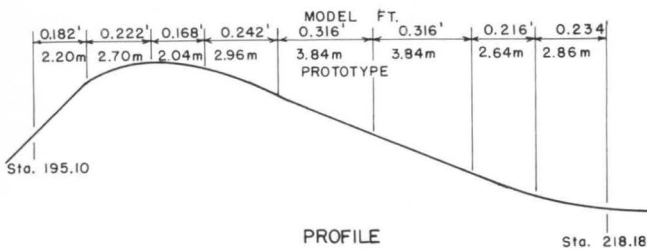
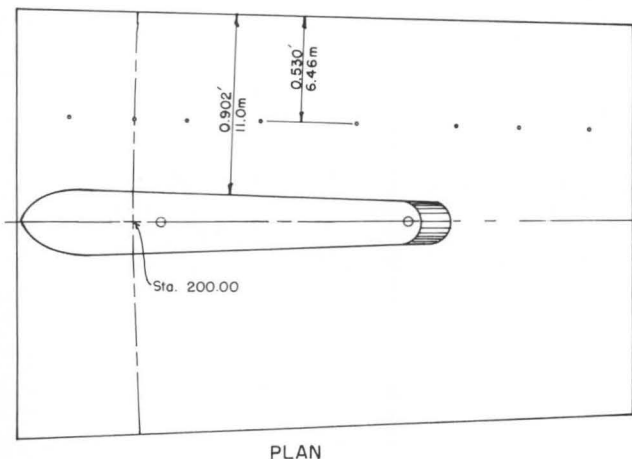
FIGURE 7 LOCATION OF PIEZOMETERS IN THE CREST

PROFILE

Sta. 218.18

PLAN

* For location of piezometers refer to Figure 7

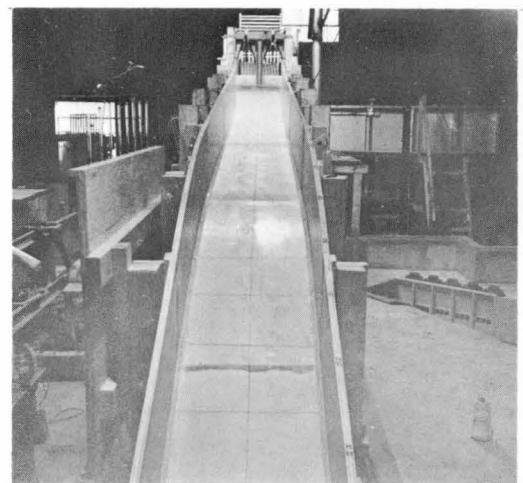
Figure 9. Completed chute model as viewed from the downstream end of the chute. The lateral lines are 10-meter markers used to aid laboratory measurements.

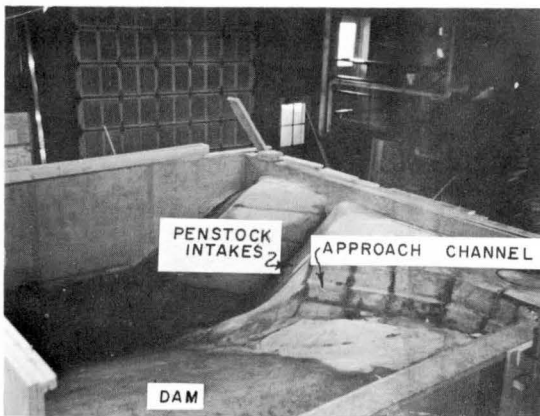
Figure 10. Completed topography in reservoir head box.

Flow entered the head box from a corner of the reservoir section through an L-shaped manifold. A rock-fill baffle was installed along two sides of the box. The purpose of the baffle was to establish uniform flow towards the spillway approach channel. Topography in the reservoir was constructed with concrete having a brushed finish and the surface of

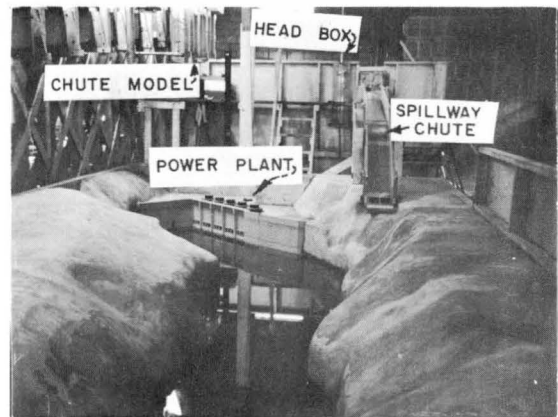
Figure 11. Completed general model.

Topography of the downstream river section was constructed according to ECI Drawing AX-T-7. The completed model is shown in Fig. 11. The concrete river banks were extended vertically to the floor of the model since the depth from the prototype river bed to rock was unknown. A depth of 1 ft was provided in the model to allow for this unknown. As will be described elsewhere in this report, three river bed conditions were studied to cover a sufficiently wide range of conditions.

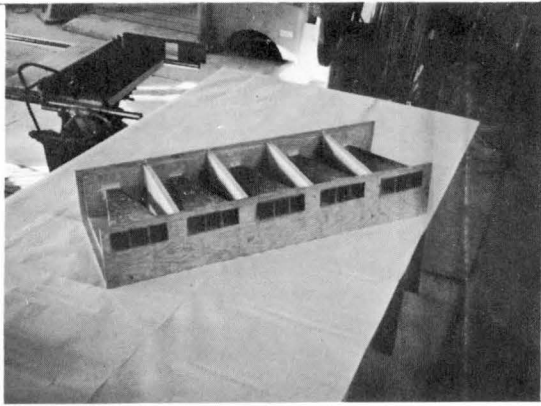
Figure 12. Model draft tubes. Dimensions of the draft tubes were scaled to size

Water was supplied to the general model by an 8-inch turbine pump and flow was measured with a calibrated pipe orifice upstream of the control valve. Flow to the power plant was provided from the city water line and controlled by separate valves to each turbine unit. Figure 12 shows the construction of the draft tube units in the model and Fig. 13, the completed power plant. The draft tubes were constructed to provide independent controlled flow through each unit. The river level was controlled by a flap gate at the end of the model.

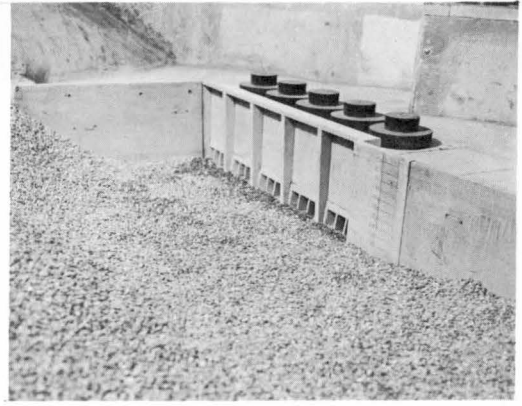
Figure 13. Completed power plant in the general model.

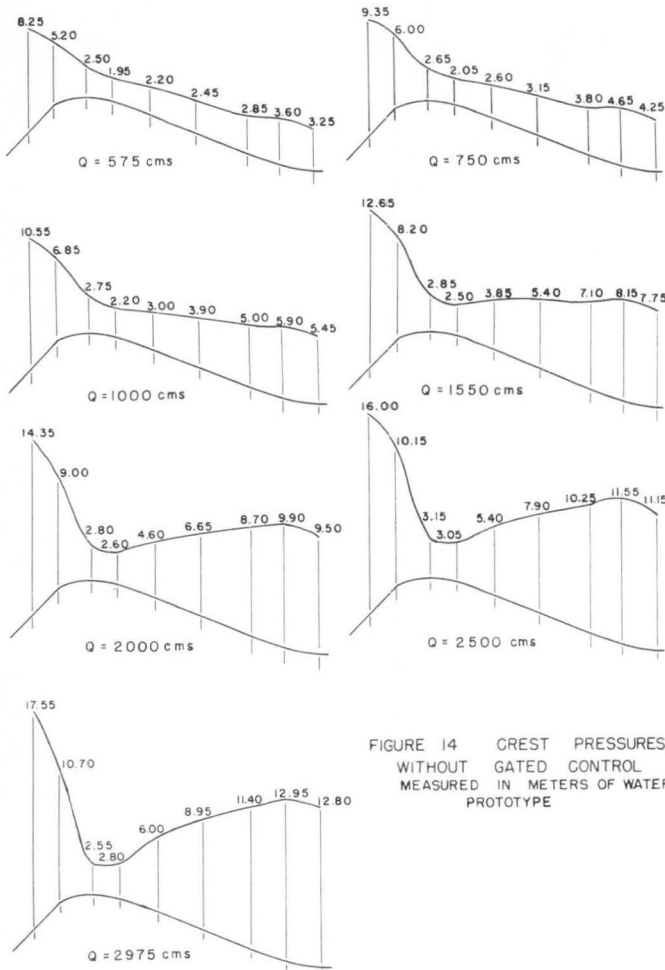
FIGURE 14 CREST PRESSURES WITHOUT GATED CONTROL MEASURED IN METERS OF WATER PROTOTYPE

Spillway Crest -- Pressure head measurements on the spillway crest in meters of water (prototype) were made at various discharges with and without gated control. The data are given in the

Appendix of this report and the significant data are shown graphically in Figs. 14 and 15. As the data and figures show, the pressures along the crest were positive for all flows and gate openings.

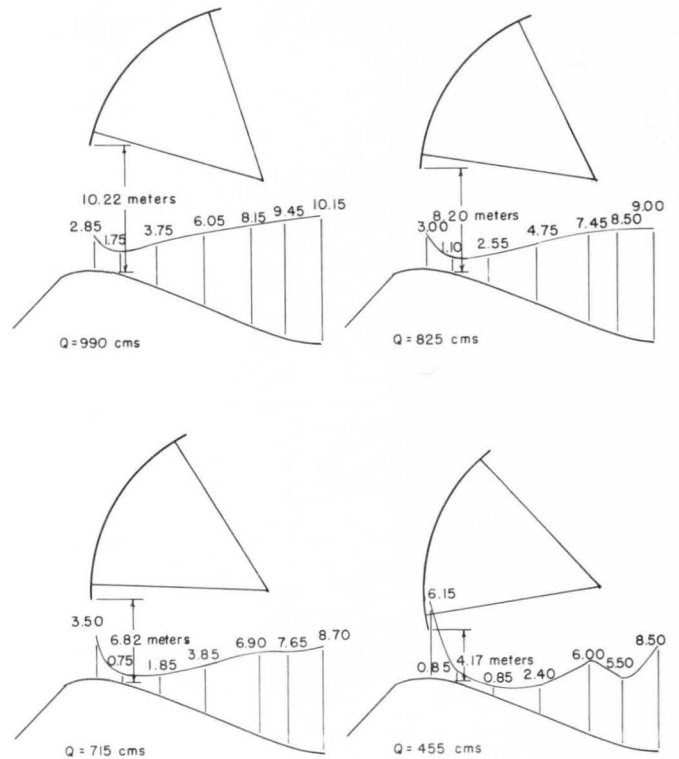
Note: Water depth above crest = 14.08 meters
 FIGURE 15 CREST PRESSURE WITH GATED CONTROL MEASURED IN METERS OF WATER PROTOTYPE

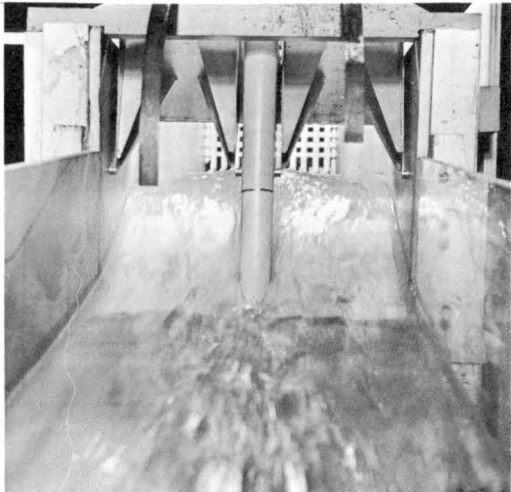
Figure 16 (a). Flow through gate structure looking upstream. $Q = 1000$ cms.

Flow conditions over the spillway crest are illustrated by the series of photographs in Fig. 16. There was some pile-up of water at the pier nose and because of the acceleration of the flow around the pier on both sides, there was draw-down of the water surface near the pier. The amount of draw-down at the crest is shown by the lateral profiles in Fig. 17 together with longitudinal water surface profiles along the crest structure wall and the pier for discharges of 1000, 2000, and 3000 cms. The preliminary position of the gate pins was too low, for at the maximum discharge of 3000 cms, the gate pins were periodically underwater as indicated in the photograph of Fig. 16 (d)

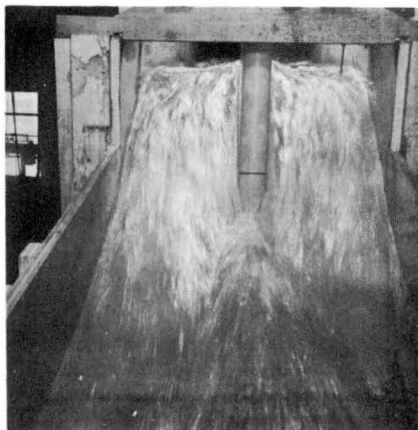
Figure 16 (b). Looking upstream at gate structure. $Q = 3000$ cms.

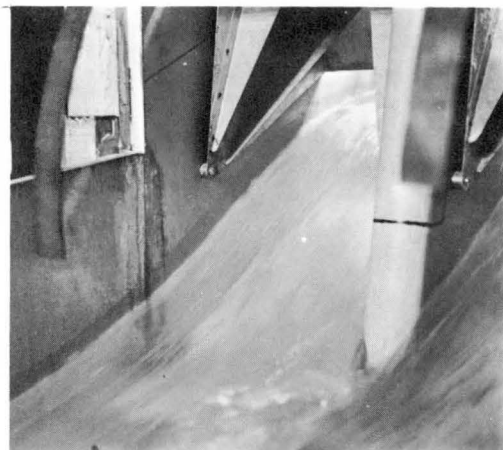
Figure 16 (c). Flow profile through gate structure. $Q = 2000$ cms.

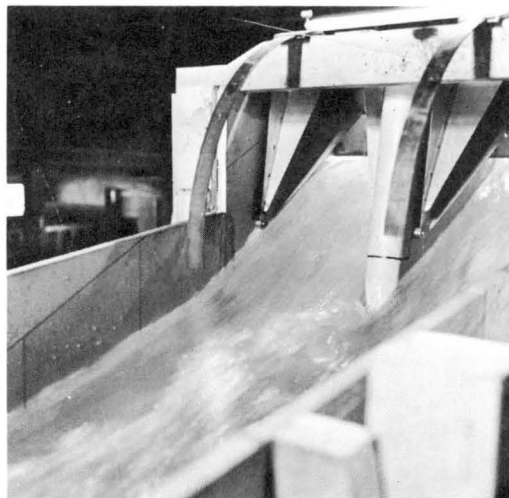
Figure 16 (d). At maximum spillway capacity the gate pin in the wall was at the water surface. The pin was subsequently elevated by tilting the gate slightly forward.

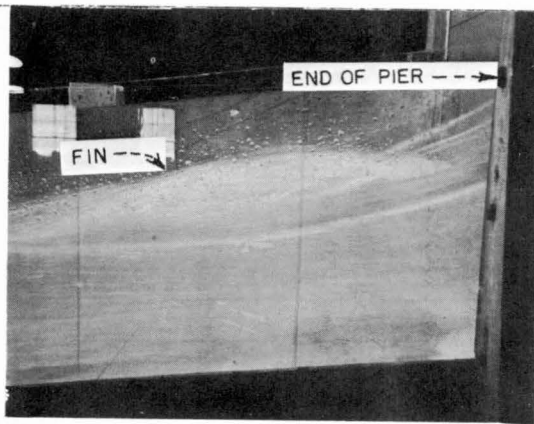
Figure 18. Fin (light area with convex top surface) at the downstream end of the pier. $Q = 3000$ cms.

Spillway Chute -- A standing wave (fin) was created at the downstream end of the pier because of the confluence of the flows from the two spillway bays at a slight angle. The fin (see Fig. 18) was the origin of a pronounced standing wave pattern which existed along the entire length of the chute. At several locations the waves overtopped the chute wall as is shown in Fig. 19. Although the chute walls were

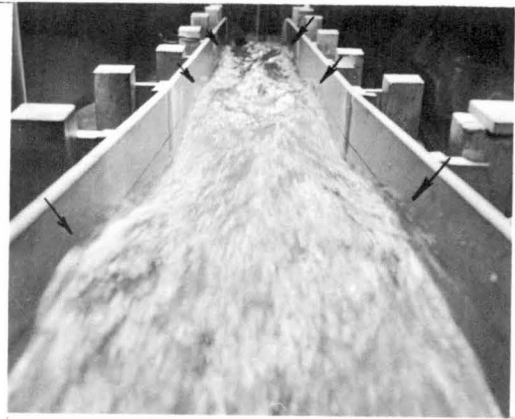
Figure 19. Standing waves in the chute at $Q = 3000$ cms looking downstream. The horizontal lines painted on the model walls represent the tops of the prototype walls. Note waves overtopped walls at the points indicated by the arrows.

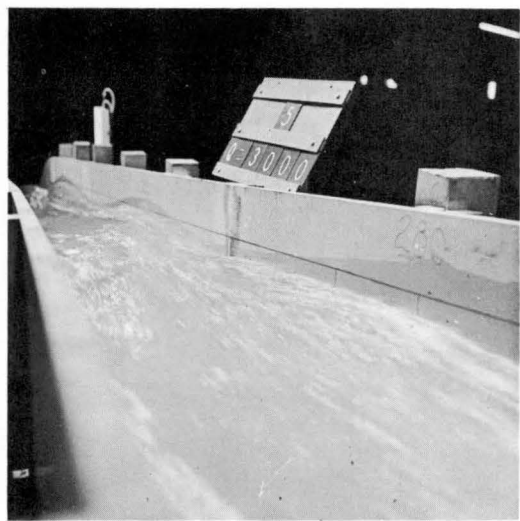
Figure 25 (a). Pier extension of 5 meters (looking downstream). Wave height remained substantially the same as that for the original pier. The painted horizontal line on the model wall indicates the top of the prototype wall.

Various lengths of extensions from 5 to 30 meters, as shown in Fig. 24, were tested. The results of the tests are shown in Figs. 25 (a) to (d). The water surface profiles along the wall were measured and are shown in Figs. 26 to 31 inclusively. These results show that the extension wall should be at least 20 meters long to effectively reduce the wave heights. Wave heights with pier extensions longer than 20 meters were not substantially more effective. A profile view of the flow in the chute transition with a 20-meter pier extension at 3000 cms is shown in Fig. 32. Reduction in wave height at the beginning of the flip bucket effected by the pier extension of 20 meters is comparatively shown in Figs. 33 (a) and 33 (b). The standing waves originating from the change in wall alignment at the end of the transition were not serious enough to cause concern, see Fig. 25 (d). After discussion of this observation with the engineers of ECI, it was decided that a change in transition length was not necessary and the preliminary transition length would be adopted for construction.

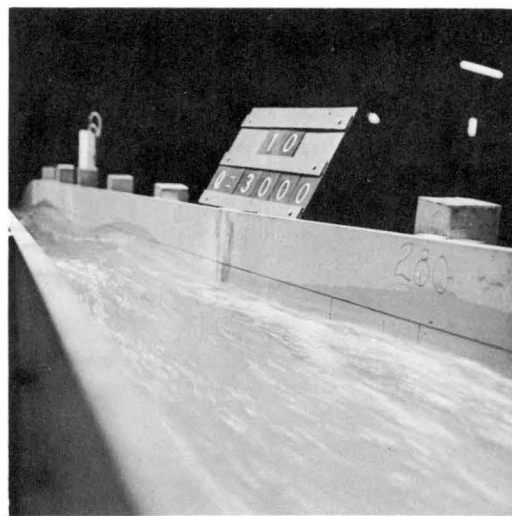
Figure 25 (b). Pier extension of 10 meters. No marked reduction in height of standing waves.

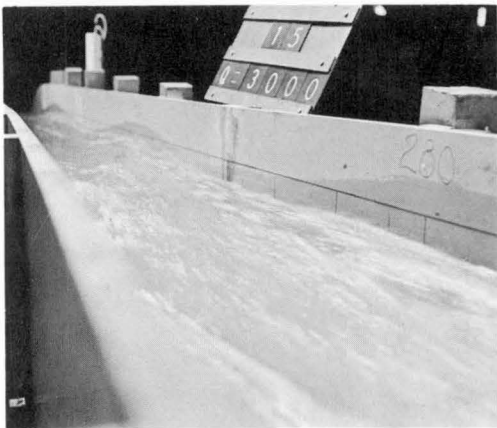
Figure 25 (c). Pier extension of 15 meters (looking downstream). Some reduction in wave height from the preliminary pier is evident.

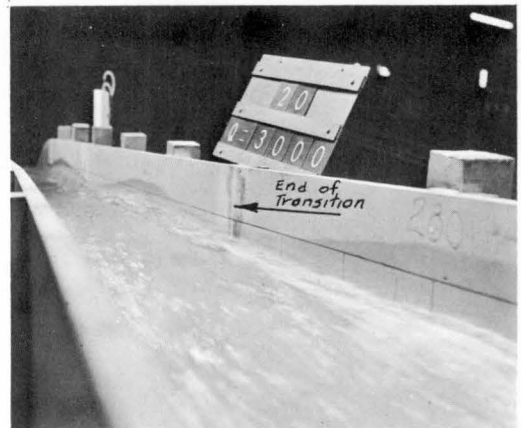
Figure 25 (d). Pier extension of 20 meters. Definite reduction in height of standing waves. The wet line seen on the wall is from previous tests.

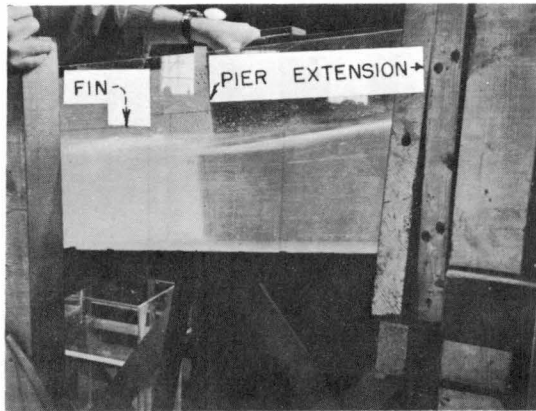
Figure 32

Water surface profile along a 20-meter long pier extension. Note the reduced fin height in comparison to Fig. 18. $Q = 3000 \text{ cms}$.

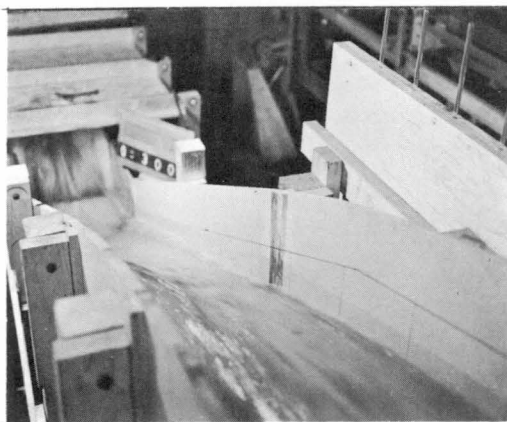
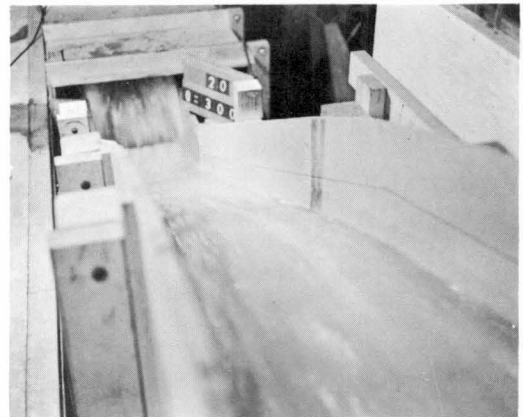
Figure 33 (a)

Comparative views (looking downstream) of the wave height reduction at the end of the chute. The left photo is without pier extension; the right is with a 20-meter pier extension wall.

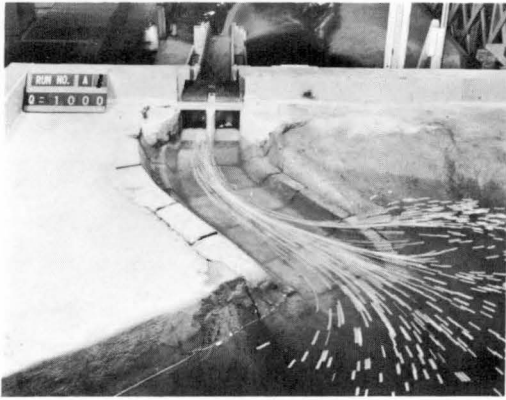
Figure 35 (a). Preliminary channel cut showing flow lines from the reservoir into the approach channel.

by the relatively high velocities (near 3.5 mps) in the approach channel. If deterioration of the right bank occurs in such a manner as to cause sizable material to be swept into the spillway chute and over the flip bucket, the abrasion resulting on the concrete surface of the channel could induce potential sources of cavitation and considerable structural damage could result. The flow conditions in the channel at discharges of 1000, 2000 and 3000 cms are illustrated in Fig. 35 (a) through (c).

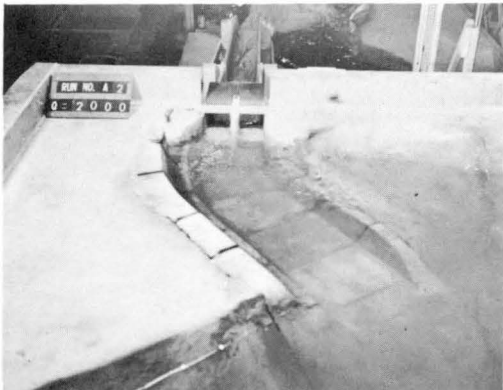
Figure 35 (b). Preliminary channel cut. Notice the rough water surface along the right bank where velocity over the cut is high and a horizontal vortex along the bank is created.

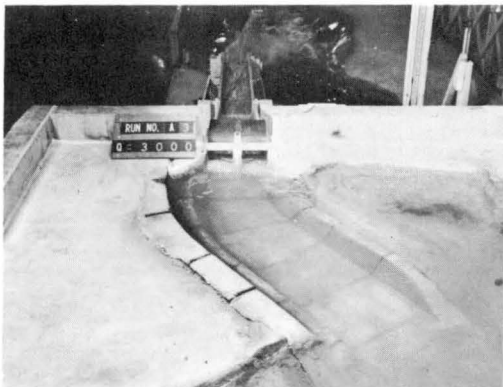
Figure 35 (c). Preliminary channel cut. The problem is not so acute at this discharge because of the higher reservoir level and greater flow depth resulting in reduced velocities over the bank.

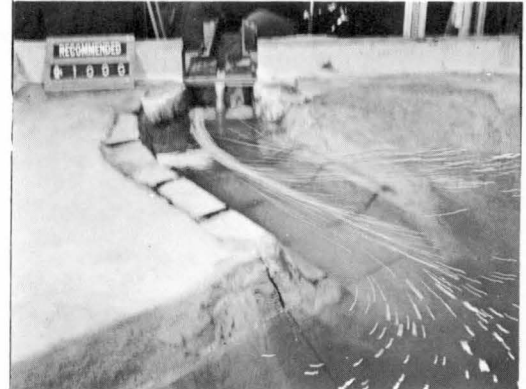
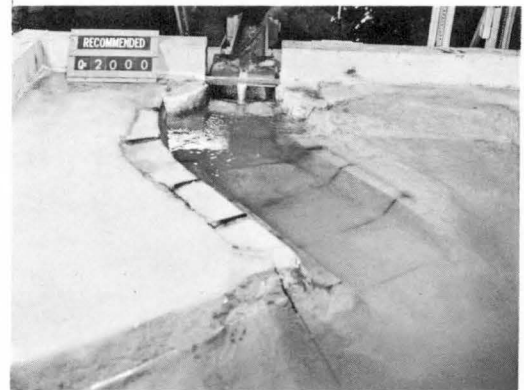
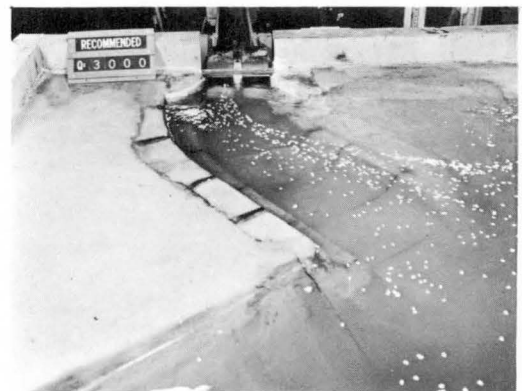
Figure 36 (a). $Q = 1000$ cms.

Figure 36 (b). $Q = 2000$ cms.

Figure 36 (c). $Q = 3000$ cms.

It is difficult to visualize the flow pattern by still photographs as shown in these figures. The flow pattern can be better seen in the motion picture film which accompany this report to the ECI firm. The improved flow over the modified cut of the right bank are illustrated by the photographs in Fig. 36.

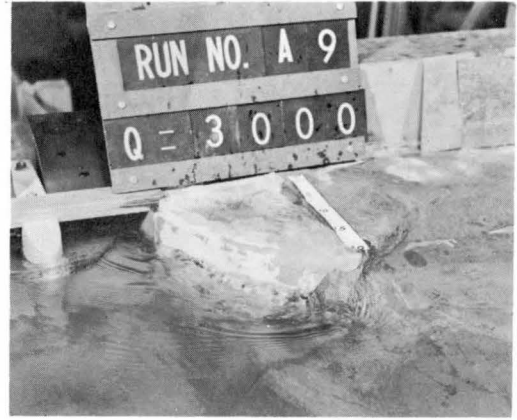
Figure 38 (a). Modification R-1 (recommended). Notice the flow over the cut bank adjacent to the wing wall.

Because of turbulent flow condition at the right wing wall, several modifications were tried with the aim of eliminating the turbulence. The modifications are shown dimensionally in plan in Fig. 37, varying from a quarter circle to a quarter ellipse with a length along the major axis of 35 meters. For convenience of reference, they are numbered R-1 through R-4 respectively. The flows at the wing wall with 3000 cms discharge are shown in Fig. 38 (a) through (d).

Although turbulence along the wall was reduced with each successive increase in wing wall length, the draw-down of the water surface at the point of the wing wall was not materially reduced. The improvement of flow in comparison to the added cost of the increased size of structure provides insufficient justification to recommend a larger structure. It was found that the abrupt draw-down could be materially reduced in the case of modification R-4 by extension of the structure into the reservoir as illustrated by the temporary arrangement shown in Fig. 39 (a). Similar improvement was indicated in Fig. 39 (b) by an extension of the modified wall R-3. In neither case, however, does it appear justified to impose the added cost of construction for relatively minor hydraulic improvement. Instead of adding length to an already sizable wing wall it is suggested that a concrete paving slab over the face of the cut slope, adjacent to the recommended wing wall shown in Fig. 34, would be sufficient to provide adequate protection to the structure foundation from erosion due to the high velocity adjacent to the wing wall.

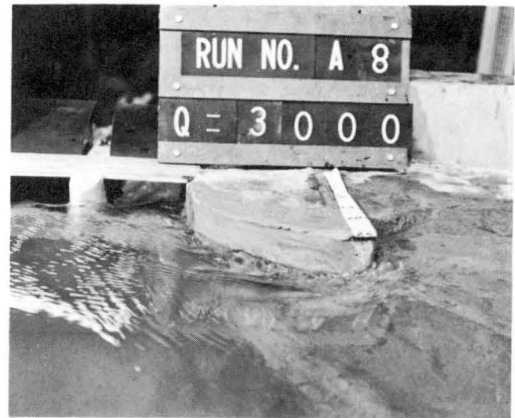
Figure 38 (b). Modification R-2. The turbulence not materially reduced. Little improvement in flow condition was noticed.

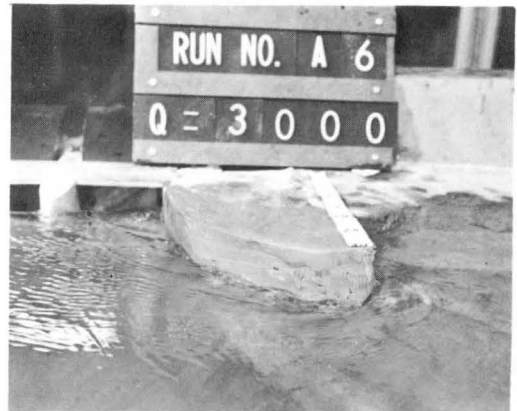
Figure 38 (c). Modification R-3. Some minor reduction in turbulence and draw-down was noticed.

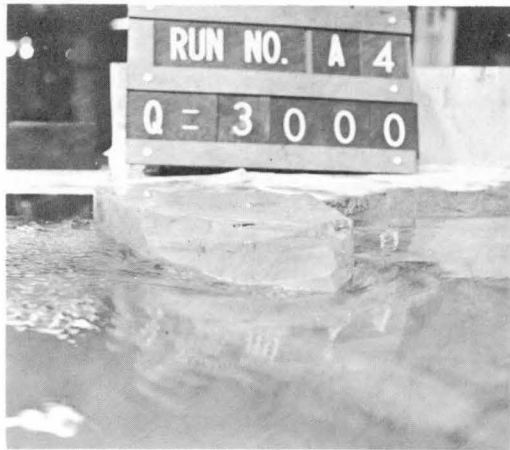
Figure 38 (d). Modification R-4. Turbulence was reduced, but draw-down at the beginning of the wing wall remained about the same as previous modifications.

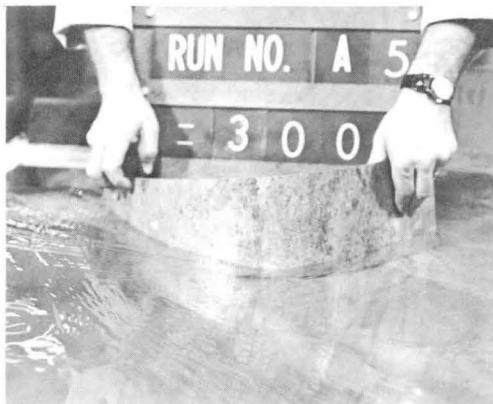
Figure 39 (a). Extension of the wing wall of modification R-4 into the reservoir. The turbulence is further diminished by a smooth transition.

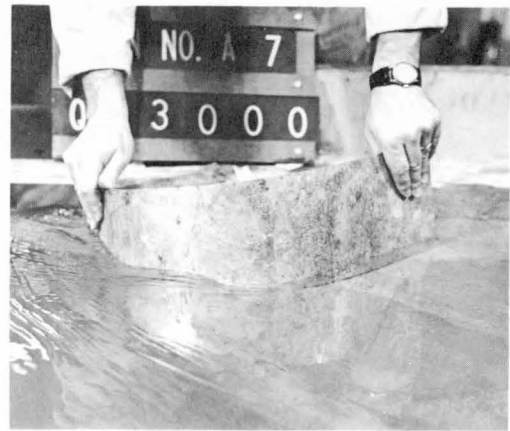
Figure 39 (b). Extension of modification R-3. Flow is smoother along the wall.

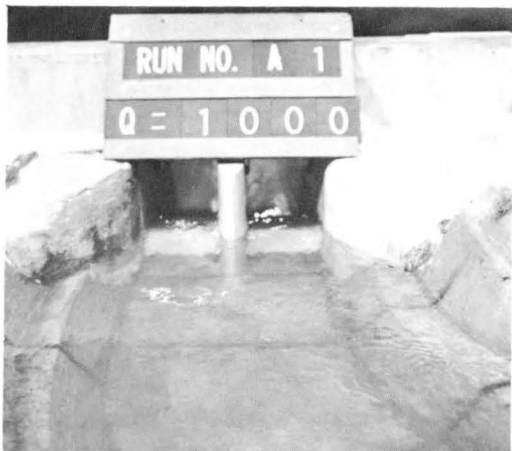
Figure 41 (a). Pier nose modification B.
Q = 1000 cms.

The water surfaces at modified pier B, as shown in Figs 41 (a), (b), and (c), indicate flow disturbances around the pier at large discharges. Since the velocity of flow in the approach channel are high, elimination of draw-down around the pier does not seem possible short of a complex shape not much different from a ship hull. Nor does it seem necessary to develop a completely smooth water surface in view of achievement of satisfactory spillway discharge coefficients. The preliminary pier nose shape was hydraulically satisfactory. If an increased length of pier is structurally necessary upstream of the crest because of the forward tilting of the gates to raise the gate pins above the water surface, an elliptical pier nose similar to modification A would be hydraulically satisfactory. In fact, anticipating this structural need, the spillway rating curve was developed with modified pier nose A.

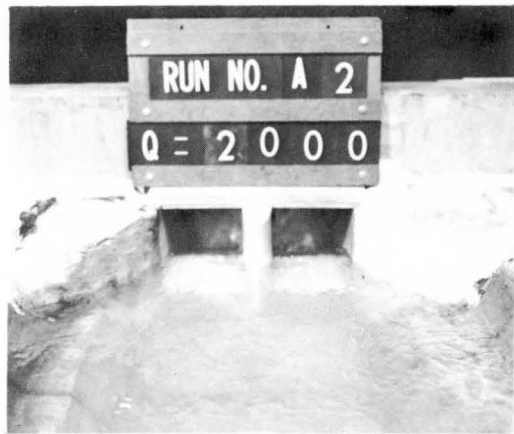
Figure 41 (b). Pier nose modification B.
Q = 2000 cms.

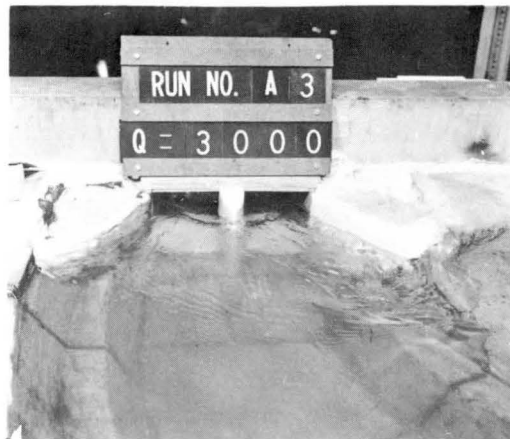
Figure 41 (c). Pier nose modification B.
Q = 3000 cms.

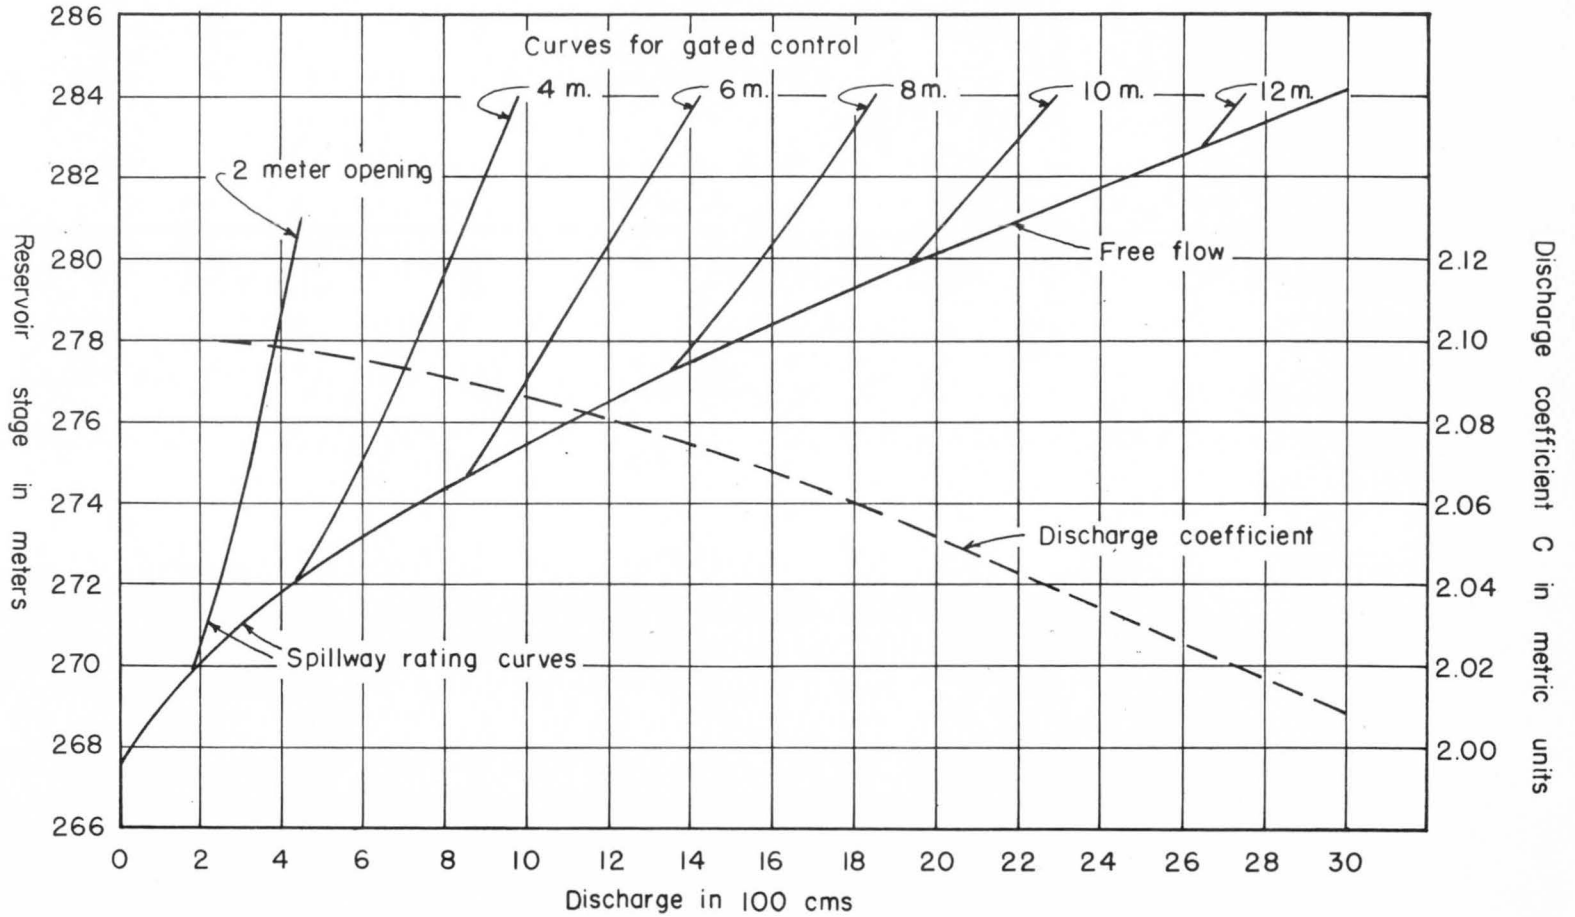
FIGURE 42 SPILLWAY RATING CURVES RECOMMENDED

Spillway Rating Curve -- A spillway rating curve was developed with the general model, which included the recommended modifications to the approach channel and the 4:1 elliptical pier nose. The rating curve is shown in Fig. 42, and was developed for free flow, that is, without gated control, and also with gated control. For the curves with gated control both radial gates were equally opened, and indicated openings are the vertical distances between the bottom of the gate and the point of contact on the gate seat. The spillway discharge coefficients for free flow are also shown in the figure.

It is recommended that the control gates on the spillway be raised and lowered equally and simultaneously to prevent severe standing wave patterns in the chute which could cause overtopping and erosion of the hillside above the power plant. Spillway rating curves with and without gated control are provided.

Unequal gate openings caused undesirable standing wave patterns. It is recommended that the gates be operated uniformly and simultaneously. In the unlikely event that failure in the hoist system of one gate should occur, discharges up to 1000 cms could be contained within the chute. Larger discharges through only one gate would cause overtopping of the chute walls.

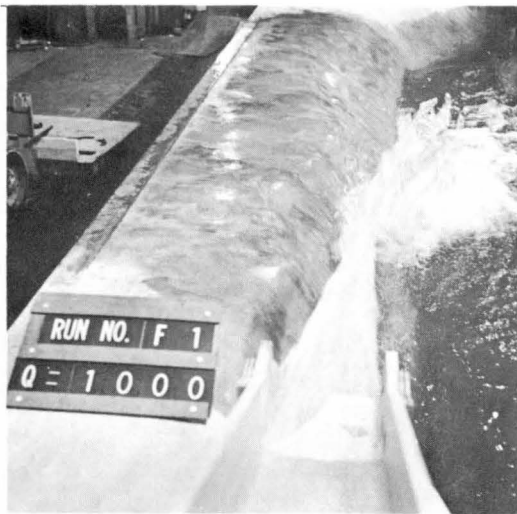
Figure 43 (a). Preliminary design. The jet impinged high on the left river bank.

Flip Bucket -- The alignment of the spillway chute with respect to the downstream river channel was such that the spillway flows had to be deflected approximately 15 degrees to the right (looking downstream) for the flip bucket jet to impinge in the river rather than on the river bank. In order to effect the change in flow direction the preliminary design indicated a curved fillet on the left side of the radial bucket. This design was tested at various discharges in the range of expected spillway flows and was found to be inadequate. While the fundamental concept of a fillet on the left side is sound, the size of the fillet was insufficient as the photographs of Figs. 43 (a) and (b) show. The jet impinged high on the left bank of the river. In the prototype this would undoubtedly erode the bank very seriously.

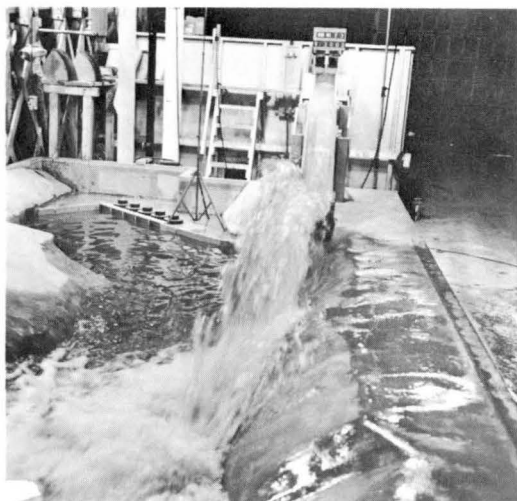
Figure 43 (b). Preliminary design. $Q = 3000$ cms. The jet deflection was inadequate.

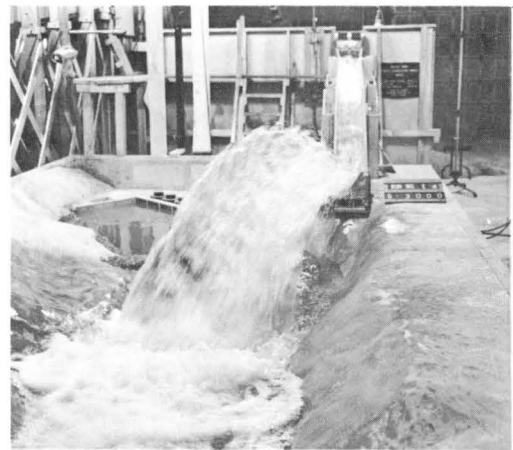
Figure 44. Results of a modification involving a larger fillet and a superelevated floor. $Q = 3000$ cms.

Many modifications were tested, some of them recorded and other trials visually inspected and rejected. Initial modifications involved larger fillets to deflect the flow. The results of some of the nearly successful modifications are shown in Figs. 44 and 45. In Fig. 44, in addition to a larger fillet, the floor of the chute downstream of the vertical curve was superelevated along the left side in an attempt to initiate general movement of the entire flow to the right. The superelevation was effected gradually to 2 meters in height, measured normal to the floor surface, across the entire chute width. Little beneficial effect from the superelevation was noted. The superelevation was increased to 4 meters but developed no notable result. The right wall of the chute was then warped outward beginning from the end of the vertical curve in combination with the superelevated floor, but again no improvement was indicated. The result of the latter modification is shown in Fig. 45.

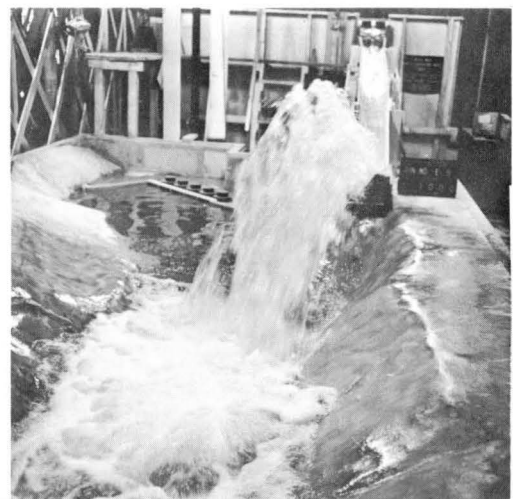
Figure 45. The right wall of the chute (when one looks downstream) was warped outward in combination with a superelevated chute floor and large fillet on the left side of the bucket. $Q = 3000$ cms.

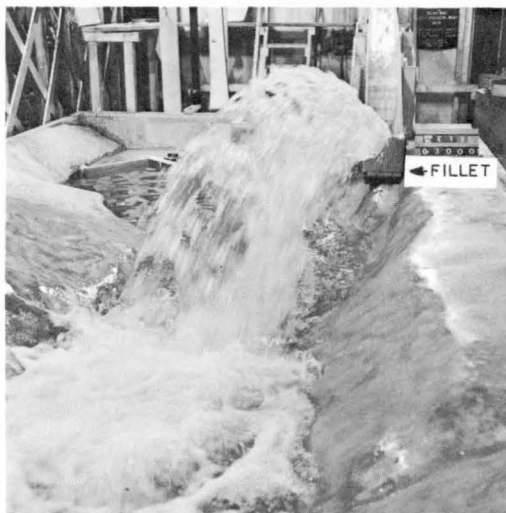
Figure 46. The modification involved a 4.2-meter longer flip bucket and larger fillet on the left side.

Later modifications included a longer bucket by about 4 meters and a return to the original spillway chute geometry involving no superelevation or warped walls. A photographically recorded result from this change is shown in Fig. 46 with a spillway discharge of 3000 cms.

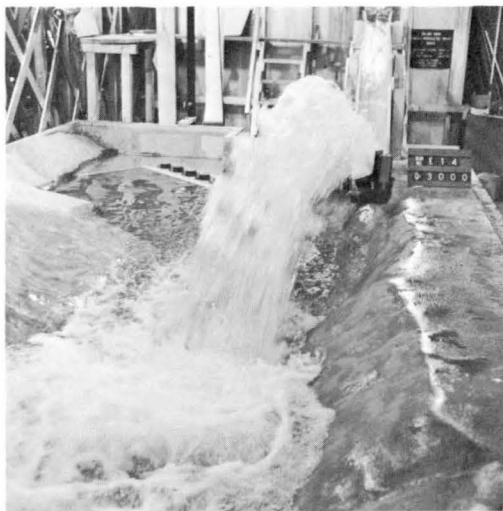
Figure 47. Modified flip bucket using plane surface fillets. The model bucket giving the above result is shown in Fig. 48.

In all of the preceding modifications the bucket and deflector were comprised of curved surfaces. Definition of such surfaces were complex and construction would be even more difficult. Because of this, modifications to the flip bucket geometry were thereafter made with a view to developing more simple geometry, involving if possible plane surfaces with a minimum of curved fillets. The results of one such attempt is shown in Fig. 47 with a view of the model bucket in Fig. 48.

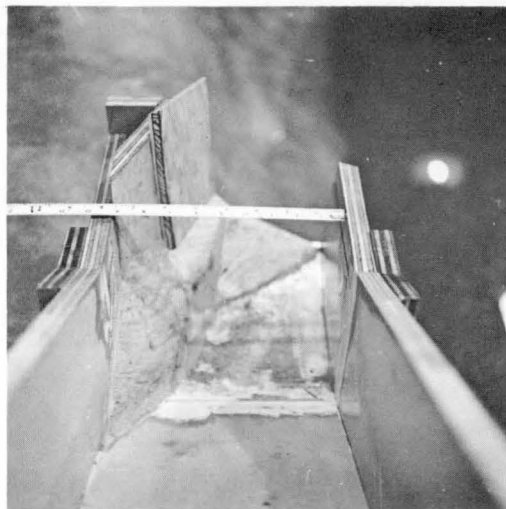
Figure 48. Modified flip bucket including radially curved floor in the vertical plane and plane surface deflectors.

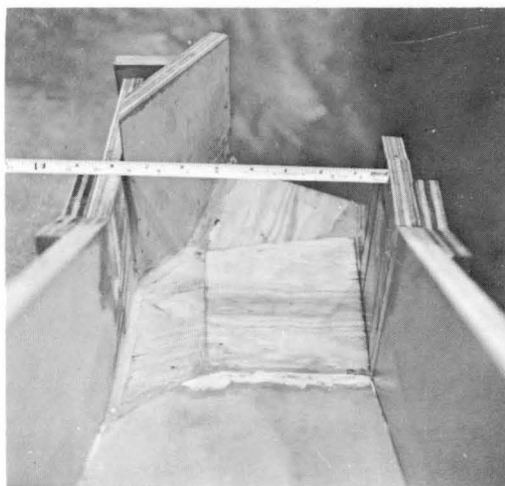
Figure 49. Recommended flip bucket. The dimensions of this bucket are given in Fig. 51.

The recommended flip bucket included only plane surfaces. The model structure of the recommended bucket is shown in Fig. 49 and flow conditions resulting therefrom are shown in Fig. 50 (a) through (j).

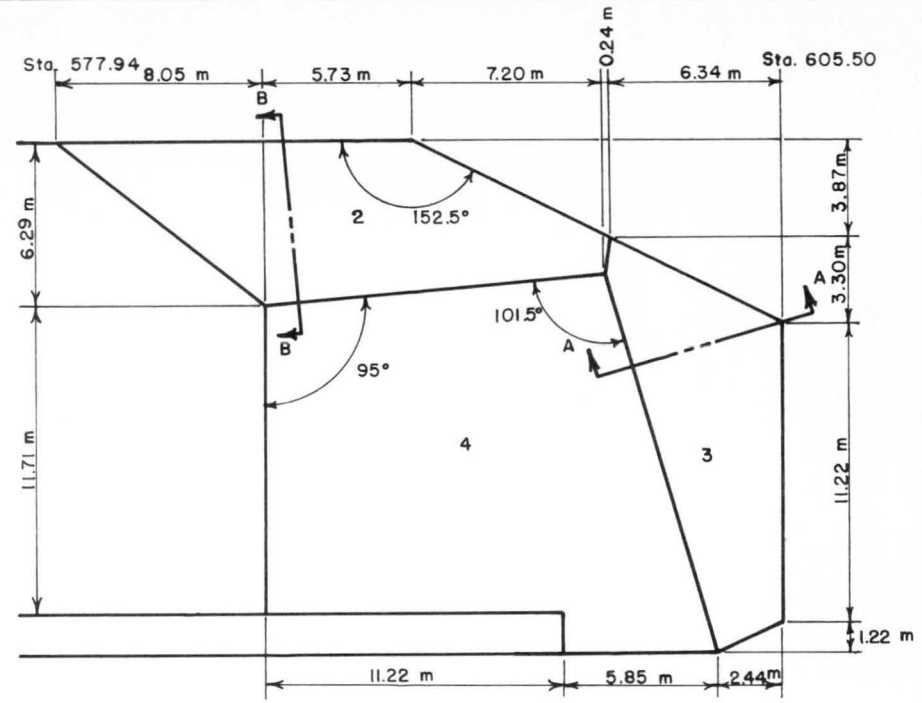
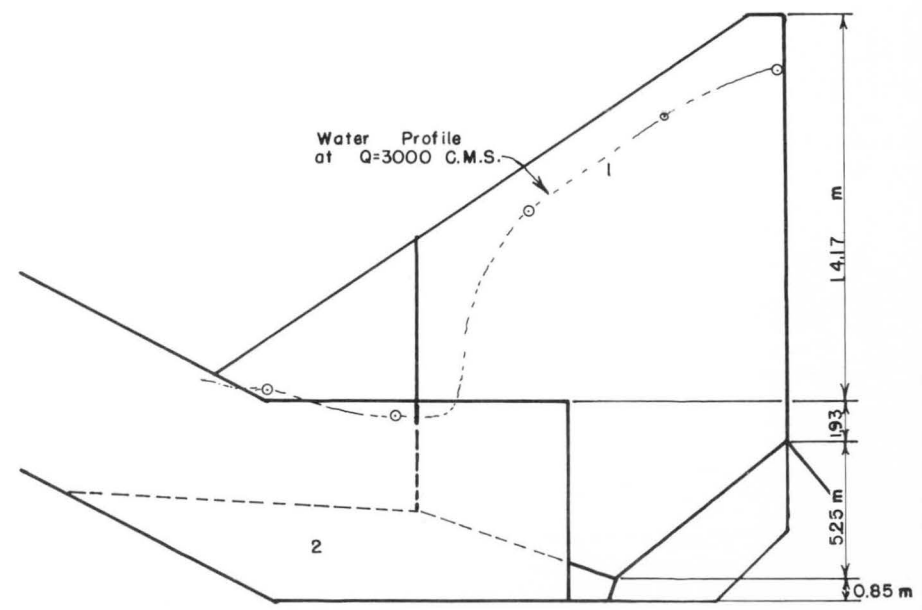
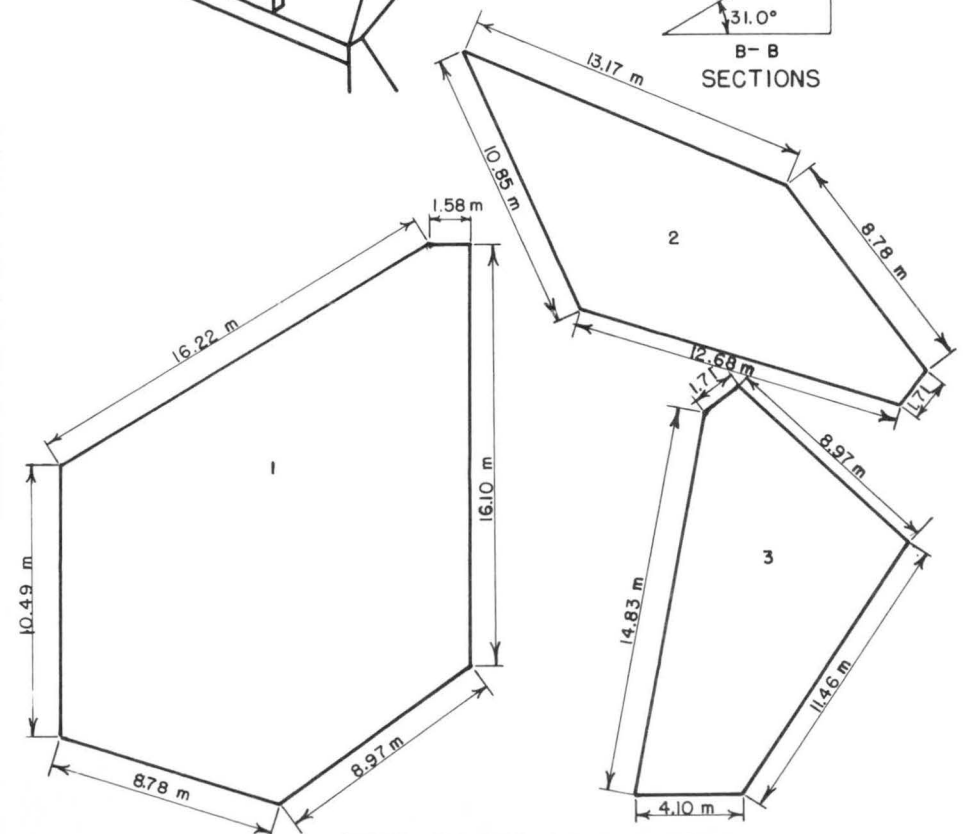
TRUE SHAPES OF PLANES
Fig. 51 RECOMMENDED FLIP BUCKET GEOMETRY

PLAN OF FLIP BUCKET

PROFILE OF FLIP BUCKET

A drawing of the bucket giving pertinent dimensions is shown in Fig. 51. The jet from the flip bucket appeared satisfactory within the flow range from 100 to 3000 cms. The jet did not impinge on the river banks. At less than 100 cms a hydraulic jump was formed in the bucket and the flow fell to the right side of the bucket and cascaded down the hillside. In order to protect the structure from possible foundation failure due to these small discharges, it is suggested that the hillside be paved or a chute be constructed down to the river level to contain these flows. If the foundation rock is sufficiently erosion-resistant to withstand the small flows or if the gates can be operated in such manner as to minimize the small flows, no extra protection will be necessary.

- (a) A functionally satisfactory deflecting flip bucket was developed involving only plane surfaces. The recommended dimensions and arrangement of the planes comprising the deflector are shown in Fig. 51.
- (b) Pressures on the surfaces of the flip bucket were all positive.
- (c) The flip bucket structure was 4.2 meters longer than the preliminary design.

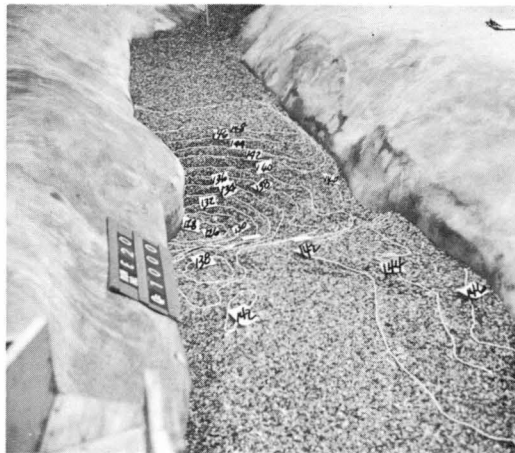
Figure 54 (a). Scour pattern with 3/8-inch gravel
 Spillway $Q = 2000$ cms
 Power Plant $Q = 0$
 Model Time = 45 minutes
 Maximum scour depth = 126.0 m
 Beginning river level = 140.6 m

The development of scour in the river bed with the 3/8-inch gravel and spillway discharge of 1000 cms is shown in Fig. 54 (a). The tail water levels at the power plant are shown in Fig. 54 (b) with progressive stages of scour beginning with the existing river bed level at elevation 140.6 m. The white lines in the photograph are contour lines. The minimum elevation in the scour hole was 126.0 m. Test results for discharges of 2000 and 3000 cms are shown in Figs. 55 and 56 respectively. The power plant wall was not overtopped in any of the tests.

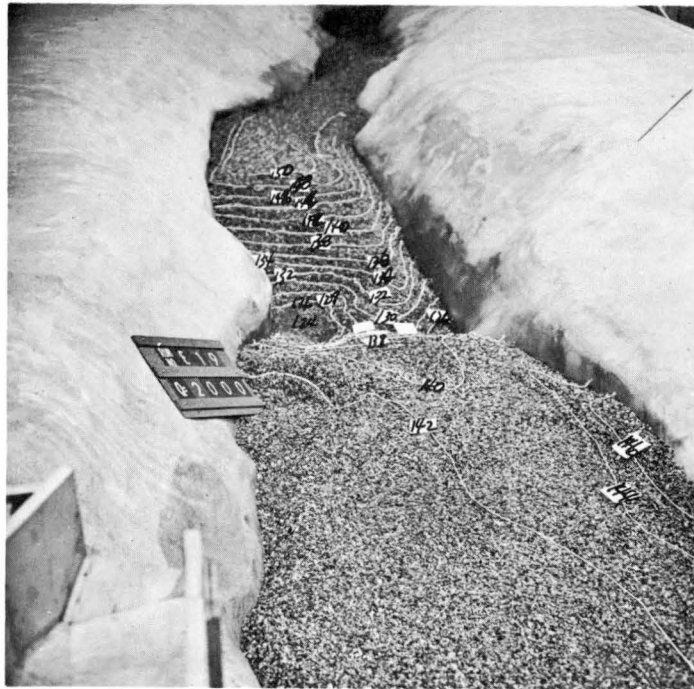
Figure 55 (a). Scour pattern with 3/8-inch gravel
 Spillway $Q = 2000$ cms
 Power Plant $Q = 400$ cms
 Model Time = 38 minutes
 Maximum scour depth = 124.0 m
 Beginning river level = 140.6 m

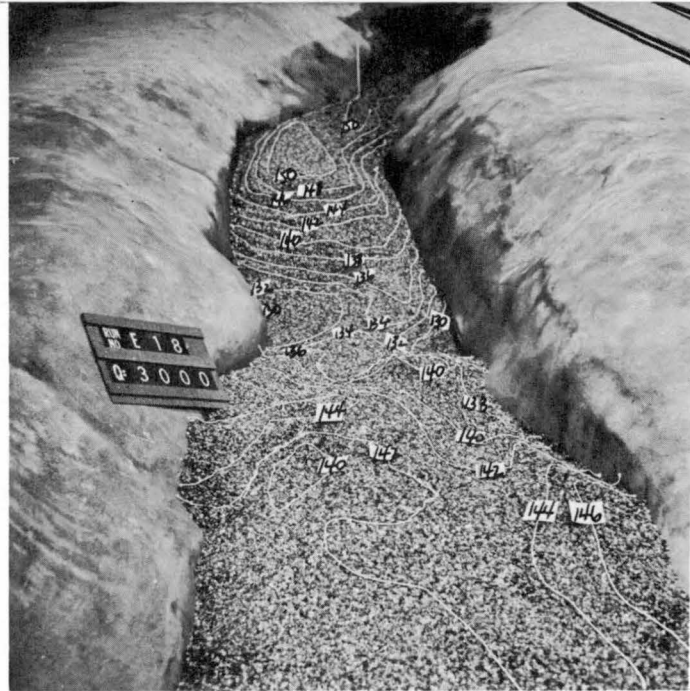
Figure 56 (a). Scour pattern with 3/8-inch gravel
 Spillway $Q = 3000$ cms
 Power Plant $Q = 400$ cms
 Model time = 26 minutes
 Maximum scour depth = 128.0 m
 Beginning river level = 140.6 m
