HYDRAULIC MODEL STUDY of the KREMASTA DAM SPILLWAY

KREMASTA HYDROELECTRIC PROJECT ACHELOOS RIVER DEVELOPMENT GREECE

FINAL REPORT ON A MODEL STUDY

S. S. Karaki
Hydraulics Laboratory
Colorado State University

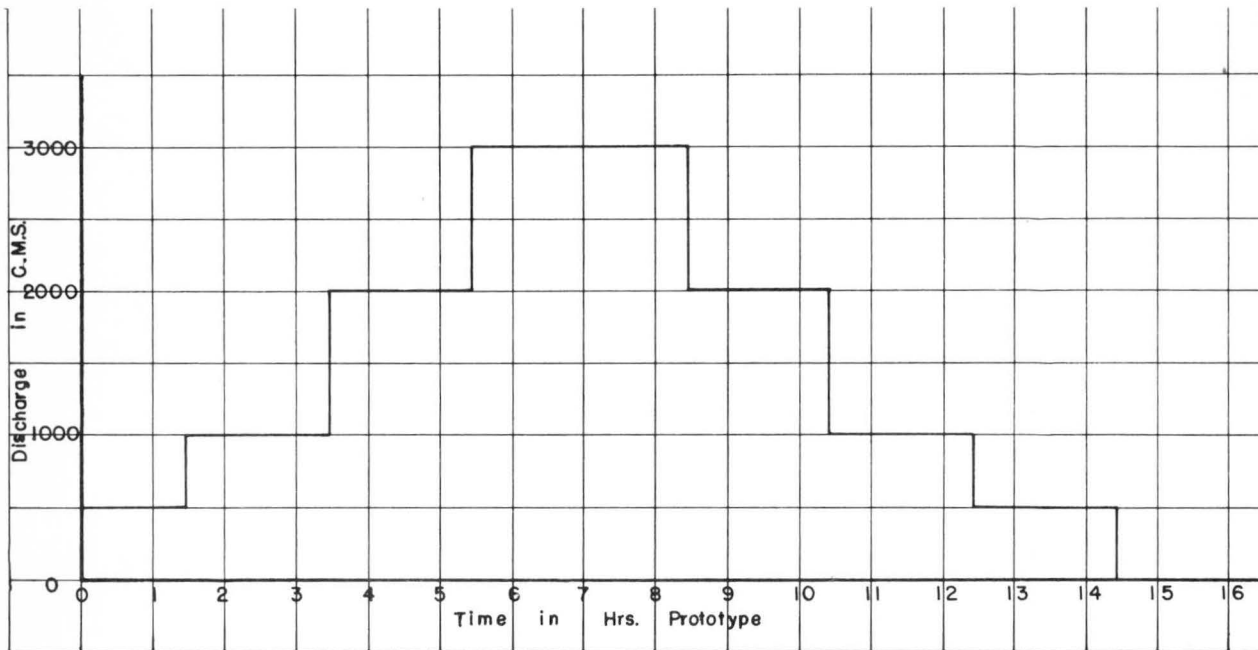
Figure 57

STEP HYDROGRAPH

power plant, a uniform step-hydrograph was discharged over the spillway. The hydrograph is shown in Fig. 57. The resulting scour pattern is shown in Fig. 58 (a).

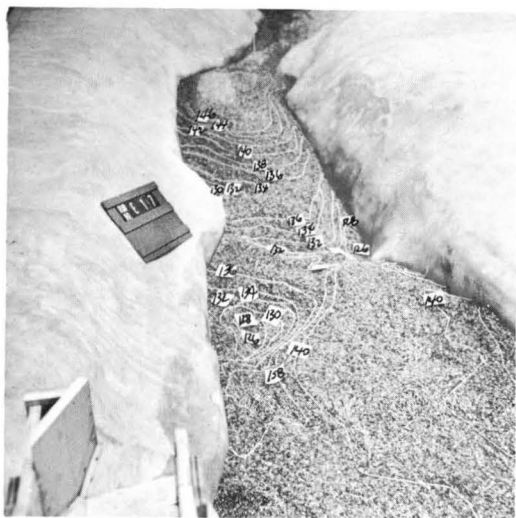
Figure 58 (a). Scour pattern with hydrograph of Fig. 57.

The scour area was more extensive and a greater amount of river bed material was transported downstream. Variation of tail water levels with discharge are shown in Fig. 58 (b). The maximum tail water level was 153.3 providing 2.7 meters of freeboard to the top of the wall. On the recession cycle of the hydrograph the power plant was shut down and tail water levels were measured with only the spillway flows. The result is shown in Fig. 58 (c).

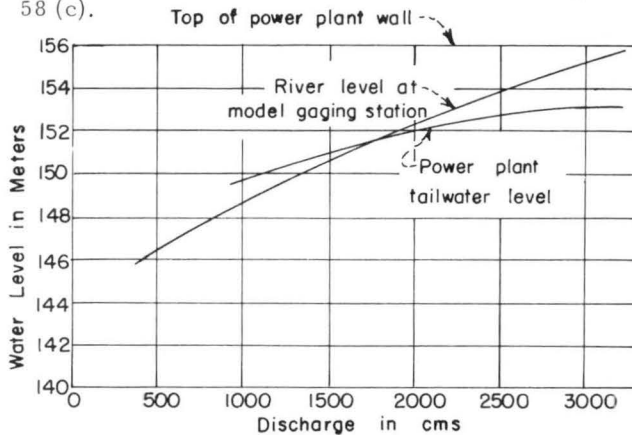
FIGURE 58 (b) POWER PLANT TAILWATER LEVEL
Power Plant Q = 400 cms

Because of the gravel bar formed downstream of the scour area, the tail water levels at the power plant were higher than at corresponding discharges during the ascending cycle of the hydrograph. There was sufficient freeboard to the top of the power plant wall at all discharges.

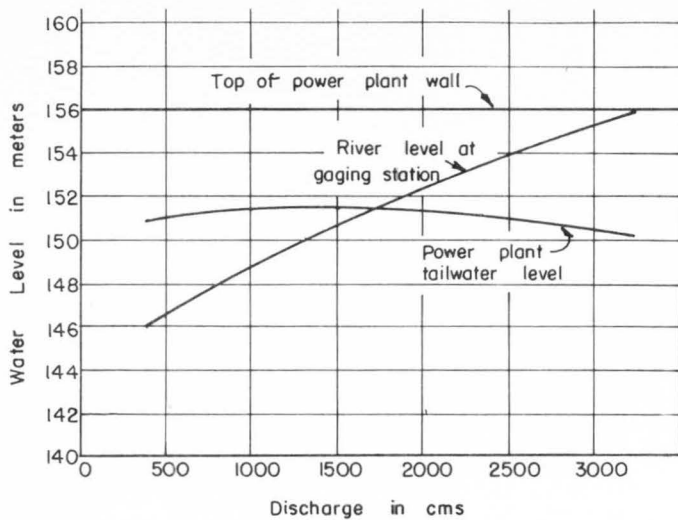
Figure 58 (c). Power plant tailwater level. No power plant discharge.

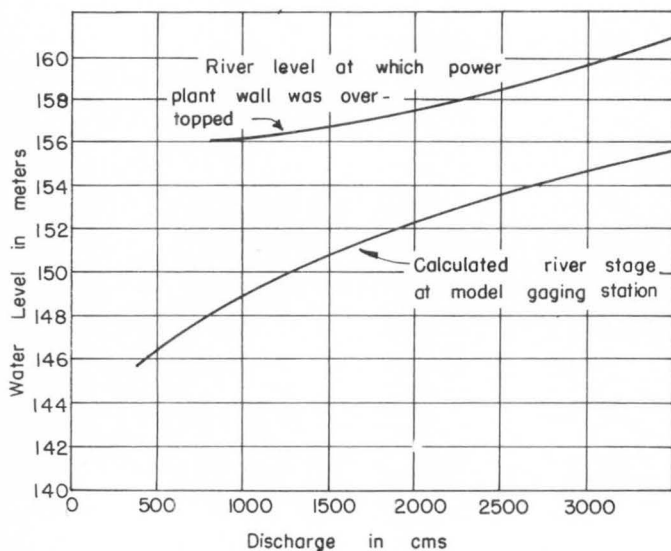
Figure 59. River Stage Studies.

The preceding results were predicated on the supposition that the estimated river stage curves shown in Fig. 53 were correct. If these curves were underestimated, the model observations of tail water levels at the power plant would in turn be too low. To determine at what river stages the power plant wall would be overtopped, tests were run at several discharges with imposed high river levels to cause overtopping. The tests were made with maximum discharges through four turbine units. Results are shown in Fig. 59. There was at least 5 meters of allowance in depth between the calculated stage and that which would cause overtopping.

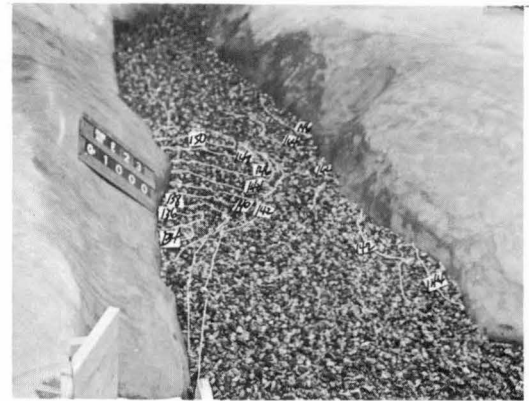
Figure 60 (a). Scour patterns with 3/4-inch gravel. $Q = 1000$ cms.

The results of tests with 3/4-inch gravel in the model river bed are shown in Fig. 60 (a) through (c) for discharges of 1000, 2000, and 3000 cms. The power plant tail water levels were the same as tests with the 3/8-inch gravel bed.

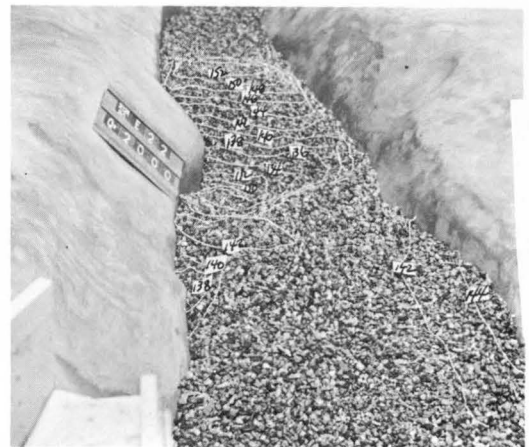
Figure 60 (b). Scour patterns with 3/4-inch gravel. $Q = 2000$ cms.

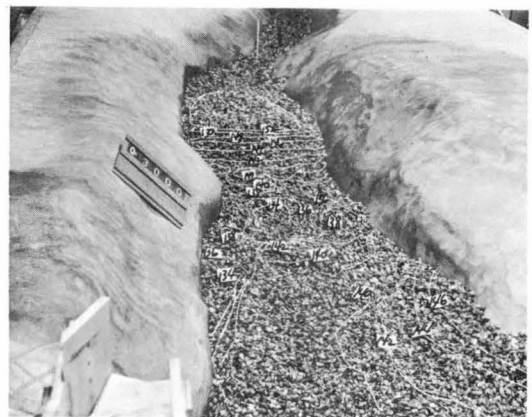
Figure 60 (c). Scour patterns with 3/4-inch gravel. $Q = 3000$ cms.

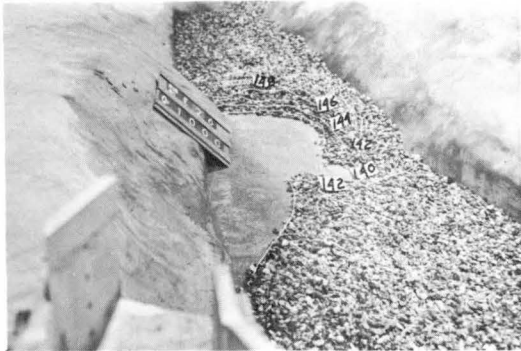
Figure 61 (a). Scour patterns with bed rock at elevation 139.0 meters. $Q = 1000$ cms.

Test results with river bed rock located at elevation 139.0 are shown in Fig. 61 (a), (b), and (c) for comparable discharges to Fig. 60. Measured tail water levels at the power plant are shown in Fig. 62. The tail water at the power plant was drawn down with increasing spillway discharges with the bed rock level at 139.0. This is reasonable since greater downstream horizontal shear component is developed on the bed and the water level upstream of the jet impingement area is drawn down as a result. No apparent tail water problem at the power plant will arise if bed rock is near the present river bottom. It might be mentioned, however, that with the high velocities of the jet, should the bed rock scale off in the form of large boulders or slabs and block the river channel, a rise in tail water is to be expected. Unless the entire river channel is completely blocked off, however, some channeling will result around the plug and overtopping should not occur at the power plant. In the event blocking should occur, naturally remedial measures should be taken as soon as practicable.

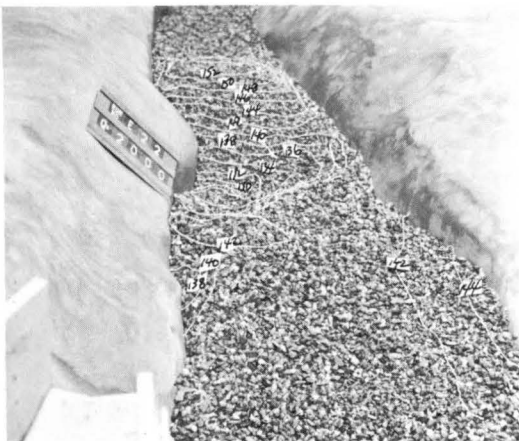
Figure 61 (b). Scour patterns with bed rock at elevation 139.0 meters. $Q = 2000$ cms.

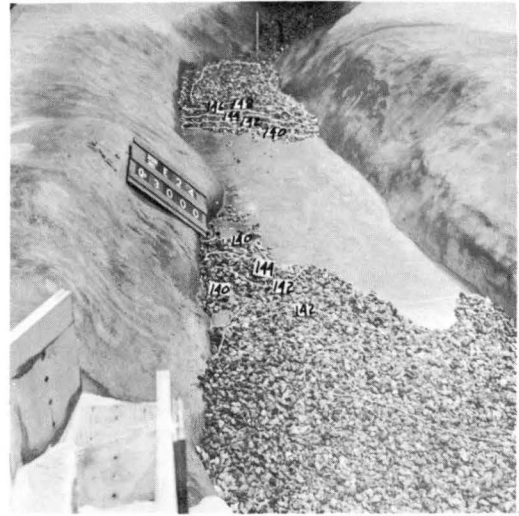
Figure 61 (c). Scour patterns with bed rock at elevation 139.0 meters. $Q = 3000$ cms.

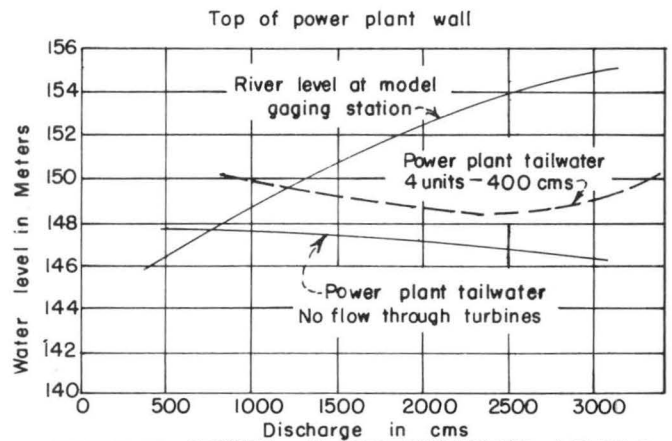
FIGURE 62 POWER PLANT TAILWATER LEVELS BED ROCK AT ELEV. 139.0
