THESIS

EXPERIMENTAL FATIGUE EVALUATION OF UNDERWATER STEEL PANELS
RETROFITTED WITH FIBER REINFORCED POLYMERS

Colorado State University

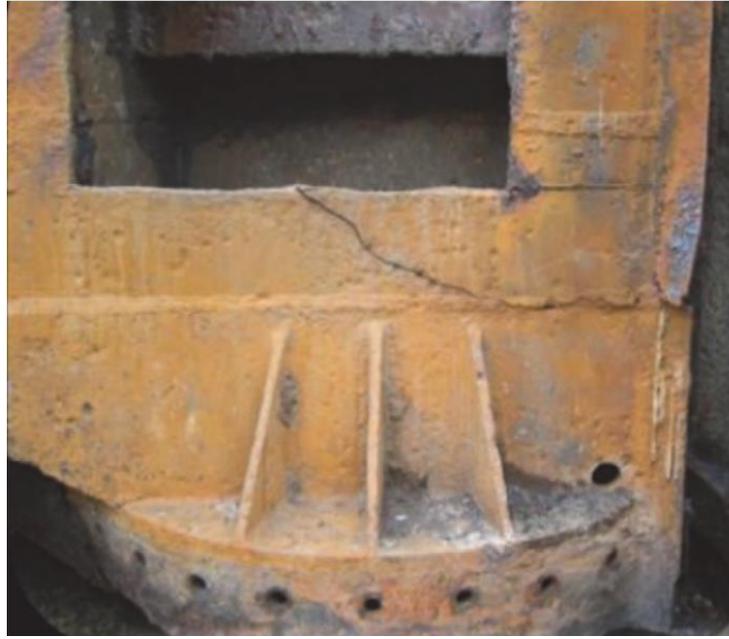
Figure 1-1. crack near the pintle socket of a miter gate (Mahmoud & Riveros, 2013)

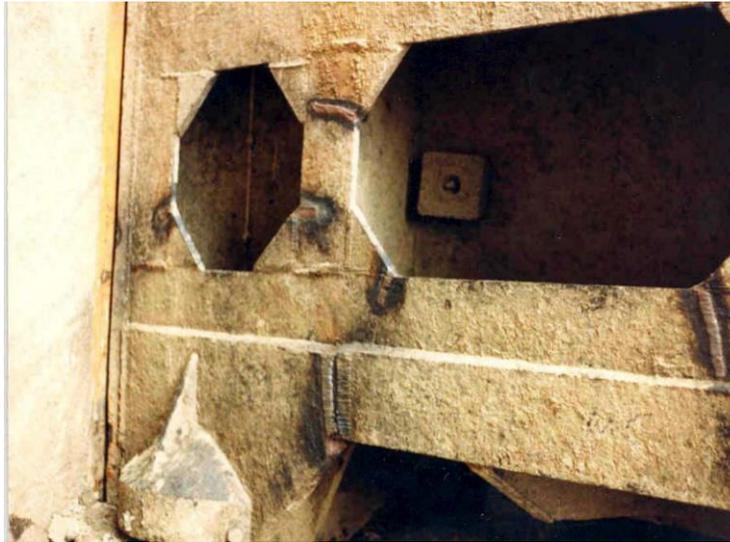
Figure 1-2. Cracks repaired by rewelding in miter gate girder and diaphragm flanges that experience compression loads during gate operation (HQUSACE, 2010)

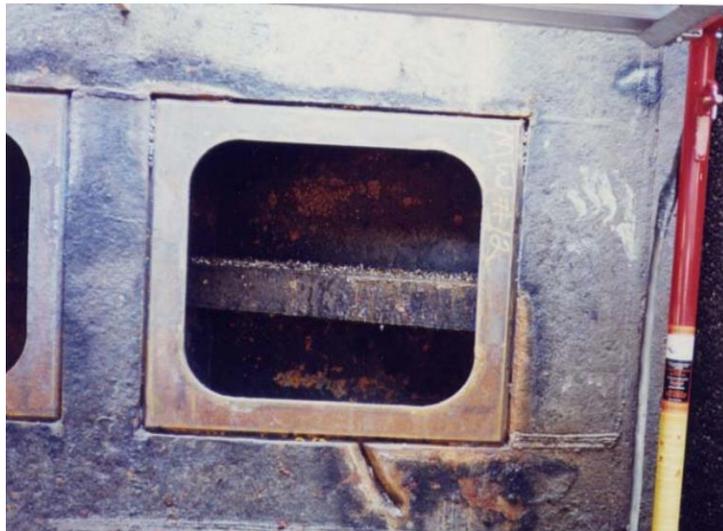
Figure 1-3. Welded window frame type repair implemented for gates at the Markland Locks and Dam

Fatigue cracks in welded joints in the miter gates at the Markland Locks and Dam on the Ohio River, for example, were first observed and repaired by gouging and rewelding in 1984 after 24 years in service. Four years after the first repairs, cracks at the previously repaired locations and new locations were noted. Triangular welded gusset plates were added to reduce stresses at the locations as shown in Figure 1-2. Six years later, cracking around the gusset plates was noticed, and the gusset plates were replaced with a window frame type repair as shown in Figure 1-3, successfully mitigated additional cracking (USACE, 2010). While existing repair methods can provide solutions to continue safe operation, frequent inspection and repair are still required afterwards. This is cumbersome and costly, as dewatering and inspection can require a structure to be temporarily taken out of service.

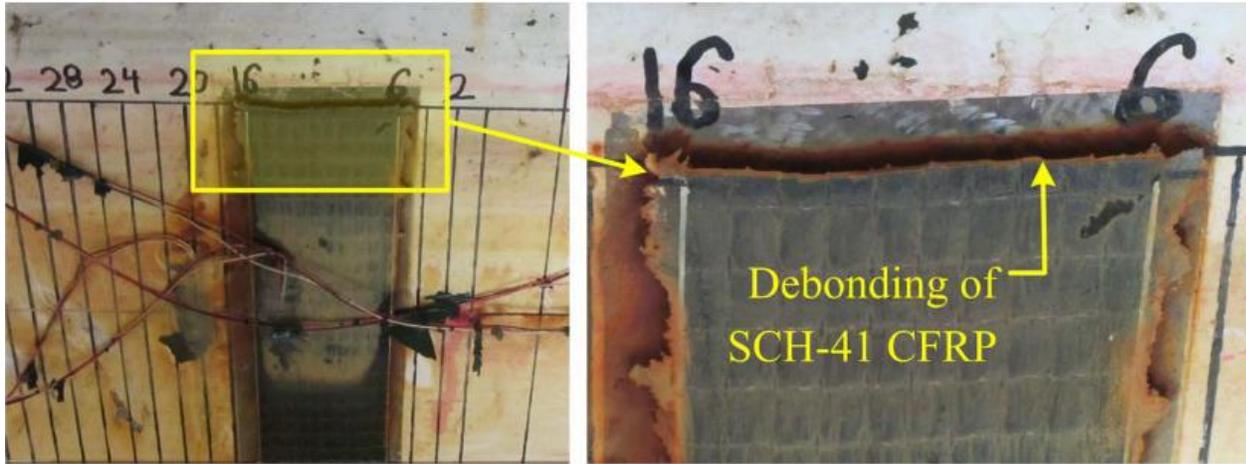
Figure 1-4. CFRP repair used underwater showing substantial debonding (Mahmoud et al., 2018)

Recent large-scale underwater testing by Mahmoud, Riveros, Memari, Valsangkar, and Ahmadi (2018) demonstrated that carbon fiber reinforced polymers (CFRP) can be a viable option for underwater repairs, but their effectiveness was limited by poor adhesion to the steel substrate. Figure 1-4 shows a specimen that was repaired with CFRP and fatigue tested underwater exhibiting substantial CFRP debonding. Some of the debonding can be attributed to corrosion both from the underwater environment and from galvanic interaction between steel and the carbon fibers in contact with each other. When applied over a crack, FRP sheets reduce the stress intensity factor and therefore the crack propagation rate by reducing the nominal stress on the crack plane and providing a crack closure effect from the fibers that bridge the crack. Both factors rely on bonding between the cracked material and FRP to be effective; therefore, additional work is needed to maximize adhesion in an underwater environment to better increase the fatigue life of repaired cracks.

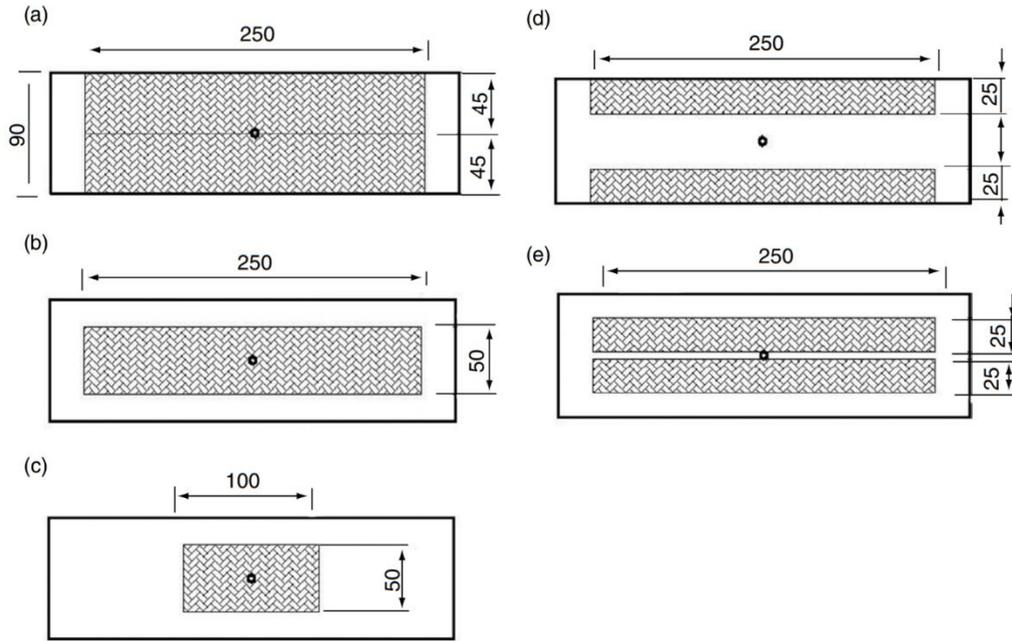
Figure 2-1. Repair configurations used by Wu et al. (2012) (hatched areas represent CFRP, dimensions in mm)

Varying the width of applied CFRP patches can change the cross-section stiffness and can also, in conjunction with patch location along the crack plane, change the length of existing crack that is covered and experiences reduced crack opening displacement. The CFRP configurations used by Wu, Zhao, Al-mahaidi, Emdad, and Duan (2012) demonstrate the use of varying widths and locations along the crack plane well. Each CFRP configuration was applied to both sides of a steel plate with a crack initiator at the center, and specimens were fatigue tested with maximum stress of 150 MPa and stress ratio of 0.1 in the horizontal direction as shown in Figure 2-1. With maximum width and CFRP covering the initial crack, configuration (a) entirely arrested the crack. The other configurations still significantly increased fatigue life when compared to a specimen with no repair with an order from most to least improvement of (b), (e), (c), and (d) as shown in Figure 2-2. Results indicate that there is less improvement when the crack is not covered and, if not covered, when the patch is farthest away from the initial crack. Additional results were found by Jones and Civjan (2003) with similar style tests where fatigue life was improved by 170% when the initial crack was covered and 115% when it was not.

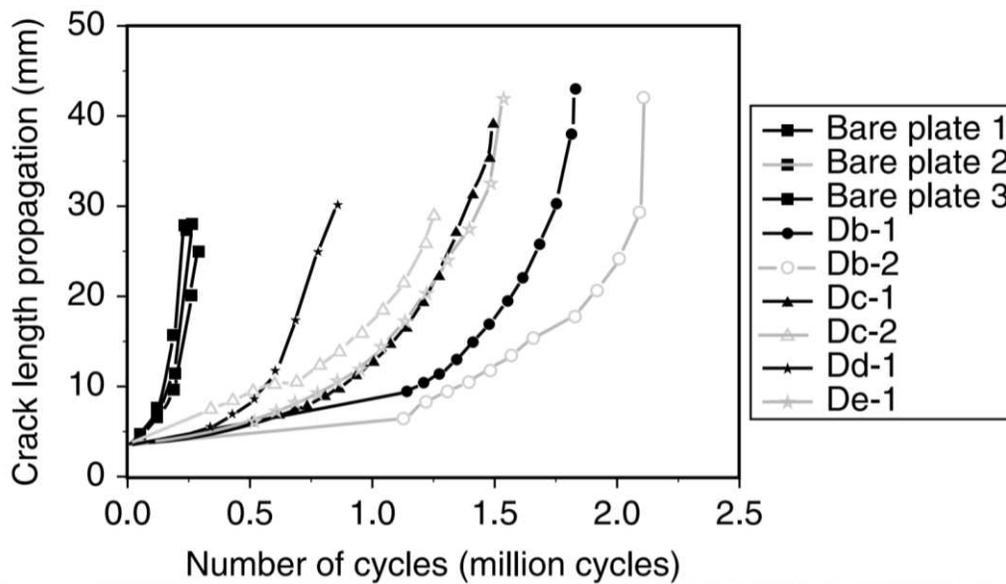
Figure 2-2. Crack growth results for various configurations as tested by Wu et al. (2012)

When comparing configurations (b) and (c) from Wu et al. (2012) it is clear that the length of an applied CFRP patch also contributes to repair effectiveness. However, performance is only

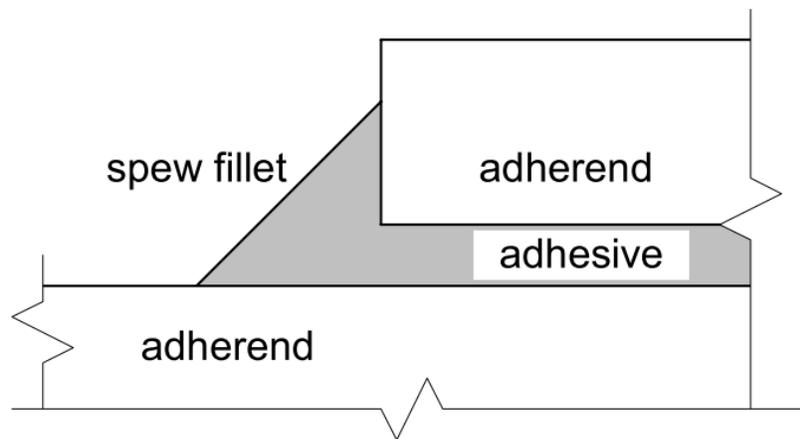
Figure 2-3. Sketch of cross-section with adhesive spew fillet (Shield et al., 2004)

If material properties of the system cannot be modified to provide better bonding, several other techniques can be used to prevent debonding at patch ends. The use of a spew fillet around the edges of CFRP patches, as shown in Figure 2-3, is known to reduce the stress concentration at the end of the adhesive as suggested by Bocciarelli et al. (2009), Deng and Lee (2007), and Shield, Nozaka, and Hajjar (2004). Mechanical clamps, such as the example shown in Figure 2-4, can also be used to apply pressure at the end of CFRP patches to prevent debonding (Gangel, 2011; Vatandoost, 2010).

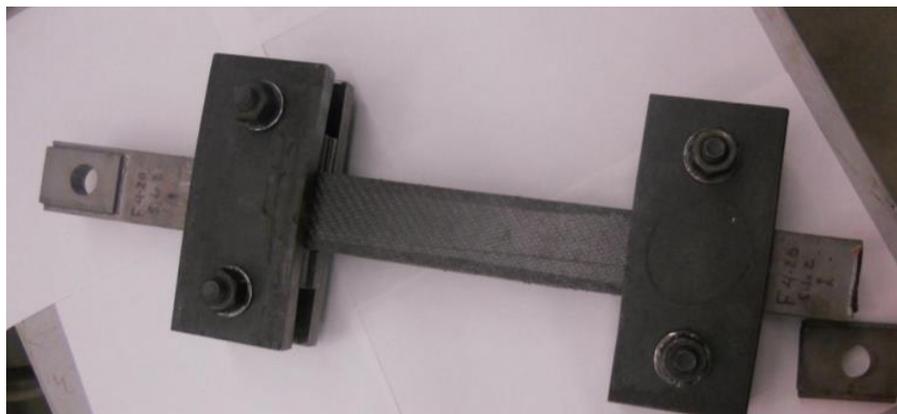
Figure 2-4. Clamp made from steel plates and pretensioned bolts to prevent CFRP debonding (Gangel, 2011)

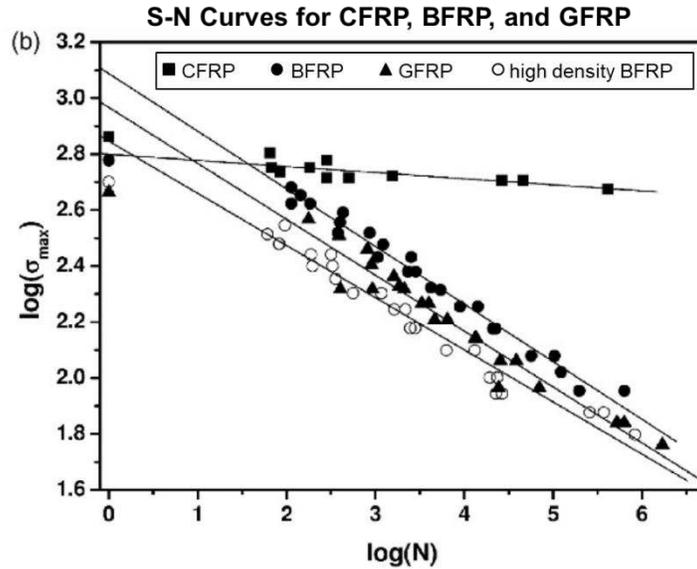
Figure 2-5. S-N curves for glass, basalt, and carbon FRP developed by Dorigato and Pegoretti (2012)

Due to previous use in other industries, fatigue life of BFRP has been studied. BFRP does not perform as well in fatigue as CFRP. Dorigato & Pegoretti (2012) developed S-N curves for carbon, basalt, and glass fiber laminates in tensile fatigue as shown in Figure 2-5. The slope of the S-N curve for BFRP is dramatically steeper than that for CFRP, indicating a reduced fatigue life in comparison to CFRP. Fatigue limits for CFRP and BFRP determined by Wu et al. (2010) indicated that BFRP has infinite life under constant amplitude fatigue when the stress is less than 55% of its tensile strength, whereas the same is true for CFRP when the stress is less than 84% of its tensile strength. Due to the lower fatigue resistance of BFRP, more fatigue life consideration of the composite may be needed when BFRP is used as an alternative to CFRP in fatigue repairs.

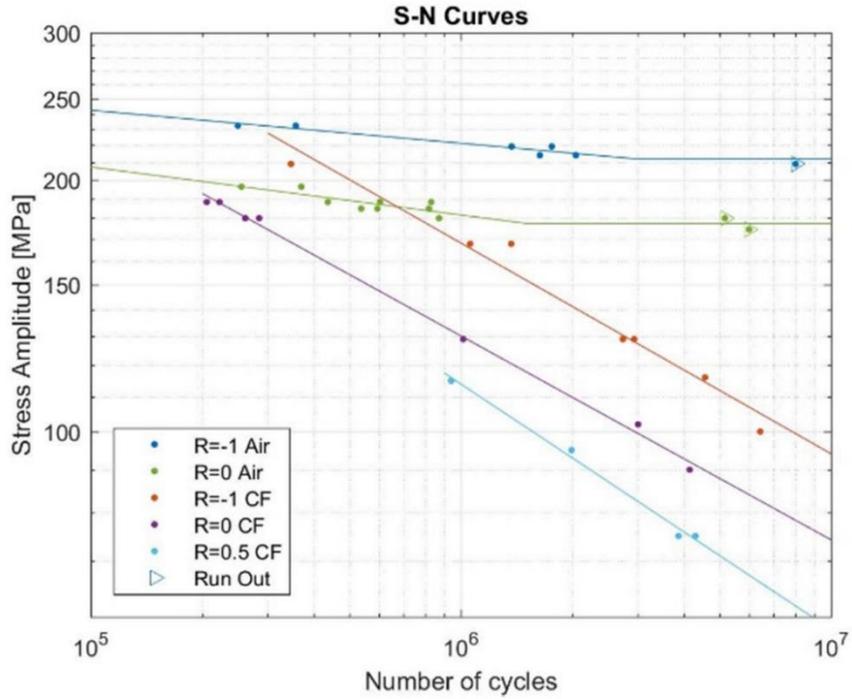
Figure 2-6. S-N curves for steel in air and fresh water corrosion fatigue (CF) (Morgantini et al., 2018)

Similarly, varying the stress range can indirectly introduce a time variable that affects fatigue life underwater. If maintaining all other variables, reducing the stress range lowers the crack growth rate and therefore increases the time required for a crack to grow to a given length. If underwater, the increased time needed for crack growth allows the environmental factors a longer time to react, resulting in more pronounced degradation. This can result in a larger difference between fatigue life in air and water with lower stress ranges compared to higher stress ranges. Plots of stress range versus number of cycles for air, fresh water, and saltwater environments were developed and compared by Morgantini, Okorokov, Gorash, Mackenzie, and Van Rijswick (2018). Round rod specimens were axially fatigue tested with varying stress ranges and stress ratios in the three environments. Comparing the resulting S-N curves for fresh water and air, as shown in Figure 2-6, indicates that the environmental factors are much more present with low stress ranges. At higher stress ranges, at which the tests took less than 10^6 cycles, the results in water showed little difference from those in air. However, at the lowest stress ranges tested, which approached 10^7 cycles, the fatigue life was reduced by a factor of 2.1 when in water. The authors attribute this to the larger amount of time in water when the stress range is low. It is also noted that the fatigue limit for the underwater environment was not reached in the stress ranges that were tested, which implies that the life reduction could be even greater with lower stress range. Comparing the resulting S-N curves in fresh water and salt water as shown in Figure 2-7 shows that salt water reduces fatigue life more so than fresh water, but the difference is very small compared to that between fresh water and air

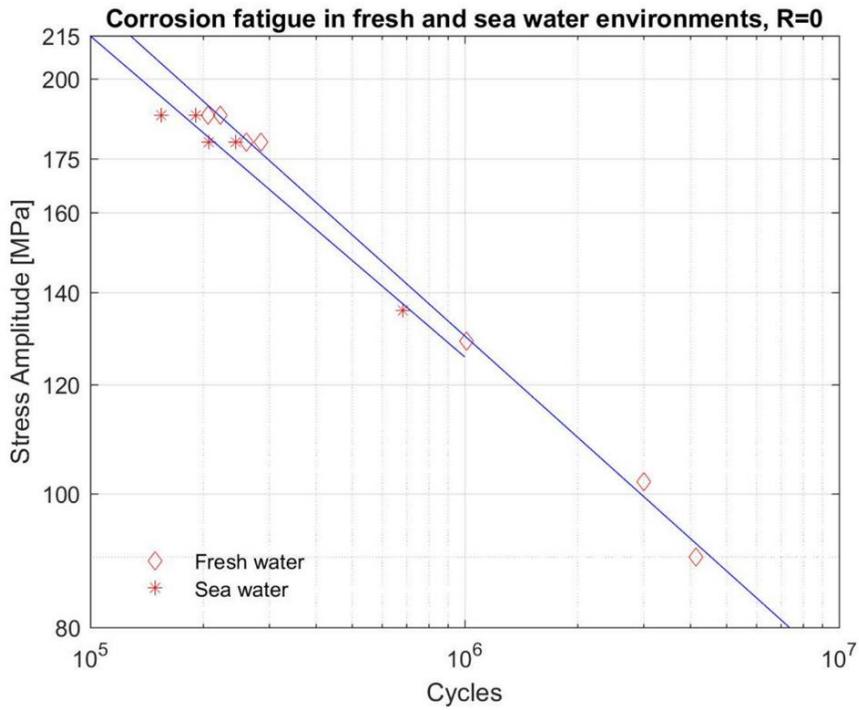
Figure 2-7. Comparison of S-N curves for steel in fresh water and salt water (Morgantini et al., 2018)

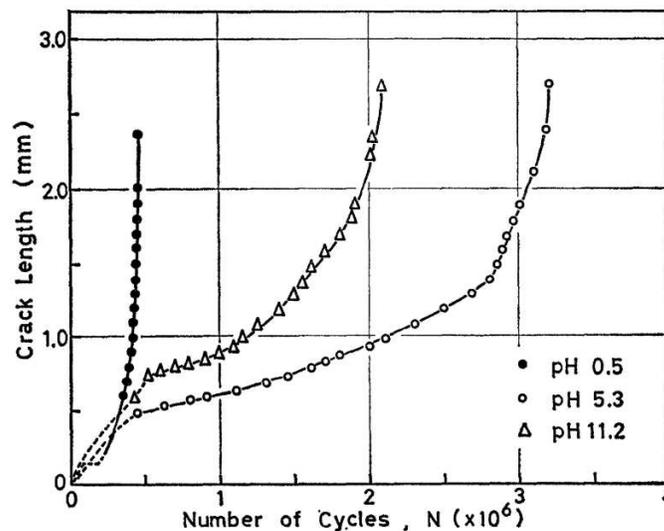
Figure 2-8. Fatigue crack propagation of steel in solutions of varying pH (Misawa & Kobayashi, 2017)

As one of the driving factors of corrosion fatigue is hydrogen embrittlement, which is caused by a reaction between steel and hydrogen, it is logical that the pH of the environment may affect fatigue life. Differences in fatigue life between steel in solutions of various acidities were explored by Misawa and Kobayashi (1976). Round rod specimens with 15 mm diameter and 2.5 mm machined notches were tested in a rotating-bending fatigue machine. A corrosion cell around the specimens contained water with pH of 0.5, 5.3, or 11.2. Crack length and number of cycles were recorded throughout each of the tests. The solution closest to neutral, with a pH of 5.3, resulted in the highest fatigue life. Both the acidic and basic solutions reduced the life; however, it was reduced significantly more with the acidic solution, as depicted in Figure 2-8. This suggests a complex relationship between the pH of water and fatigue life of steel.

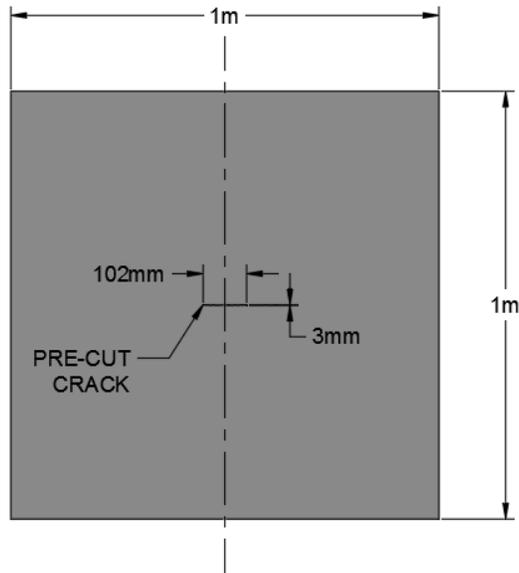
Figure 3-1. Dimensions of center-cracked steel plates

The center-cracked steel plates tested were identical to those used by Mahmoud et al. (2018) with dimensions of 1 m by 1 m, a thickness of 9.5 mm (3/8 in), and centered 102 mm (4 in) precut crack as shown in Figure 3-1. Additionally, because only crack propagation, not initiation, was of interest, tack welds were placed at the ends of the pre-cut crack to promote the initial step of crack propagation from the precut crack. Dimensions were selected based on analysis completed and described by Mahmoud et al. (2018). One unretrofitted specimen (specimen 2) was tested in fresh water for comparison to the repaired specimens, while another unretrofitted specimen (specimen 1) was tested in air to determine the reduction in fatigue life in steel caused by the underwater environment.

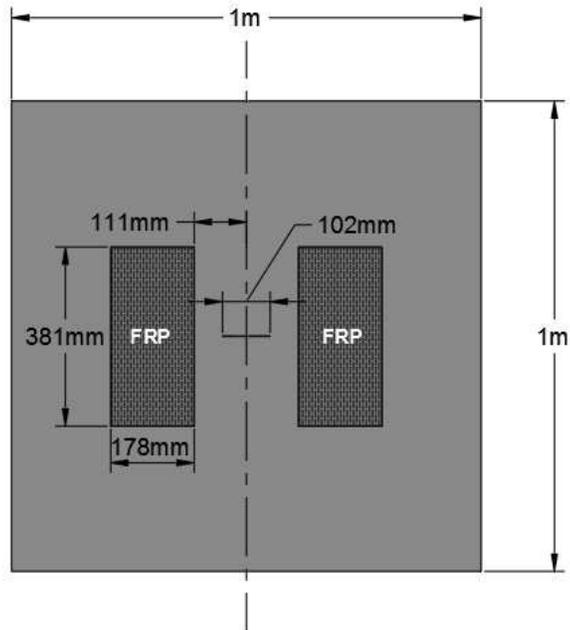
Figure 3-2. Dimensions of retrofitted specimens

Two specimens were retrofitted with FRP patches on both faces. The retrofitted specimens were tested in fresh water to simulate the environment experienced by steel hydraulic structures since both the steel and FRP system can be deteriorated by moisture. It should be noted that treated fresh water was used as a baseline condition and river water that hydraulic structures are exposed to may be more complex and introduce more factors contributing to deterioration. An FRP patch width of 178 mm (7 in) was selected based on the manufactured width of the basalt fiber fabric that was used. A patch length of 381 mm (15 in) was used to be consistent with previous experiments conducted by Mahmoud et al. (2018). Both repaired specimens used two layers of FRP on each face. CFRP and BFRP were used for specimen 3 and specimen 4, respectively. The retrofit method and test environment for each specimen are summarized in Table 3-1. Figure 3-2 shows dimension of the retrofitted specimens.

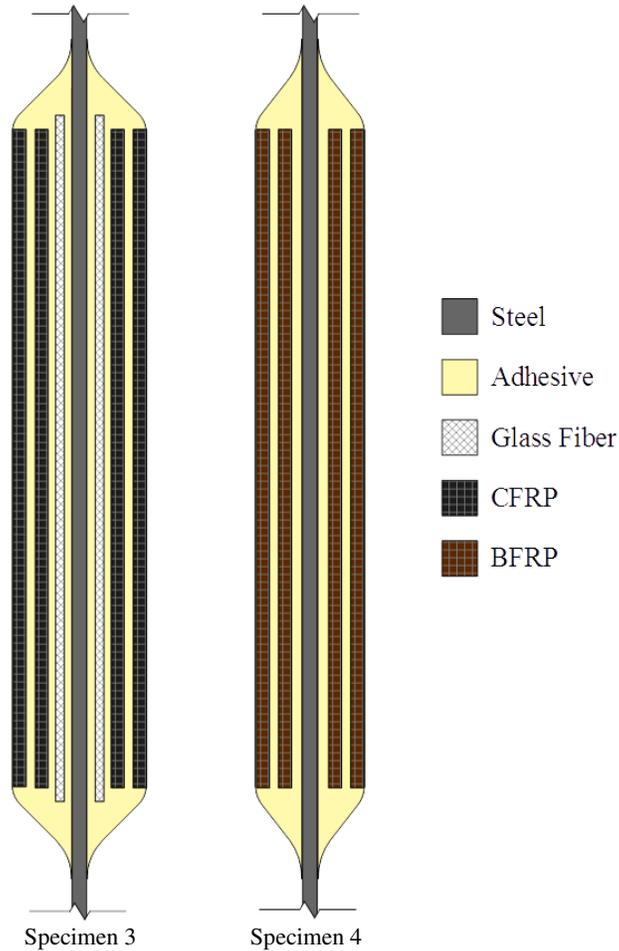
Figure 3-3. Cross-sectional view of FRP patches (not to scale)

An adhesive epoxy was used between the steel and FRP patch and between subsequent layers of FRP to improve bonding. A spew fillet was also formed from the adhesive around the perimeter of the FRP patch to reduce stress concentrations and prevent debonding at the patch ends. For the specimen repaired with CFRP, an additional layer of glass fiber fabric was installed between the steel and CFRP to provide an insulating barrier and prevent galvanic corrosion. Cross-sectional views of the FRP patch locations are illustrated in Figure 3-3.

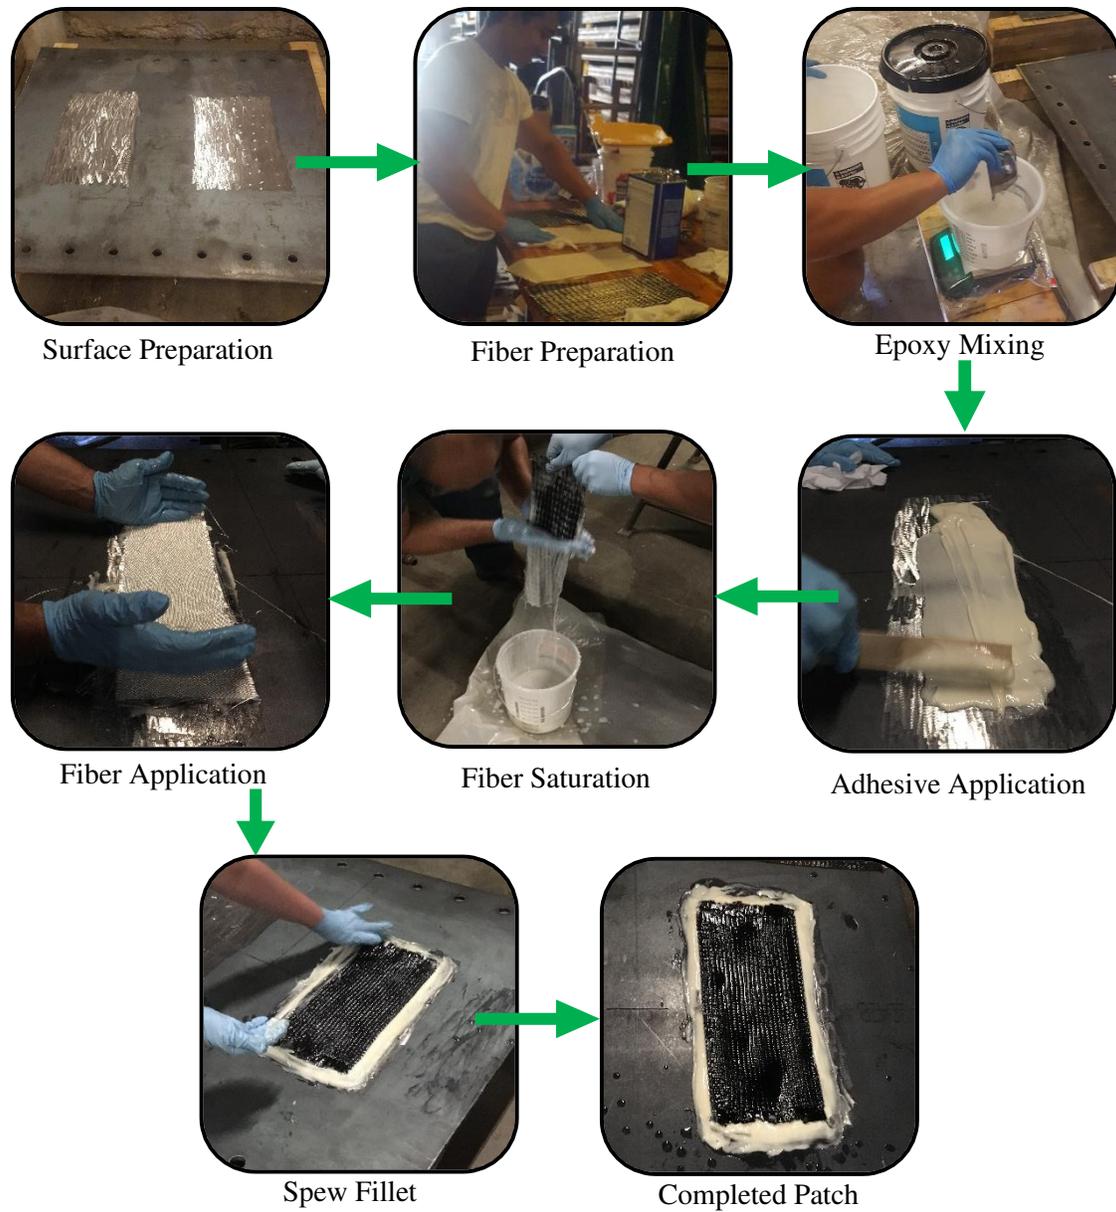
Figure 3-4. FRP patch retrofit application process

After all the layers were applied, spew fillets around the patches were formed by hand from additional adhesive to create a smooth transition between the patch and the steel. Any spilled or excess epoxy on the specimen was then removed. The epoxies were allowed to harden before being handled, and the manufacturer specified cure time was provided. The FRP application process is illustrated in Figure 3-4.

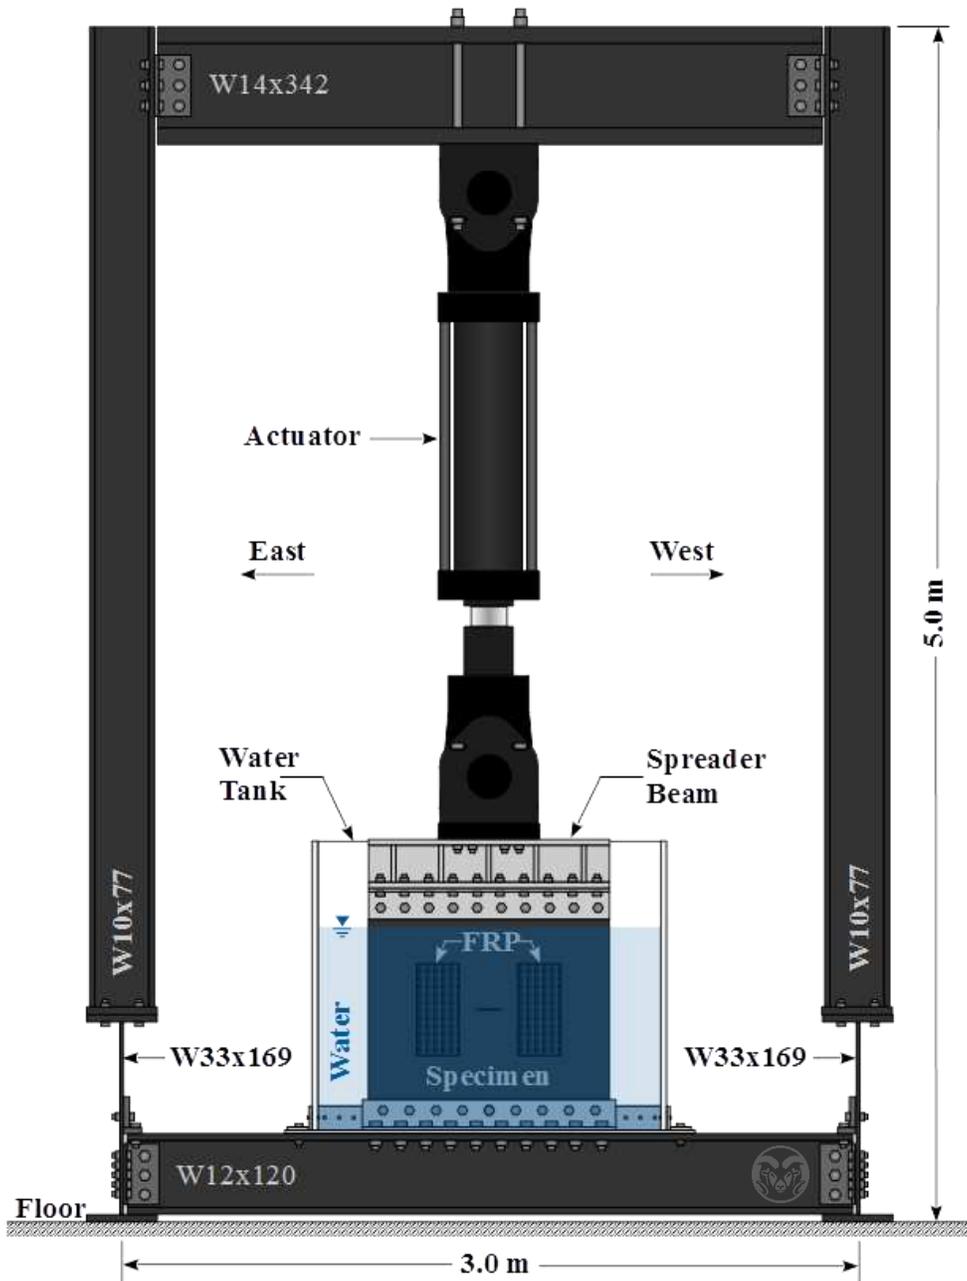
Figure 3-5. Schematic of self-reacting test frame looking south

extend the frame's fatigue life. Once installed, specimens were positioned such that the faces of the steel plates were oriented to the north and south and cracks would propagate to the east and west. Specimens were attached to the lower beam using a double angle connection. Another double angle connection at the top of the specimens attached a stiffened built-up I-beam used to distribute load from the actuator. The actuator was secured to the test frame's upper beam with threaded rods that spanned from the actuator through to the top flange of the beam. Strain gauges on the rods were used to monitor pretensioning of the rods. All bolts in the test frame were pretensioned using direct tension indicating washers.

A tank was built surrounding the specimens for use when an underwater test environment was needed. The steel tank floor rested on the lower test frame beam. Acrylic sheets were used as tank walls so that the specimens could be easily observed from outside the tank. Pumps were installed so that the tank could be easily filled and drained when needed. A schematic of the test frame and water tank as viewed looking south is provided in Figure 3-5. A photo of the test system viewed looking south is shown in Figure 3-6.

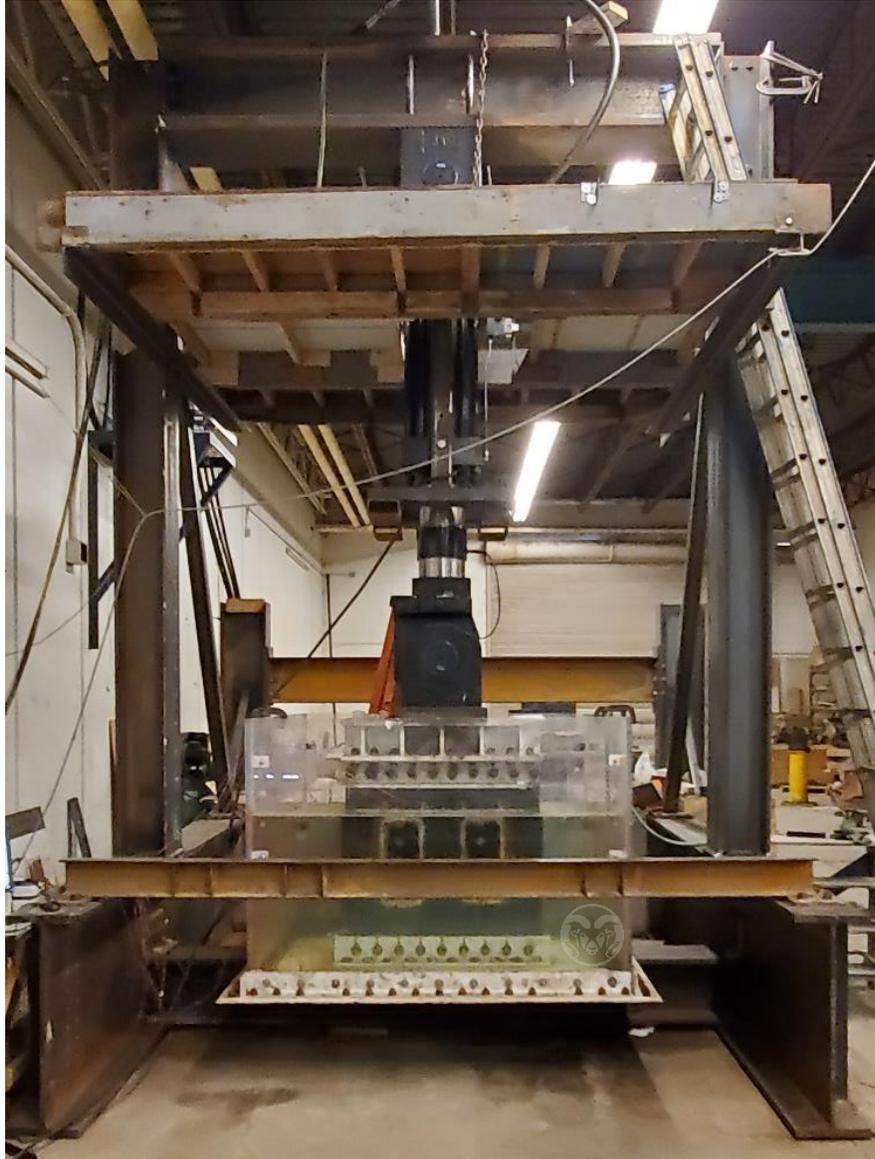
Figure 3-6. Photo of test frame

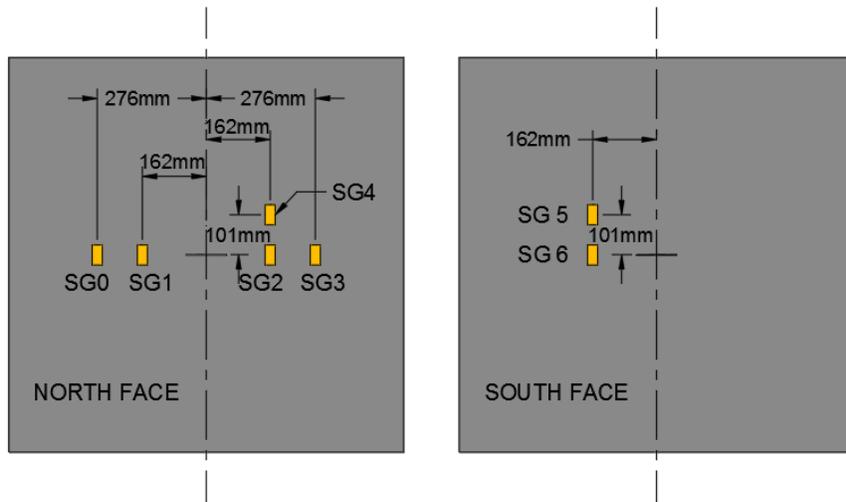
Figure 3-7. Specimen 1 strain gauge layout

Strain gauges were installed on each specimen as shown in Figure 3-7 through Figure 3-10. Specimen 1 included strain gauges located above the crack plane to verify the applied nominal stress. All specimens had multiple strain gauges installed along the crack plane. Readings from these gauges were expected to increase with crack growth and grow rapidly as the crack

approached a gauge. For the retrofitted specimens, additional strain gauges were used to monitor FRP debonding, if any, by placing them along the height of the patches. A drop in a reading from a gauge on the FRP indicated that the bond directly beneath it was no longer intact. Strain gauges applied to specimens 2 through 4 were covered in silicone sealant to protect them from the water. A National Instruments PXI data acquisition system was used for recording strain readings.

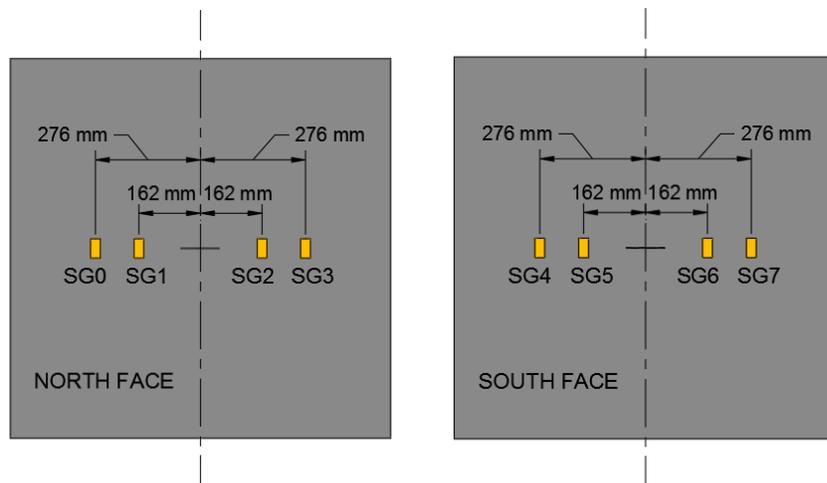
Figure 3-8. Specimen 2 strain gauge layout

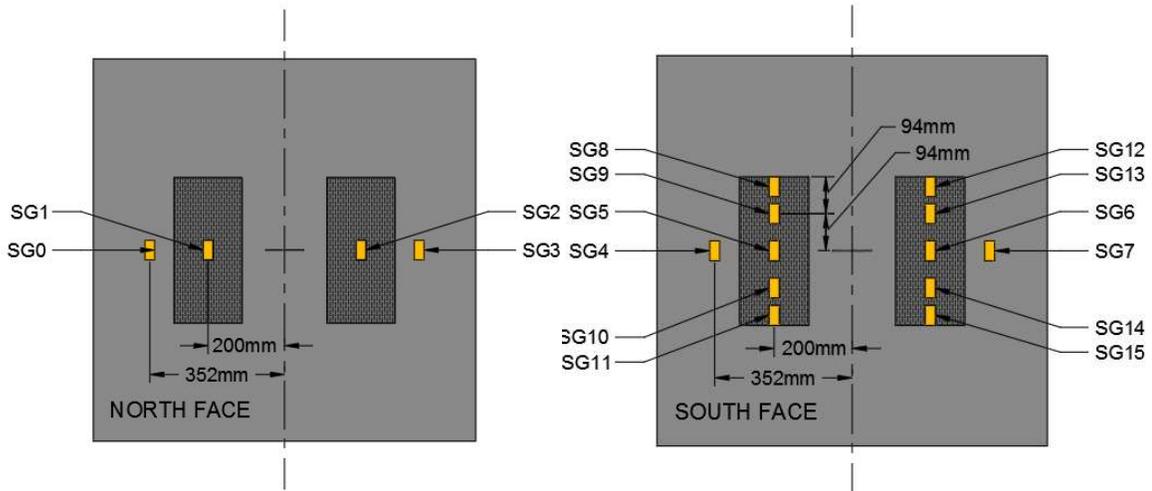
Figure 3-9. Specimen 3 strain gauge layout

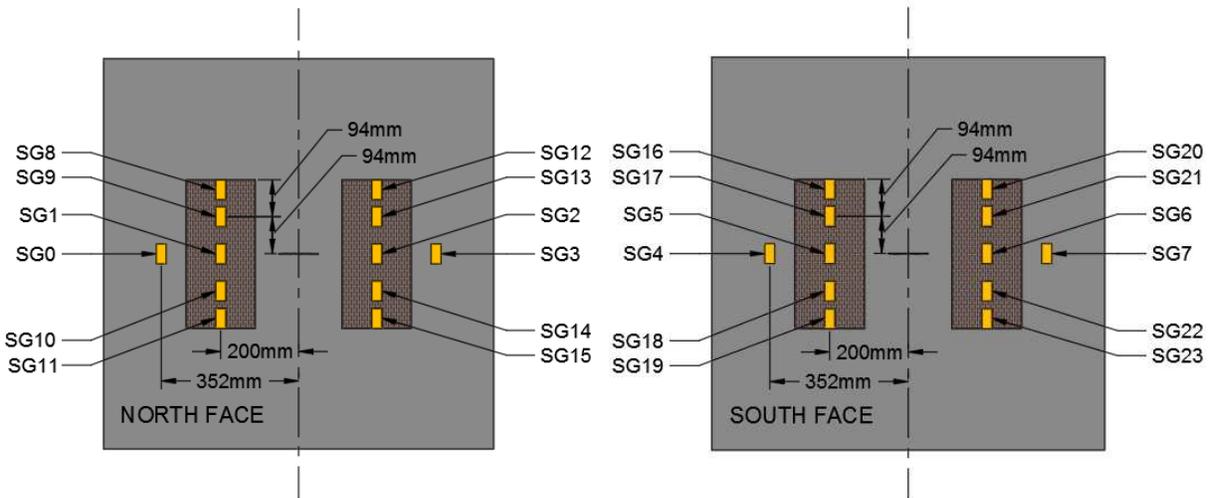
Figure 3-10. Specimen 4 strain gauge layout

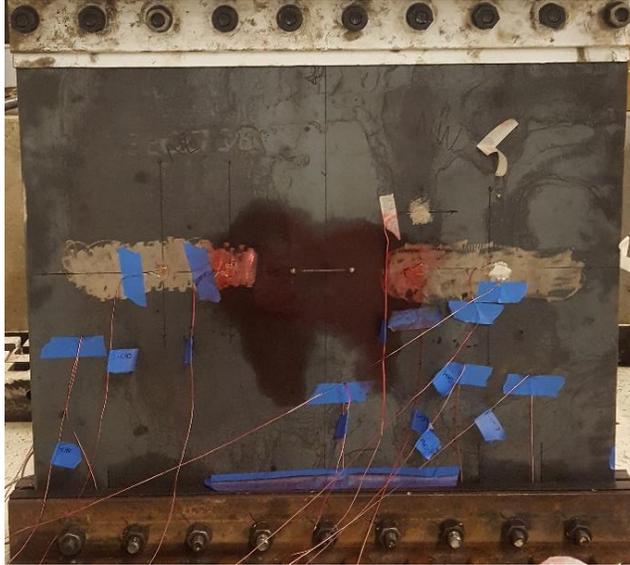
Figure 4-1. North face of specimen 1 at early stage of test

Specimen 1 was tested in air with no retrofit, as shown in Figure 4-1. In addition to the typical strain gauges applied along the crack plane for all specimens, an additional gauge was installed 100 mm above the crack plane on both faces of specimen 1 for the purpose of verifying the nominal applied stress range. The applied load range corresponds with a stress range of 55 MPa. At the beginning of the test before crack propagation, the gauges were checked and strains corresponding to stress ranges of 72 MPa and 37 MPa were recorded on the north and south faces, respectively. This indicates the presence of some level of out-of-plane bending, which was attributed to slight misalignment in the test frame. It was assumed that the stress distribution through the plate thickness was linear, so that stress range experienced at mid-thickness was 55 MPa. Despite the bending, crack growth was essentially equal on the north and south faces for specimen 1 and all other specimens.

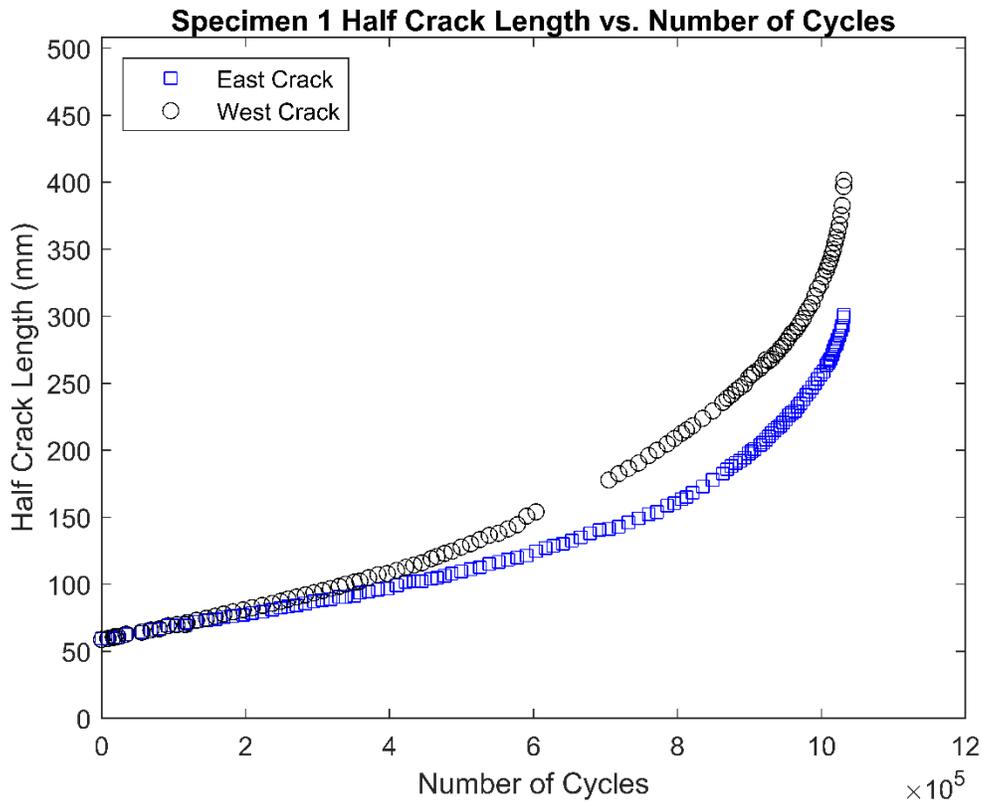
Figure 4-2. Specimen 1 crack growth measurements

Cracks initiated from the tack welds at both ends of the pre-cut crack at approximately the same time. Crack propagation measurements are shown in Figure 4-2. The two crack tips propagated at similar rates until reaching a half crack length of 75 mm. After this point the west crack began to propagate more quickly than the east crack. The difference in length between the two cracks increased throughout the test. At the completion of the test, the west crack was 100 mm longer than the east crack.

The west side of the crack exhibited stable growth until a half crack length of approximately 300 mm at 975,000 cycles. The east side of the crack became unstable at a slightly lower crack length of approximately 250 mm at 990,000 cycles due to the uneven crack growth across the two sides. The test was stopped at 1,031,428 cycles when fracture of the west side was considered imminent to avoid damage to the test frame. Although fracture of the east side was not yet imminent, the east crack was showing unstable growth. The crack at the time of test completion is shown in Figure 4-3.

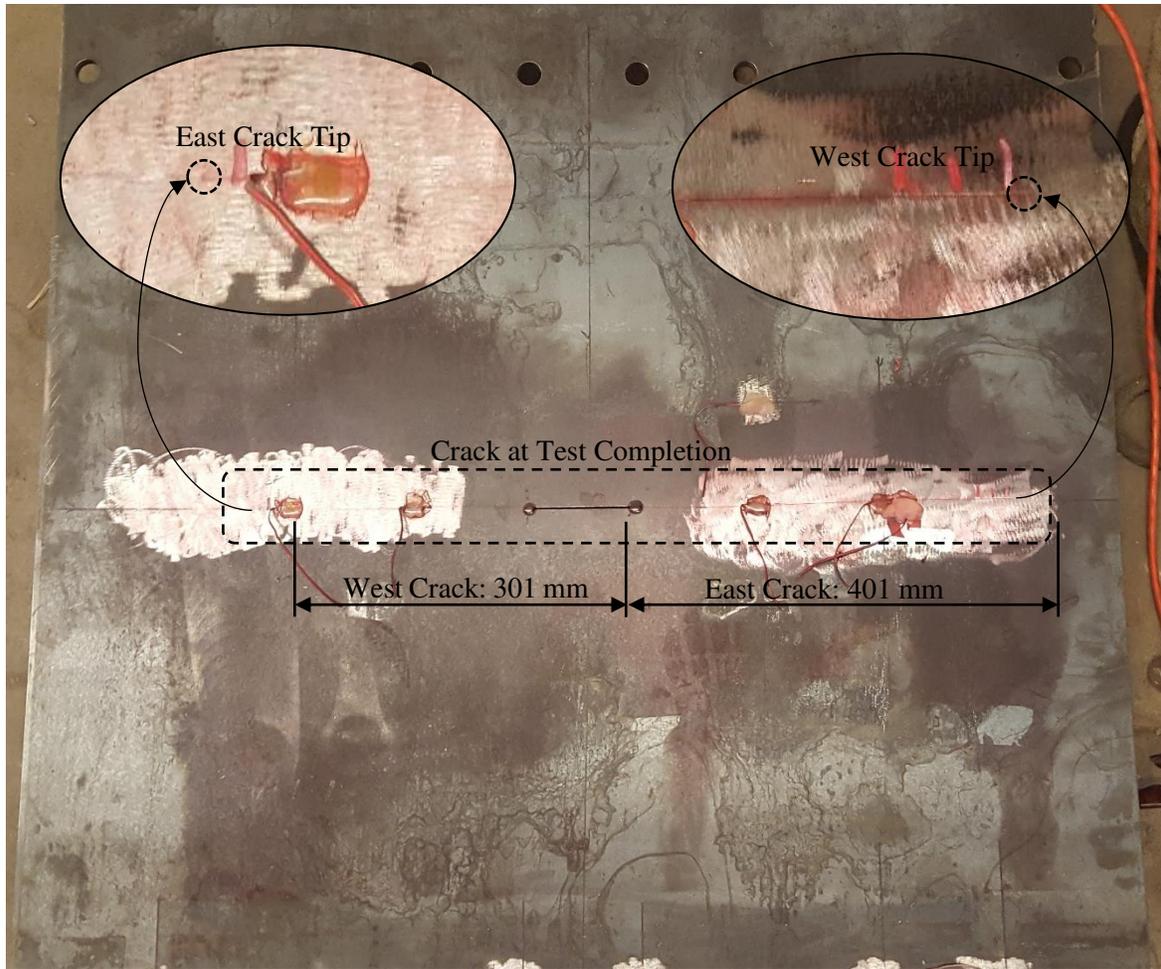
Figure 4-3. North face of Specimen 1 at test completion showing final length of east and west cracks and crack tip locations

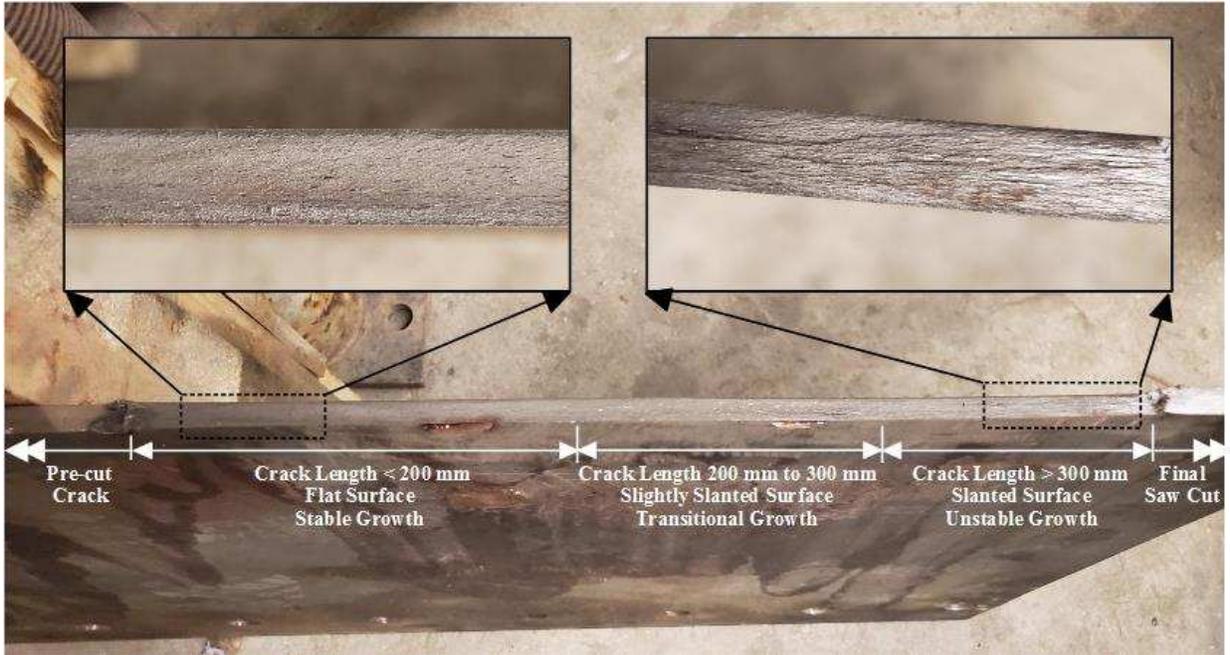
Figure 4-4. Specimen 1 west crack surface indicating transition from stable to unstable crack growth

After the test was completed, the remainder of the crack plane was cut so that the crack surface could be observed. The west crack is shown in Figure 4-4. The surface was flat, as shown in Figure 4-5, and smooth, as shown in Figure 4-4, until a half crack length of 200 mm, indicating stable growth. Between 200 mm and 300 mm, the surface began to curve as the crack growth transitioned to unstable growth. After a half crack length of 300 mm, the crack surface is clearly slanted, as shown in Figure 4-6 with a rough surface, as shown in Figure 4-4, indicating unstable growth and high ductility.

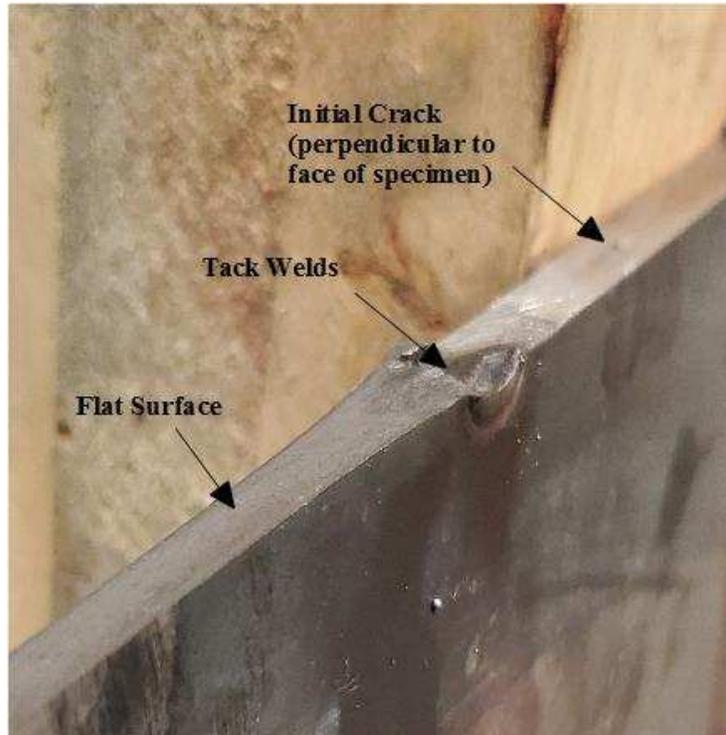
Figure 4-5. Specimen 1 west crack surface location near initial crack showing flat, smooth surface and indicating stable growth

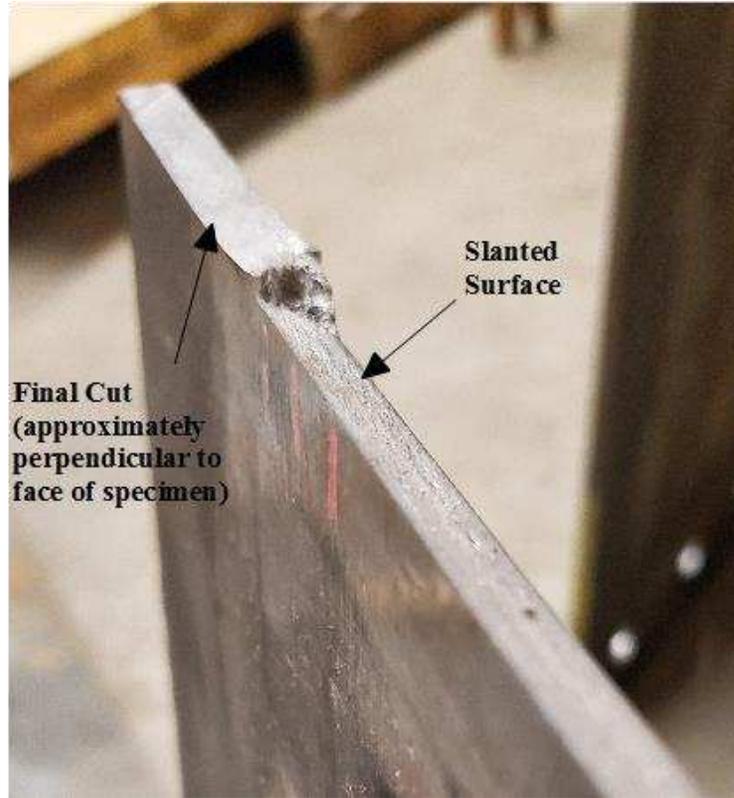
Figure 4-6. Specimen 1 west crack surface location at large crack length showing slanted surface and indicating unstable growth

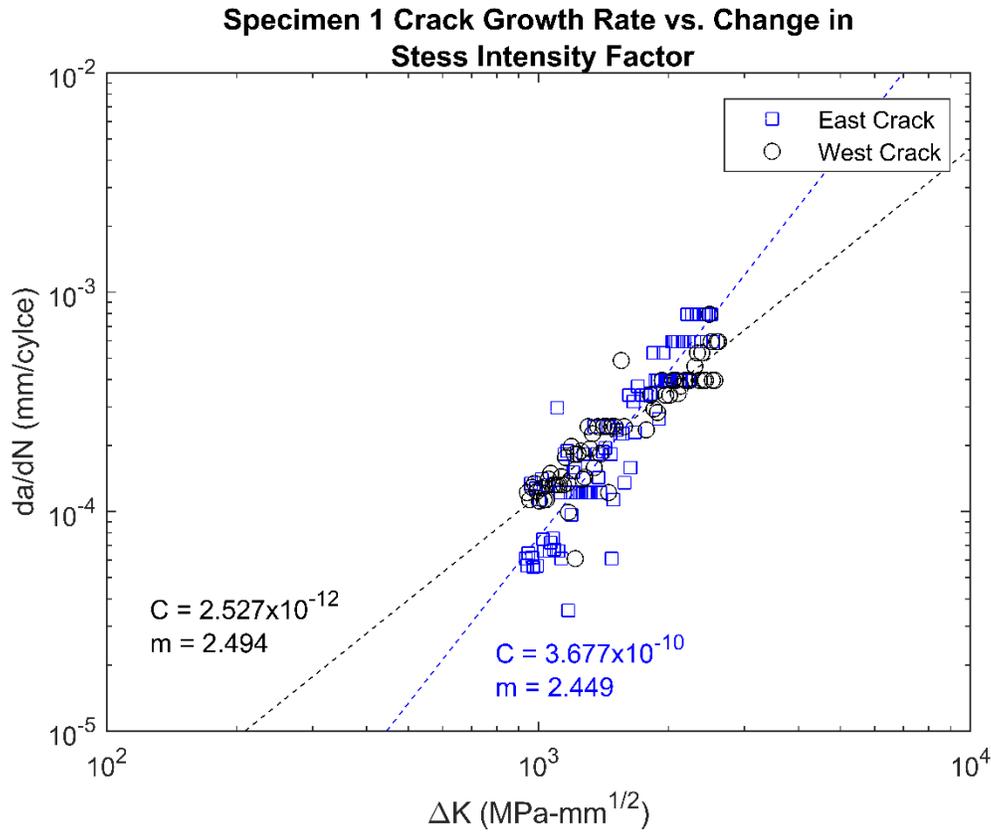
Figure 4-7. Plot of crack growth rate and stress intensity factor range for determination of Paris Law parameters for specimen 1

Since specimen 1 was not retrofitted, the Paris Law, which is explained in detail in Riveros et al. (2019), can be applied as a simple method for estimating the crack growth rate. Using the crack growth data acquired from testing, the Paris law parameters C and m were estimated by calculating crack growth rate (da/dN) and stress intensity factor range (ΔK). C and m are the y-intercept and slope, respectively, of da/dN versus ΔK plotted on a log-log scale, as shown in Figure 4-7. Separate parameters were calculated for the east and west crack, and resulting values are presented in Table 4-1. Calculated parameters are for crack length and stress intensity factor in units of mm and $\text{MPa}\cdot\text{mm}^{1/2}$, respectively. The first several crack length measurements were excluded from the calculation because they may have been affected by the presence of the tack
