THESIS

EXPERIMENTAL FATIGUE EVALUATION OF UNDERWATER STEEL PANELS
RETROFITTED WITH FIBER REINFORCED POLYMERS

Colorado State University

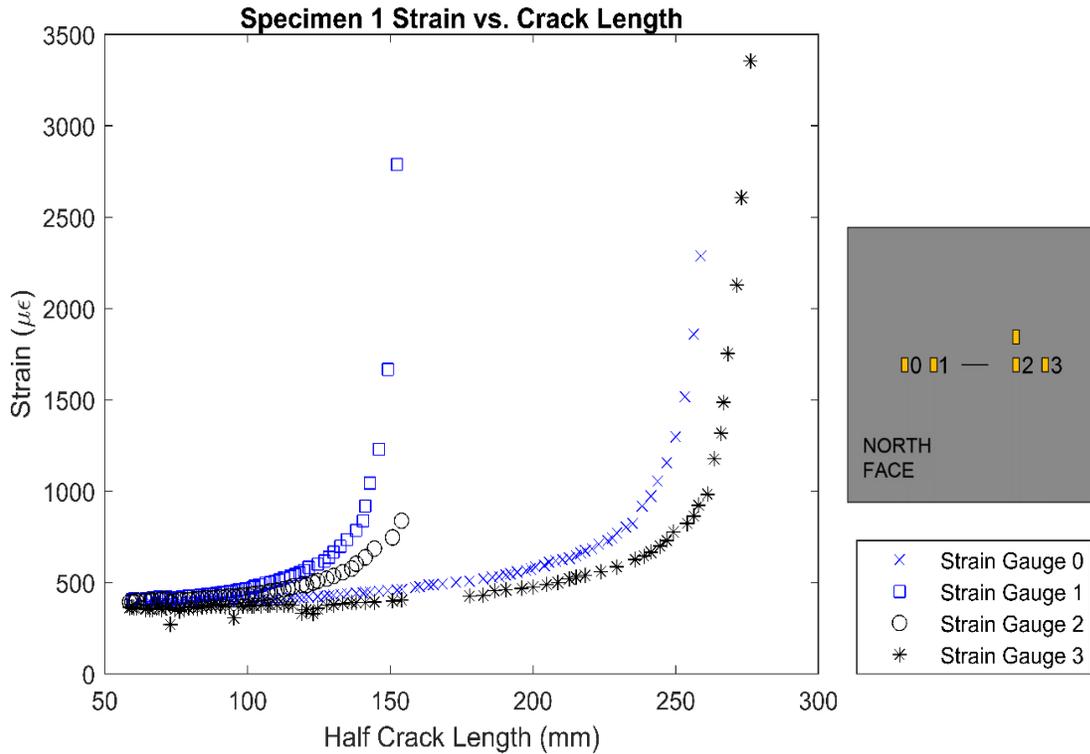
Figure 4-8. Specimen 1 strain in crack plane vs. half crack length

to grow rapidly, as the gauge is then located within the plastic zone around the crack tip. Results from specimen 1 shown in Figure 4-8 follow the expected behavior. The crack reached strain gauges 1 and 2 first, as they were placed closer to the center of the specimen.

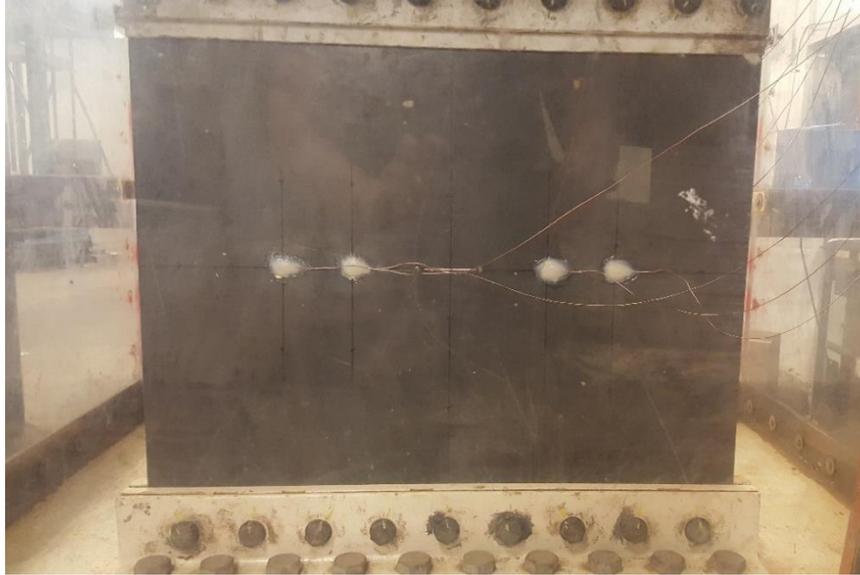
Figure 4-9. Specimen 2 before beginning test (prior to filling tank with water)

Specimen 2 was tested in fresh water with no FRP repair. As Shown in Figure 4-9, specimen 2 was identical to specimen 1 aside from the addition of the water tank. Figure 4-10 shows specimen 2 in the water tank midway through the test.

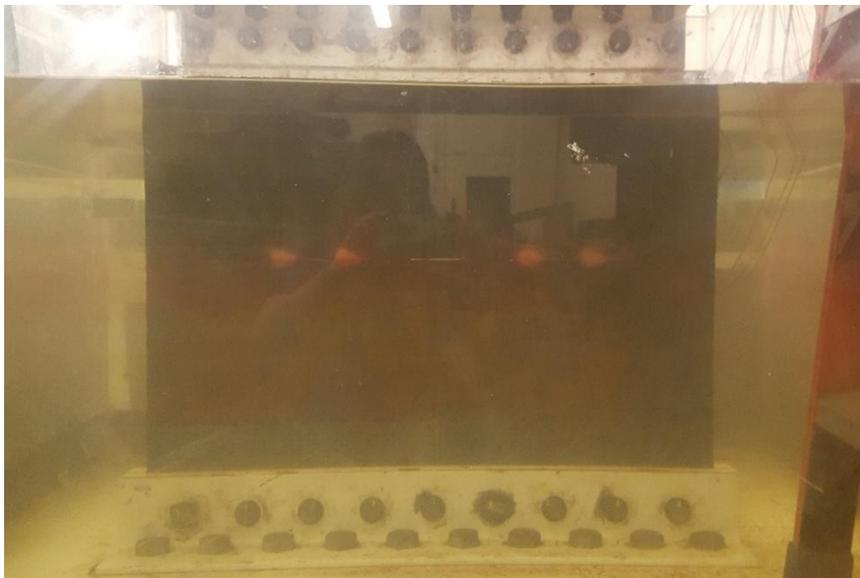
Figure 4-10. Specimen 2 underwater during test

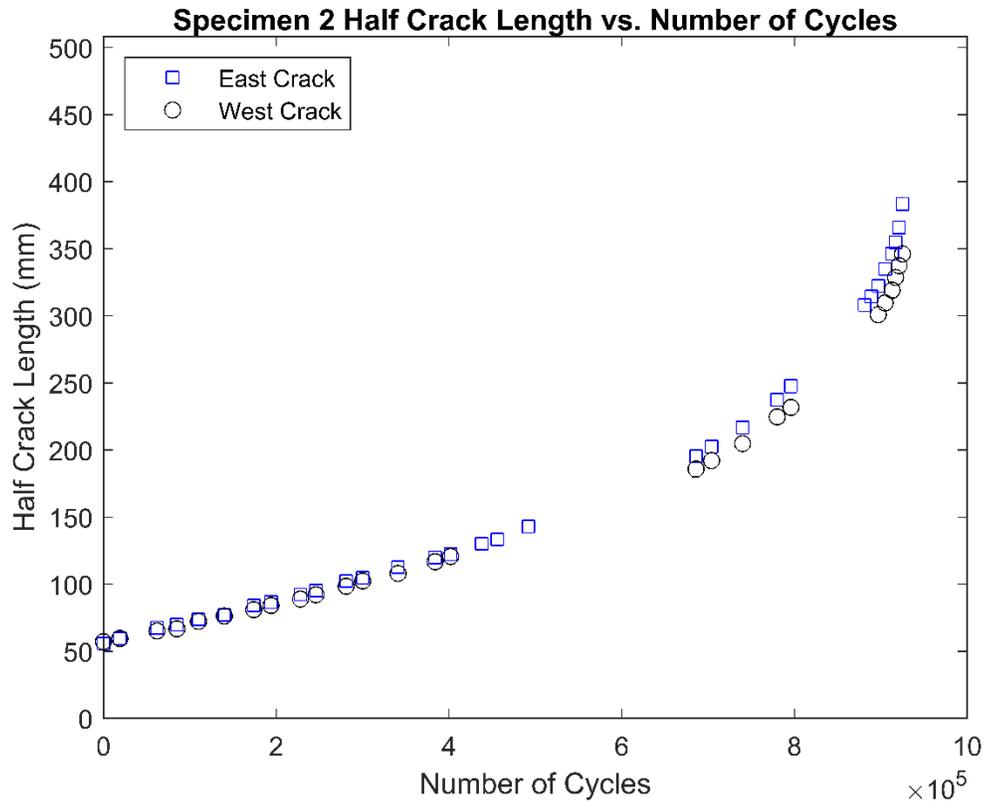
Figure 4-11. Specimen 1 Crack Growth Measurements

Measurements of crack growth for specimen 2 are shown in Figure 4-11. Measurements were taken less frequently for the underwater specimens compared to specimen 1 due to the added time needed to drain and refill the water tank to take a measurement. Additionally, gaps in the

Cracks on the east and west sides of specimen 2 began to propagate from the tack welds at the same time. Both cracks grew equally until reaching lengths of approximately 200 mm at which point the east side began to propagate faster than the west side. At the end of the test, the east crack was approximately 40 mm longer than the west crack.

Crack growth was stable until a half crack length of approximately 300 mm. Both cracks reached 300 mm after approximately 880,000 cycles. The test was stopped at 925,000 cycles, when the crack began to grow very rapidly and fracture was imminent. Figure 4-12 shows the south face of specimen 2 after the test was completed and it was removed from the testing frame.

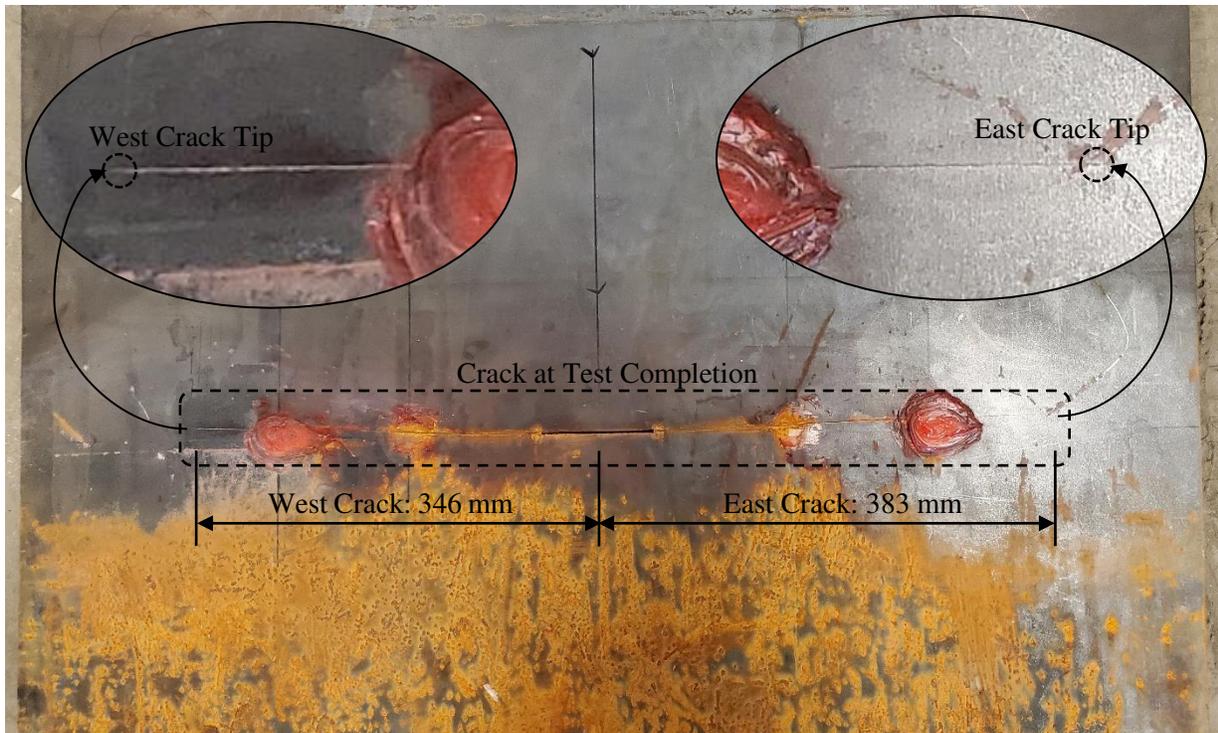
Figure 4-12. South face of specimen 2 after test completion showing final crack lengths and crack tip locations

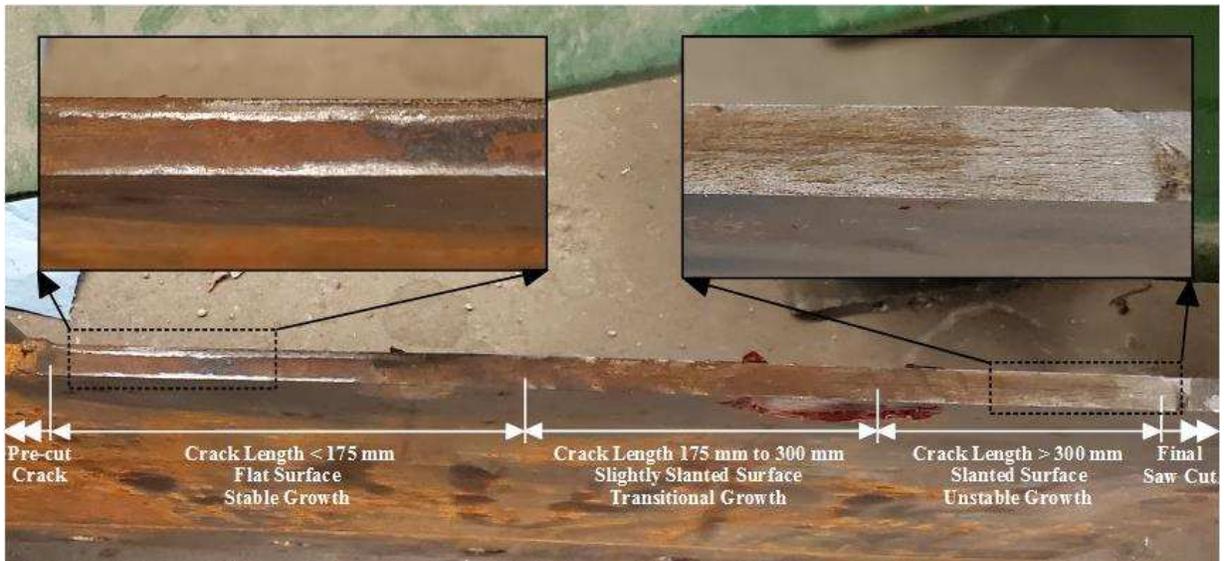
Figure 4-13. Specimen 2 east crack face showing transition from stable growth to unstable growth with increasing crack length

The remainder of the crack plane was cut so that the crack surface could be observed, as shown in Figure 4-13. The surface was flat and smooth, as shown in Figure 4-14, until a half crack length of 175 mm, indicating stable growth. Between 175 mm and 300 mm, the surface began to curve as the crack growth transitioned to unstable growth. After a half crack length of 300 mm, the surface became slanted, as shown in Figure 4-15, indicating unstable growth and high ductility.

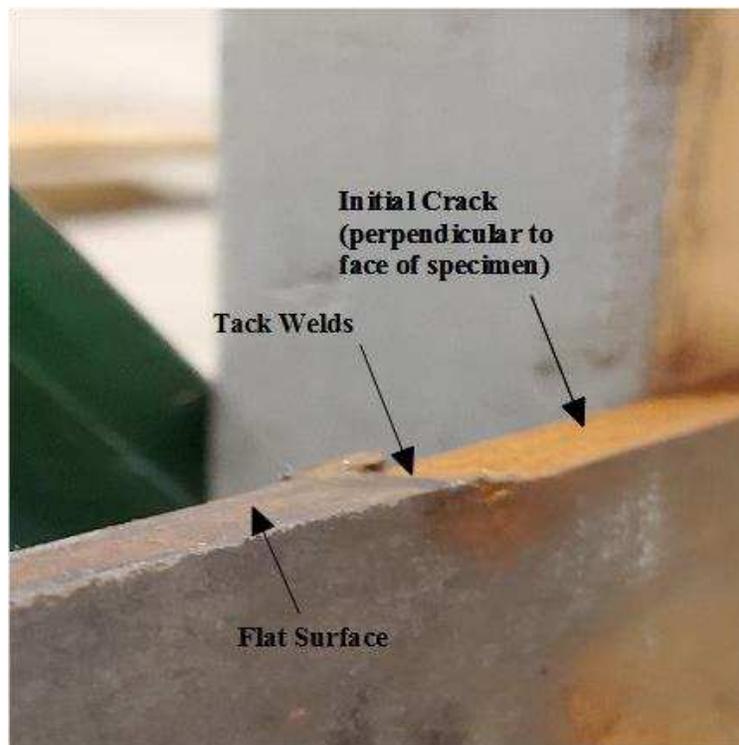
Figure 4-14. Specimen 2 east crack face location near initial crack showing flat surface and indicating stable growth

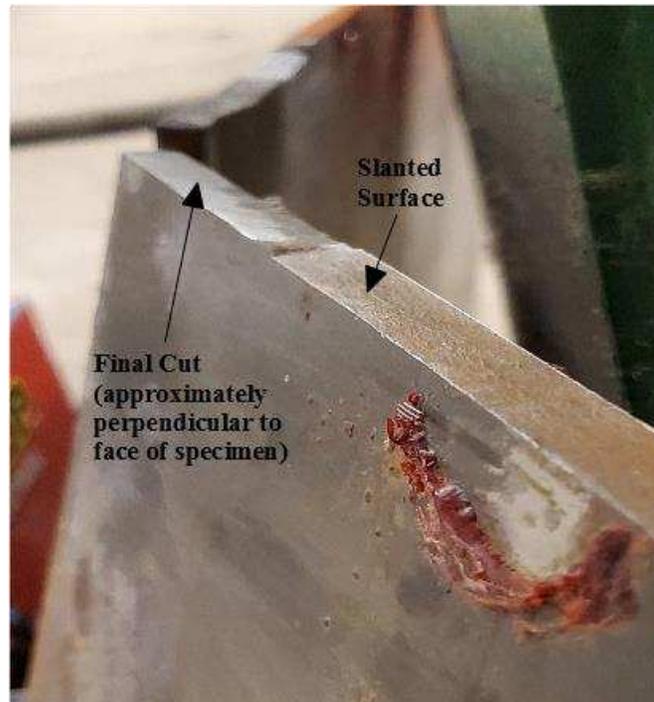
Figure 4-15. Specimen 2 east crack face location at large crack length showing slanted crack surface and indicating unstable growth

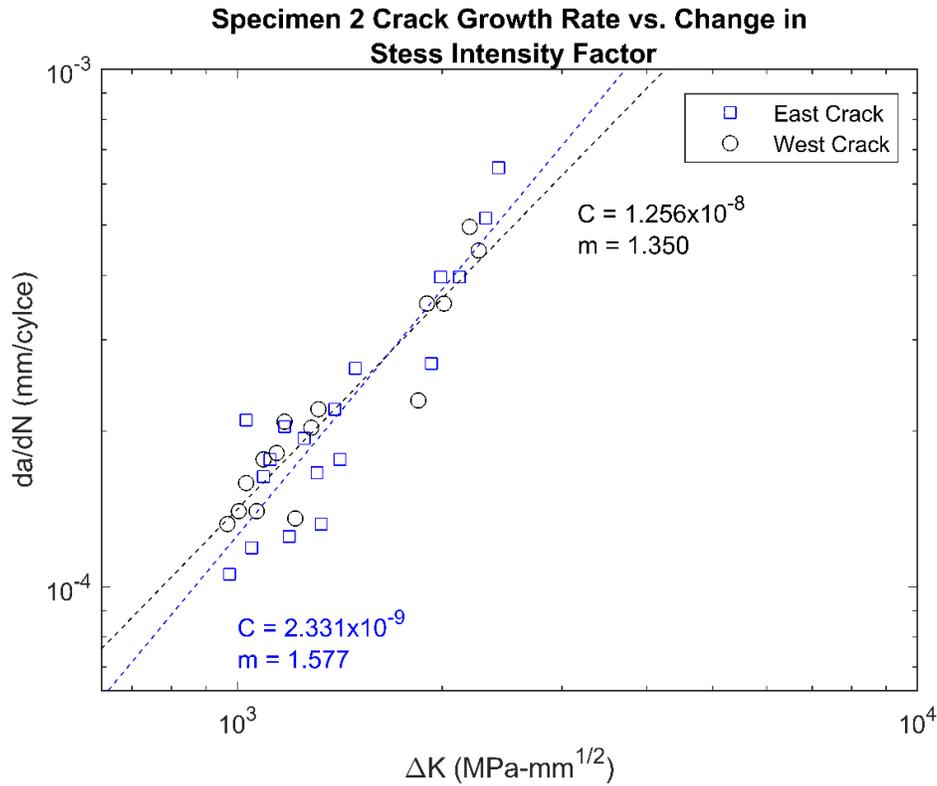
Figure 4-16. Plot of crack growth rate and stress intensity factor range for determination of Paris Law parameters for specimen 2

The Paris Law parameters (C and m) were calculated for specimen 2 in the stable growth region in the same way as was done for specimen 1. Figure 4-16 shows the log-log plot used in the calculation, and resulting values are presented in Table 4-2. The results account for the underwater environment and are specific to the procedure and geometry used in the test.

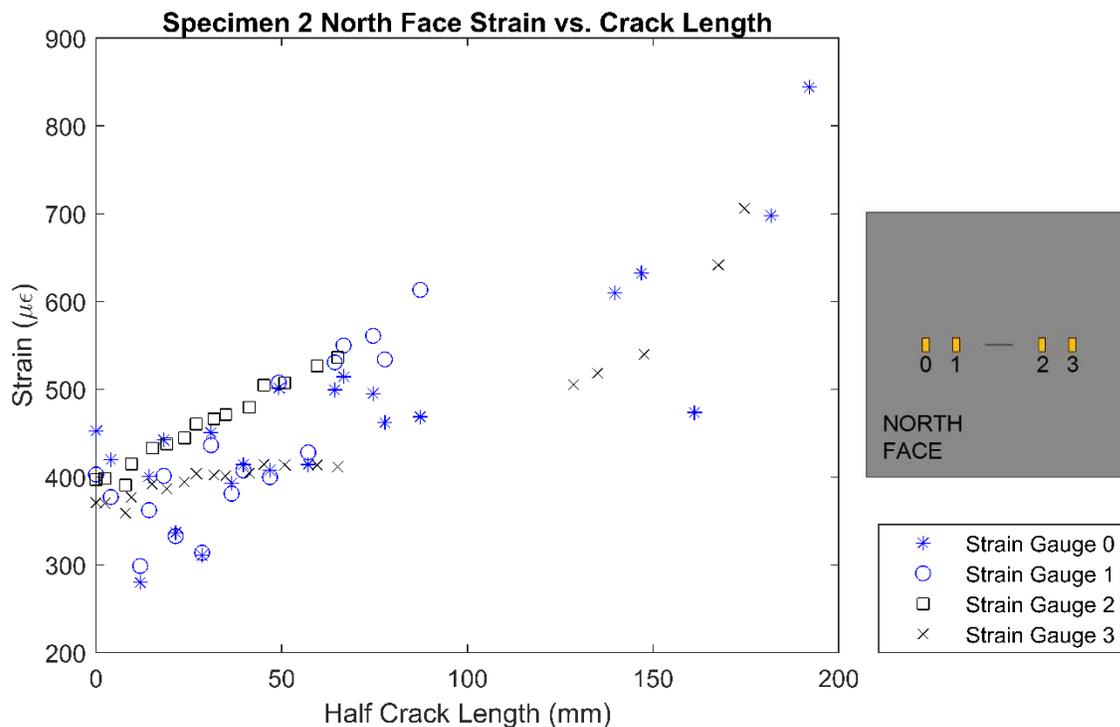
Figure 4-17. Specimen 2 north face strain in crack plane vs. half crack length

Four strain gauges were located along the crack plane on each face of specimen 2. For clarity, strain results from the north and south faces are plotted separately in Figure 4-17 and Figure 4-18, respectively. All strain gauges showed the expected behavior with a rapid increase in strain as the crack approached the gauge location. The rapid increases are less apparent for specimen 2 than specimen 1 because crack could not be measured as close to the strain gauges due to the additional sealant. On the north face, strain gauges 0 and 1 followed the expected trend, but showed scattered results. This may be due installation or sealing errors.

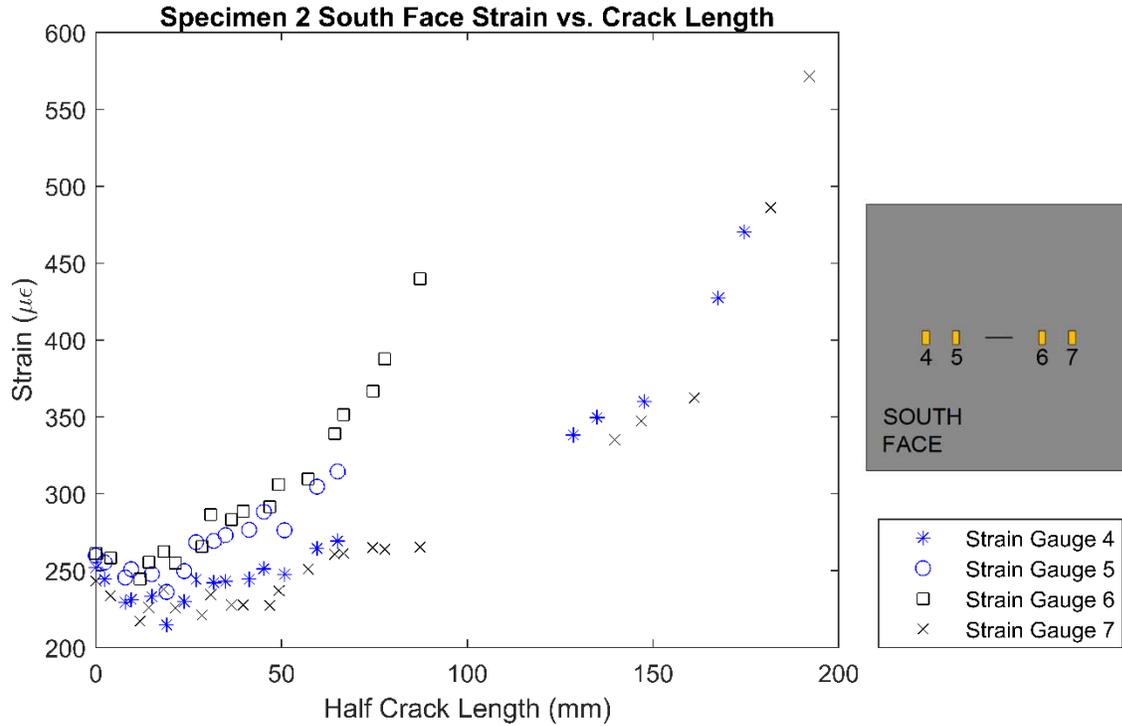
Figure 4-18. Specimen 2 south face strain in crack plane vs. half crack length

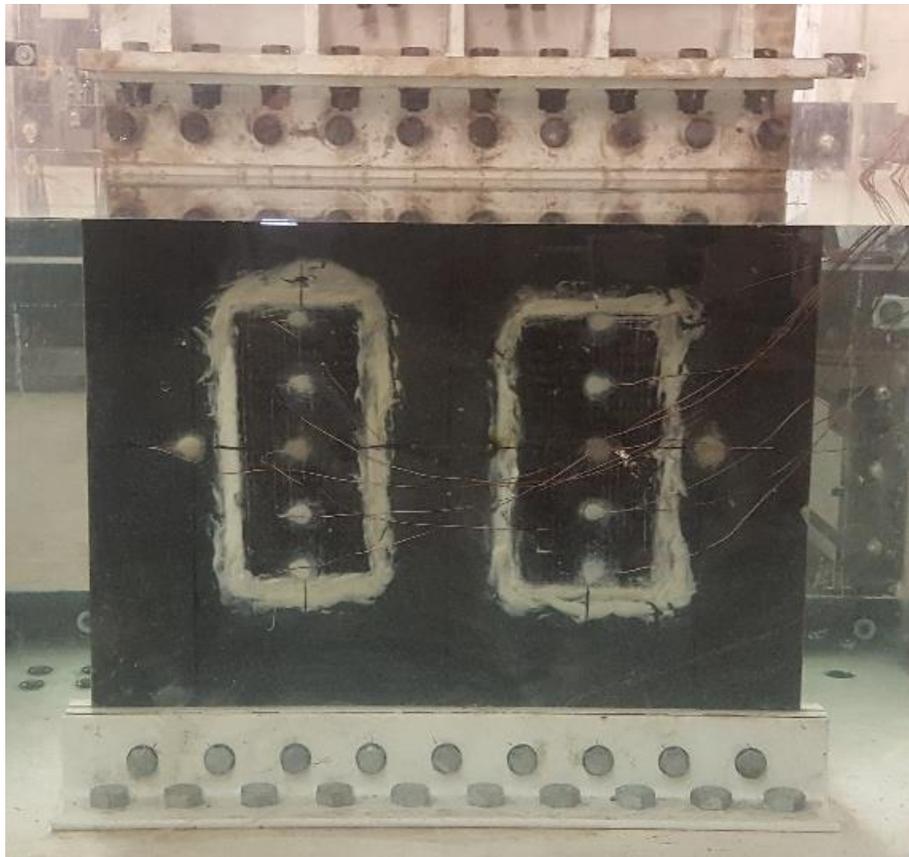
Figure 4-19. South face of specimen 3 before beginning test

Specimen 3 was retrofitted with two layers of CFRP on both faces and tested underwater as shown in Figure 4-19. Strain gauges, in addition to those along the crack plane, were placed along the length of the CFRP patches on the south face to detect any debonding.

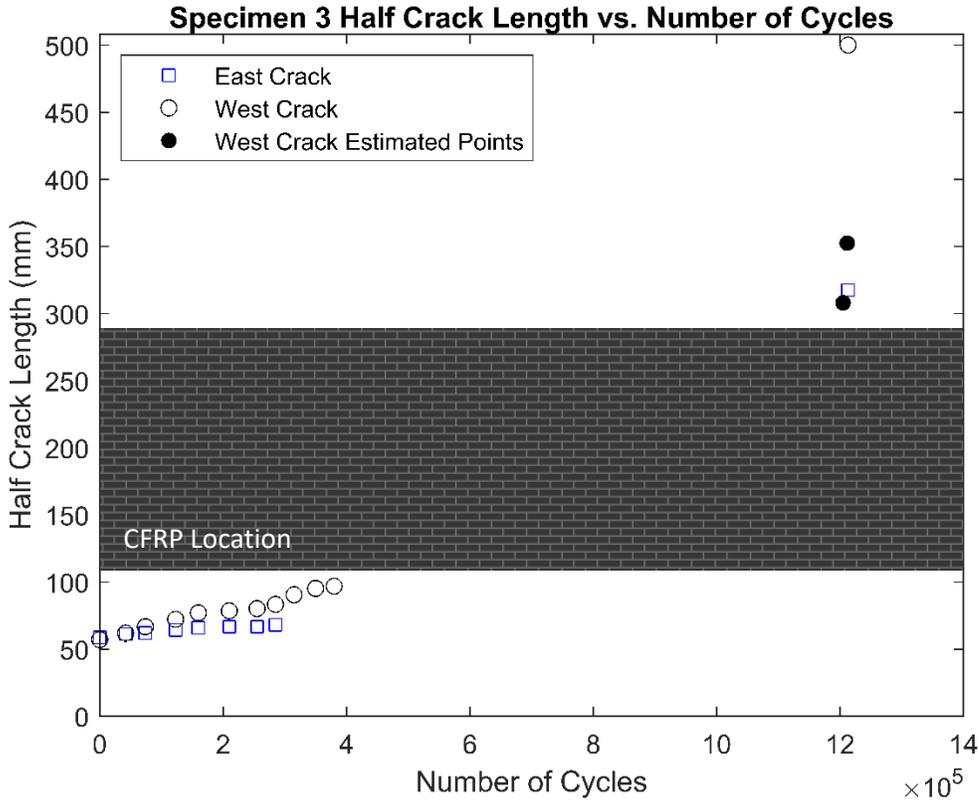
Figure 4-20. Specimen 3 crack growth measurements

Due to the applied CFRP retrofit, measurement of crack propagation was limited to locations where the steel was exposed for specimen 3. Cracks began to propagate on both sides of the initial crack at a similar time. Crack propagation is shown in Figure 4-20. The west side of the crack immediately began to grow more quickly than the east side. The width of the adhesive extending beyond the CFRP varied slightly at each location but was approximately 80 mm from the tack welds. The west crack reached a length of 93 mm at 380,000 cycles before reaching the adhesive. The east crack reached a length of 68 mm at 285,000 cycles and then could no longer be measured.

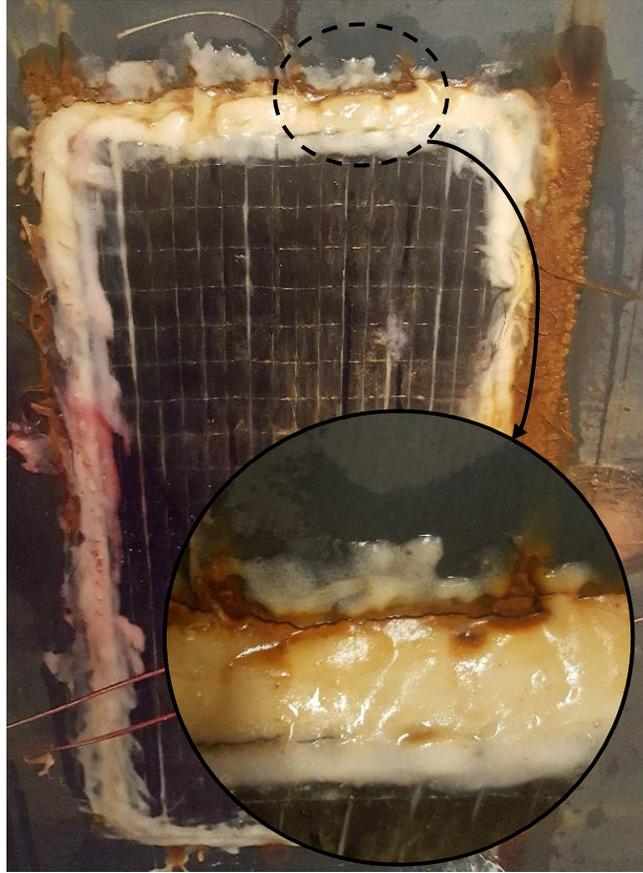
Figure 4-21. Debonding along edge of CFRP patch

When the east crack reached the adhesive, the adhesive on the north face became visibly debonded around the crack. The adhesive at the other crack tips visibly appeared to remain bonded following the cracks reaching the adhesive. On the north face of the west crack, the adhesive debonded around the crack tip at approximately 415,000 cycles. The adhesive on the south face did not appear to debond around the crack tip throughout the entire test. Debonding was also noticed along the top boundary of the CFRP patches on the north side at 380,000 cycles as is shown in Figure 4-21. By 705,000 cycles the debonding of both north patches had propagated down the top quarter of the inner edges of the patches. At 905,000 cycles, the inner edges of the north patches had debonded on the entire top half, and the outer edges had debonded on the top quarter. The edges of the entire top half of the north CFRP patches had debonded by 955,000 cycles.

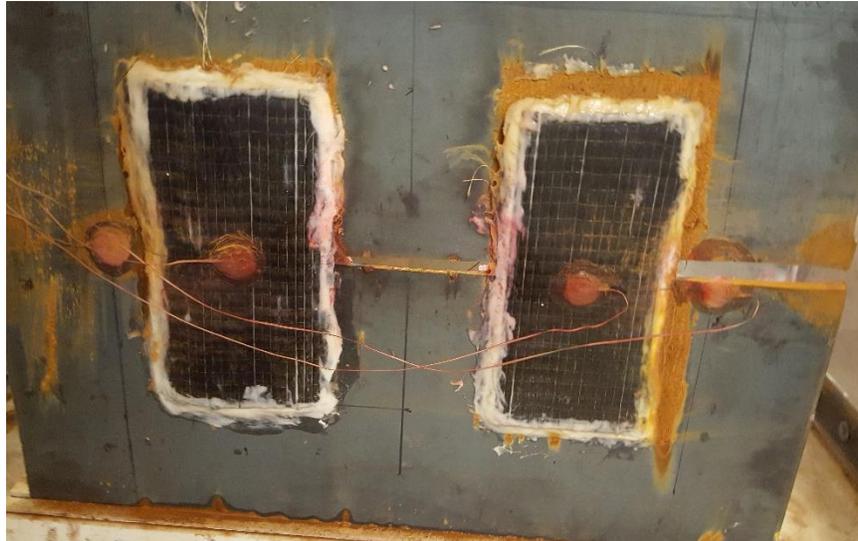
Figure 4-22. North face of specimen 3 after fracture

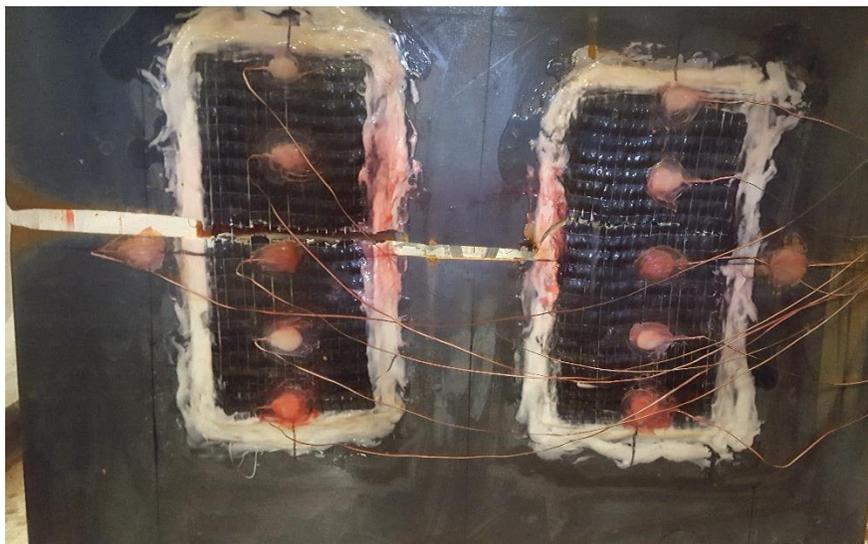
Figure 4-23. South face of specimen 3 after fracture

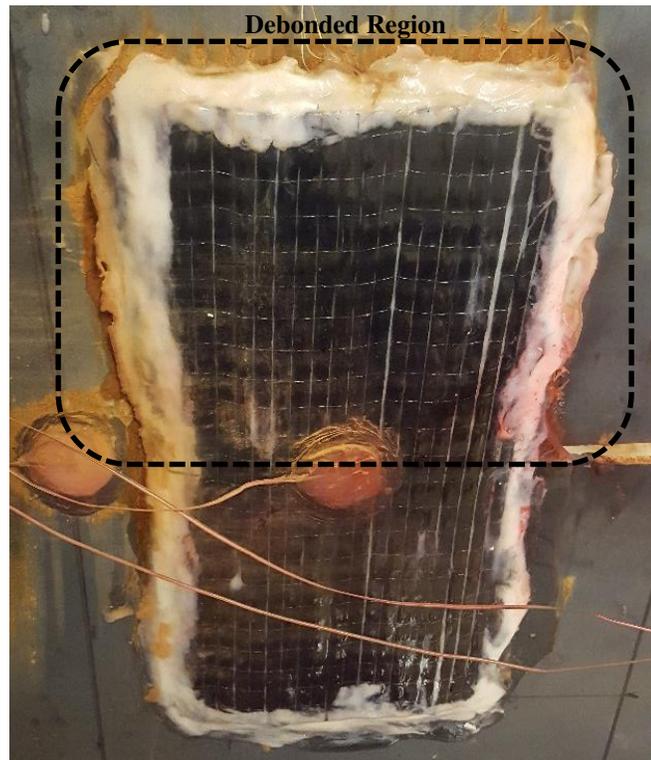
Figure 4-24. CFRP patch on north side of specimen three with top half debonded after steel fracture

When the specimen fractured, the CFRP on the north side remained adhered to the steel below the crack and was entirely debonded above the crack as shown in Figure 4-24. On the south face, there was no visibly detectable debonding, and fiber rupture was observed, indicating that

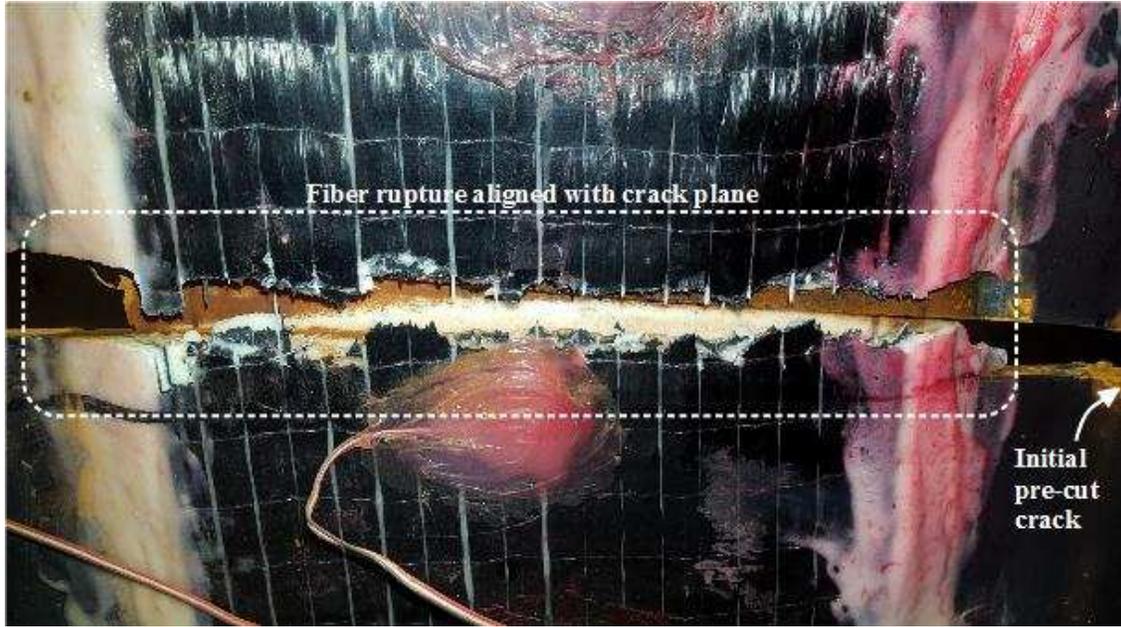
Figure 4-25. CFRP fracture of west patch on south face of specimen 3

the full strength of the CFRP was reached. The west patch on the south face ruptured through the entire cross-section directly over the crack as shown in Figure 4-25. Fibers in the east patch on the south face ruptured but not directly over the crack as shown in Figure 4-26. The better bond behavior on the south face of the specimen may be attributed to the bending in the specimens mentioned earlier. The north face experienced a higher stress, causing more debonding. This suggests that there may be a threshold stress at which the adhesive will not debond below.

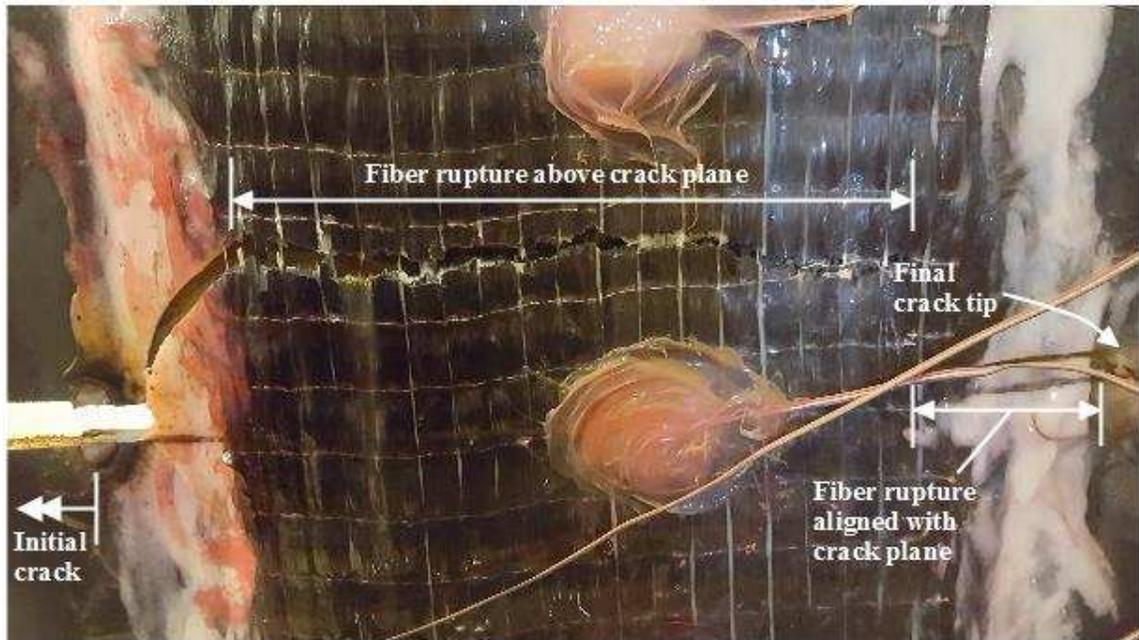
Figure 4-26. CFRP fracture of east patch on south face of specimen 3

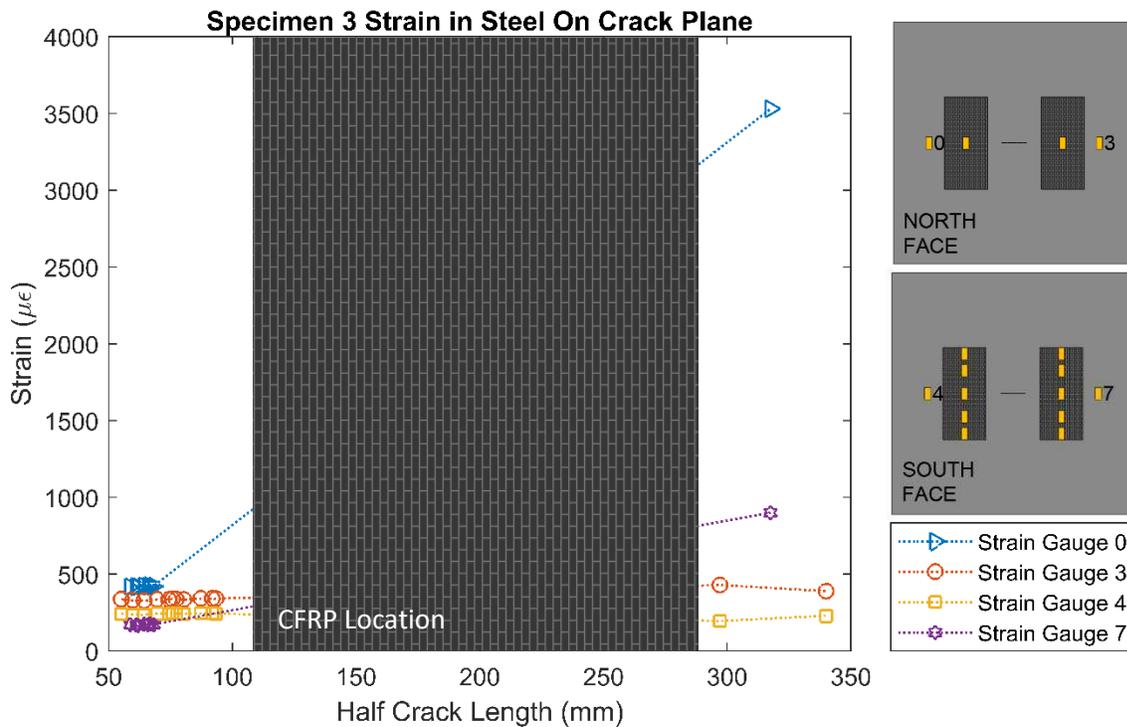
Figure 4-27. Specimen 3 strain in steel on crack plane

Strain gauges applied on the steel were located along the crack plane, and readings corresponding to measured crack lengths are shown in Figure 4-27. For the retrofitted specimens,

the strain in steel in the crack plain is expected to show similar behavior to that of unrepaired specimens. Strain should increase gradually, although it should be slightly lower for the repaired specimens, and it should increase rapidly as the crack tip reaches the gauge. For specimen 3, the gauges located on the east side of the specimen followed this trend, but the crack did not reach all the way to the gauges before the west side fractured, meaning that the maximum strain that would have occurred when the crack tip reached the gauges was not recorded. Strain gauges on the west side showed a slight increase as the crack approached, but no rapid increase in strain occurred. As the west crack grew, it curved slightly upward such that its path was above the strain gauges rather than directly through them, so the elevated strain at the crack tip could not be observed.

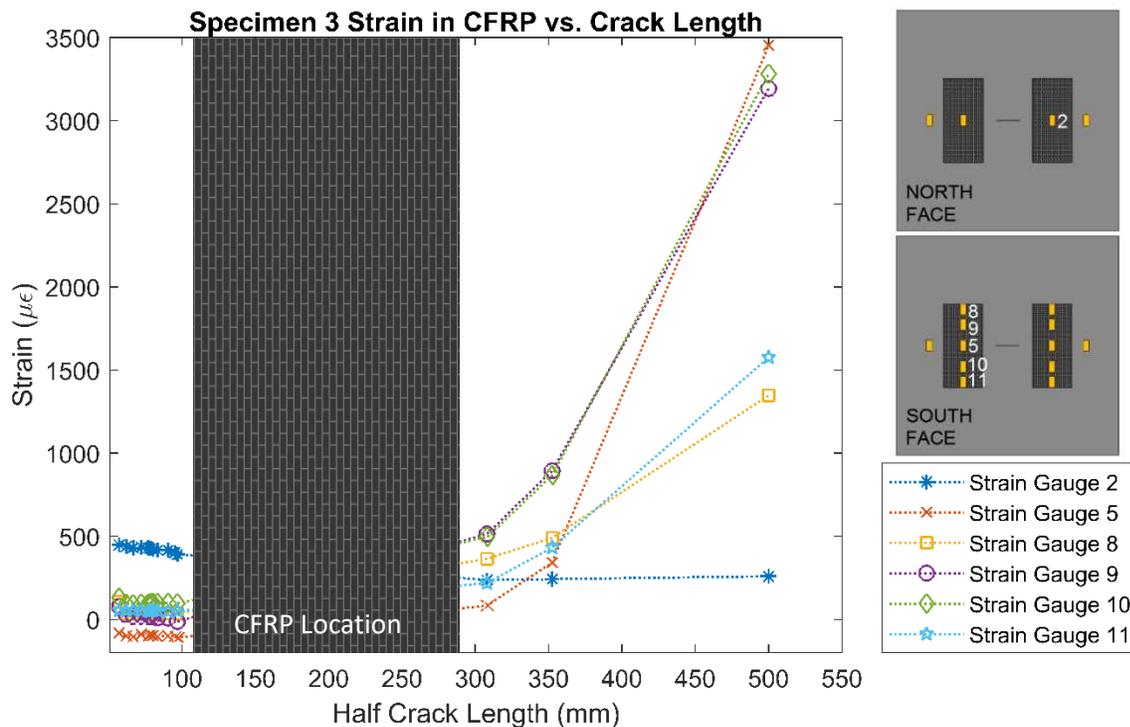
Figure 4-28. Specimen 3 west half strain in CFRP

Strain gauges on the CFRP were located along the crack plane on both faces and along the height of the patches on the south face. The gauges on the CFRP patches were intended to assist with detecting debonding from the steel. A decrease in strain at a single strain gauge would indicate debonding at its location. However, the patches on the south face remained intact throughout the tests. Due to the limited crack length data available from the east crack, strain results from the west half of the specimen are used in Figure 4-28. to observe the CFRP behavior. Only the strain gauge that was located on the north side of the specimen showed decreasing values throughout the test. This aligns as expected with the visually observed debonding on that face. All the strain gauges on the south face recorded increasing strains throughout the test, indicating that they remained well bonded. Therefore, the south patches were bridging the crack and providing a crack closure effect until they ruptured.

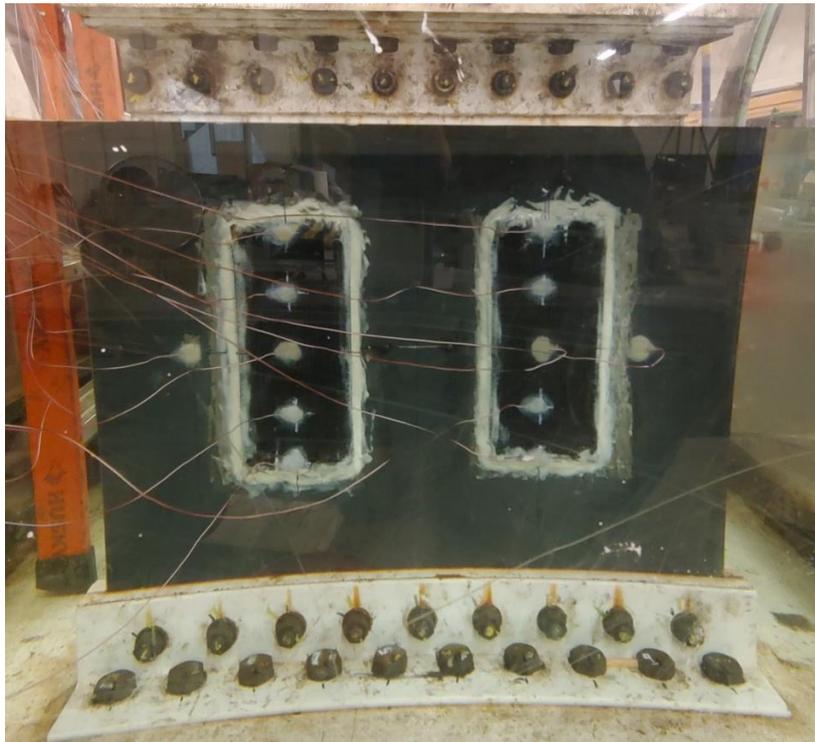
Figure 4-29. North face of specimen 4 before beginning test

Specimen 4 was retrofitted with two layers of BFRP on both faces and tested underwater as shown in Figure 4-29. Strain gauges, in addition to those along the crack planes, were placed along the length of the BFRP patches on both faces to assist in detecting any debonding.

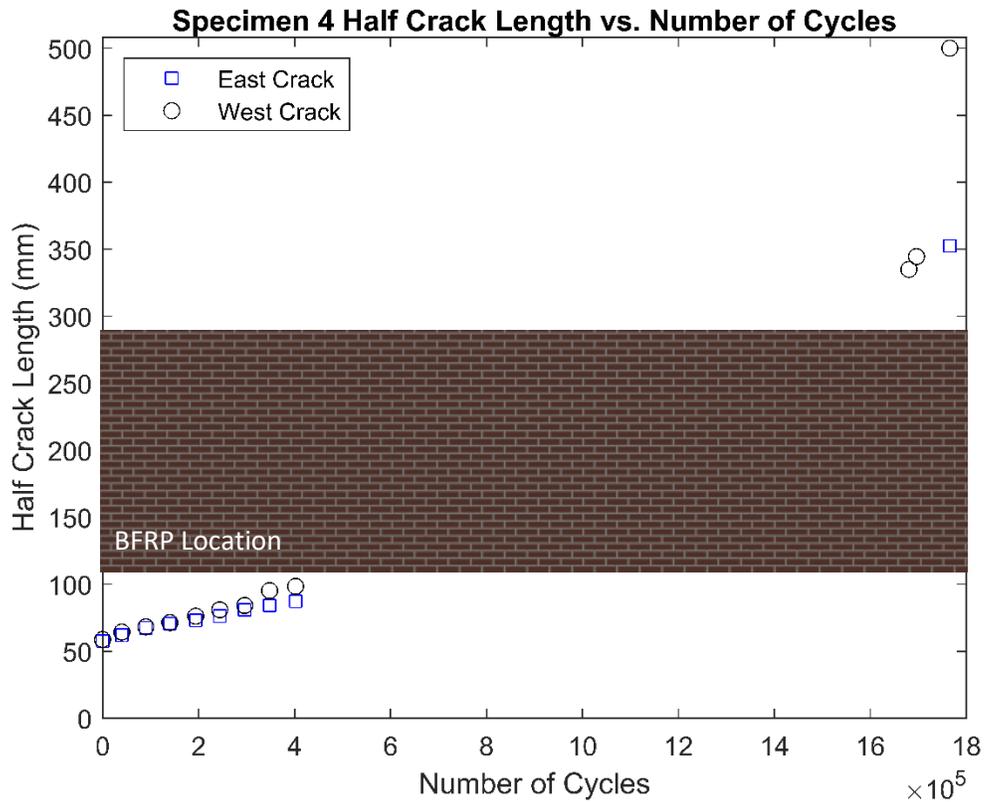
Figure 4-30. Specimen 4 crack growth measurements

For specimen 4, measurement of crack propagation was again limited to locations where the steel was exposed. Cracks began to propagate on both sides of the initial notches at the same time. Crack propagation results are shown in Figure 4-30. The width of the adhesive extending beyond the BFRP varied slightly at each location. The length of the west crack was 98 mm at 402,000 cycles before reaching the adhesive. The east crack reached a length of 87 mm at 402,000 cycles and then could no longer be measured.

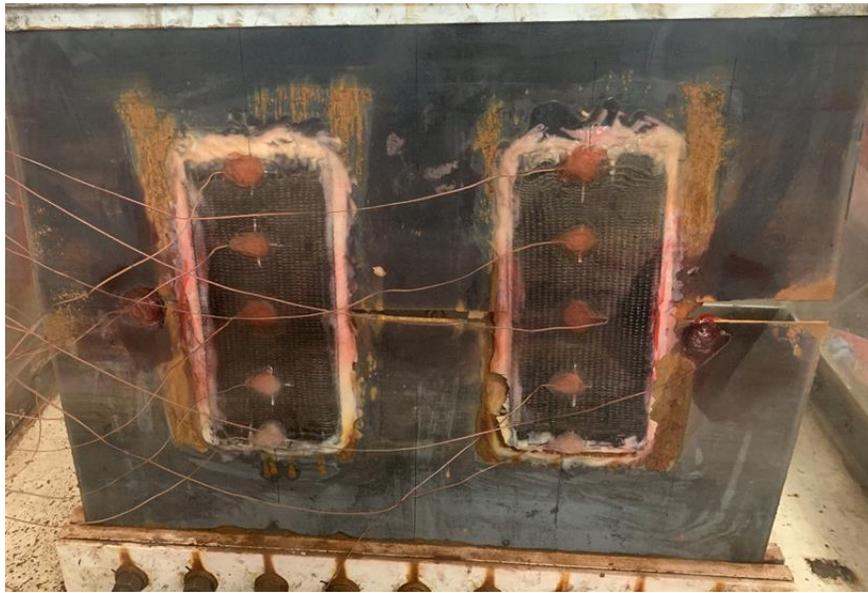
Figure 4-31. North face of specimen 4 after fracture of west crack

At 1,680,100 cycles, the west crack, with a length of 275 mm, appeared beyond the BFRP patch. Once beyond the patch, the west crack grew quickly until it fractured at 1,765,458 cycles. The east crack was not visible beyond the BFRP patch until the final fracture of the west half, at which point it was approximately 20 mm beyond the adhesive fillet. Figure 4-31 and Figure 4-32 show the north and south faces, respectively, of specimen 4 after fracture. Half of each BFRP patch (either the half above or the half below the crack plane) experienced failure of the adhesive bond

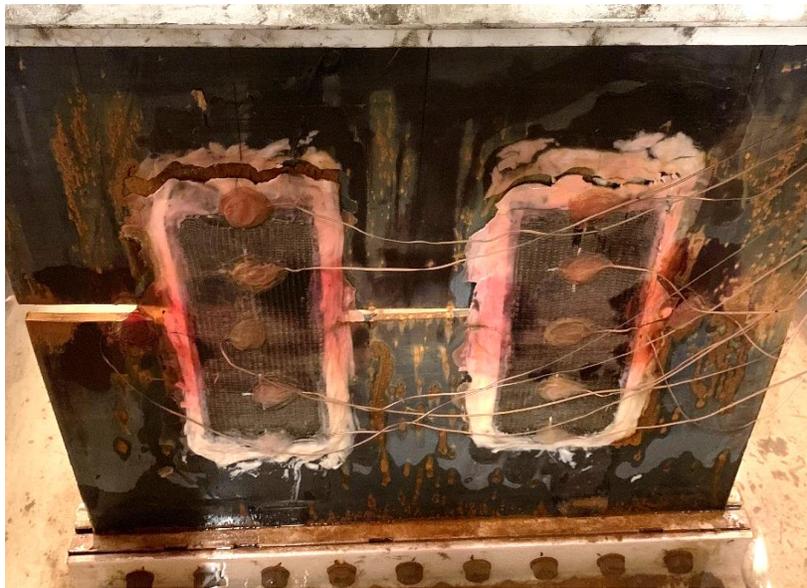
Figure 4-32. South face of specimen 4 after fracture of west crack

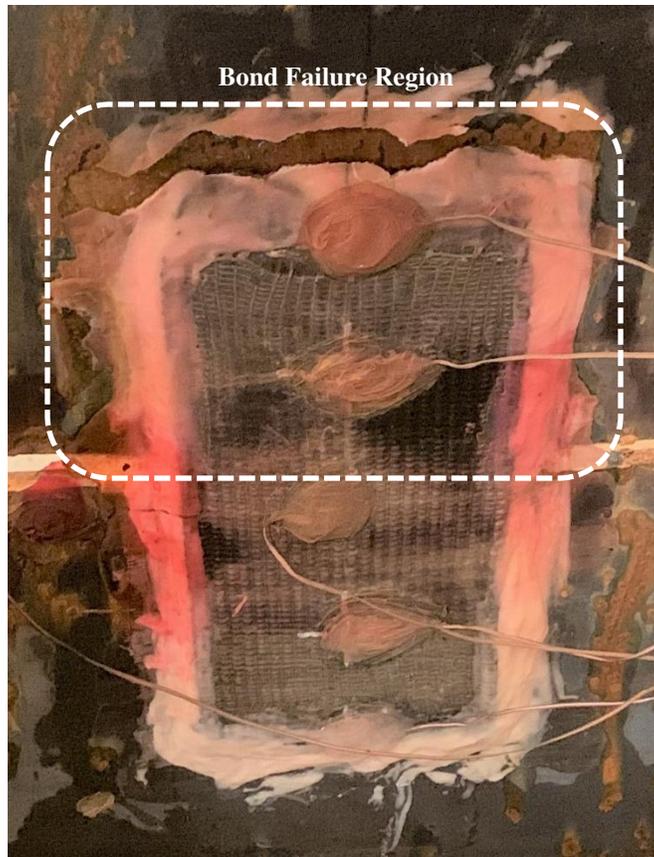
Figure 4-33. Bond failure on upper half of southwest BFRP patch

to steel at the time of fracture. Bond failure in all patches was similar to that shown in Figure 4-33, which illustrates the bond failure in the southwest BFRP patch. It is worth noting that this bond failure was attributed to deformation caused by out-of-plane bending of the specimen once fracture occurred.

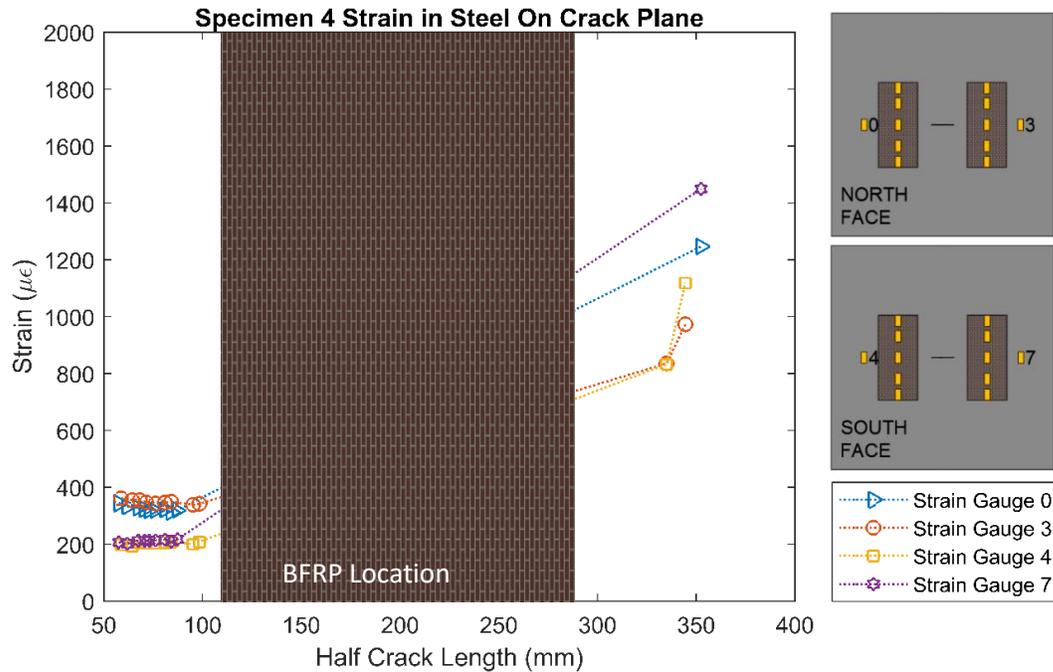
Strain gauges applied on the steel were located along the crack plane, and readings corresponding to measured crack lengths are shown in

Figure 4-34. A rapid increase in the readings from strain gauges 3 and 4 along the west was recorded after the crack length was beyond the BFRP. However, the elevated values are not as high as those recorded for other specimens because the crack grew slightly above the strain gauges, so maximum strains right at the crack tip were not obtained. The east crack approached strain gauges 0 and 4 just as the fracture of the west half occurred, and increased values were recorded at that instance.

Figure 4-34. Specimen 4 strain in steel

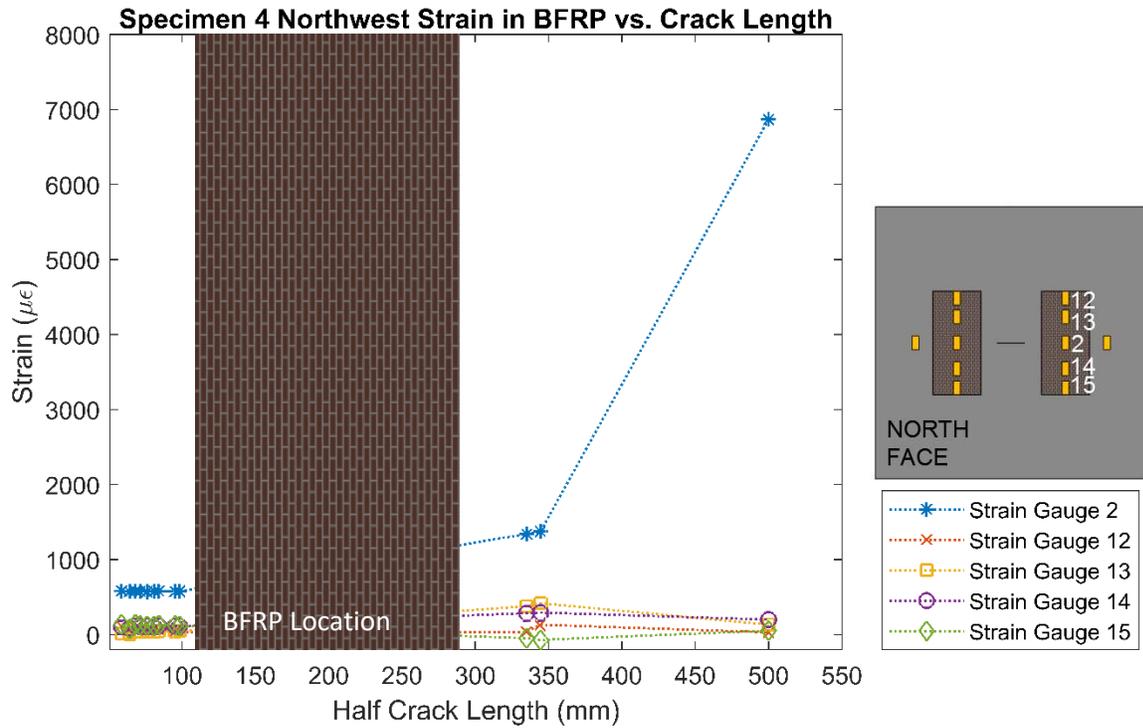
Strain gauges on the BFRP were located along the height of the patches on both faces to assist in detecting debonding. Results for the west patch on the north face are shown in Figure 4-35. Those for the west patch on the south face are shown in Figure 4-36. Both patches on the east half of the specimen showed similar results to those from the west patch on the same face.

The strain in the gauges located in the center of the patches directly over the crack plane increased as the cracks propagated under the patches. Readings from the patch ends, such as those from gauges 12, 15, 16, and 19 as shown in Figure 4-35 and Figure 4-36, decreased as the crack propagated under the patches, indicating some bond deterioration may have occurred although it was not visibly detectable. However, the same gauges at the patch ends did still record increased values when the crack became very large and the patches began to carry more of the applied stress, indicating that while possibly deteriorated, the bonds remained intact at patch ends.

Figure 4-35. Specimen 4 strain in northwest BFRP patch
