THESIS

EXPERIMENTAL FATIGUE EVALUATION OF UNDERWATER STEEL PANELS
RETROFITTED WITH FIBER REINFORCED POLYMERS

Colorado State University

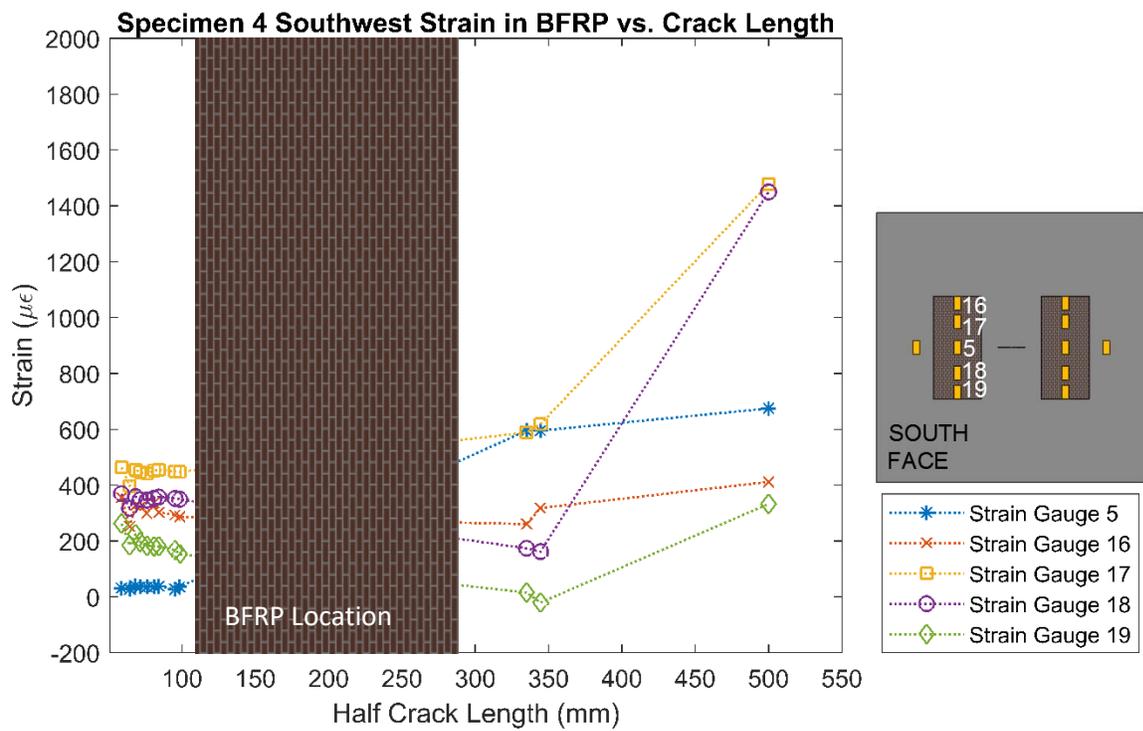
Strain gauges on the BFRP were located along the height of the patches on both faces to assist in detecting debonding. Results for the west patch on the north face are shown in Figure 4-35. Those for the west patch on the south face are shown in Figure 4-36. Both patches on the east half of the specimen showed similar results to those from the west patch on the same face.

The strain in the gauges located in the center of the patches directly over the crack plane increased as the cracks propagated under the patches. Readings from the patch ends, such as those from gauges 12, 15, 16, and 19 as shown in Figure 4-35 and Figure 4-36, decreased as the crack propagated under the patches, indicating some bond deterioration may have occurred although it was not visibly detectable. However, the same gauges at the patch ends did still record increased values when the crack became very large and the patches began to carry more of the applied stress, indicating that while possibly deteriorated, the bonds remained intact at patch ends.

Figure 4-36. Specimen 4 strain in southwest BFRP patch

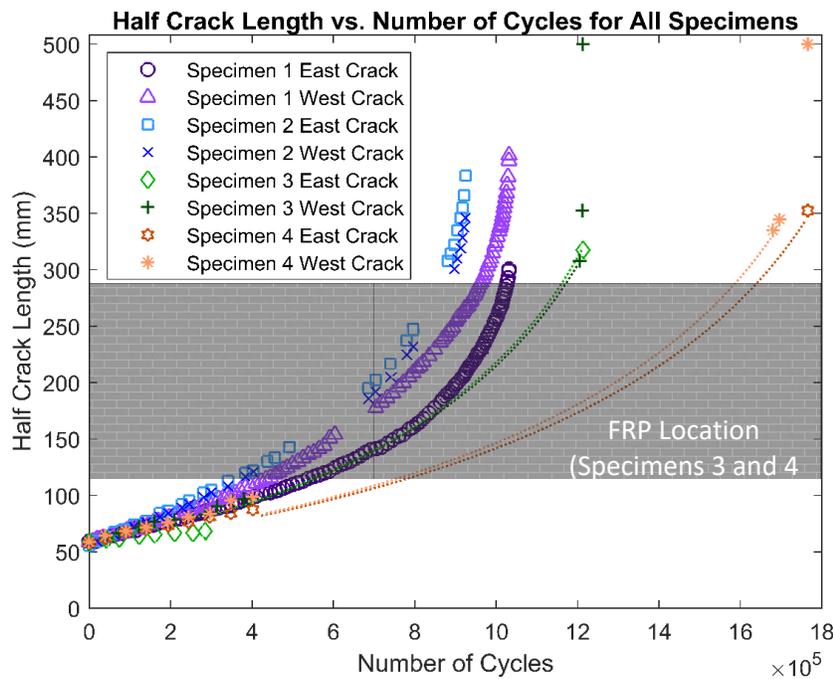
Fatigue life was used as the primary metric for comparing results across specimens and determining effectiveness of the retrofits. As expected, both retrofit methods improved fatigue life, and the underwater environment reduced fatigue life in comparison to fatigue in air. Crack growth data for all specimens are shown in Figure 4-37. Specimens were also compared in pairs to identify key outcomes of the experimental program. For visual clarity and to provide an illustration of behavior behind FRP patches, estimated crack growth curves for specimens 3 and 4 are included as dashed lines in Figure 4-34 and later crack growth comparison plots. Stress intensity factors were calculated for an unrepaired specimen and then scale factors specific to each crack were used to reduce each stress intensity factor value to account for the FRP repair. Scaled values were used in the Paris Law with the parameters found from specimen 2 to obtain crack growth estimates only under the patches.

Figure 4-37. Comparison of crack growth for all specimens

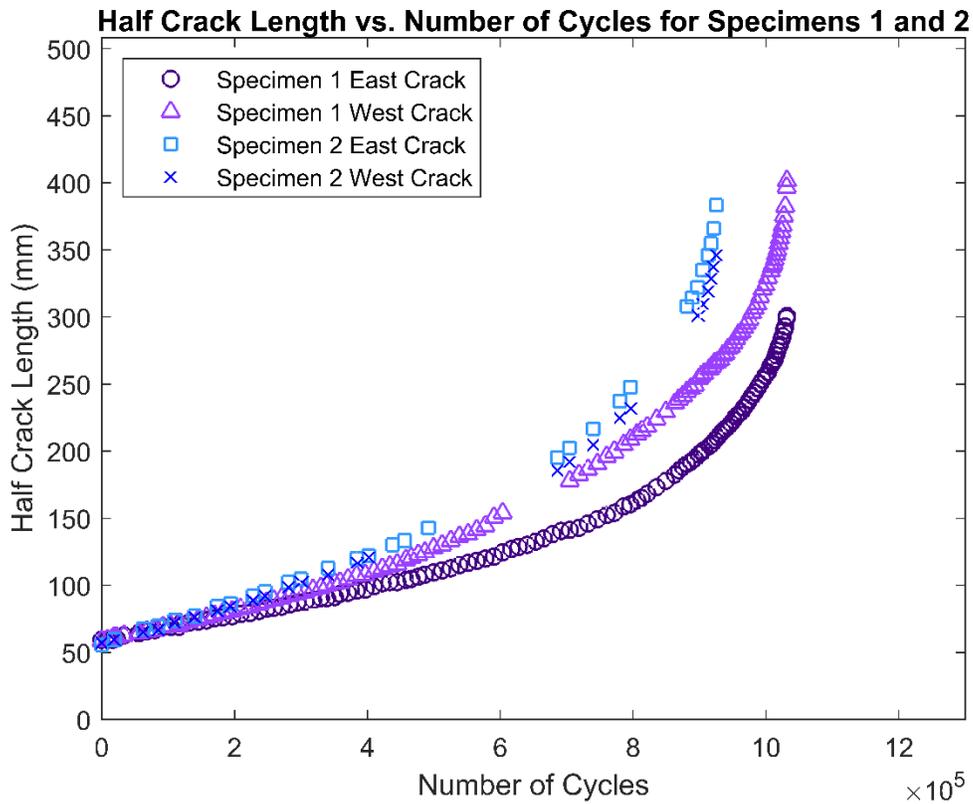
Comparing specimens 1 and 2 allowed for the environmental effects on the steel panel alone to be quantified. The introduction of fresh water for specimen 2 reduced the fatigue life by 10.3% compared to specimen 2. Results for specimens 1 and 2 are shown together in Figure 4-38.

Figure 4-38. Comparison of crack growth for specimens 1 and 2

The reduced life when underwater is expected considering the mechanisms described in Chapter 2. As was also previously described, the life reduction caused by an underwater environment can vary greatly and requires the consideration of more factors than fatigue in air. Here, the reduction in life is moderate. There is a clear reduction in life but it is less dramatic than some results reported by others, such as the reduction of over 50% reported by Morgantini et al. (2018). When comparing the Paris Law parameters calculated for the two specimens, the values

are also clearly reduced when underwater. It should be noted that, because of the large scatter typical of fatigue results, a repeated test in air resulting in fatigue life less than that of specimen 1 and similar to that of specimen 2 would not be considered unusual.

Although the mechanisms contributing to the reduced fatigue life underwater were not studied in detail, observation of the crack surfaces revealed that the specimen 2 showed more brittle behavior than specimen 1. Brittle behavior in specimen 2 was expected because, as discussed in Chapter 2, hydrogen embrittlement is a major factor in underwater fatigue. When comparing the crack surfaces at large crack lengths (during unstable growth), the indicators of ductile fracture were more pronounced for specimen 2. The crack surface for specimen 1 appeared more slanted and rougher than that of specimen 2.

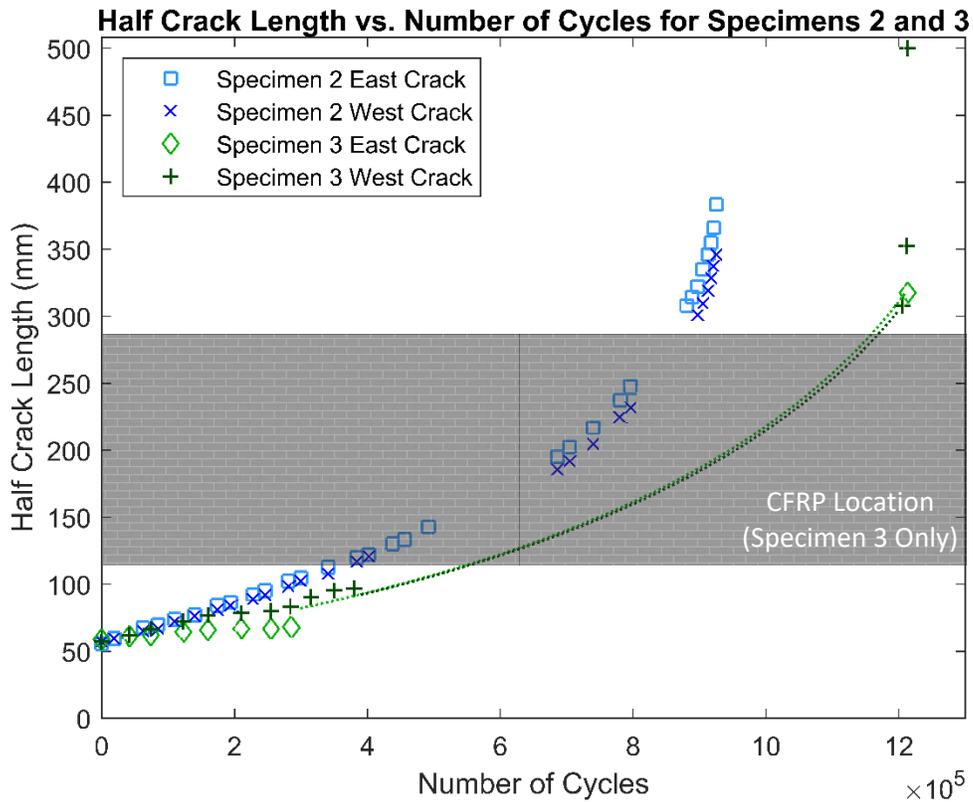
Specimens 2 and 3 were compared to assess the effectiveness of the CFRP repair used underwater. Crack growth results for both specimens are presented together in Figure 4-39. The CFRP retrofit used underwater for specimen 3 provided a 31.1% increase in fatigue life over specimen 2, which was tested underwater with no repair. For small crack lengths before the crack reached the CFRP patch, the crack growth rate was noticeably lower for specimen 3 than specimen 2. This can be attributed to the increased cross-sectional stiffness and reduced nominal stress from the CFRP application. The influence of the crack closure effect that took place once the crack propagated beneath the CFRP is difficult to evaluate since crack length measurements could not be taken when the crack was growing beneath the patch. However, due to the substantial debonding of the CFRP patches on the north face of specimen 3, it is known that the crack closure effect was not fully utilized. It is believed that had the bond remained intact, a greater improvement in fatigue life would have been achieved.

Figure 4-39. Comparison of crack growth for specimens 2 and 3

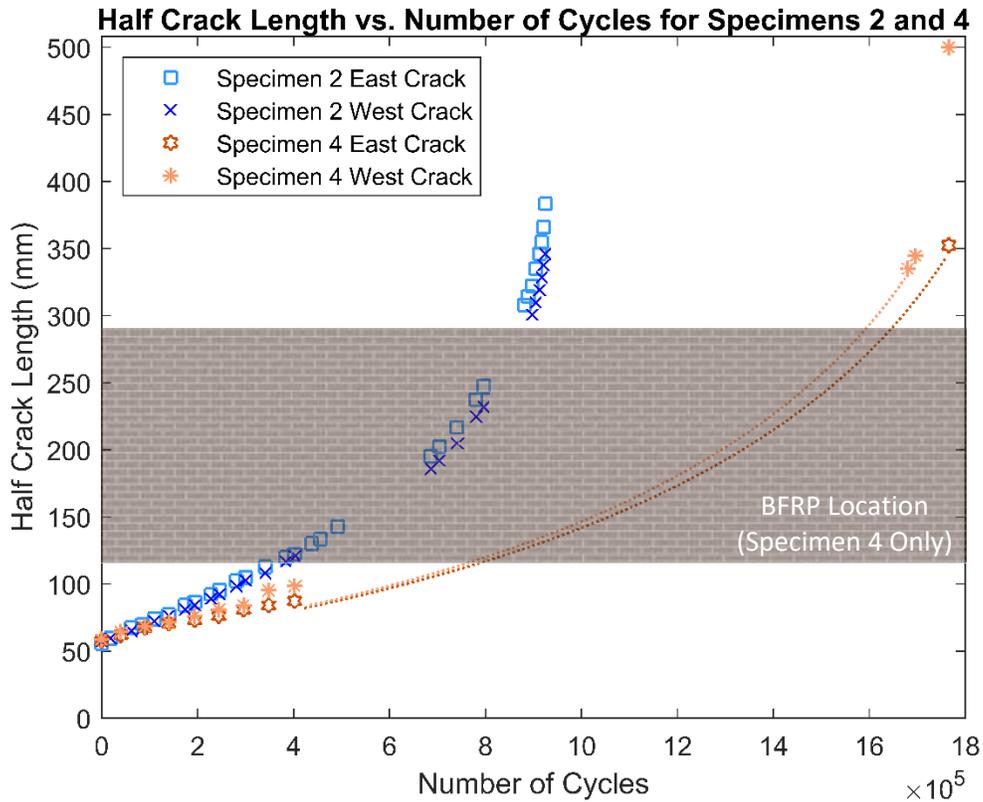
Specimens 2 and 4 were compared to assess the effectiveness of the BFRP repair used underwater. Crack growth results for specimen 2 and specimen 4 are presented together in Figure 4-40. The BFRP retrofit used underwater for specimen 4 provided a 90.9% increase in fatigue life over specimen 2 which was tested underwater with no repair. For small crack lengths before the crack reached the BFRP patch, the crack growth rate was noticeably lower for specimen 4 than specimen 2. This can be attributed to the increased cross-sectional stiffness and reduced nominal stress caused by the BFRP application. The BFRP further reduced the crack growth in comparison to specimen 2 by limiting the crack opening displacement once the crack propagated under the patch.

Figure 4-40. Comparison of crack growth for specimens 2 and 4

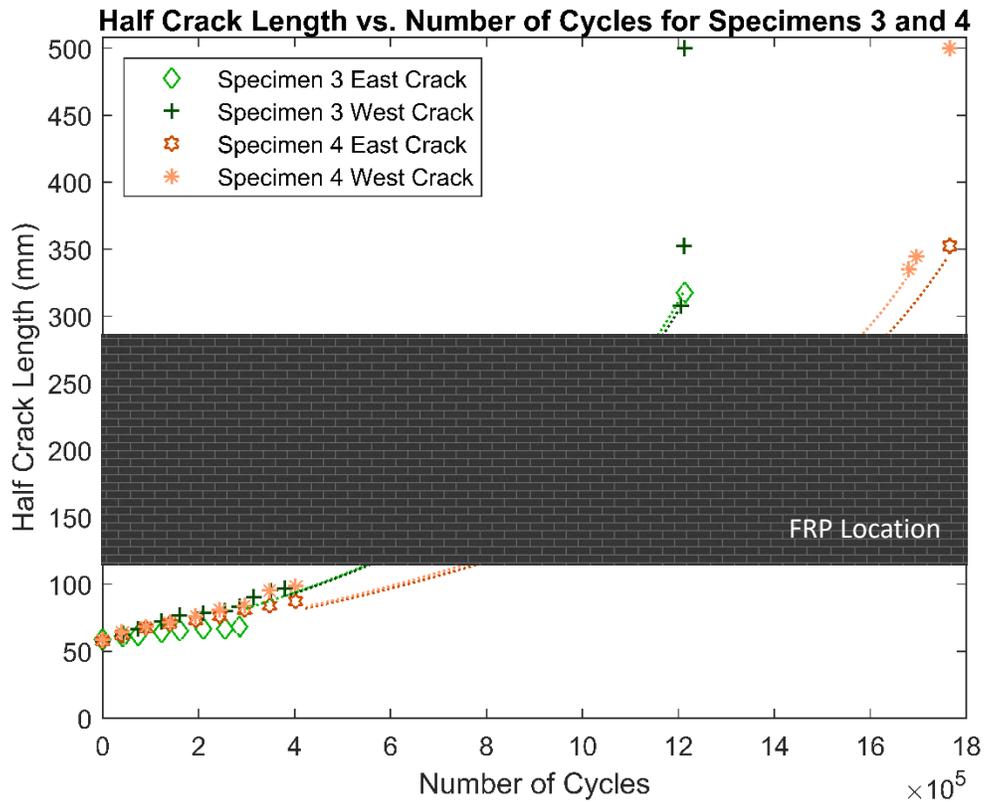
The use of CFRP and BFRP was compared by evaluating results from specimens 3 and 4. Results from specimen 3 and specimen 4 are shown together in Figure 4-41. At the early stage of the tests when the cracks had not yet reached the FRP patches, the crack growth rate was lower for specimen 3 due to the higher stiffness of the CFRP patches. As the crack continued to propagate, the BFRP did not experience debonding at the patch ends, and thus it was more effective at reducing the crack opening displacement than the CFRP, which debonded significantly.

Figure 4-41. Comparison of crack growth for specimens 3 and 4

Had the CFRP used for specimen 3 not debonded, it likely would have limited the crack opening displacement better than the BFRP since the CFRP has higher stiffness. A single cause for the debonding of the CFRP cannot be clearly identified from the results of this study alone. Variations in the FRP application process, absence of any galvanic corrosion, or lower demand on the adhesive due to lower BFRP stiffness may have contributed to the better bond behavior observed when using BFRP.
