OUACHITA RIVER PROJECT
ARKANSAS
REMMEL DAM SPILLWAY

June 1971

Report
Hydraulic Model Studies
Remmel Dam Auxiliary Spillway

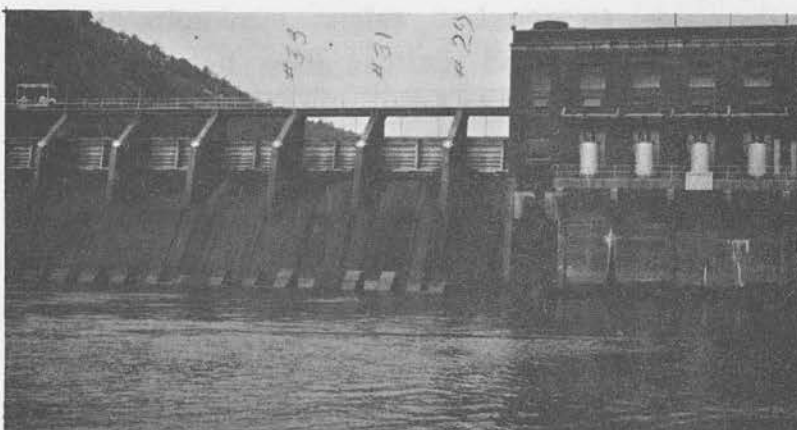
FIG. 3

A View of North Abutment that will become Crest for Auxiliary Spillway

B Downstream Side of Abutment where Plunge Pool will be Located

C Downstream Side of Main Spillway and Powerhouse

Rommel Dam Spillway Study
1:42 Scale Model
Views of Existing Prototype Spillway
Powerhouse and North Abutment

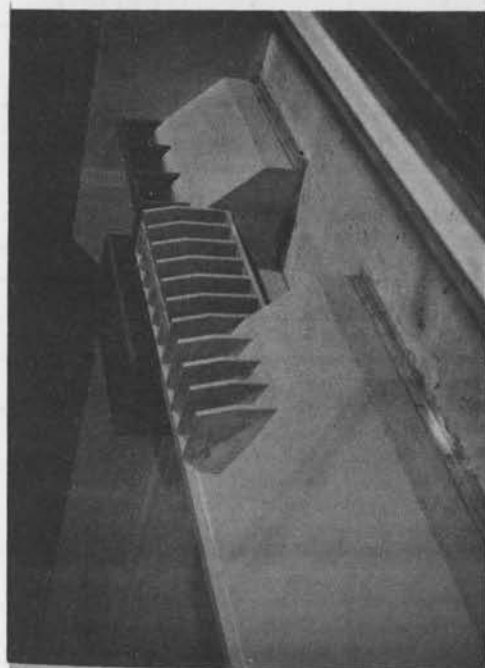
A Upstream side of Powerhouse and Spillway sections

B Downstream side of Powerhouse and Spillway section

C Downstream side of Powerhouse and Abutment sections

D Downstream side of completed Model

Rommel Dam Spillway Study
 1:42 Scale Model
 Model Components in Place
 Without Topography

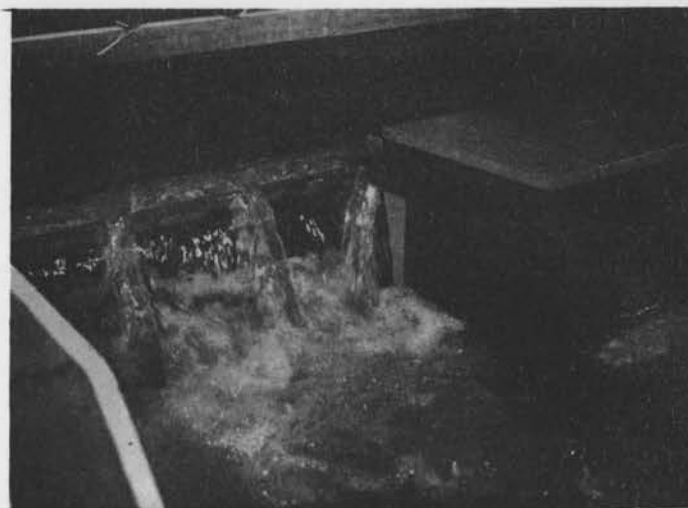
A Top section of trashway bay open

B Top of trashway bay closed

Rommel Dam Spillway Study
1:42 Scale Model
Flow Conditions Downstream from
Spillway Gate No. 1 With and Without
Top of Trashway Bay Closed

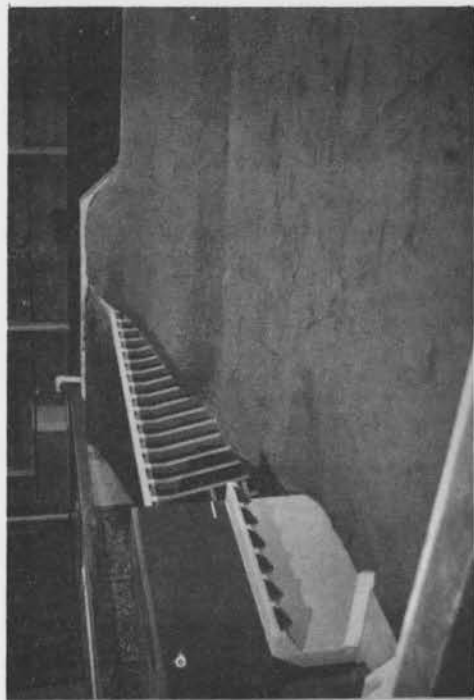
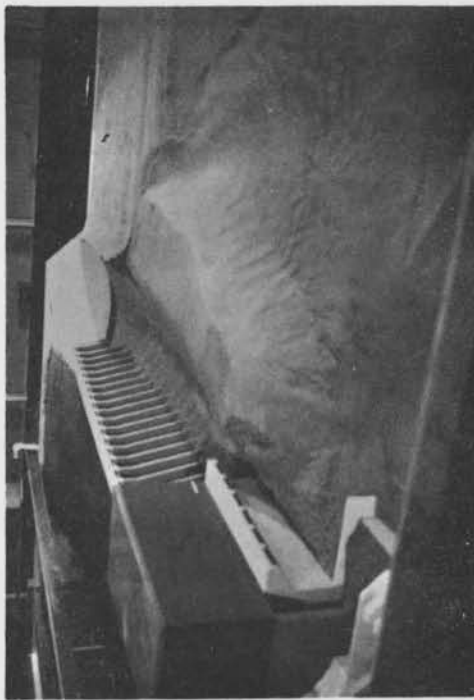
A Before test

B North Bank before test

C Scour Conditions at end of test

D Scour Conditions Downstream from North Abutment

Rommel Dam Spillway Study
1:42 Scale Model
Topography Before and After Test
Compacted Sand Topography, Test No. 4

For the initial preliminary test related to using the north abutment as an overflow spillway the model topography was molded entirely of compacted sand, (figure 14A and B), having the gradation shown on Figure 6. The test also provided some indication as to what scour severity might be expected in subsequent testing of the model.

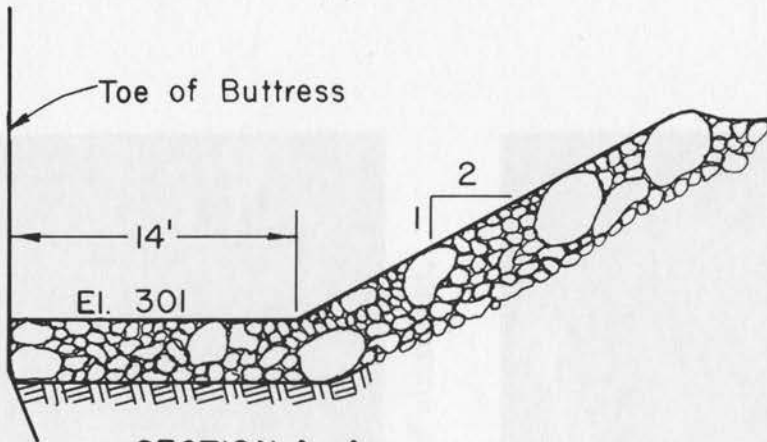
REMMEL DAM SPILLWAY STUDY
 1:42 Scale Model
 Plunge Pool Formed by Excavated
 Slopes Armored With Riprap- Auxiliary
 Spillway
 Test No. 5

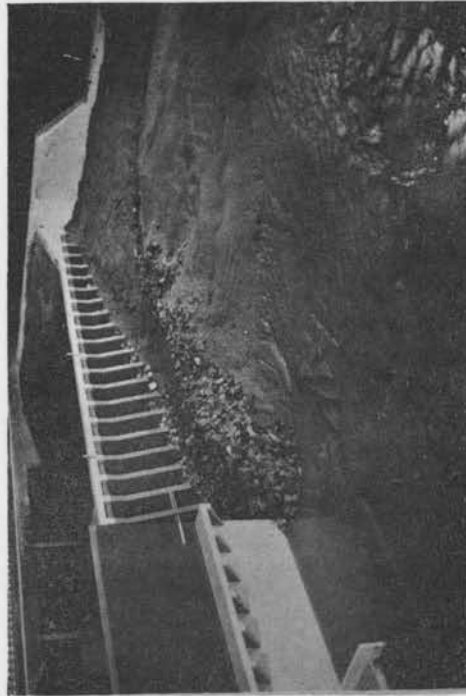
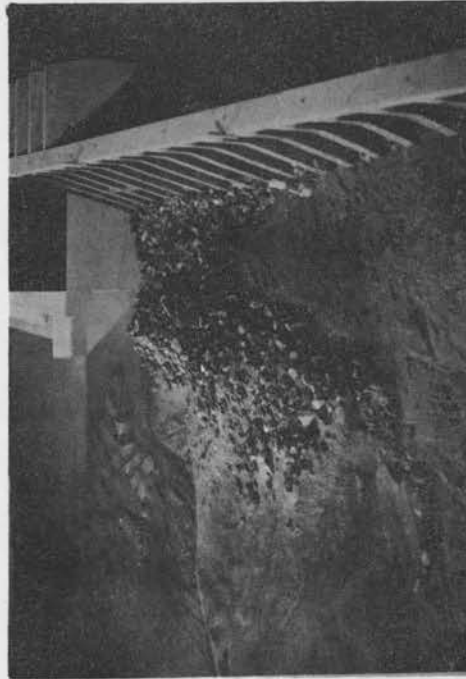
A Downstream side of abutment, before test

B. North bank downstream from abutment, before test

C Scour conditions below abutment, after test, looking north

D. Scour conditions below abutment, after test, looking south

Remmel Dam Spillway Study
1:42 Scale Model
Conditions Before and After Test
Armored Excavated Slopes Downstream
from North Abutment, Test No. 5

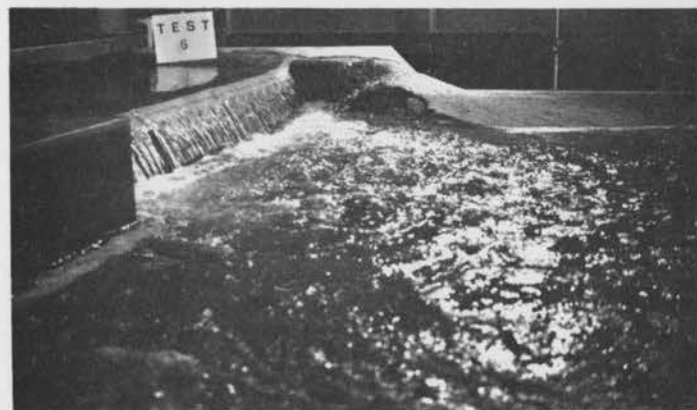
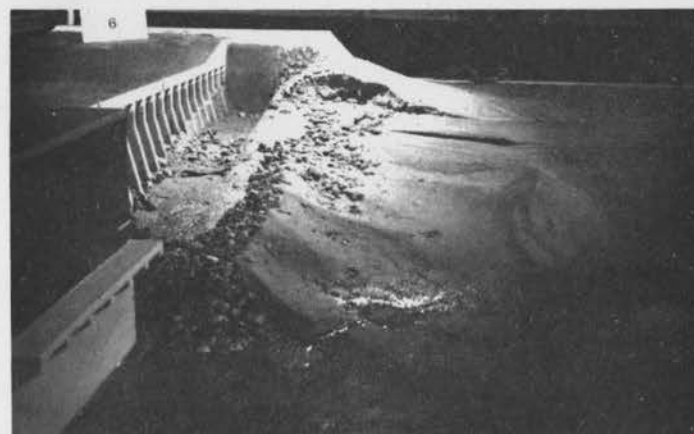
A Excavated Channel and Riprap Slopes
Downstream from North Abutment Before Test

B Flow Conditions and Scour at North End
of Abutment

C Scour Conditions Downstream from
Abutment

Rommel Dam Spillway Study
1:42 Scale Model
Conditions Before and After Test - Rock Excavation
and Riprap Slopes Downstream from
North Abutment, Test No. 6

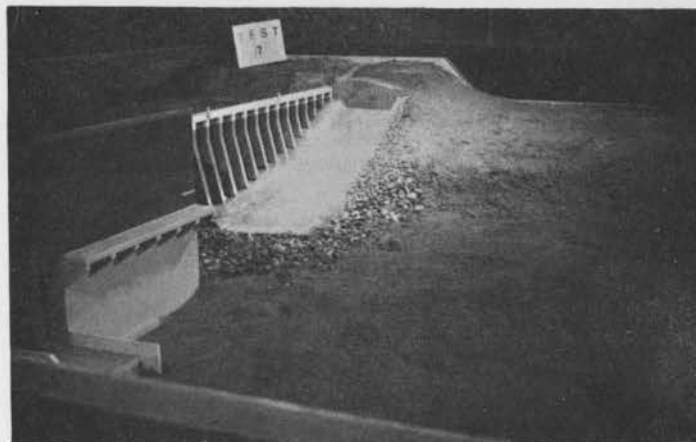
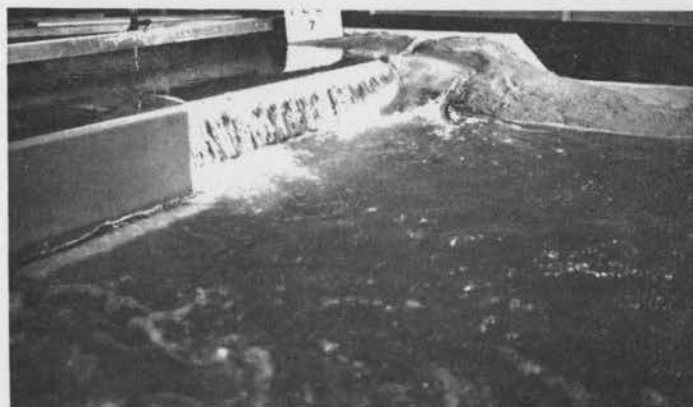
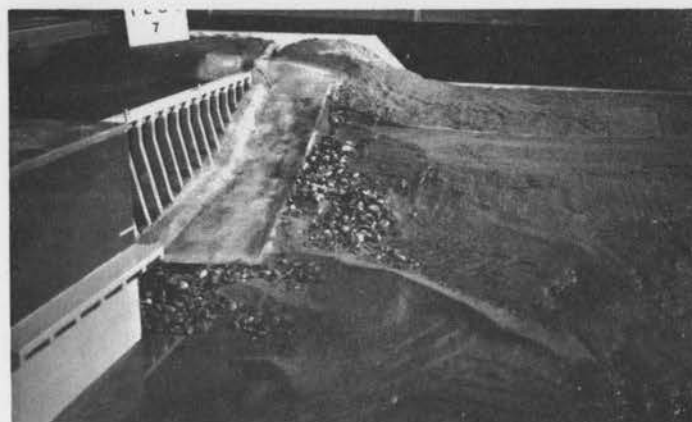
A Concrete-lined Channel and
Riprap Armor, Before Test

B Flow Conditions at North
End of Abutment Section

C Scour Conditions Downstream
from Abutment Section

Rommel Dam Spillway Study
1:42 Scale Model
Flow and Scour Conditions, Plunge Pool with
Concrete-lined Trough No. 1 and
Riprap Protection, Test No. 7

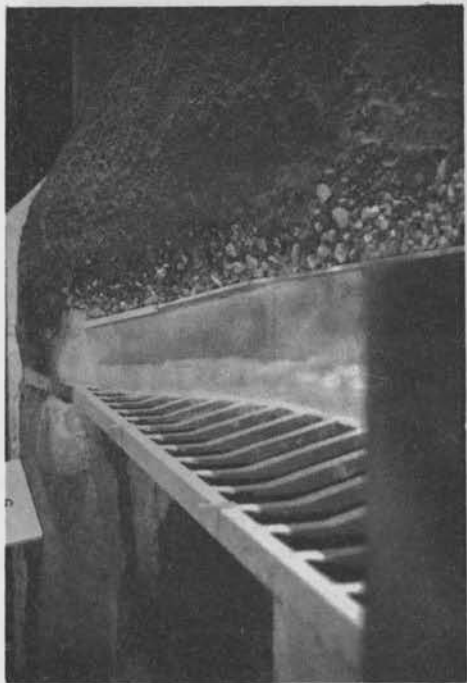
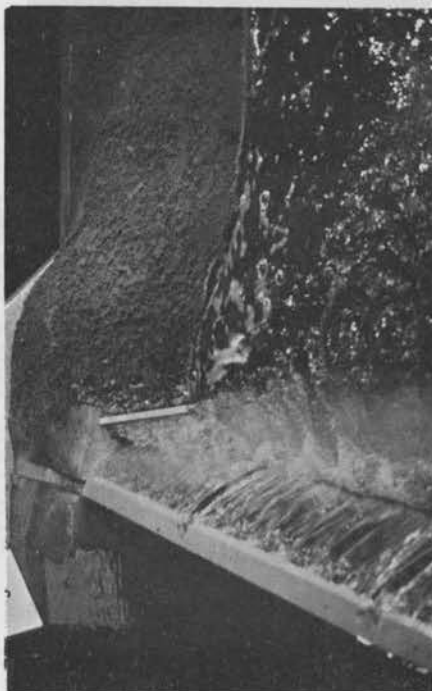
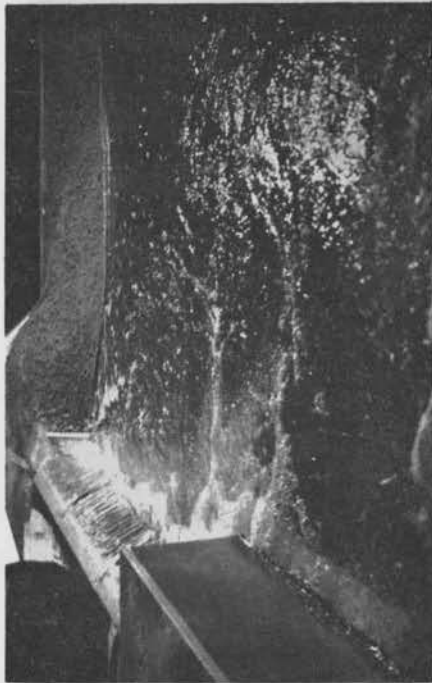
A Concrete-lined Trough and Riprap Protection, Before Test

B. Concrete-lined Trough and Downstream Wall and Riprap Protection Before Test

C Flow Action at North End of Trough

D Flow Conditions Downstream from North Abutment

Conditions Before and During Test, Plunge Pool with
Concrete-lined Trough No. 2 Downstream
from North Abutment, Test No. 9

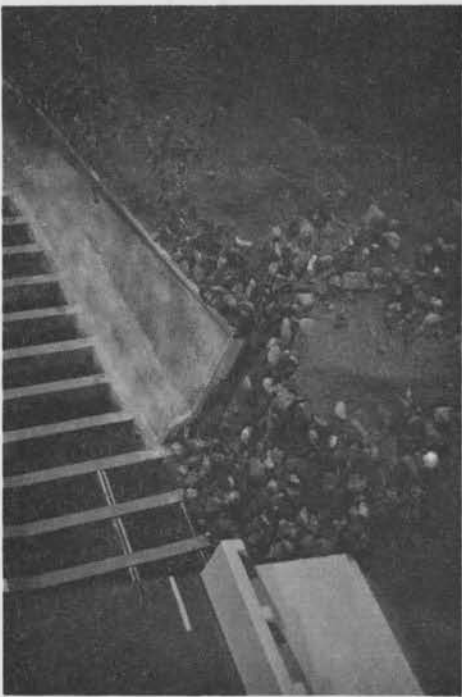
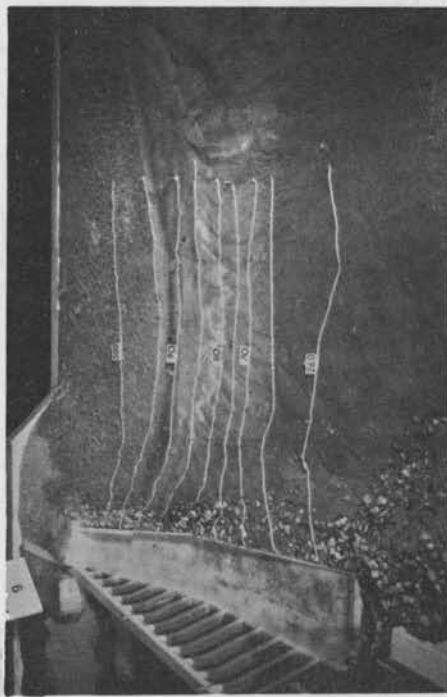
A Scour Downstream from Concrete-lined Trough

B Scour at South End of Trough

C Contour Lines Showing Scour Conditions at End of Test

D Contour Lines Showing Scour Conditions at End of Test

Scour Conditions After Test of 1 Hour (Model) with Reservoir at El. 322, Plunge Pool with Concrete-lined Trough and Sea Wall at North End, Test 9

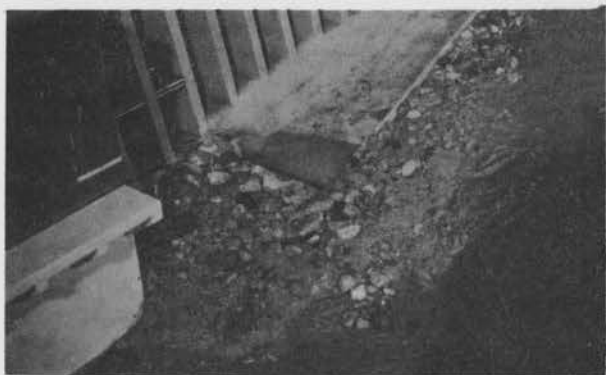
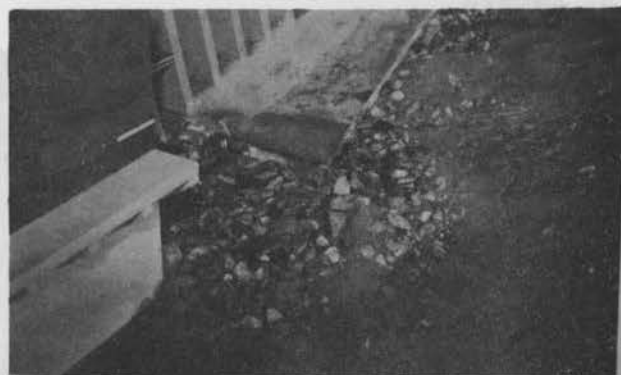
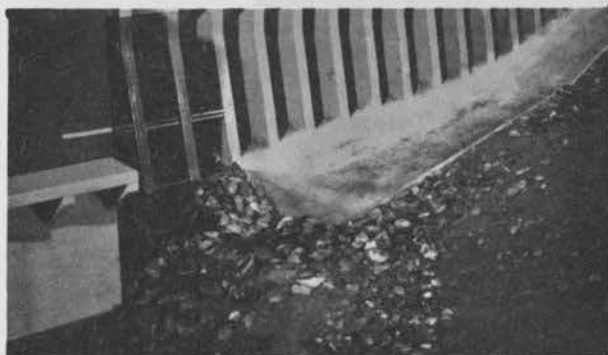
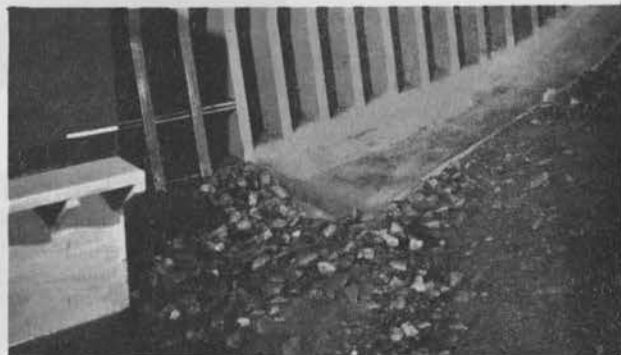
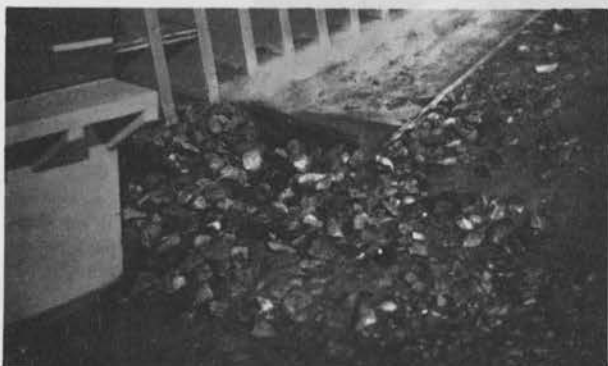
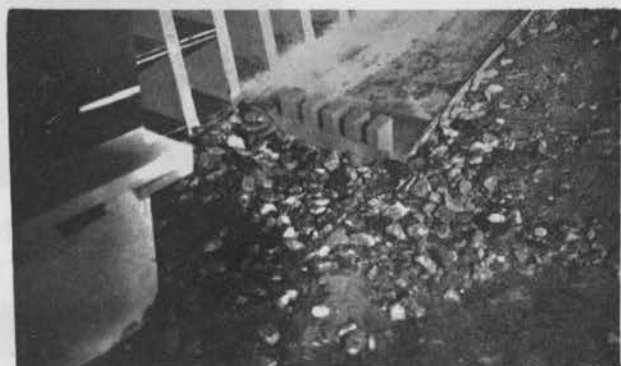
C 5-foot, 45° Wall

D 5-foot Vertical Wall

E 5-foot Sea Wall

F 10-foot Dentated Wall

Scour Conditions at South end of Trough

With and Without Various Walls at South End of Trough, Test No. 9

This first modification produced little if any improvement in scour conditions and the wall height was increased to 5 feet but at the same time retaining the 1:1 slope on its north side, (Wall No. 2, figure 24). Slight improvement was realized but further improvement seemed desirable, (figure 25C). The 1:1 slope on the north side of the wall was removed to determine whether or not it was more effective than a vertical wall of the same height, (Wall No. 3, figure 24). There was no discernible difference for the two walls, (figure 25D).

pattern obtained at Reservoir El. 322. At the end of a half hour of operation a significant movement of the riprap was noted with the area of exposed bedrock much greater than for the lower reservoir elevation. It was again concluded from the two tests that walls at the end of the trough were relatively ineffective in preventing scour. However, a 5-foot high vertical wall was placed across the trough behind Buttress No. 15, Wall No. 6, (figure 24). This arrangement provided some pavement adjacent to the wall and to the south. The purpose was to confine any turbulence from the wall to the paved surface.

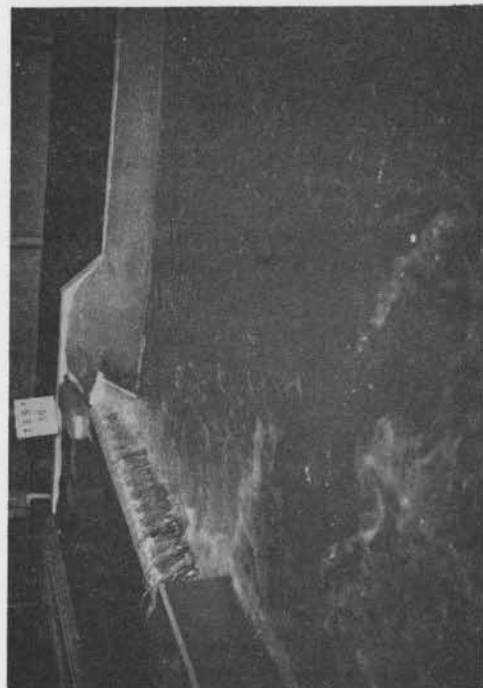
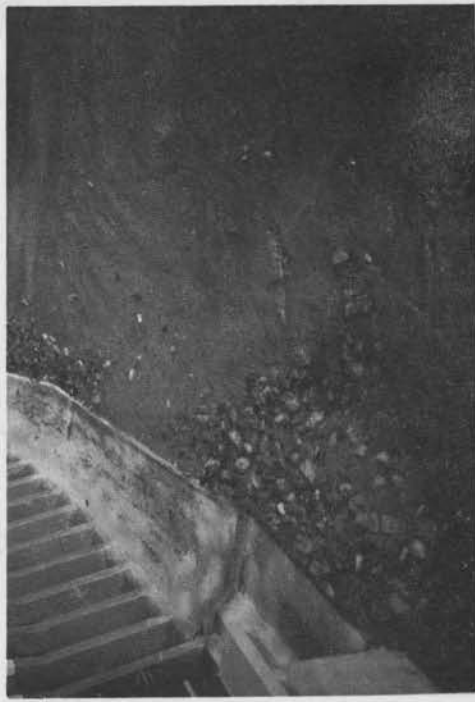
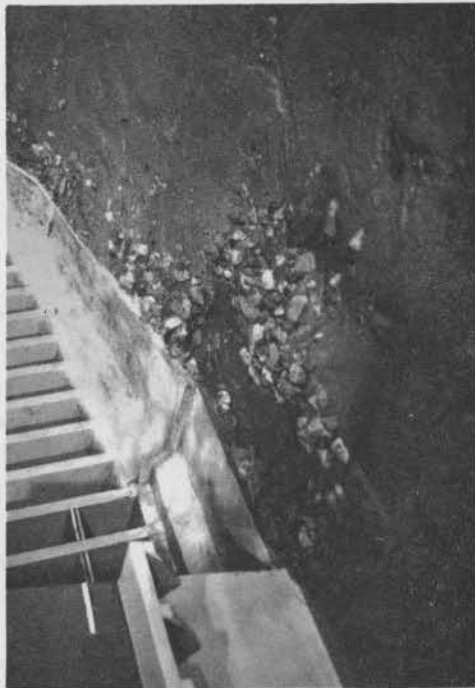
A Reservoir El. 322

B Reservoir El. 325

C After 1 hr. at Res. El. 322

D After Additional 1/2 hr. at Res. El. 325

Rommel Dam Spillway Study
1:42 Scale Model
Flow and Scour Conditions
Recommended Plunge Pool Downstream
from North Abutment, Test No. 10

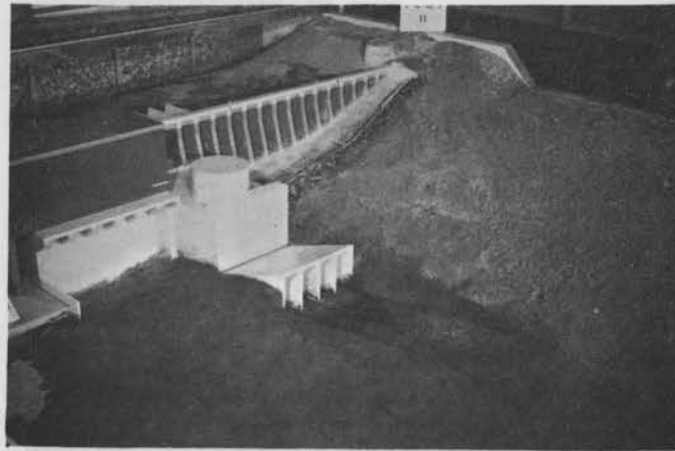
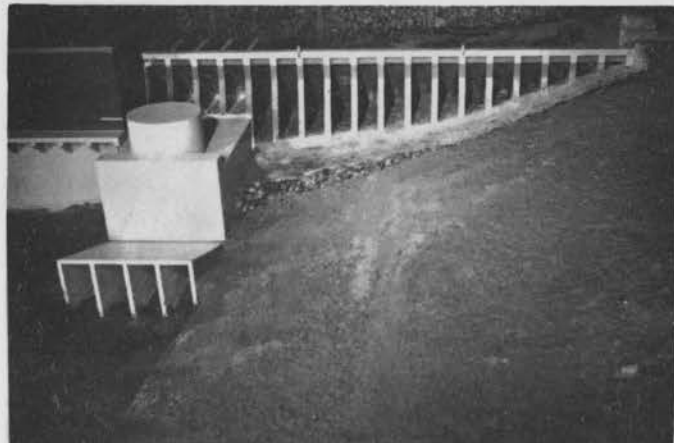
A Model Before Test

B Powerhouses and North Abutment

C Future Outdoor Power Unit

Rommel Dam Spillway Study
1:42 Scale Model
Recommended Auxiliary Spillway Plunge Pool with
Future Outdoor Power Unit Enclosure in Place
Test No. 11

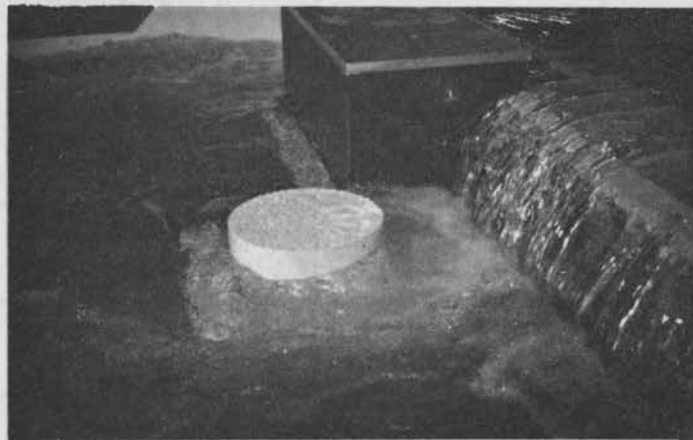
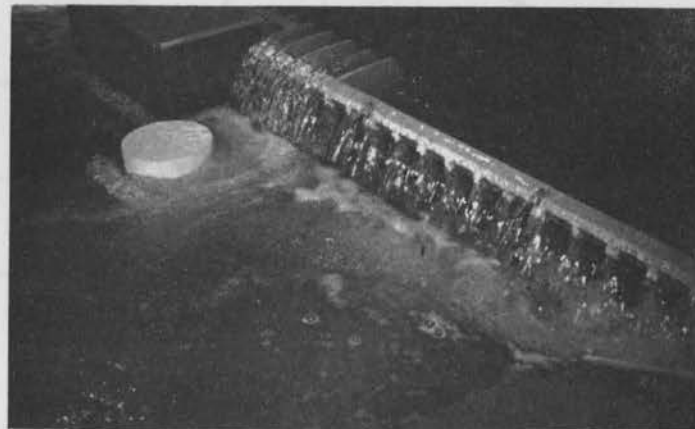
A Flow Conditions Downstream from North Abutment

B Flow Conditions at Future Power Unit

C Flow Conditions at Base of North Abutment

Rommel Dam Spillway Study
1:42 Scale Model
Flow Conditions Downstream from
North Abutment with Recommended Plunge Pool and
Future Outdoor Power Unit Enclosure in Place, Res. El. 322

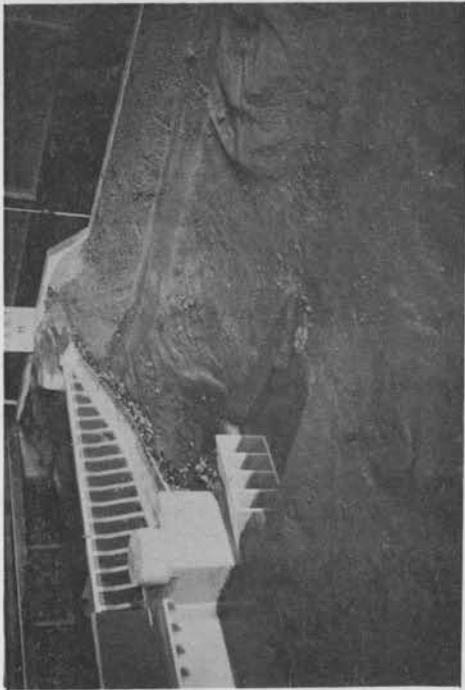
A Scour Downstream from North Abutment

B Scour North of Future Outdoor Power Unit

C After 1 hour Operation at Reservoir El. 322

D After Additional 1/2 hour Operation at Reservoir El. 325

Scour Adjacent to Future Outdoor Power Unit

Scour Conditions, Recommended Auxiliary Spillway Plunge Pool with Future Outdoor Power Unit Enclosure in Place, Test No. 11
