THESIS

GEOMORPHIC IMPACTS OF LARGE WOOD RESTORATION IN AN URBAN
COLORADO STREAM

Department of Civil and Environmental Engineering

Spring 2025

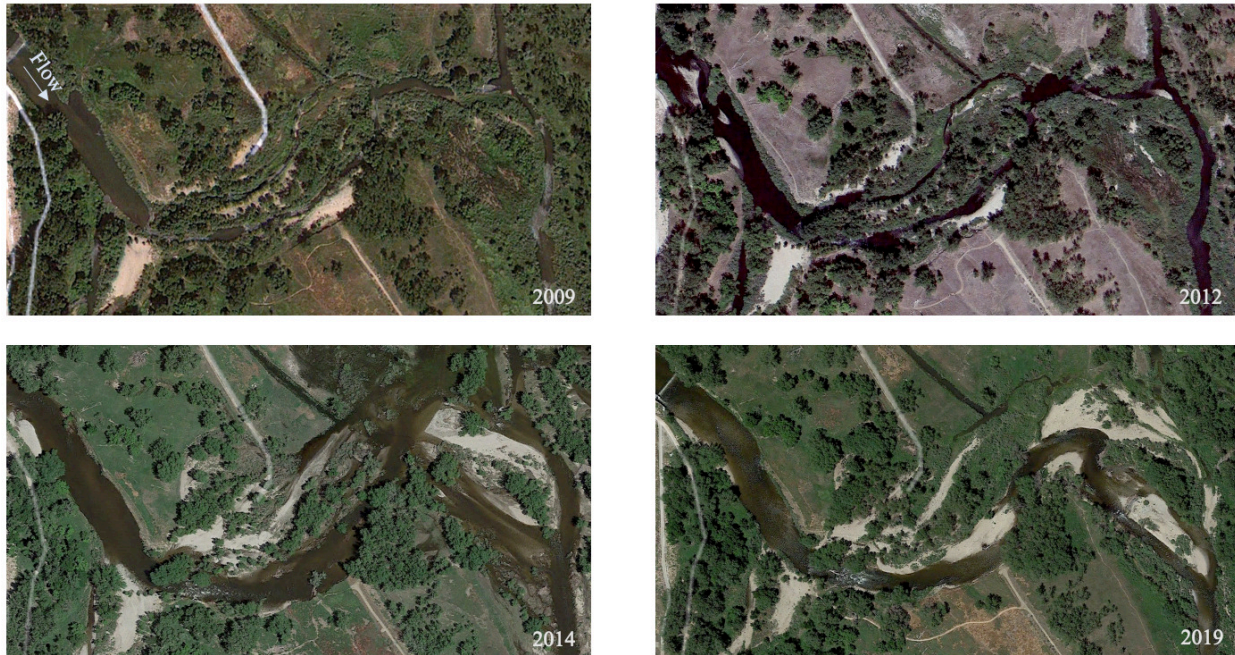
Figure 2. Historical imagery of the Poudre River within the ELC around peak runoff. Top two images show multiple flow paths prior to avulsion. Bottom two images show channelization due to the 2013 Flood.

In 2013, a large storm resulted in a five-year flood (~140 CMS), which subsequently caused an avulsion within the Environmental Learning Center (ELC) along the Poudre (Figure 2). The avulsion in the new mainstem decreased channel length and steepened longitudinal slope to transport the same amount of water which caused the river to head cut. The head cut at the ELC posed a risk to a nearby low-head dam. The City of Fort Collins’s goal was to stop the head cut from impacting the dam and to retain environmental water rights by rewatering the avulsed mainstem. Therefore, they hired a private contractor to develop restoration designs. The contractor design included some process-based techniques with the goal of capturing sediment to stop the head cut and support ecosystem processes. In April 2023, the project construction was finished

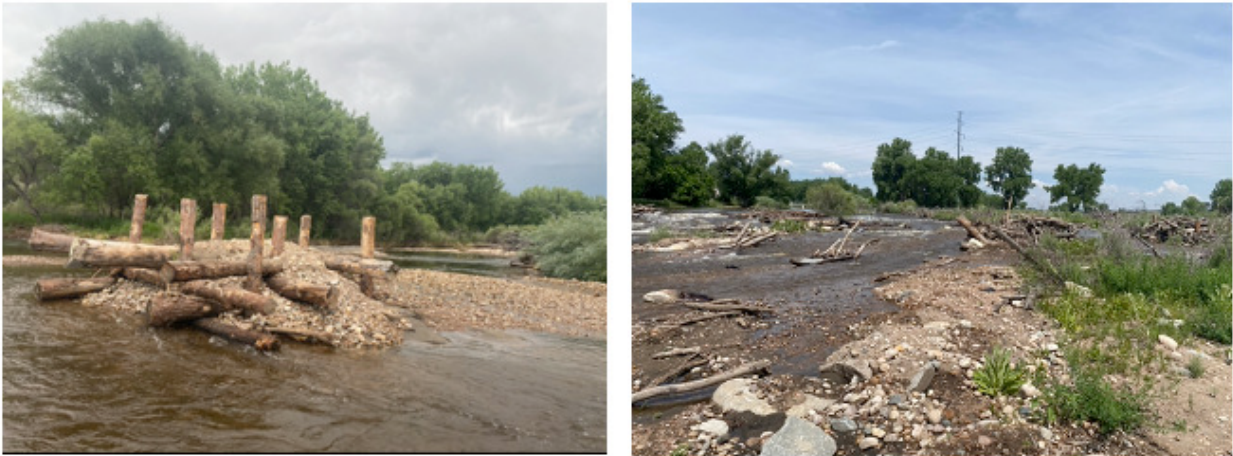
Figure 3. Left: Downstream log structures. Right: Upstream log structures.

further secondary connections. Large wood structures were placed on the north floodplain and in the main stem and floodplain on the downstream bend.

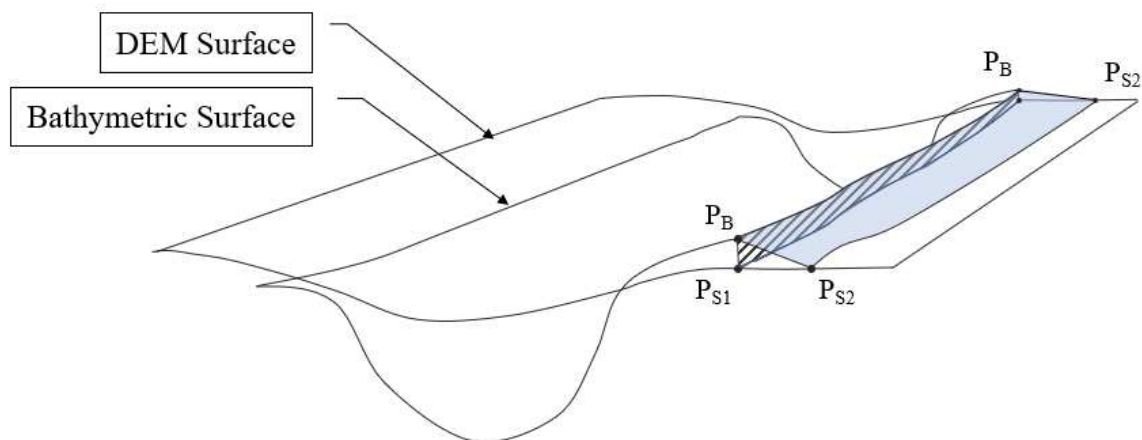
Figure 4. Diagram of how to combine bathymetric and topographic surfaces.

A bathymetric surface was created in AutoCAD Civil 3D using the survey performed in September. Survey points were converted to feature lines for the thalweg, toe and top of the channel (line between P_B points, Figure 4). The feature lines were then applied to a blank surface as break lines, which created a rough bathymetric surface. Since there are small discrepancies between the bathymetric surface and DEM surface (area defined by diagonal hatch, Figure 4) an intermediary surface was built. The tops of bank feature lines were offset 0.15 meters (distance between P_{S1} and P_{S2} , Figure 4) and placed on the SfM DEM where the topographic values could be extracted to line vertices. These top of bank elevation defined lines (between P_{S2} points, Figure 4) were pasted as new features into the bathymetric surface to ensure the SfM DEM and bathymetric surface aligned. Finally, the bathymetric surface and SfM DEM were pasted into a blank surface to be combined and exported into ArcGIS for further analysis.

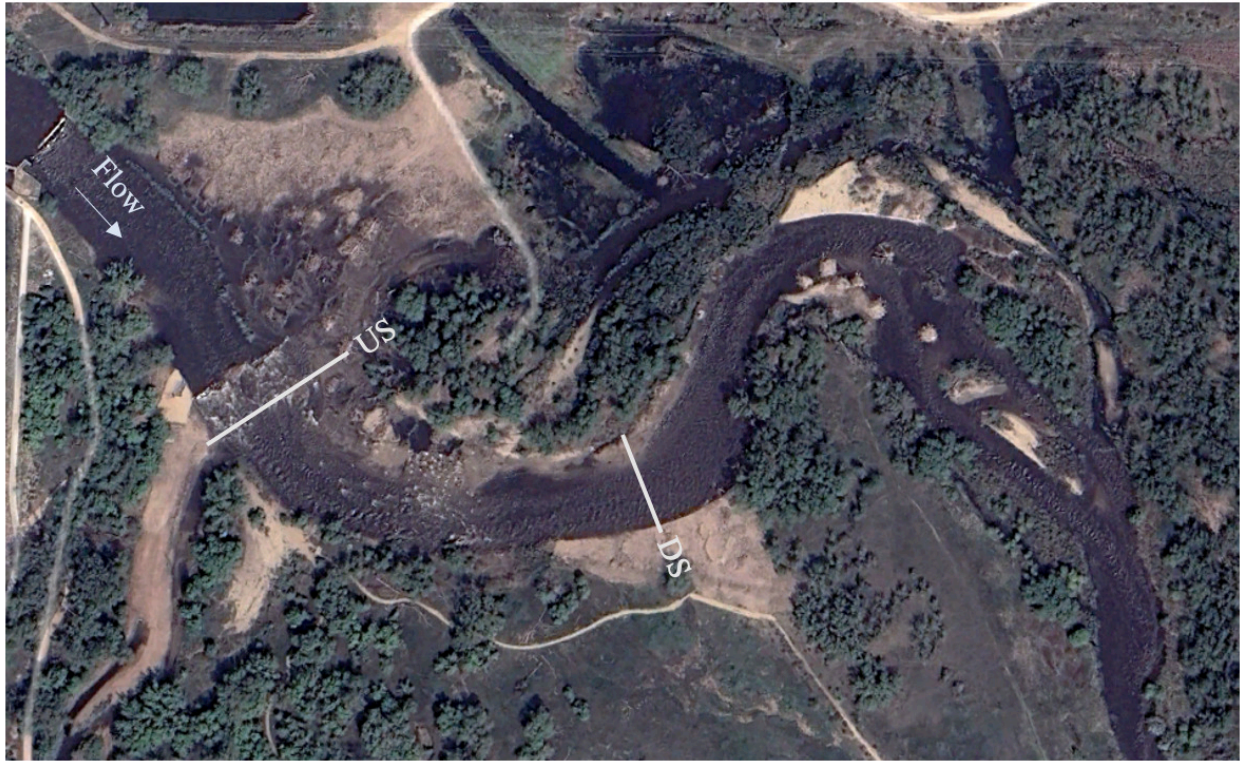
Figure 5. Locations of pebble counts overlain on a 2023 (post-construction) aerial.

A defining goal of the restoration project was to mitigate the head cut threatening the low-head dam by increasing sediment deposition. The contractor conducted a pre-restoration cross-sectional pebble count in April 2020 prior to construction and I reconducted the pebble count 7-months post-restoration in November 2023. The upstream section was taken at the bottom of the first riffle, and the downstream cross-section was taken at the first bend in the channel (Figure 5). Tape measures were placed across the channel and a blind point and pick method was used to measure sediment every 0.3 meters. Each piece of sediment was measured using a gravelometer and anything below 2 mm was recorded as fines but analyzed in calculations as 2 mm.

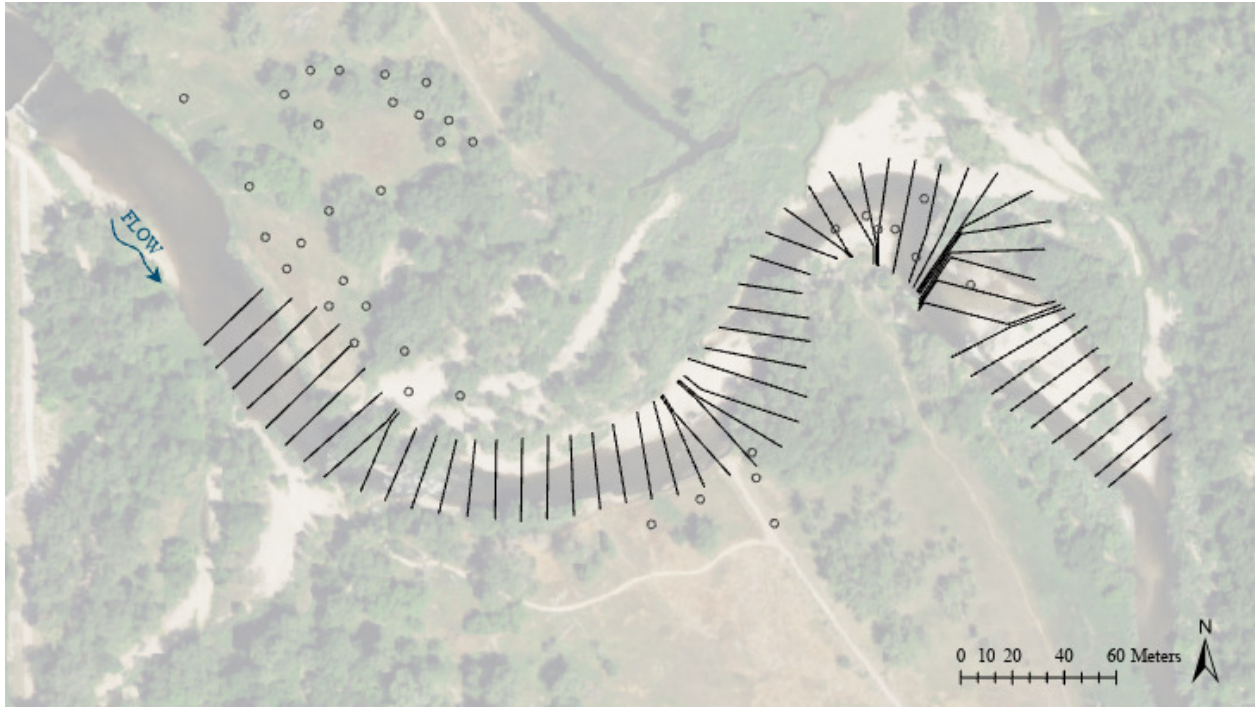
Figure 6. Cross-sections used for sediment transport analysis, dark lines are cross sections and open circles are placement of log jams.

To determine changes in sediment, I created a denser series of cross sections 10 meters apart (Figure 6). Between each cross section I created polygons spanning one cross section to the next. I ran a raster statistic function on the DoD for each polygon. This calculated the average DoD cell value between each cross section within the November active channel as defined by grade breaks and vegetation boundaries.

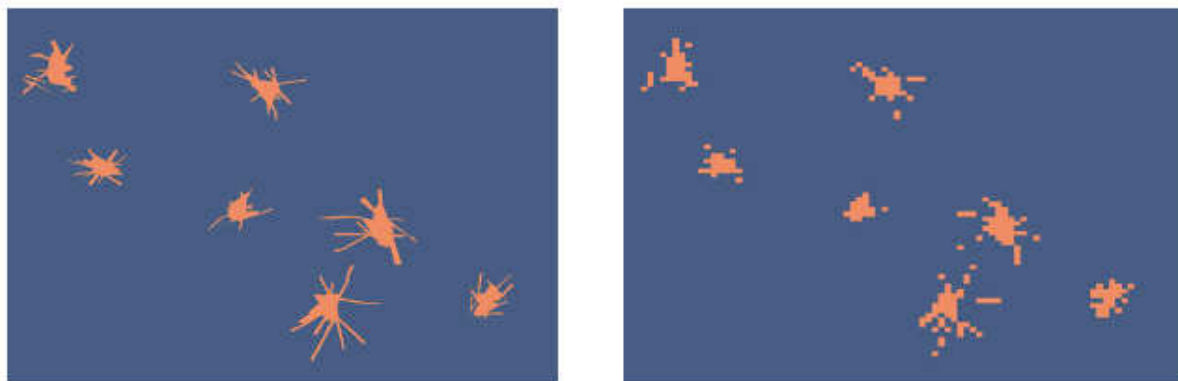
Figure 7. Left: Wood patch delineation as polygons in the north floodplain. Right: The same wood patch delineation as rasters after processing.

Styles, 2024). Delineation of above-water geomorphic units was completed using orthomosaic imagery and digital elevation data obtained through drone imagery. Units were predefined and included terraces, floodplains, ledges, lateral bars, in-channel bars, islands, side channels, chutes, pools, riffles, and wood using the River Styles approach. After delineation, patch types were dissolved and merged in ArcGIS so that one shapefile contained all patch types, and each type was one multi-patch polygon. The combined polygon shapefile was turned into a raster file with a cell size 0.15 meters. This resulted in numerous one cell patches. This is because of the process used to overwrite and combine overlapping patch areas in ArcGIS, where the method described above supports the delineation of micro patches, sometimes only 0.1 m². The “Polygon to Raster” function reinforces this inflation by requiring a raster cell size which promotes a false discretization of patches. There are a total of 8 patches, including the floodplain background on the left, while the right has approximately 45 (Figure 7).

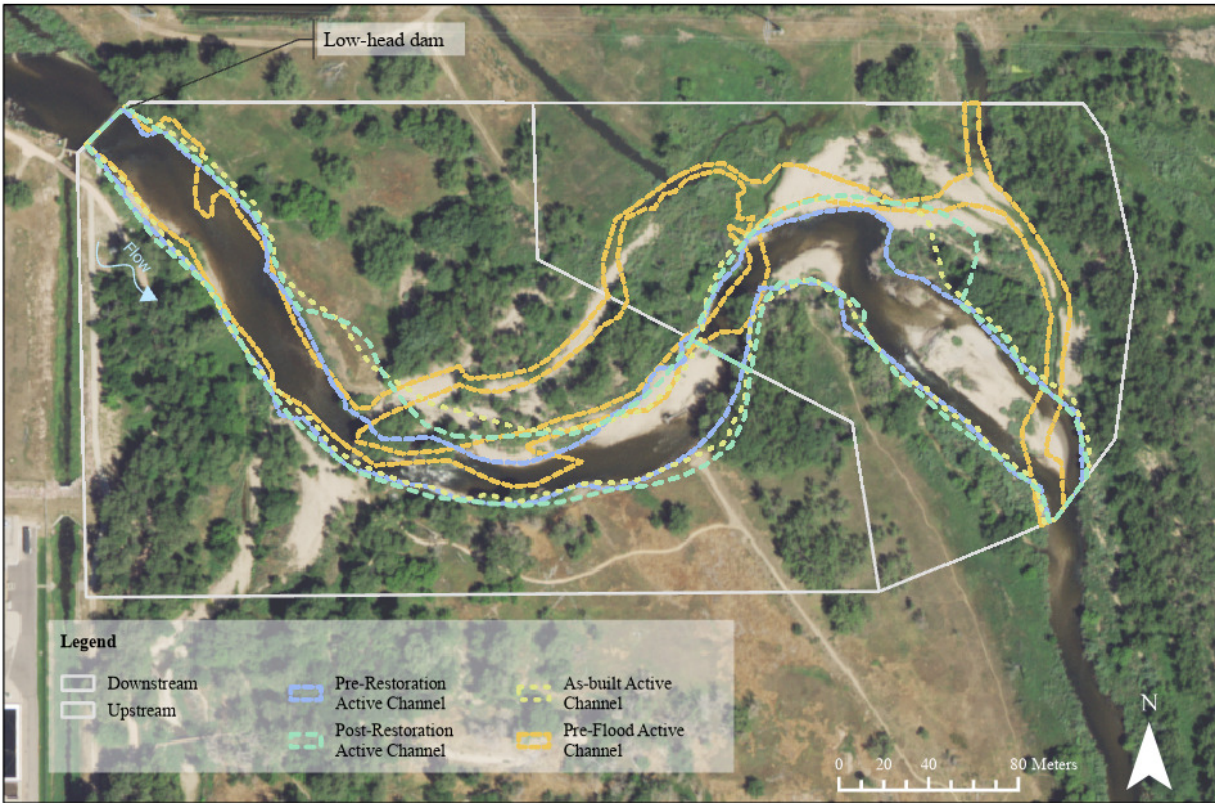
Figure 8. Area of analysis and the separation between up and downstream reaches as indicated by white line crossing the middle of the study area.

The two delineated areas seen in Figure 8 were compared spatially and temporally. Spatial analysis compared each heterogeneity metric between the upstream and downstream reach. Temporal analysis compared pre-restoration, as-built, and post-restoration metrics. To assess how restoration techniques effected the results within the active channel, I delineated the active channel based on established vegetation for each scenario. In areas where vegetation was absent or disrupted due to construction activities, I prioritized identifying breaks in the topographic grade. Each active channel delineation accompanied by the appropriate raster was used in the “Extract by Mask” ArcGIS Pro to isolate the area of interest for analysis. This resulted in six rasters per point in time to be analyzed; a full site, full active channel, full upstream, full downstream, full active channel

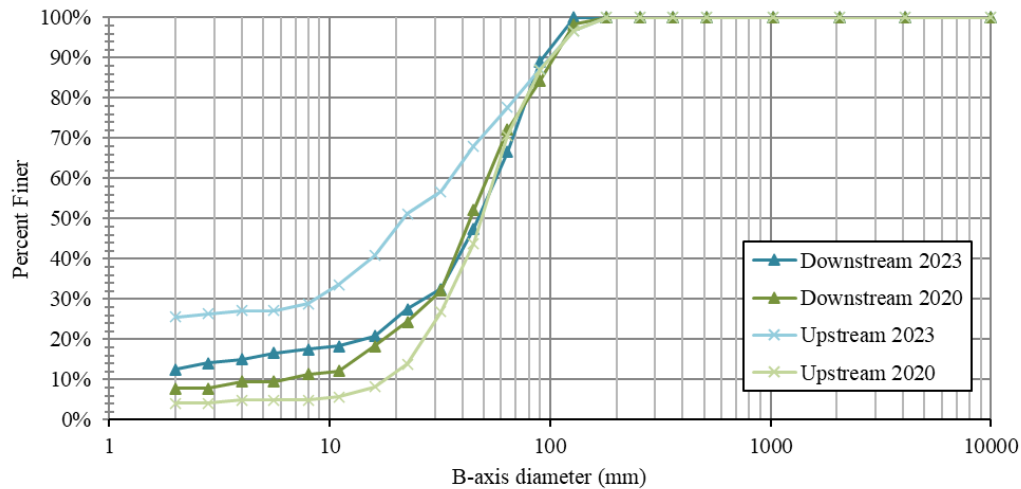
Figure 9. Bed sediment analysis at two cross sections for pre-restoration (2020) and post-restoration (2023). The green lines show pre-restoration (2020) sediment size results, while the blue lines show sediment size results for post-restoration (2023). Triangle markers indicate the downstream cross section while “x” markers the upstream cross section.

The pebble count results show a post-restoration reduction in median sediment size and increased deposition of fine particles. After restoration, the upstream cross-section coarsened whereas the downstream cross-section became finer (Figure 9). The D_{50} measurement decreased at the upstream reach from 48.8 mm, very coarse gravel, to 21.7 mm, coarse gravel using the Wolman class size standard. The downstream cross-section increased a small amount from 43.4 mm to 47.1 mm resulting in no sediment class change. There was an increase in fines (2 mm or smaller) in the upstream sediment composition after restoration from 4% in 2020 to 25% in 2023. Despite a slight coarsening in D_{50} , there was an increase in downstream fines from 8% in 2020 to 12% in 2023. The increase in fines shows increased entrapment of small particles at these locations (Table 1).

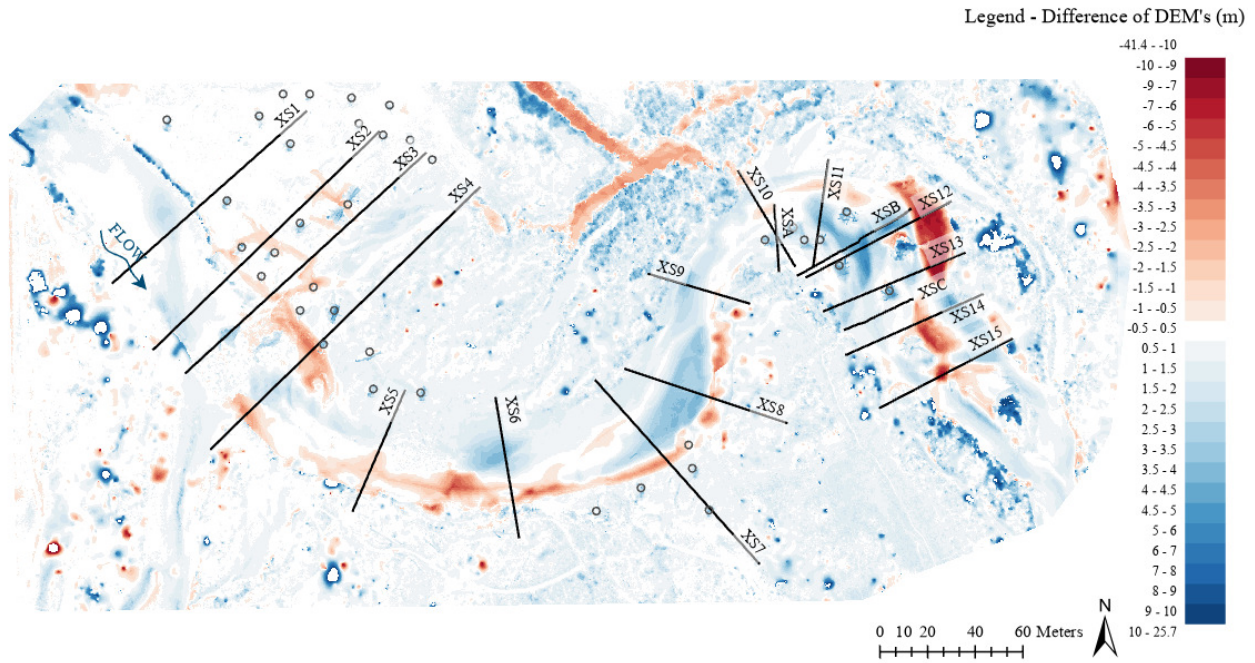
Figure 10. Difference of DEMs between as-built (April 2023) and post-restoration (November 2023) topography, where red denotes erosion and blue denotes aggradation. Open circles indicate locations of ELJ's.

DEM differencing between as-built conditions and post-restoration (November) shows net aggradation at every cross-section except for cross-section 13, including cross-sections A, B, and C (Figure 10). The latter cross sections show consistent aggradation from as-built conditions until sometime between November and January, with net erosion at all three locations (Table 2). There was aggradation across the site except for cross-section 4, 5, and 13, which lost 1.1, 1.4, and 2.4 m³ of sediment, respectively. When examining sedimentation changes upstream and downstream, it's evident that the downstream reach exhibits a larger magnitude (-2.6 to 2.9 meters) and average value (0.14 meters) of sediment alteration compared to the upstream reach (ranges from -1.65 to 1.25 meters and has an average value of 0.08 meters) (Figure 10). Cross sectional sediment analysis shows that the area of highest erosion is at the bend near the in-channel ELJ's. The other location that on average had deposition was near either constructed riffle. Additionally, the location with highest erosion is near the in-channel ELJ's (Figure 11).

Areas of high erosion include the outer banks of each bend, the first near the emergent gravel bar (XS 7 and 8) and the other north of the downstream log structures (XS 12 and 13). Cross-sections 7 and 8 have a maximum vertical change of 2.4 meters and cross-sections 12 and 13 changed 1.2 meters vertically. Bank erosion of 2.7 linear meters occurred at the upstream outer bend (XS 7) between April and May, then another 1.2 linear meters between May and November. Erosion at the downstream bend cut into the bank upwards of 14.9 meters at cross-section 12. Other notable areas of erosion are the side channels on the northern floodplain (XS 1 through 4), which have eroded upwards of 0.6 m. Areas of high aggradation include sedimentation in the upstream riffle (XS 3), the emergent gravel bar, and the increased height of the lateral bar (XS A, B, and C) (Figure 10), aggrading upwards of 1.5 meters (Figure 12).

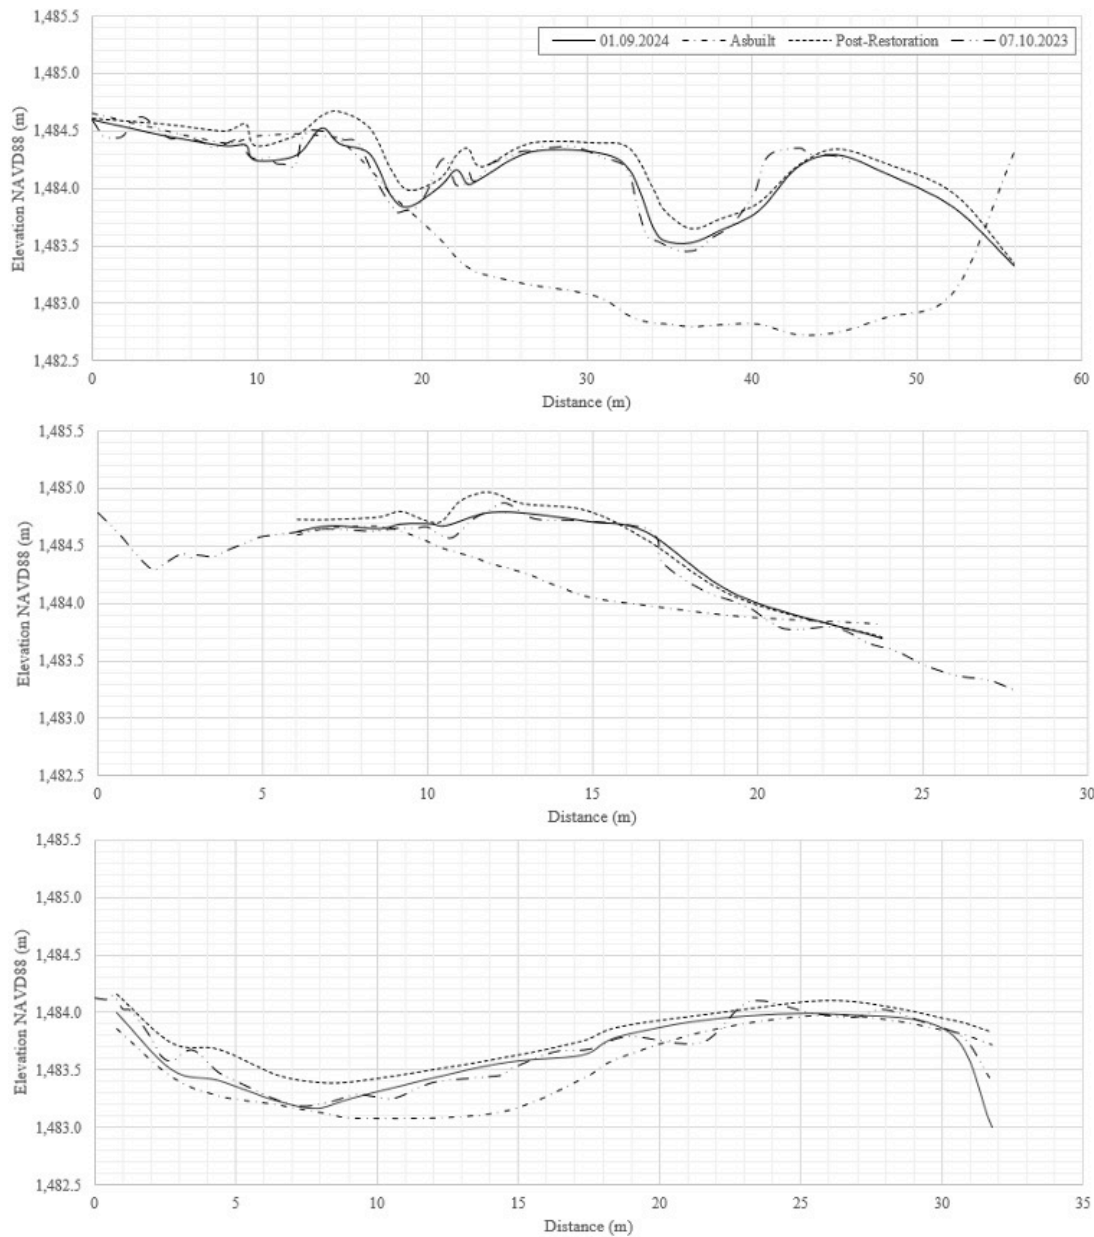
Figure 12. Elevation data for cross-sections A, B, and C.

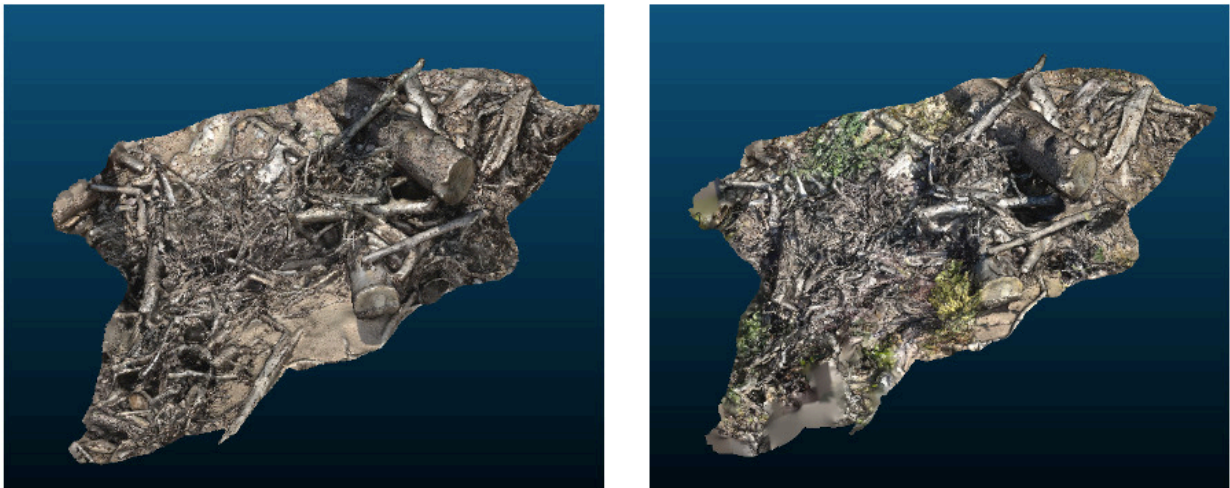
Figure 15. Left. SfM rendering of the front face of ELJ 3 in July 2023. Right: SfM rendering of the front face of ELJ 3 in October 2023. Changes in small woody debris and vegetation presence as it affects volume and porosity calculations.

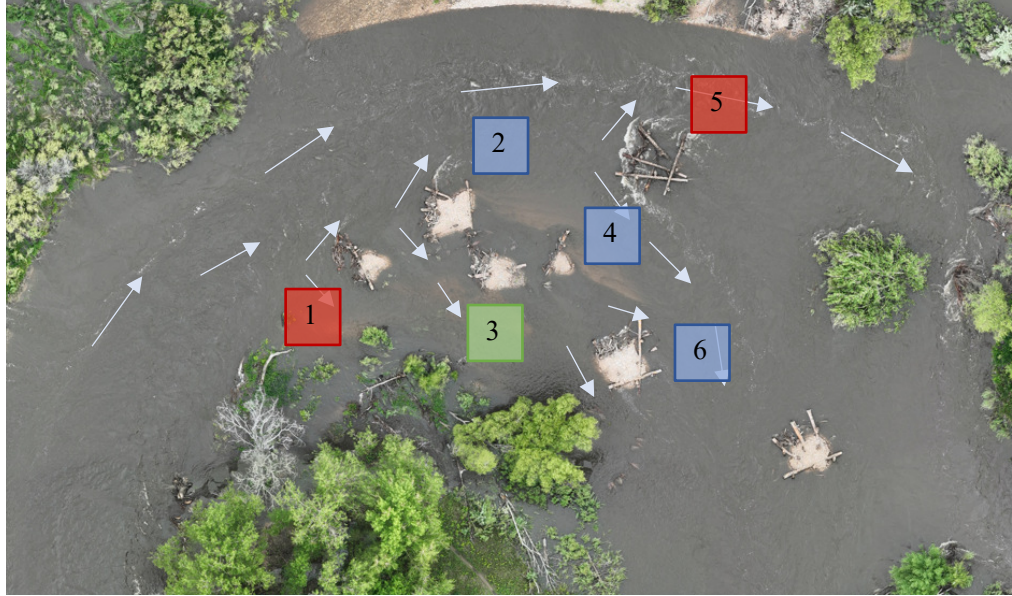
Figure 16. Predicted flow vectors (light blue arrows) at peak flow in response to placement of large wood in the channel. Structures with red outlines indicate a net loss of material due to placement in the flow field, structures with a blue outline indicate a net gain of material with increased packing, while structures with green outlines indicate increased packing and a minimal net loss of volume.

Large wood jam faces placed in areas exposed to unobstructed flow demonstrated a net decrease in volume and increased porosity, addressing my third objective. In contrast, ELJs that were partially sheltered or to the side of the main flow demonstrated a net gain of material and decreased porosity. This shows a threshold below which there is insufficient velocity for transport and above which there is sediment/wood loss due to high velocities. Something to consider is that the delineation of wood accumulated at the front end is difficult to separate from sediment accumulation as there is a layering of wood and sediment. Values do not measure only the change in wood but also the change in sediment. This is because the changes in sediment can obfuscate the changes in wood as it covers the newly accumulated wood or fills in the gaps between newly accumulated wood. Hence, wood volume analysis cannot be separated from sediment. ELJ 3 was an anomaly in categorization because there was reduced porosity and increased volume, demonstrating accumulation as well as pore packing (Figure 15). This is likely due to the placement of the ELJs with respect to other structures and flow paths. In Figure 16, ELJ 3 is sheltered from flow by ELJ 1, 2 and 4. While the flow impacts from ELJ 2 do push velocities towards 3, velocities move along the south side of the ELJs and not towards the front face, which allows sediment and debris to drop out. I expected that the dropping of sediment and wood at this structure would increase volume, but there was a net decrease. Considering the change in volume was one percent, this indicates that smaller debris was likely lodged in microhabitats, decreasing

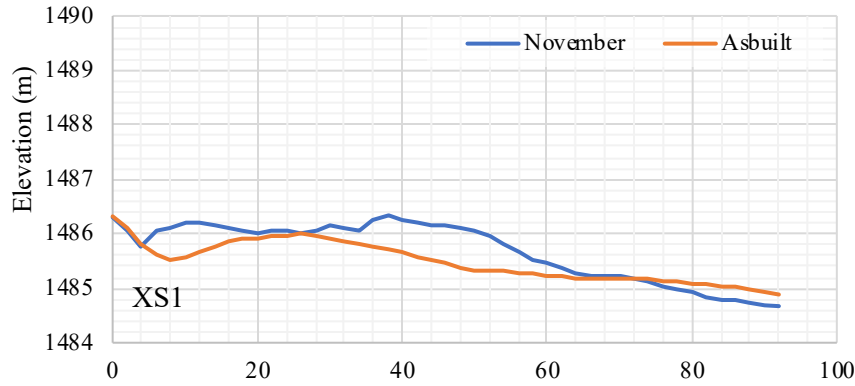
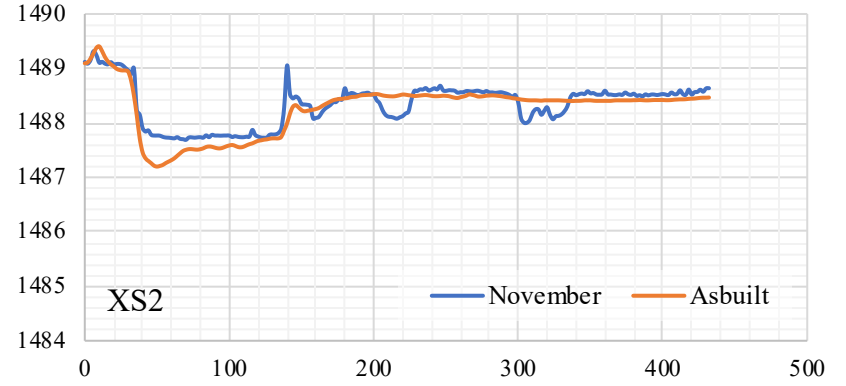
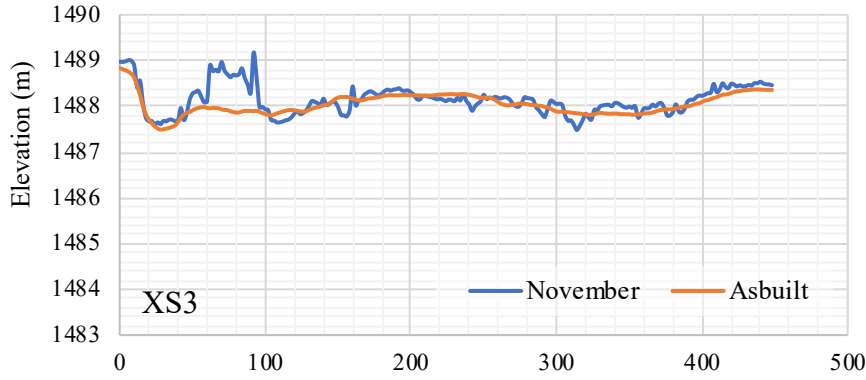
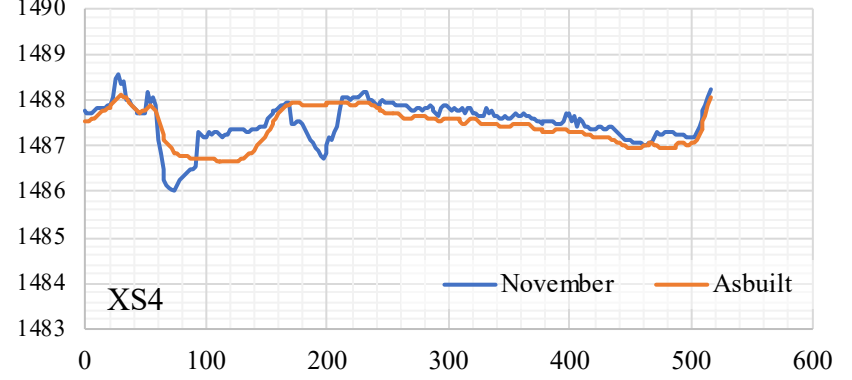
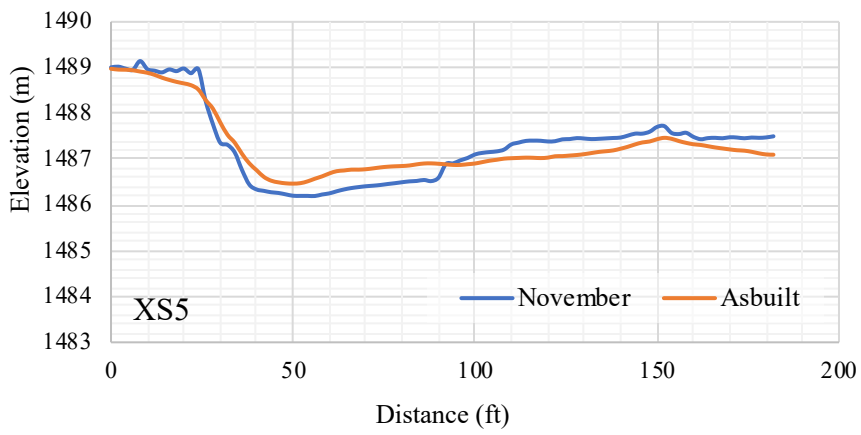
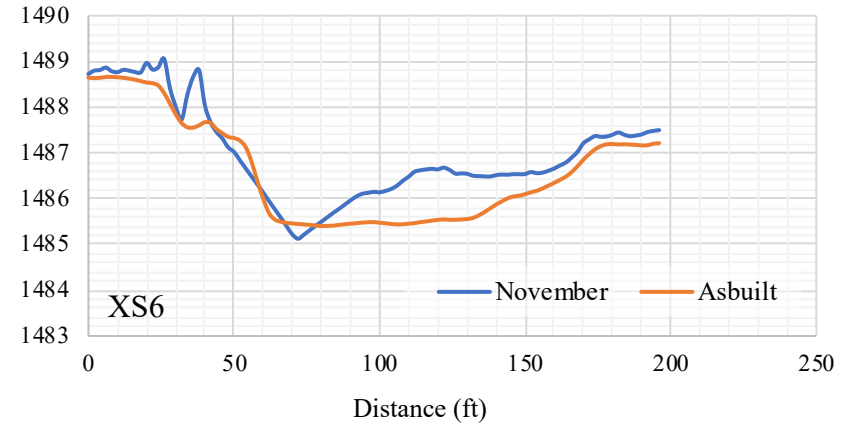
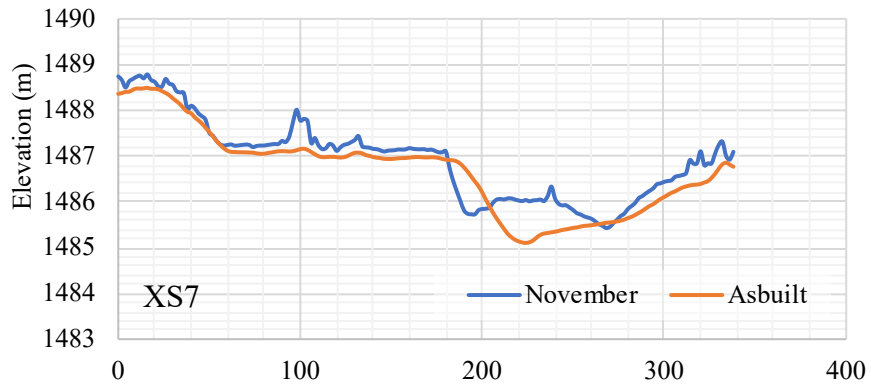
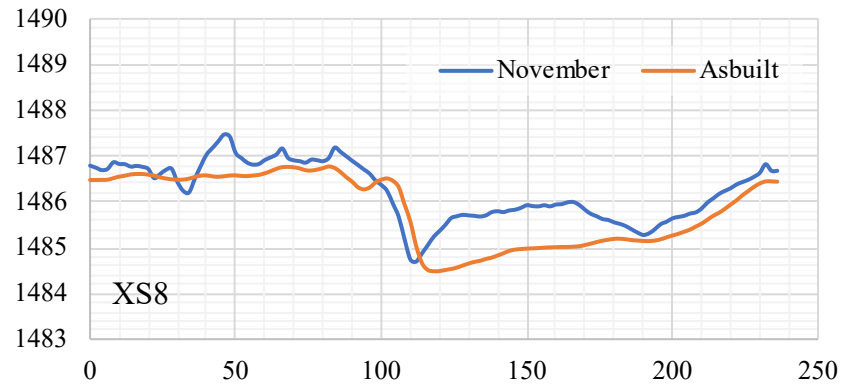
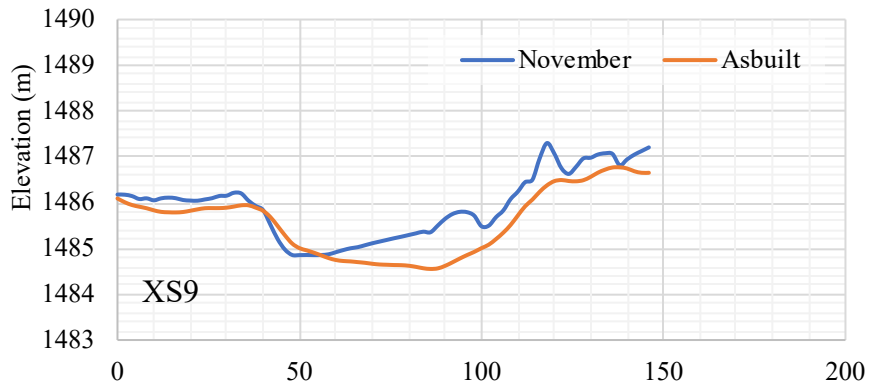
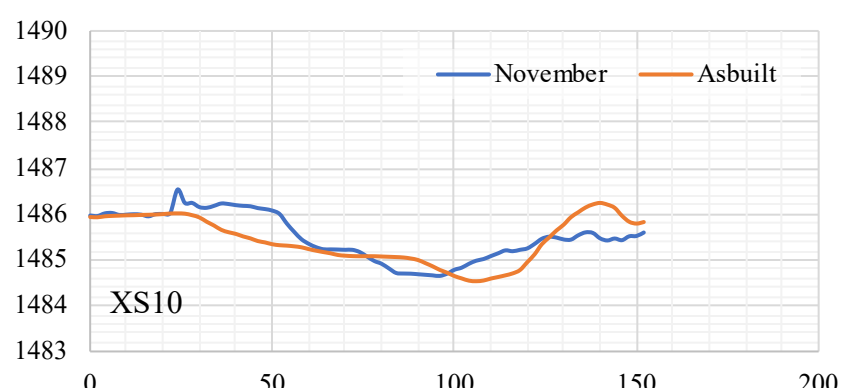
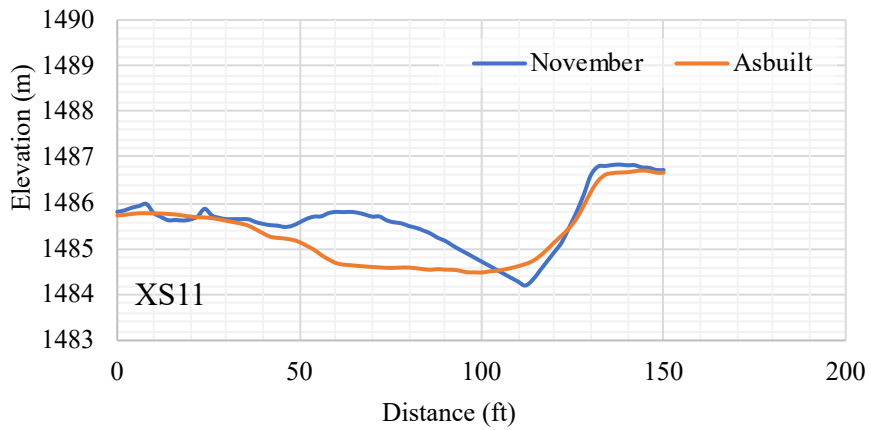
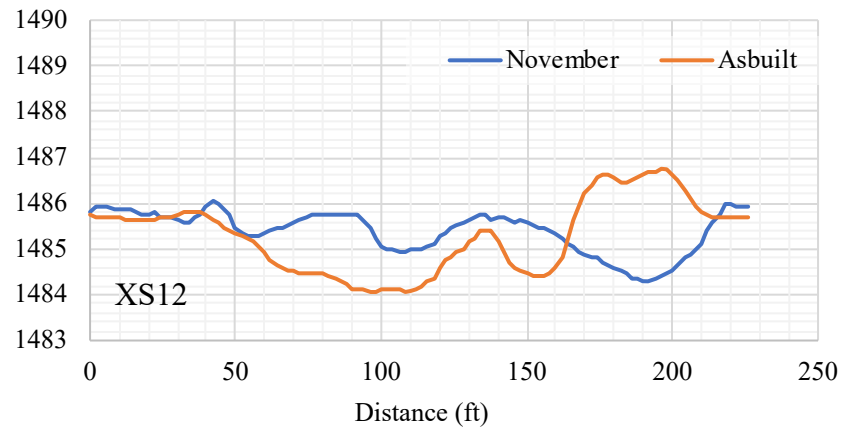
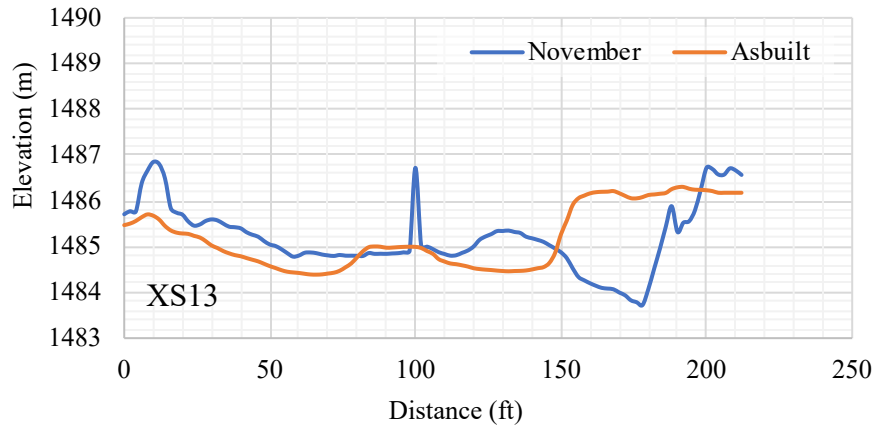
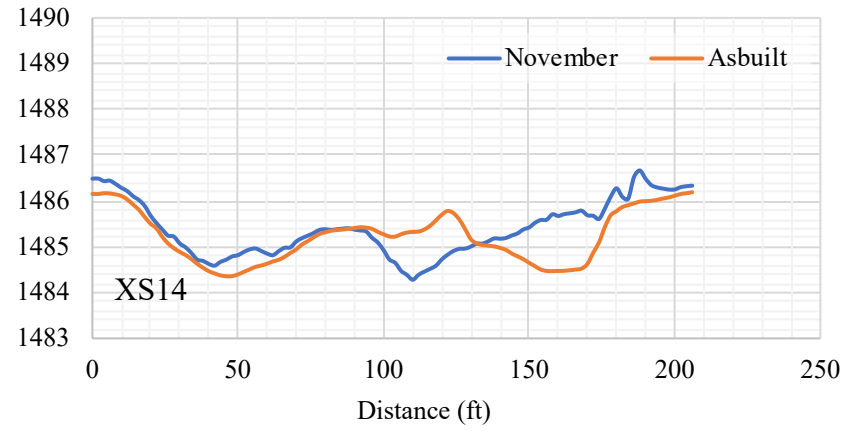
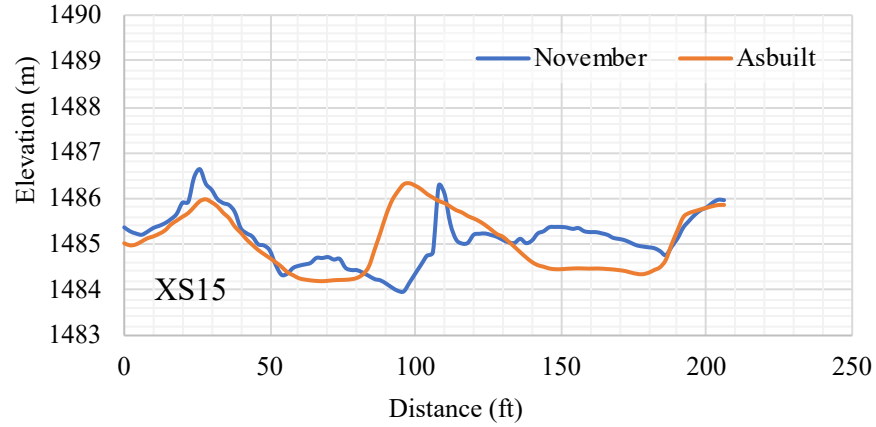
Appendix B

Cross Section	April – January (m ²)	April – January (m ³)
1	9.47	1.74
2	9.64	2.45
3	13.79	2.98
4	15.91	-1.12
5	1.51	-1.35
6	23.32	4.29
7	24.78	3.00
8	28.79	5.93
9	16.08	2.43
10	3.76	2.02
11	14.20	3.93
12	7.76	2.11
13	-0.85	-2.35
14	10.58	1.71
15	3.76	0.06
