Historical Forest Structure on the Uncompahgre Plateau: Informing restoration prescriptions for mountainside stewardship

Prepared by the Colorado Forest Restoration Institute,
Colorado State University, Ft Collins, CO 80523
August 2008

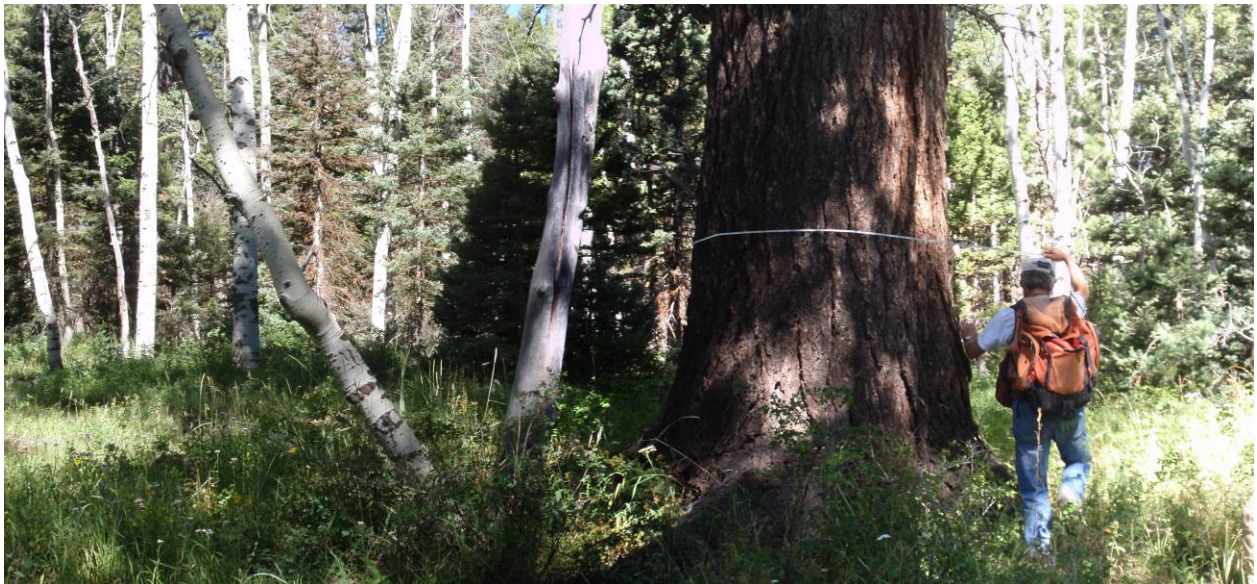
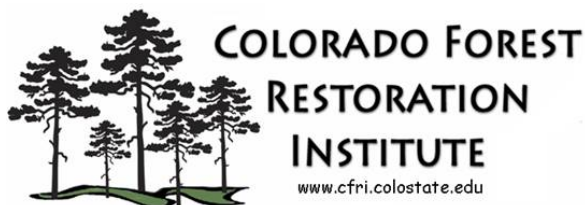
Contacts: Dan Binkley (dan@cnr.colostate.edu), Bill Romme (romme@cnr.colostate.edu), Tony Cheng (chengt@cnr.colostate.edu)

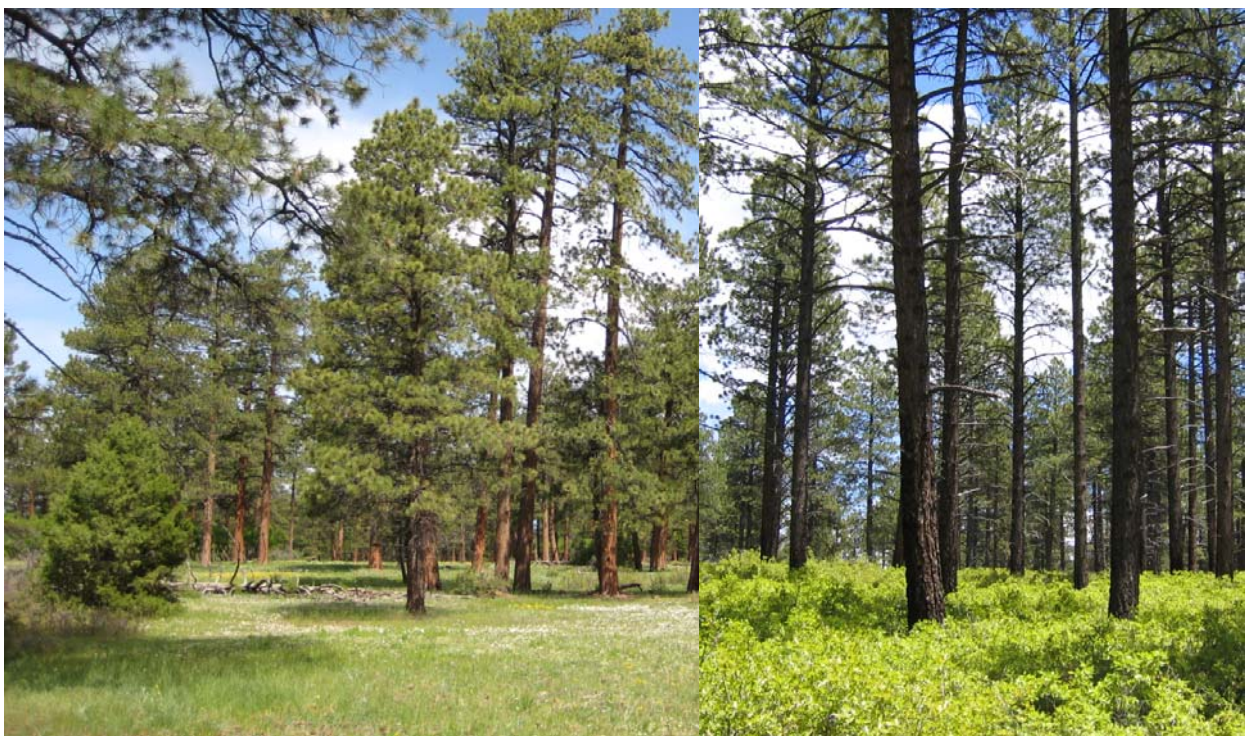
Figure 2. In 1875, most (all?) of the lower elevation ponderosa pine forests had low density of trees, clumped within a mosaic of meadows or Gambel oak. We don't know how dominant the meadow type or shrub type was; historical records are not very helpful, and any hidden clues still on the landscape would take intensive research to find.

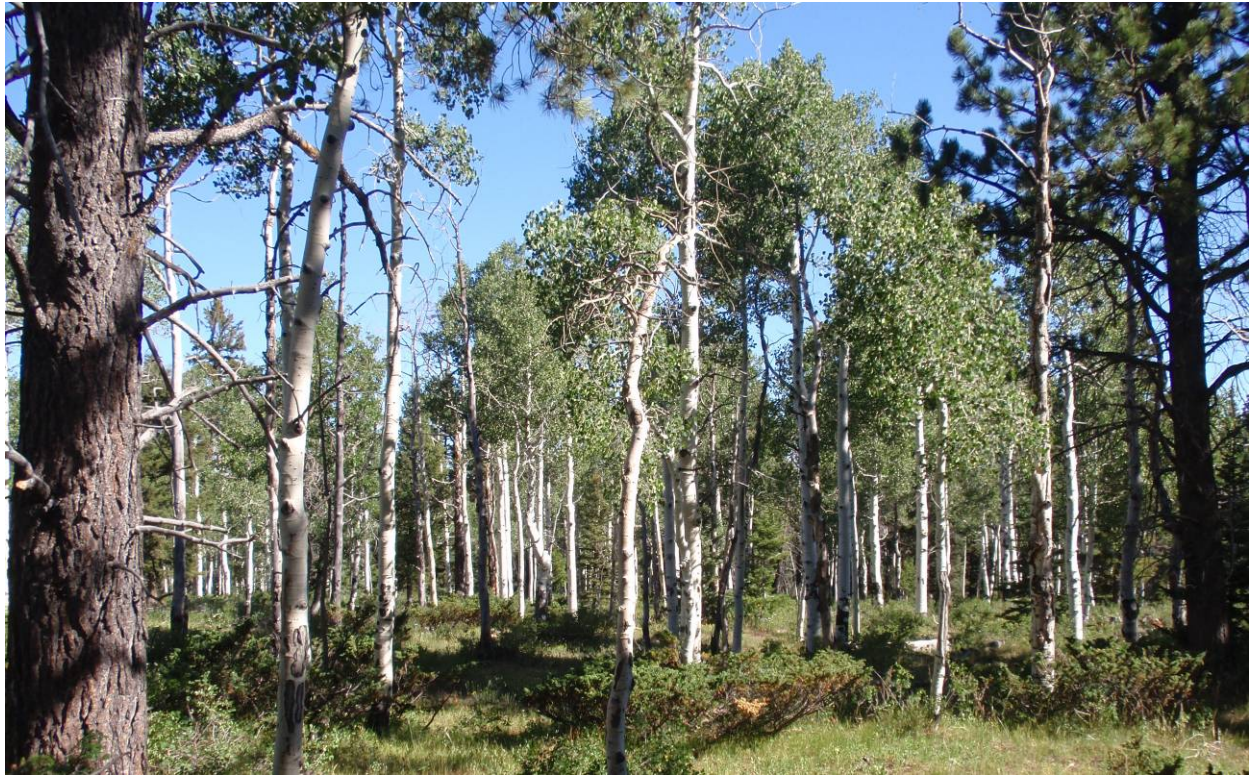
Figure 3. In 1875, moister sites with ponderosa pine trees had substantial amounts of aspen. The aspen cover in most of these forests has declined, as evidenced by large numbers of decaying aspen logs. Some locations have increased densities of younger pine, Douglas-fir and spruce.

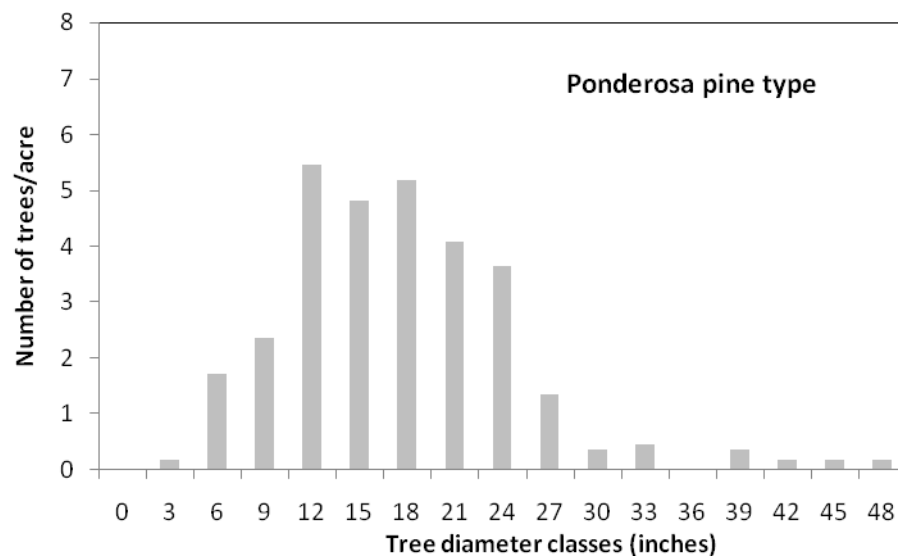
aspen reconstructions in the Front Range), given the widespread presence of aspen stems in many ponderosa-pine type stands. The forests in 1875 could have had many aspen trees that died (after the 1879 fire, or more gradually) and decomposed. Across all plots, the average forest structure was characterized by a few large pines (including some greater than 3 feet in diameter), a relatively even distribution of medium-size trees (1-2 feet in diameter), and relatively few small trees. Again, more small trees may have been present in 1875, leaving no trace to be detected 125 years later.
