**Survey of Critical Wetlands
Bureau of Land Management Lands
South Park, Park County, Colorado
2003-2004**

**Prepared for the
Royal Gorge Field Office
3170 East Main Street
Cañon City, CO 81212**

September 2004

Prepared by:
**Denise R. Culver
September 2004**

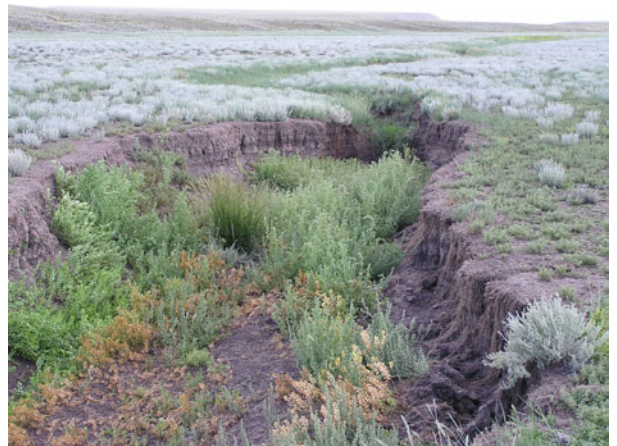
Agate Creek dry gully

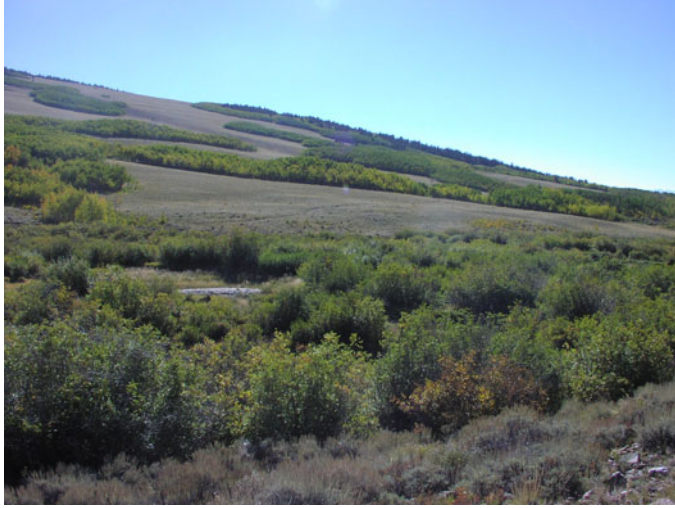
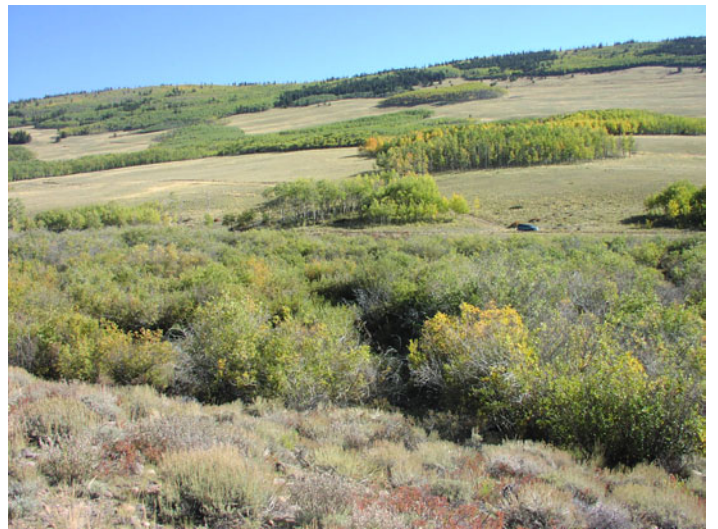
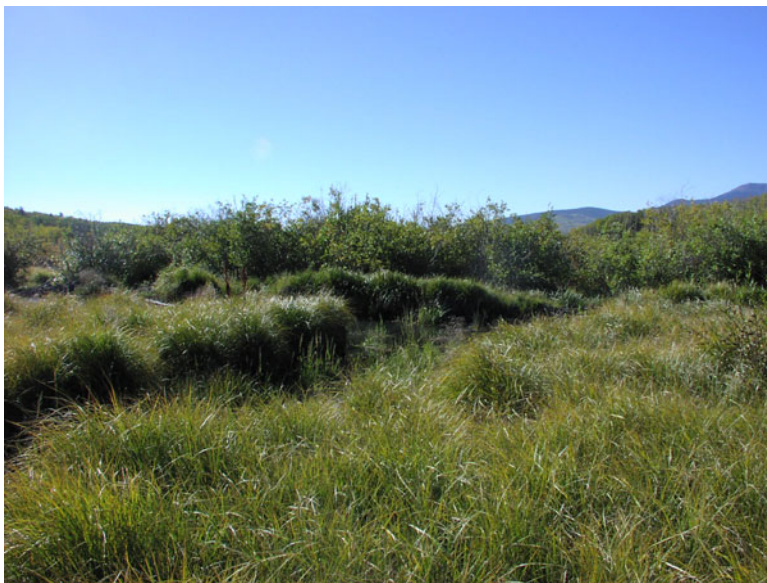
Sheep Creek Willow Carr

Wetland’s viability could be affected by future activities upstream on private property, e.g., improper grazing or other forms of altered hydrology.

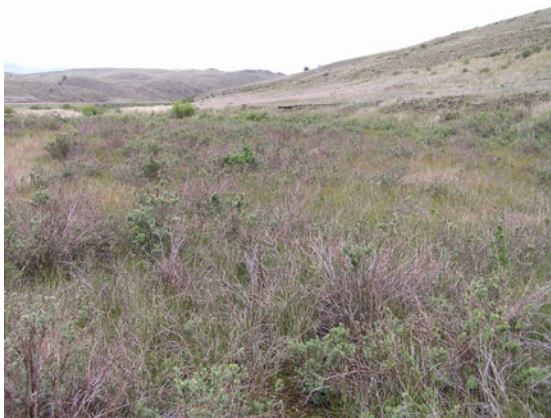
Randall Ditch

Nonfunctional _____ X _____

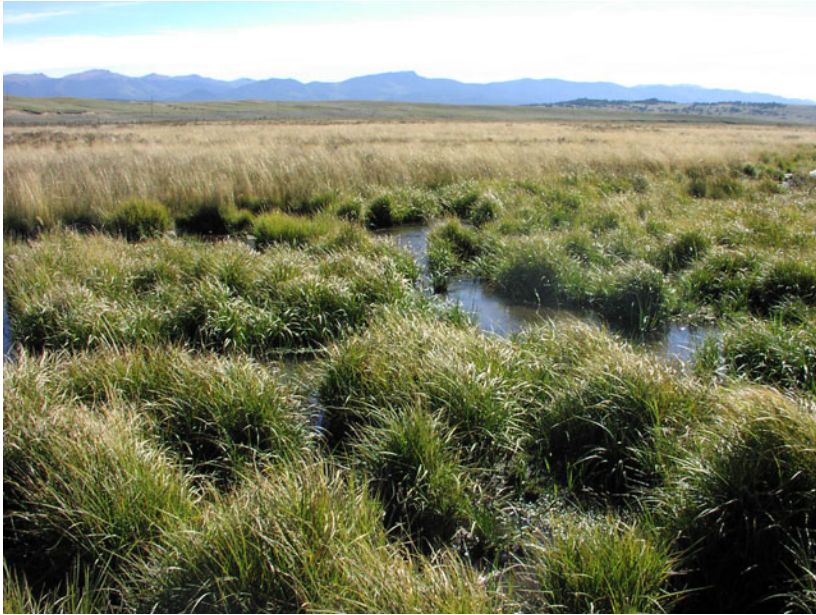
The ultimate goal for this parcel is protect stream banks and wet meadows from intense grazing.

Carex utriculata wetland next to Tarryall River

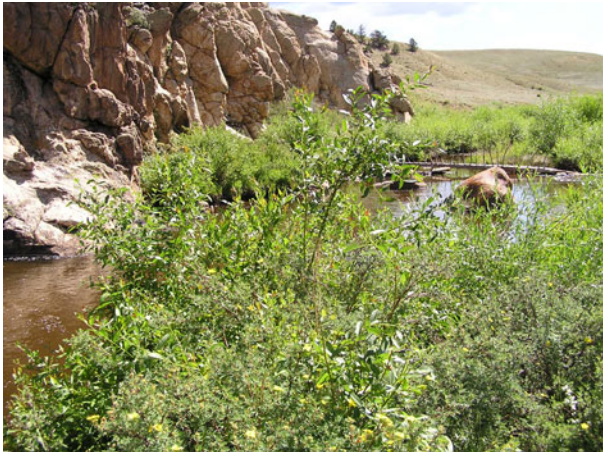
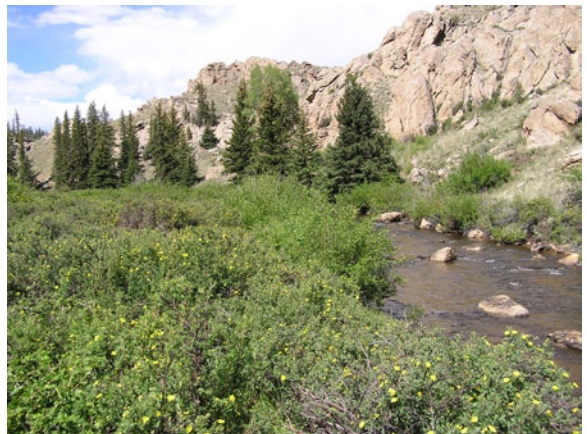
Tarryall River East

If the Tarryall River has minimal stream flow and allowed to flood on a seasonal basis, the goal for this parcel could be to leave as is, for currently it appears to functioning properly.

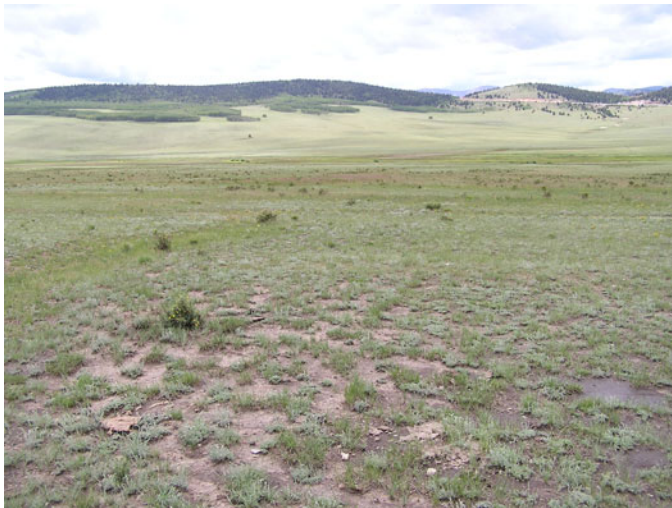
Shortgrass prairie on Trout Creek/ CR 7 Parcel

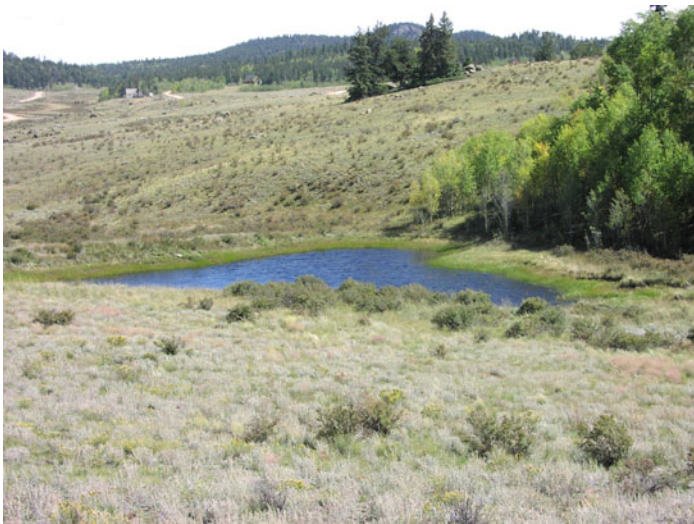
The pond is located in a natural depression but is enhanced by the human made berm. Ecological status is dependent on the structure.

Indian Gulch Pond with *Eleocharis palustris* and *Carex utriculata* encircling pond

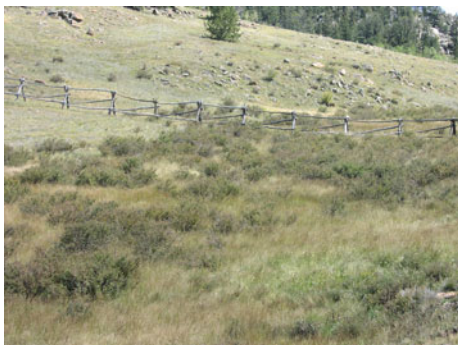
Dasiphora floribunda plant association

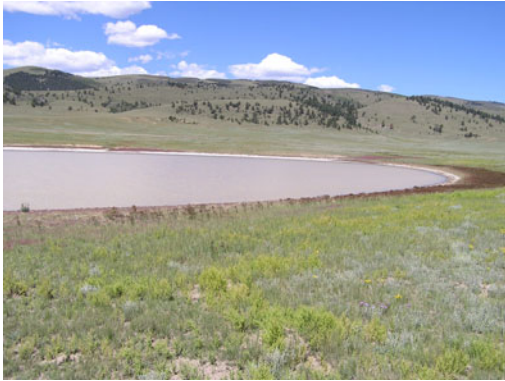
Middle Playa

Monitoring of grazing is essential to prevent degradation of shores and hydrology. Elk, deer and pronghorn use area, likely a main water source for wildlife.

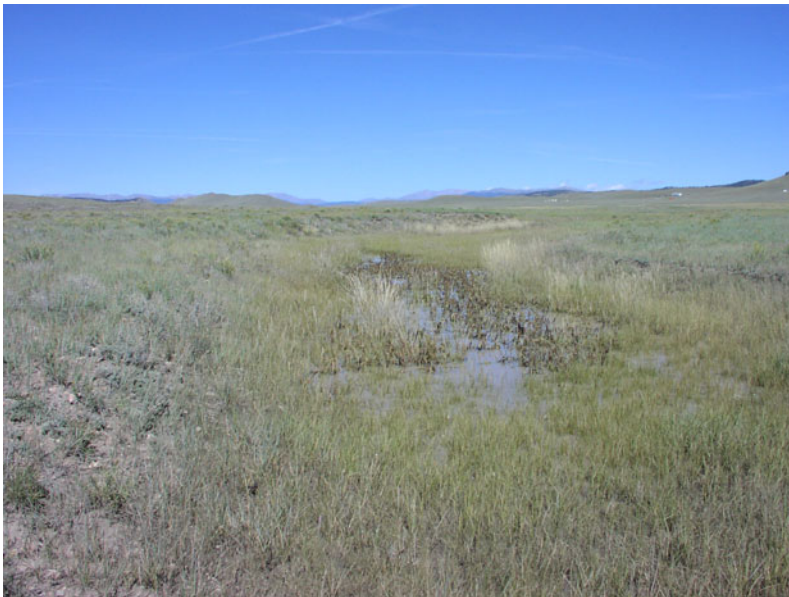
James M. Jones SWA
Intermittent stream with *Juncus*
balticus wetland

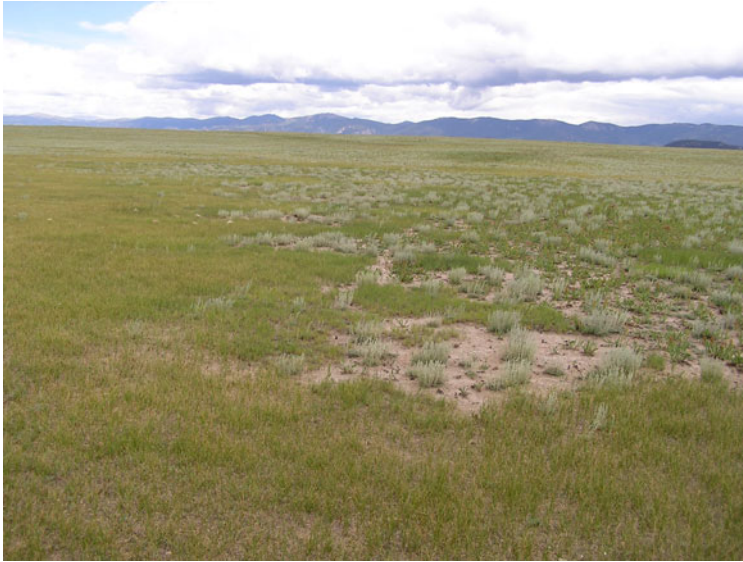
Natural depressions at Steel Gulch
