THESIS

EVALUATING THE LONG-TERM DURABILITY OF FIBER REINFORCED
POLYMERS VIA FIELD ASSESSMENTS OF REINFORCED CONCRETE
STRUCTURES

Colorado State University

Fall 2011

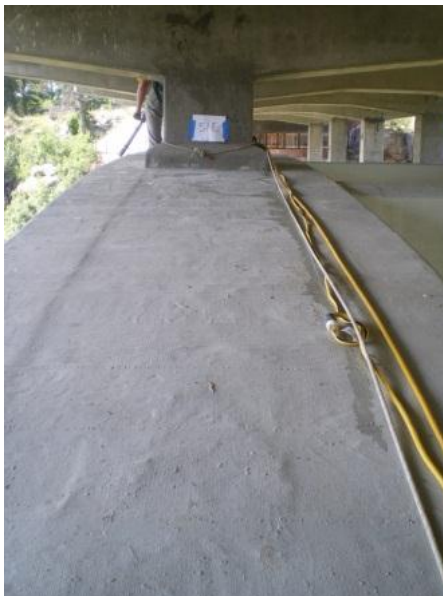
Bay 5NE: No Defects Found

Figure A14. Bay 5NE

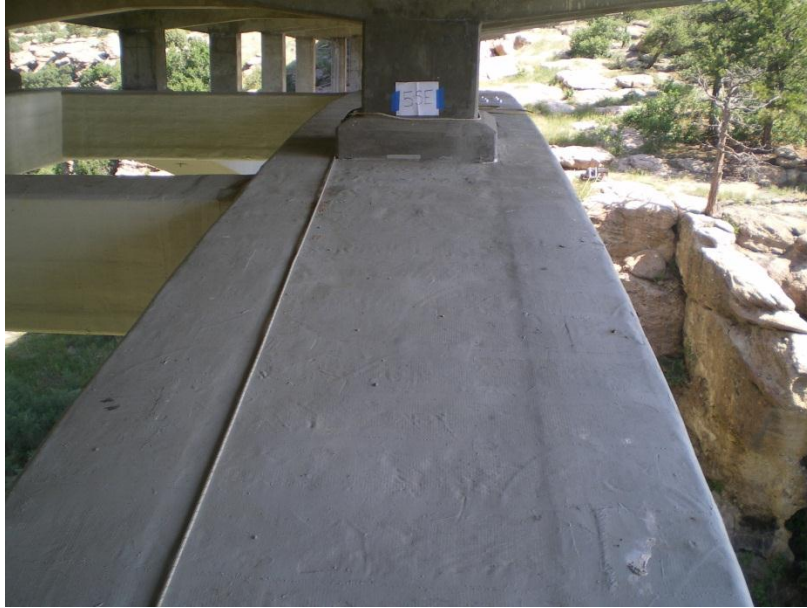
Bay 5SE: No Defects Found

Figure A15. Bay 5SE

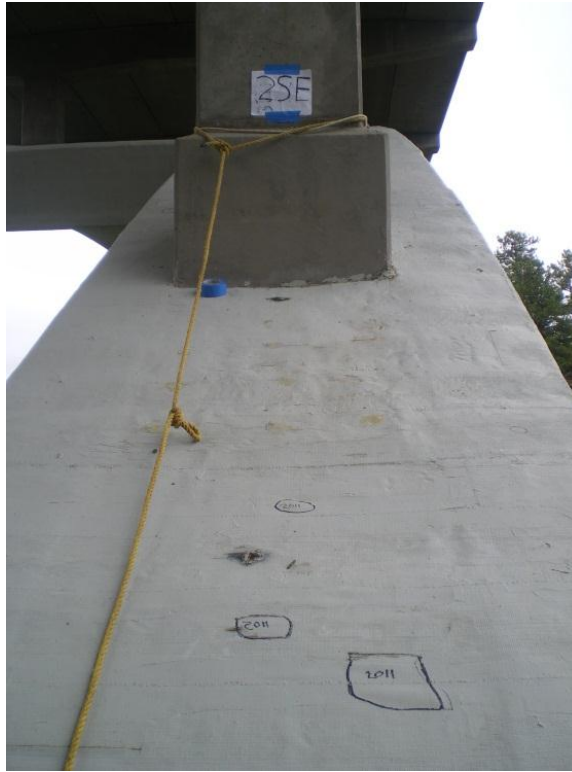
Bay 2SE: 3 Voids

Figure A20. Bay 2SE

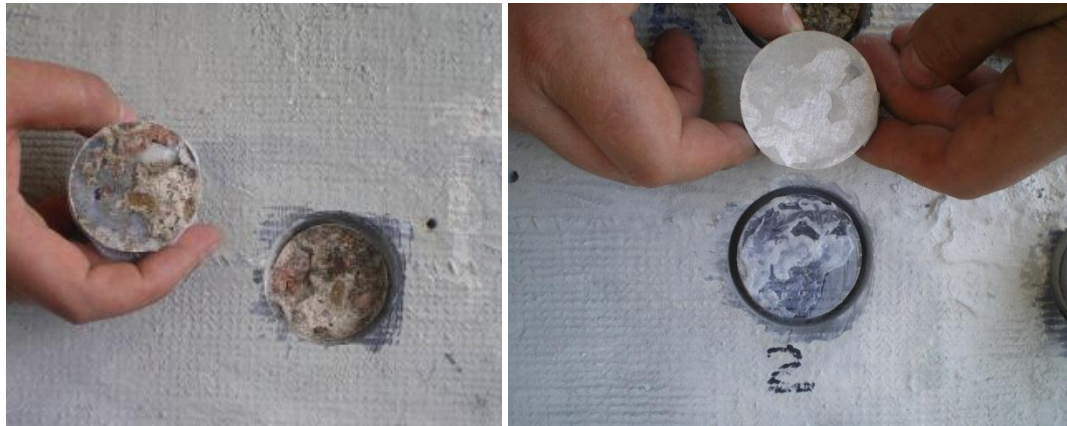
Figures B1 and B2. Tests No.1 and 2

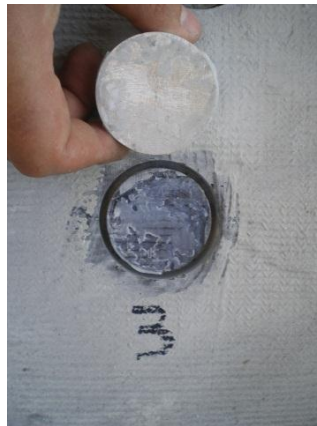
Figure B3. Test No.3, Photograph of Test No.4 is not available

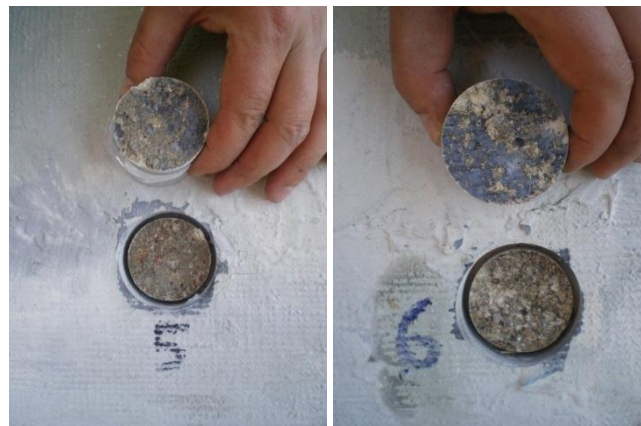
Figures B4 and B5. Test No.5, note puck slid off of center while epoxy was setting, and Test No. 6

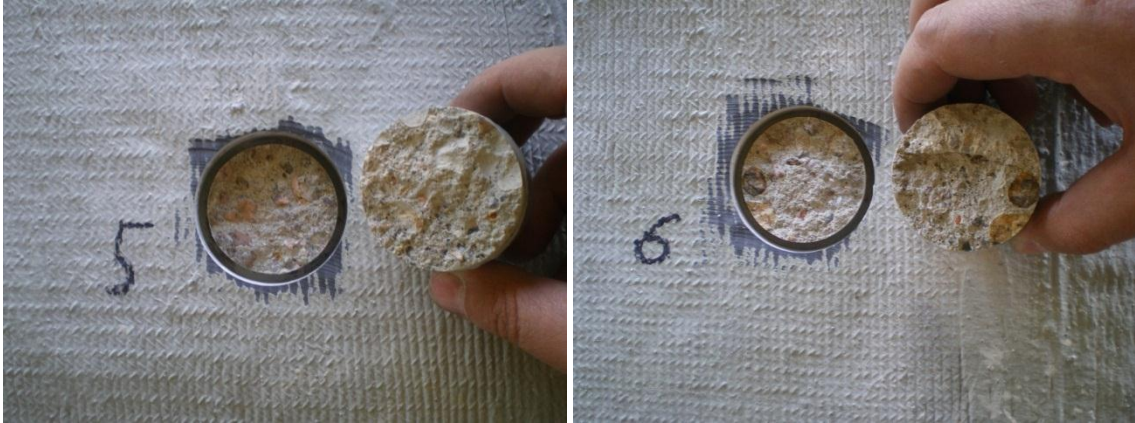
Figures B20 and B21. Test No.23, weak bond strength (poorly mixed concrete?), and Test No.24

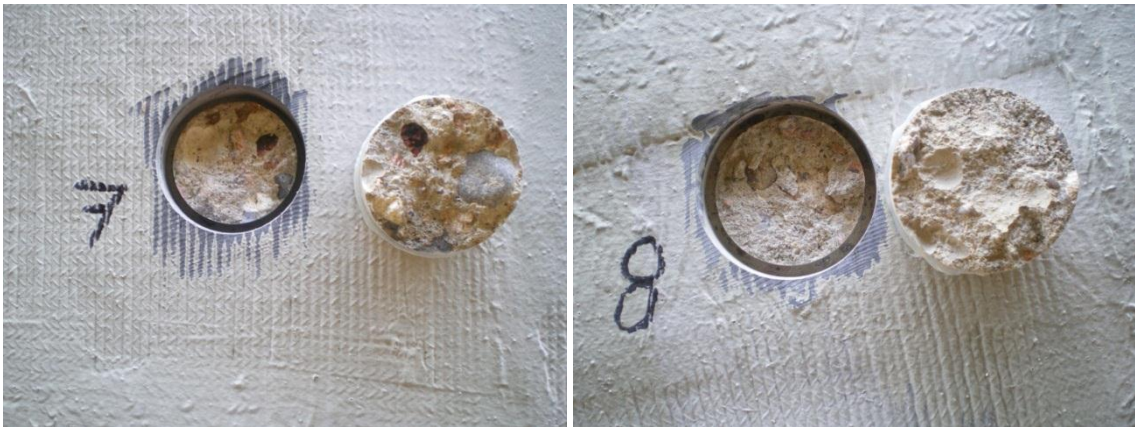
Figures B22 and B23. Test No.25 and Test No.26, note very weak bond strength (poorly mixed concrete?)

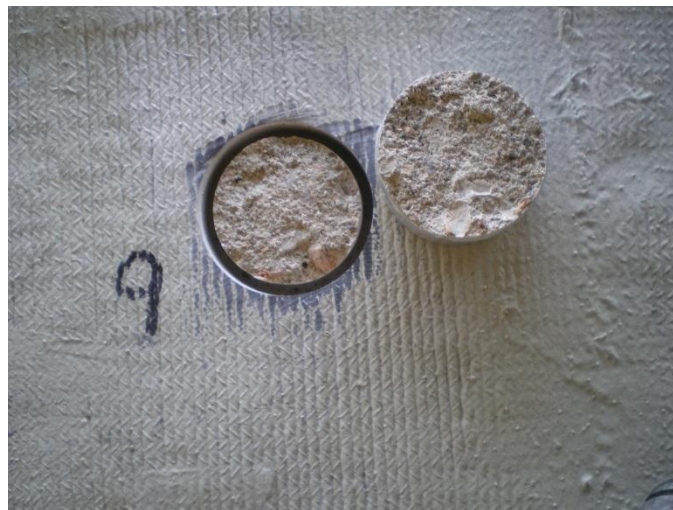
Figure B24. Test No.27
